Project:  
**MERIVALE AND JAMIE  
 AUTO GARAGE**  
 1871 MERIVALE ROAD  
 OTTAWA, ONTARIO

Drawing:  
**TREE CONSERVATION  
 REPORT**

Scale: 1:300 Date: 09 SEP, 2014  
 Design By: SH Drawn By: SH  
 Project Number: 1887-02 Sheet Number: TCR 01

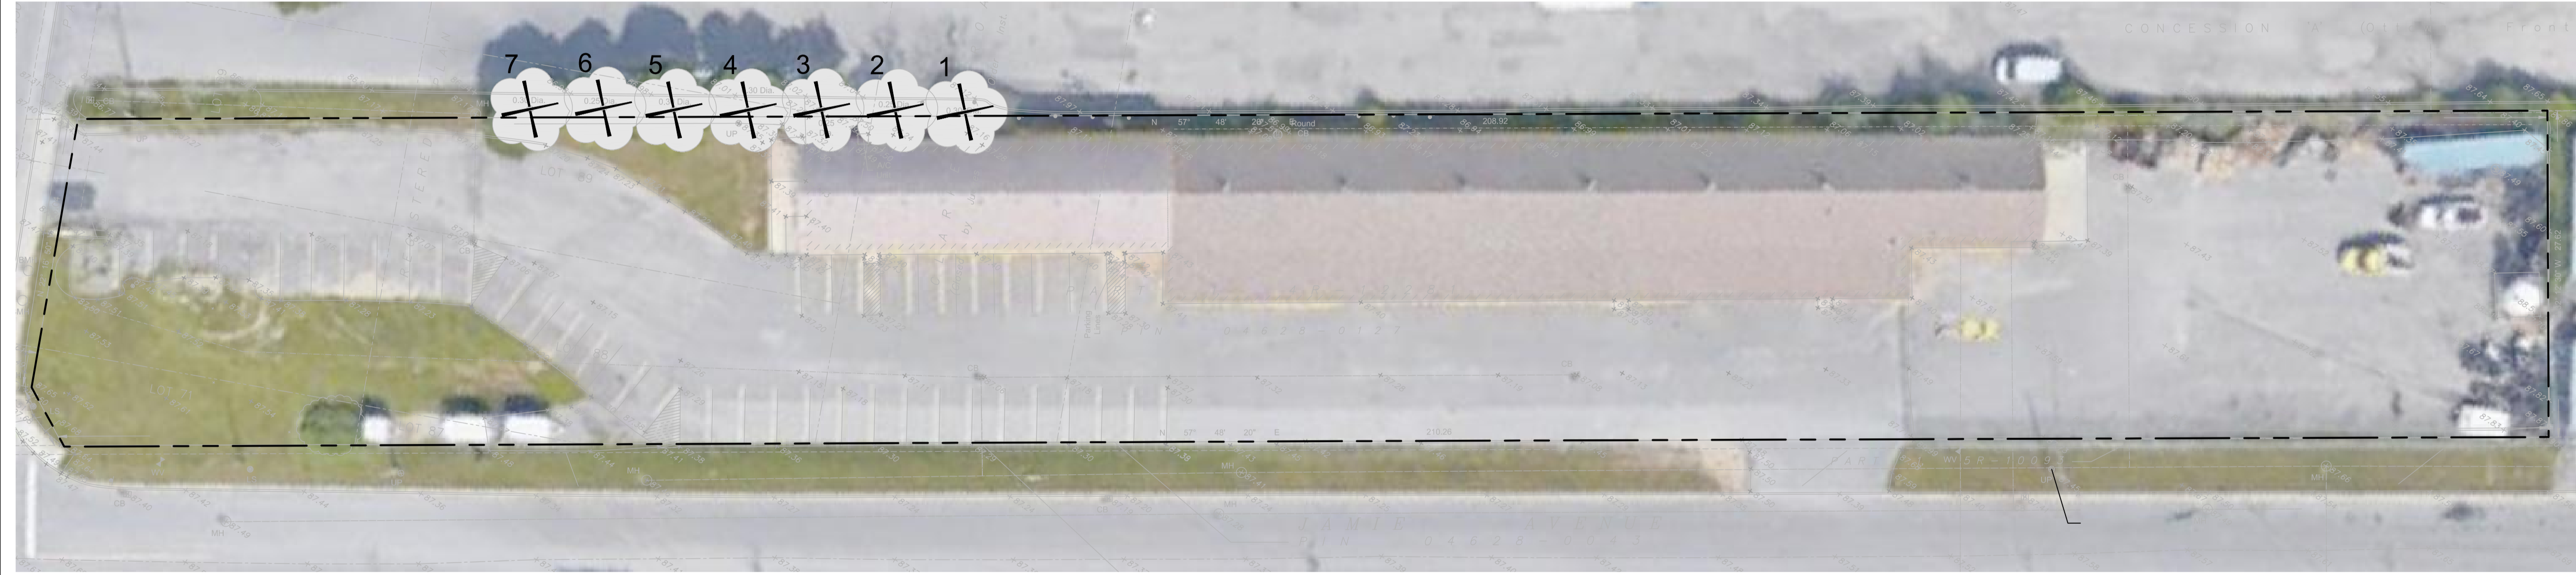
TREE INVENTORY PLAN – AERIAL PHOTOGRAPHY:

THERE IS A ROW OF SEVEN TREES ALONG THE NORTHERN PROPERTY LINE THAT WILL BE REMOVED TO ACCOMMODATE THE PROPOSED BUILDING. A PORTION OF THE SOFT LANDSCAPE IS REQUIRED TO BE REMOVED. THIS IS NECESSITATED BY THE NATURE AND SCALE OF THE PROPOSED USE. THIS WILL HAVE IMPACT ON THE DRAINAGE OF THE SITE, PLEASE REFER TO THE CIVIL LOT GRADING AND DRAINAGE PLAN.

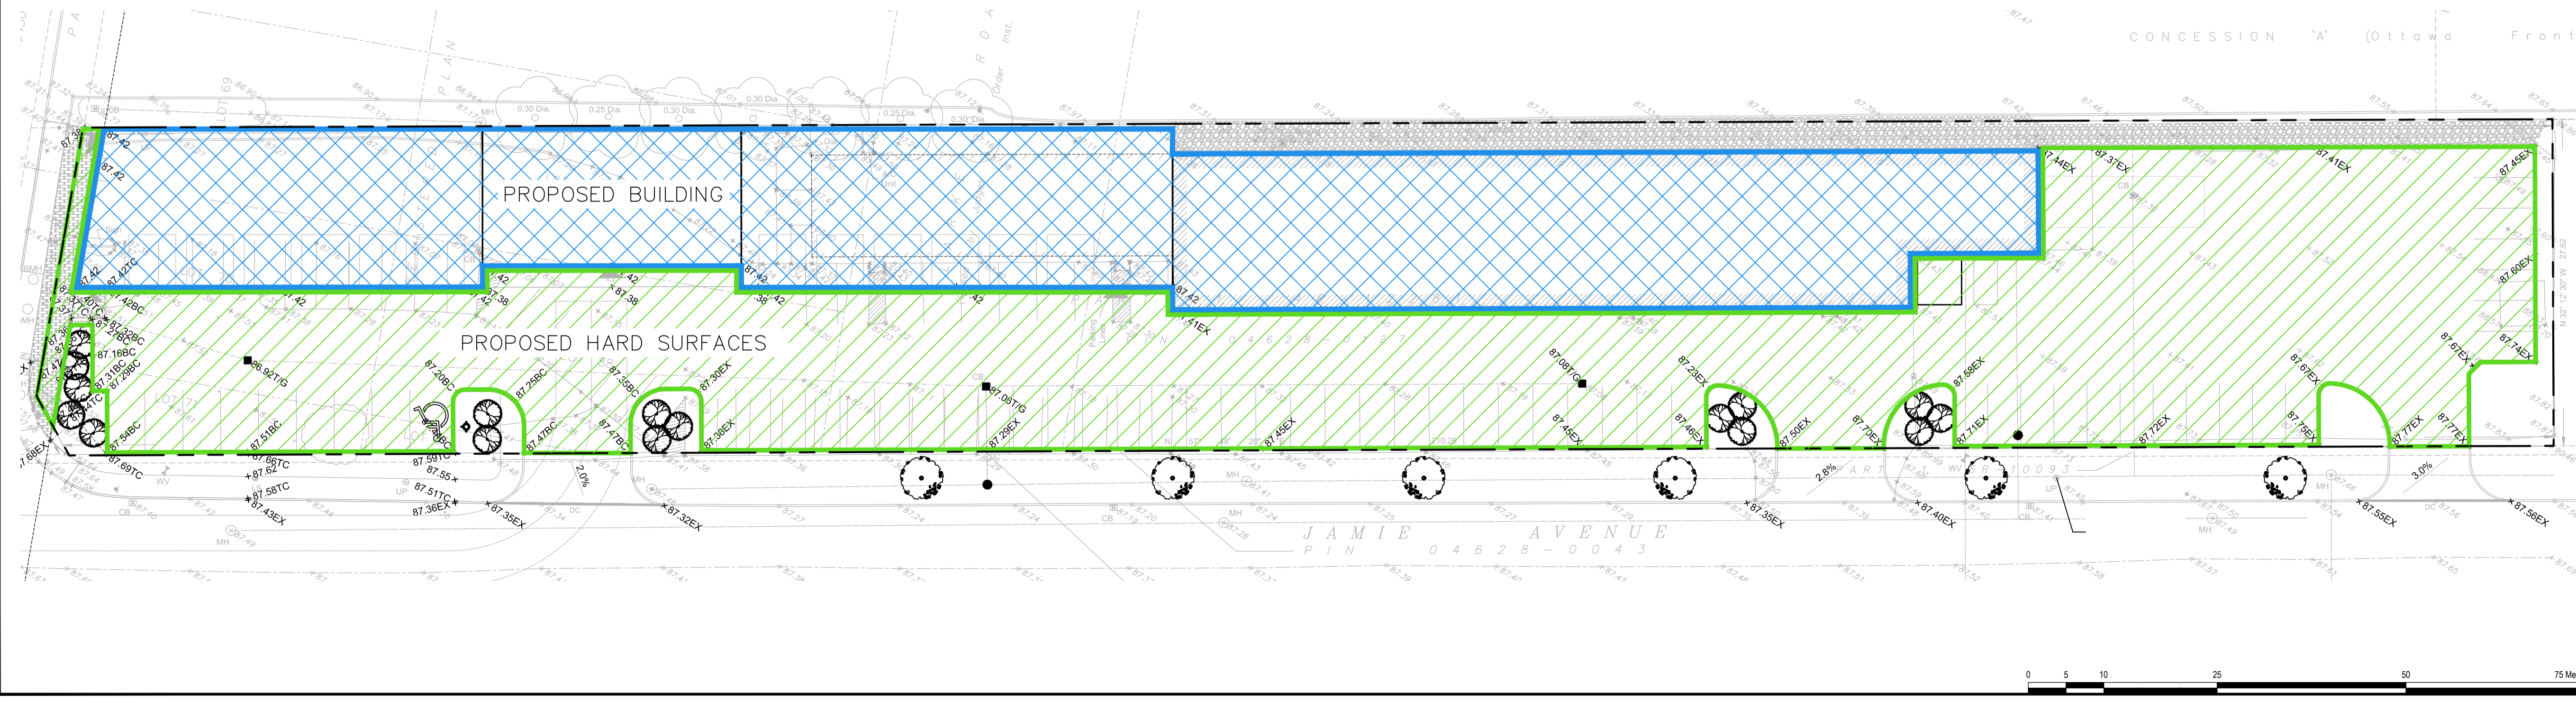
TREE INVENTORY PLAN – PROPOSED DEVELOPMENT:

- THE PROPOSED LOSS OF TURF/ TREE AREA FOR THIS DEVELOPMENT WILL BE APPROXIMATELY 326 m<sup>2</sup>.  
 - APPROXIMATELY 326 m<sup>2</sup> TO BE COVERED WITH NEW HARD SURFACE
