SITE DESCRIPTION:

THE SITE INCLUDES AN EXISTING 2-STORY OFFICE BUILDING WITH ASPHALT ACCESS DRIVE AND PARKING AREAS AND UNIT PAVED PATHWAYS. THE ENTRANCE AREAS AND PERIMETER OF THE EXISTING BUILDING ARE MAINTAINED AS MOWN GRASS LAWNS WITH MATURE CONIFERS WITH PERIMETER AREAS OF UNMAINTAINED WOODLOT TO THE WEST AND SOUTH OF THE SITE. THE SITE IS GENERALLY FLAT WITH A SHORT BANK ALONG THE SOUTHERN BOUNDARY AT AKERSON ROAD AND THE ASPHALT MUP.

TREE CONSERVATION PLAN  
EXISTING CONDITIONS

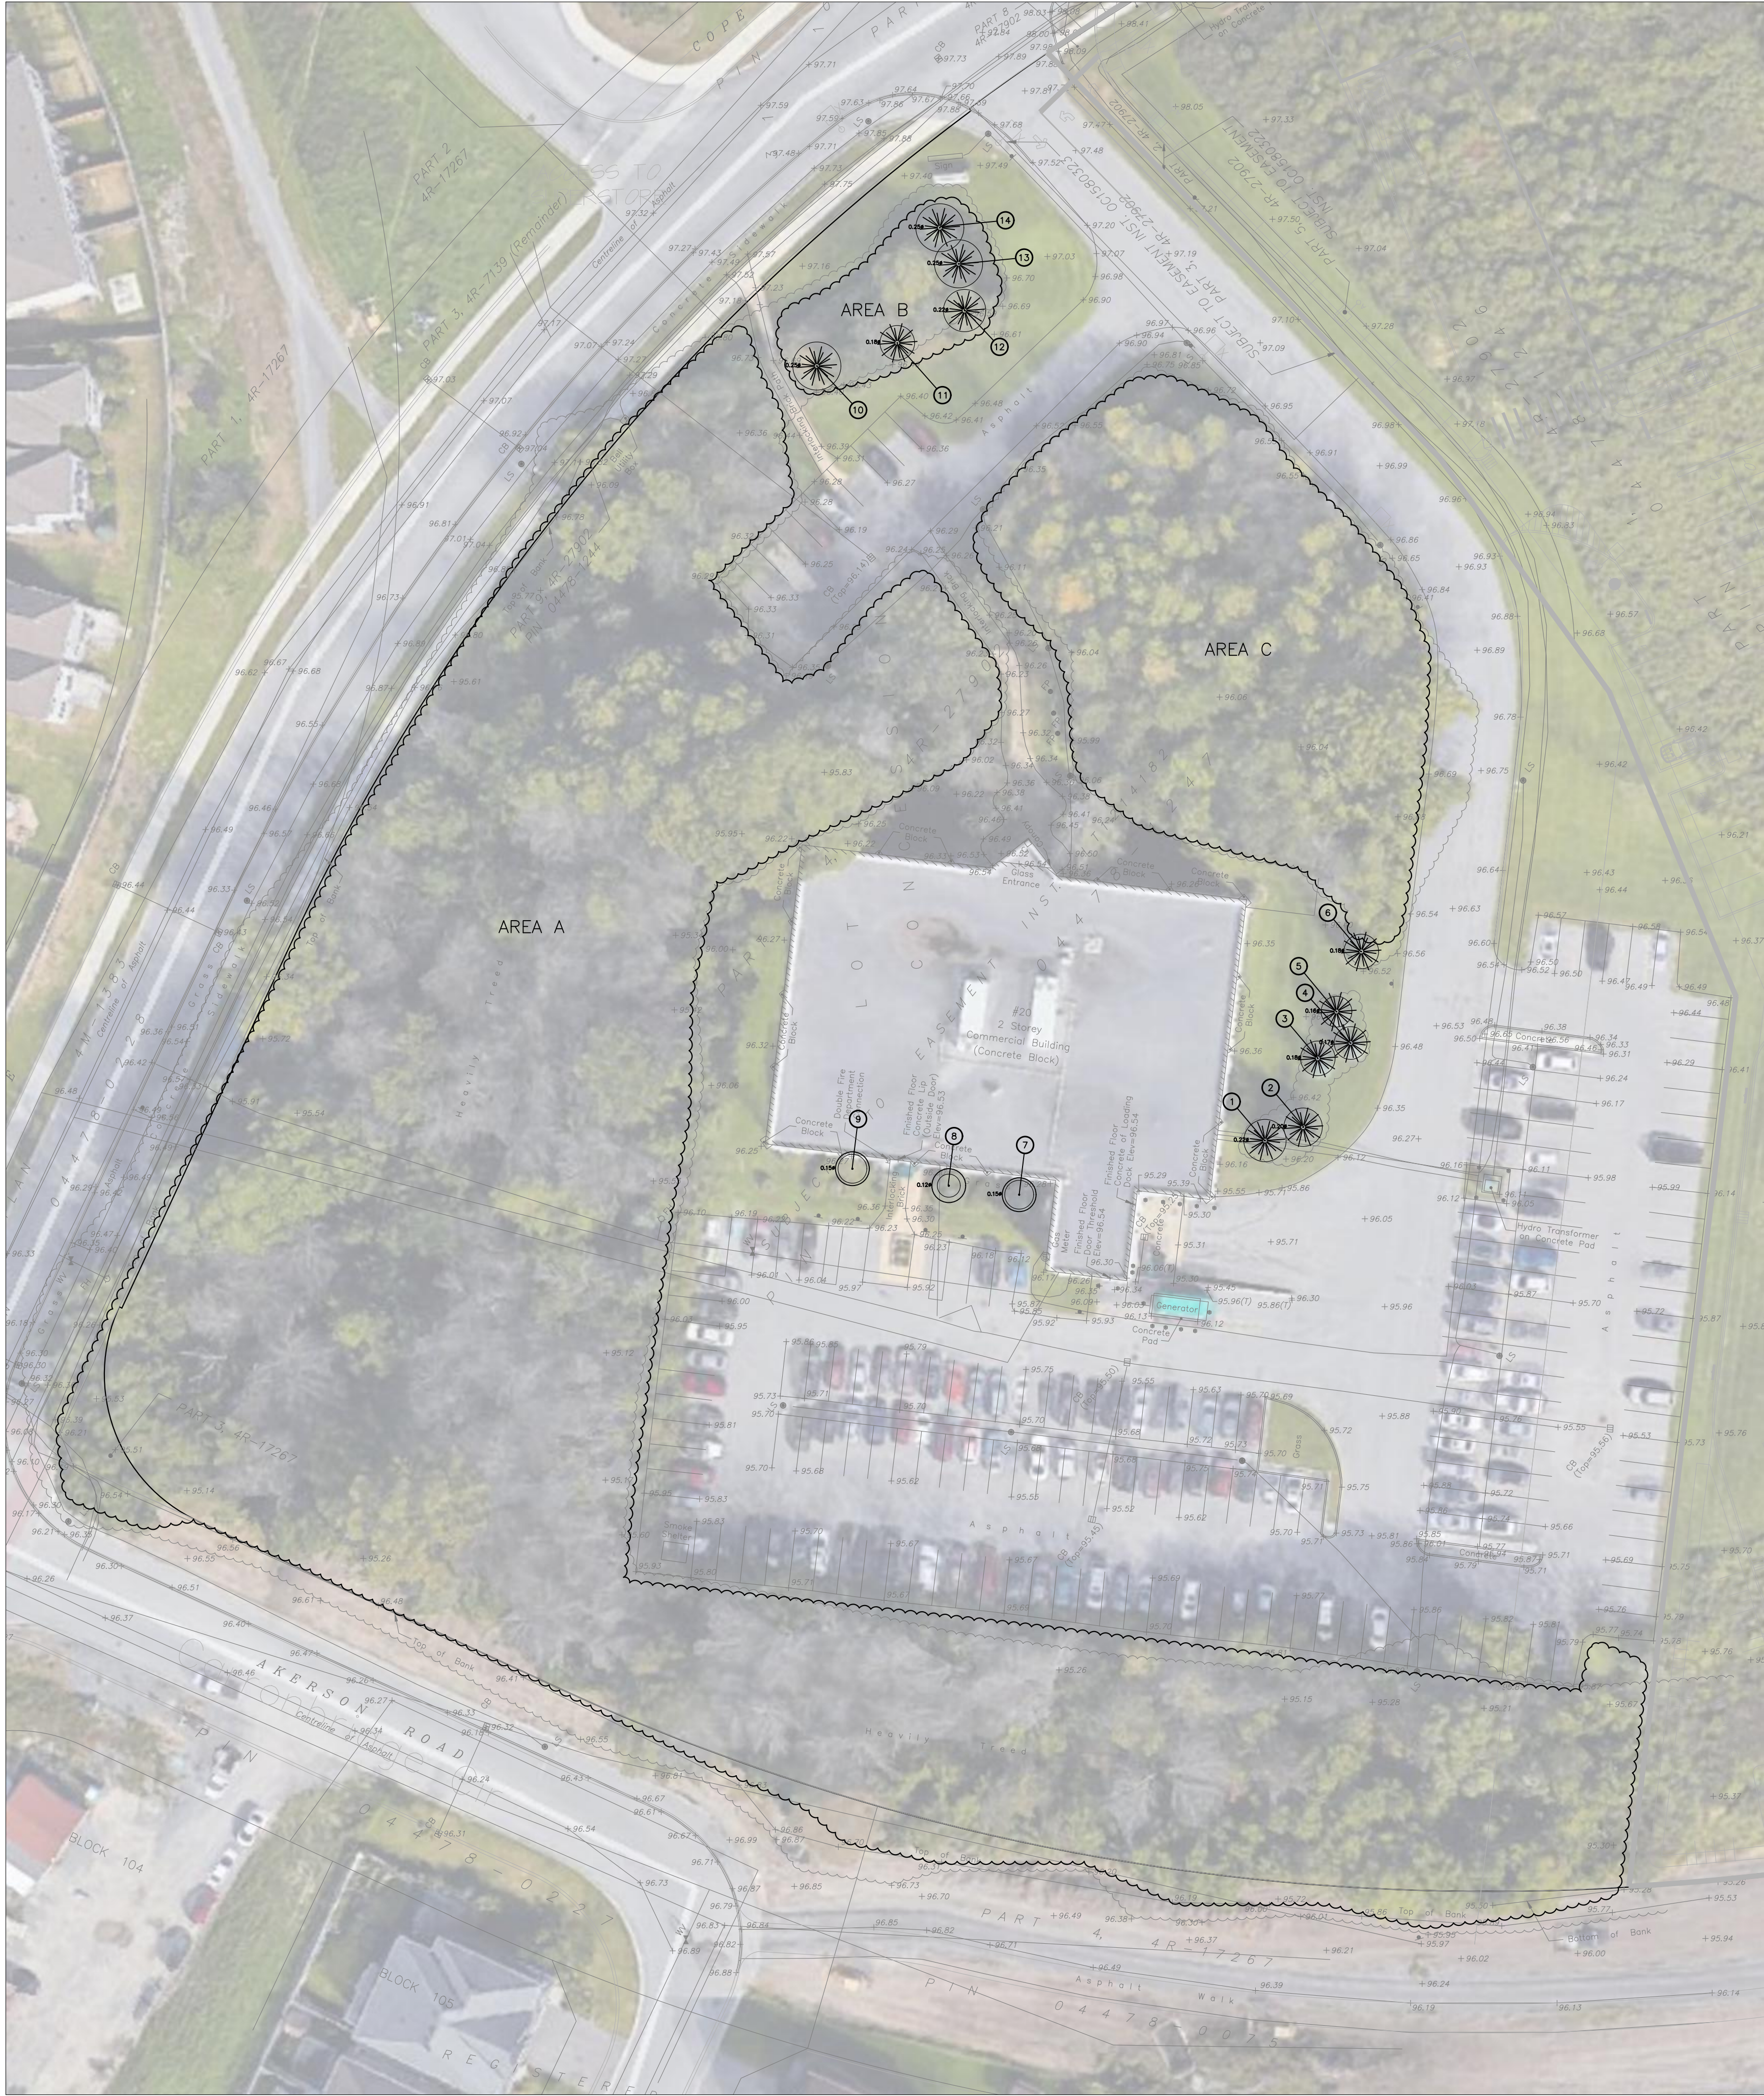
THE SOUTHERN BOUNDARY OF THE SITE IS BORDERED BY A 5-8m WIDE STRIP OF MOWN GRASS BETWEEN THE WOODLOT EDGE AND EXISTING MULTI-USE PATHWAY.

CURRENT SITE BOUNDARY / AREA IS 20,699m2. THIS DEVELOPMENT PROPOSES THE FOLLOWING:

- EXISTING CONDITIONS
- APPROXIMATELY 1,394m2 OF EXISTING BUILDING
  - APPROXIMATELY 6,936m2 OF EXISTING HARD / NON-PERMEABLE PAVING

- PROPOSED DEVELOPMENT
- APPROXIMATELY 1,455m2 OF NEW BUILDING
  - APPROXIMATELY 5,169m2 OF NEW HARD / NON-PERMEABLE PAVING

- DEVELOPMENT TOTALS
- APPROXIMATELY 2,849m2 TOTAL BUILDING AREA
  - APPROXIMATELY 9,421m2 TOTAL HARD / NON-PERMEABLE PAVING
  - PLANTING OF 60 NEW DECIDUOUS TREES
  - PLANTING OF 40 NEW CONIFEROUS TREES

THE PROPOSED DEVELOPMENT REQUIRES THE REMOVAL OF APPROX. 6135m2 WOODLOT. THE LOCATION FOR NEW TREE PLANTING HAS BEEN DETERMINED TO ALLOW FOR MAXIMUM SOIL VOLUMES AND MINIMAL CONFLICTS TO ALLOW FOR THE ESTABLISHMENT OF LARGE MATURE TREES TO OVER A LONG PERIOD OF TIME.
