Site Servicing and Stormwater Management Design Brief

## **Carleton University, New Student Residence**

1125 Colonel By Drive

Project: 190444600

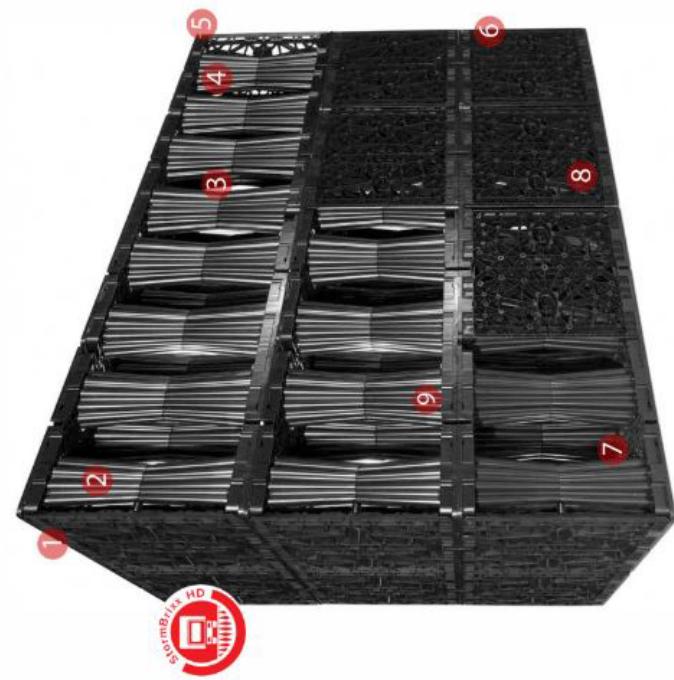
StormBrixx® HD is ACO's heavy duty plastic geocellular surface water management system. It consists of a single, recyclable, polypropylene body that can be assembled in a variety of ways to form an open bonded structure.

- 1 4.5 Half bodies per cubic metre
- 2 Functional design combined with an intelligent snap-lock system make for easy handling and rapid installation
- 3 High void ratio of 97% of total volume available for storage
- 4 Height of 1 layer: 24" (610mm)
- 5 Min. cover depth (see image above):  
19.7" (0.5m)
- 6 StormBrixx® units can be cut in half to allow integration into the overall system
- 7 The open structure of StormBrixx® allows inspection cameras and cleaning devices to have free passage through the system

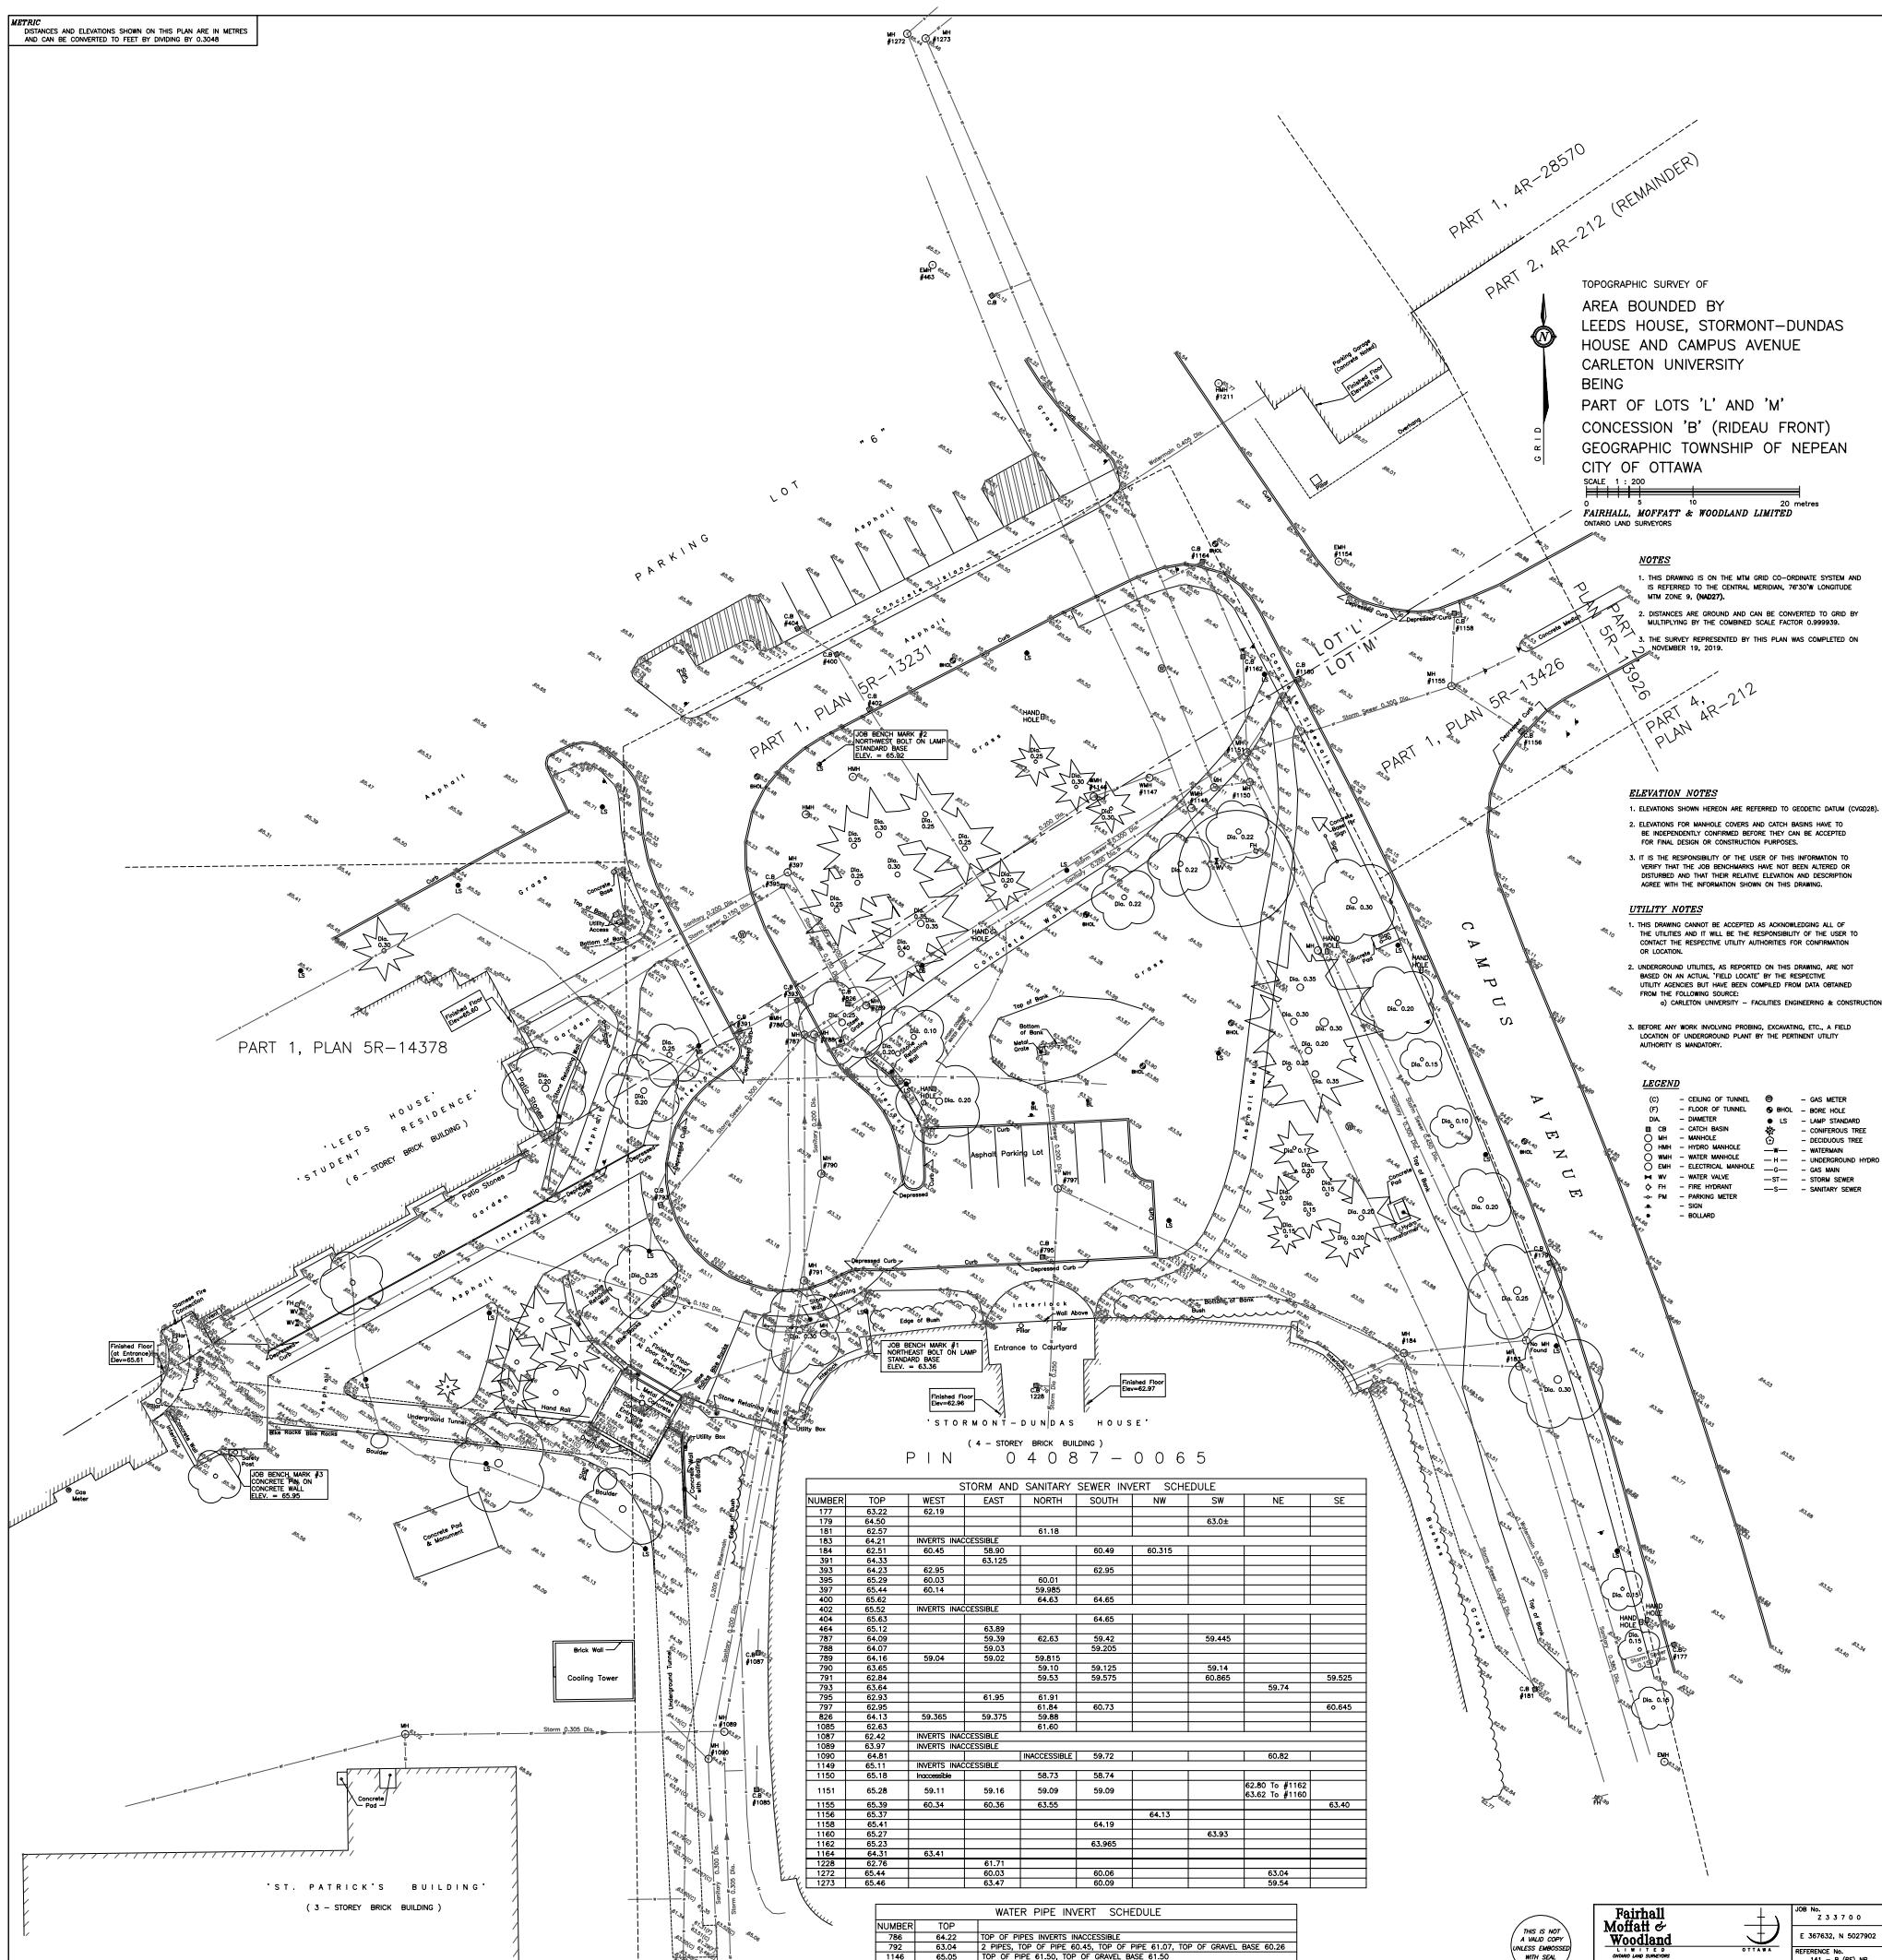
### **Topographic and Legal Survey**

METRIC  
DISTANCES AND ELEVATIONS SHOWN ON THIS PLAN ARE IN METRES  
AND CAN BE CONVERTED TO FEET BY DIVIDING BY 0.3048

Existing conditions are shown on the Topographic and Legal Survey (**Appendix F**).
