Hydrogeological Review

Proposed Multi-Storey Building 36 Robinson Avenue Ottawa, Ontario

Report PG5231-REP.02

Paterson Group Inc.

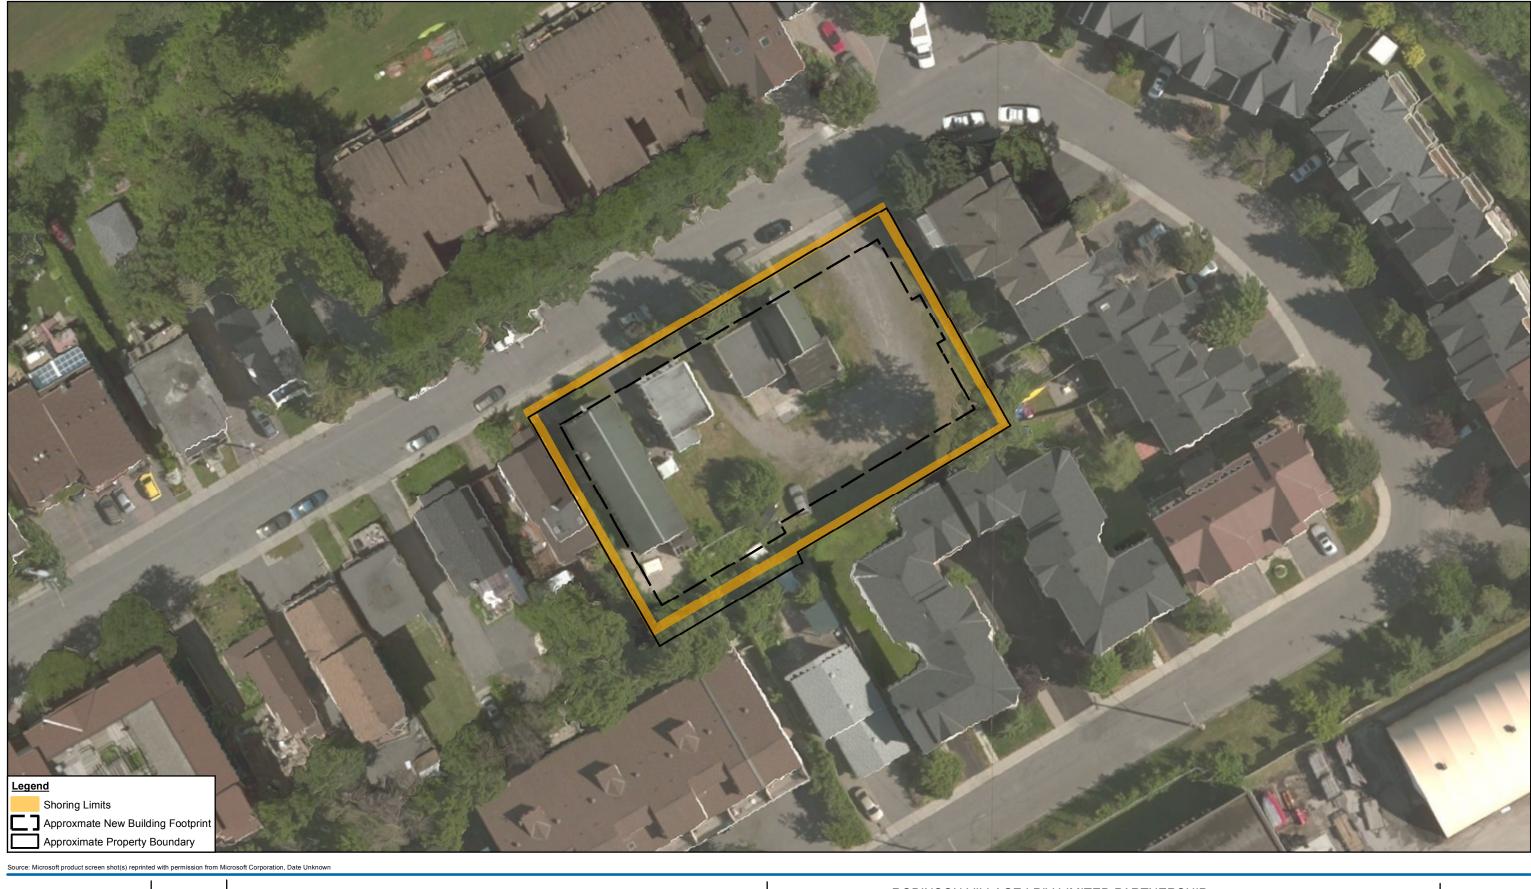
FIGURE 1.2

Figure 1.2 - Site Plan (by Others)

Paterson Group (Paterson) was commissioned by TC United Development on behalf of Robinson Village LPIV Limited Partnership to prepare a hydrogeological review for the proposed multi-storey building to be located at 36 Robinson Avenue in Ottawa, Ontario (refer to Figure 1.2 - Site Plan by others within Appendix 1).

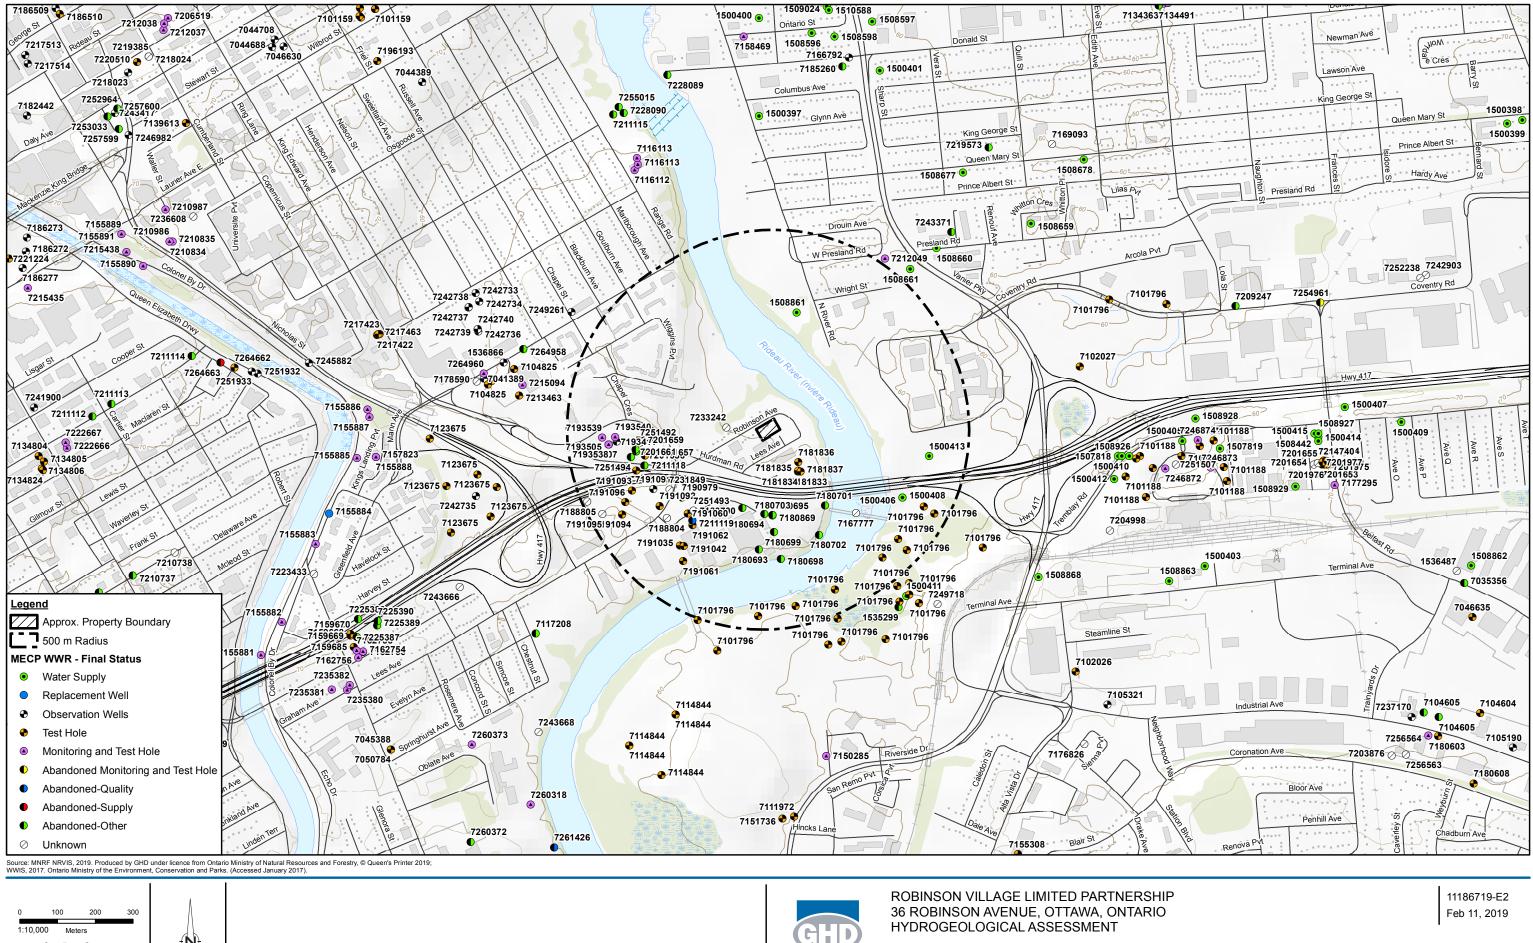
FIGURE 2.3

Coordinate System NAD 1983 UTM Zone 18N

MECP WATER WELL RECORDS

A search of the Ontario Water Well Records database indicates there are a large number of wells within 500 m of the site as depicted in Figure 2.3 by others included in Appendix 1. However, these wells are predominantly monitoring well installations or abandoned wells. It should be noted that 2 groundwater supply wells were identified east of the Rideau River and located well outside the theoretical radius of influence.

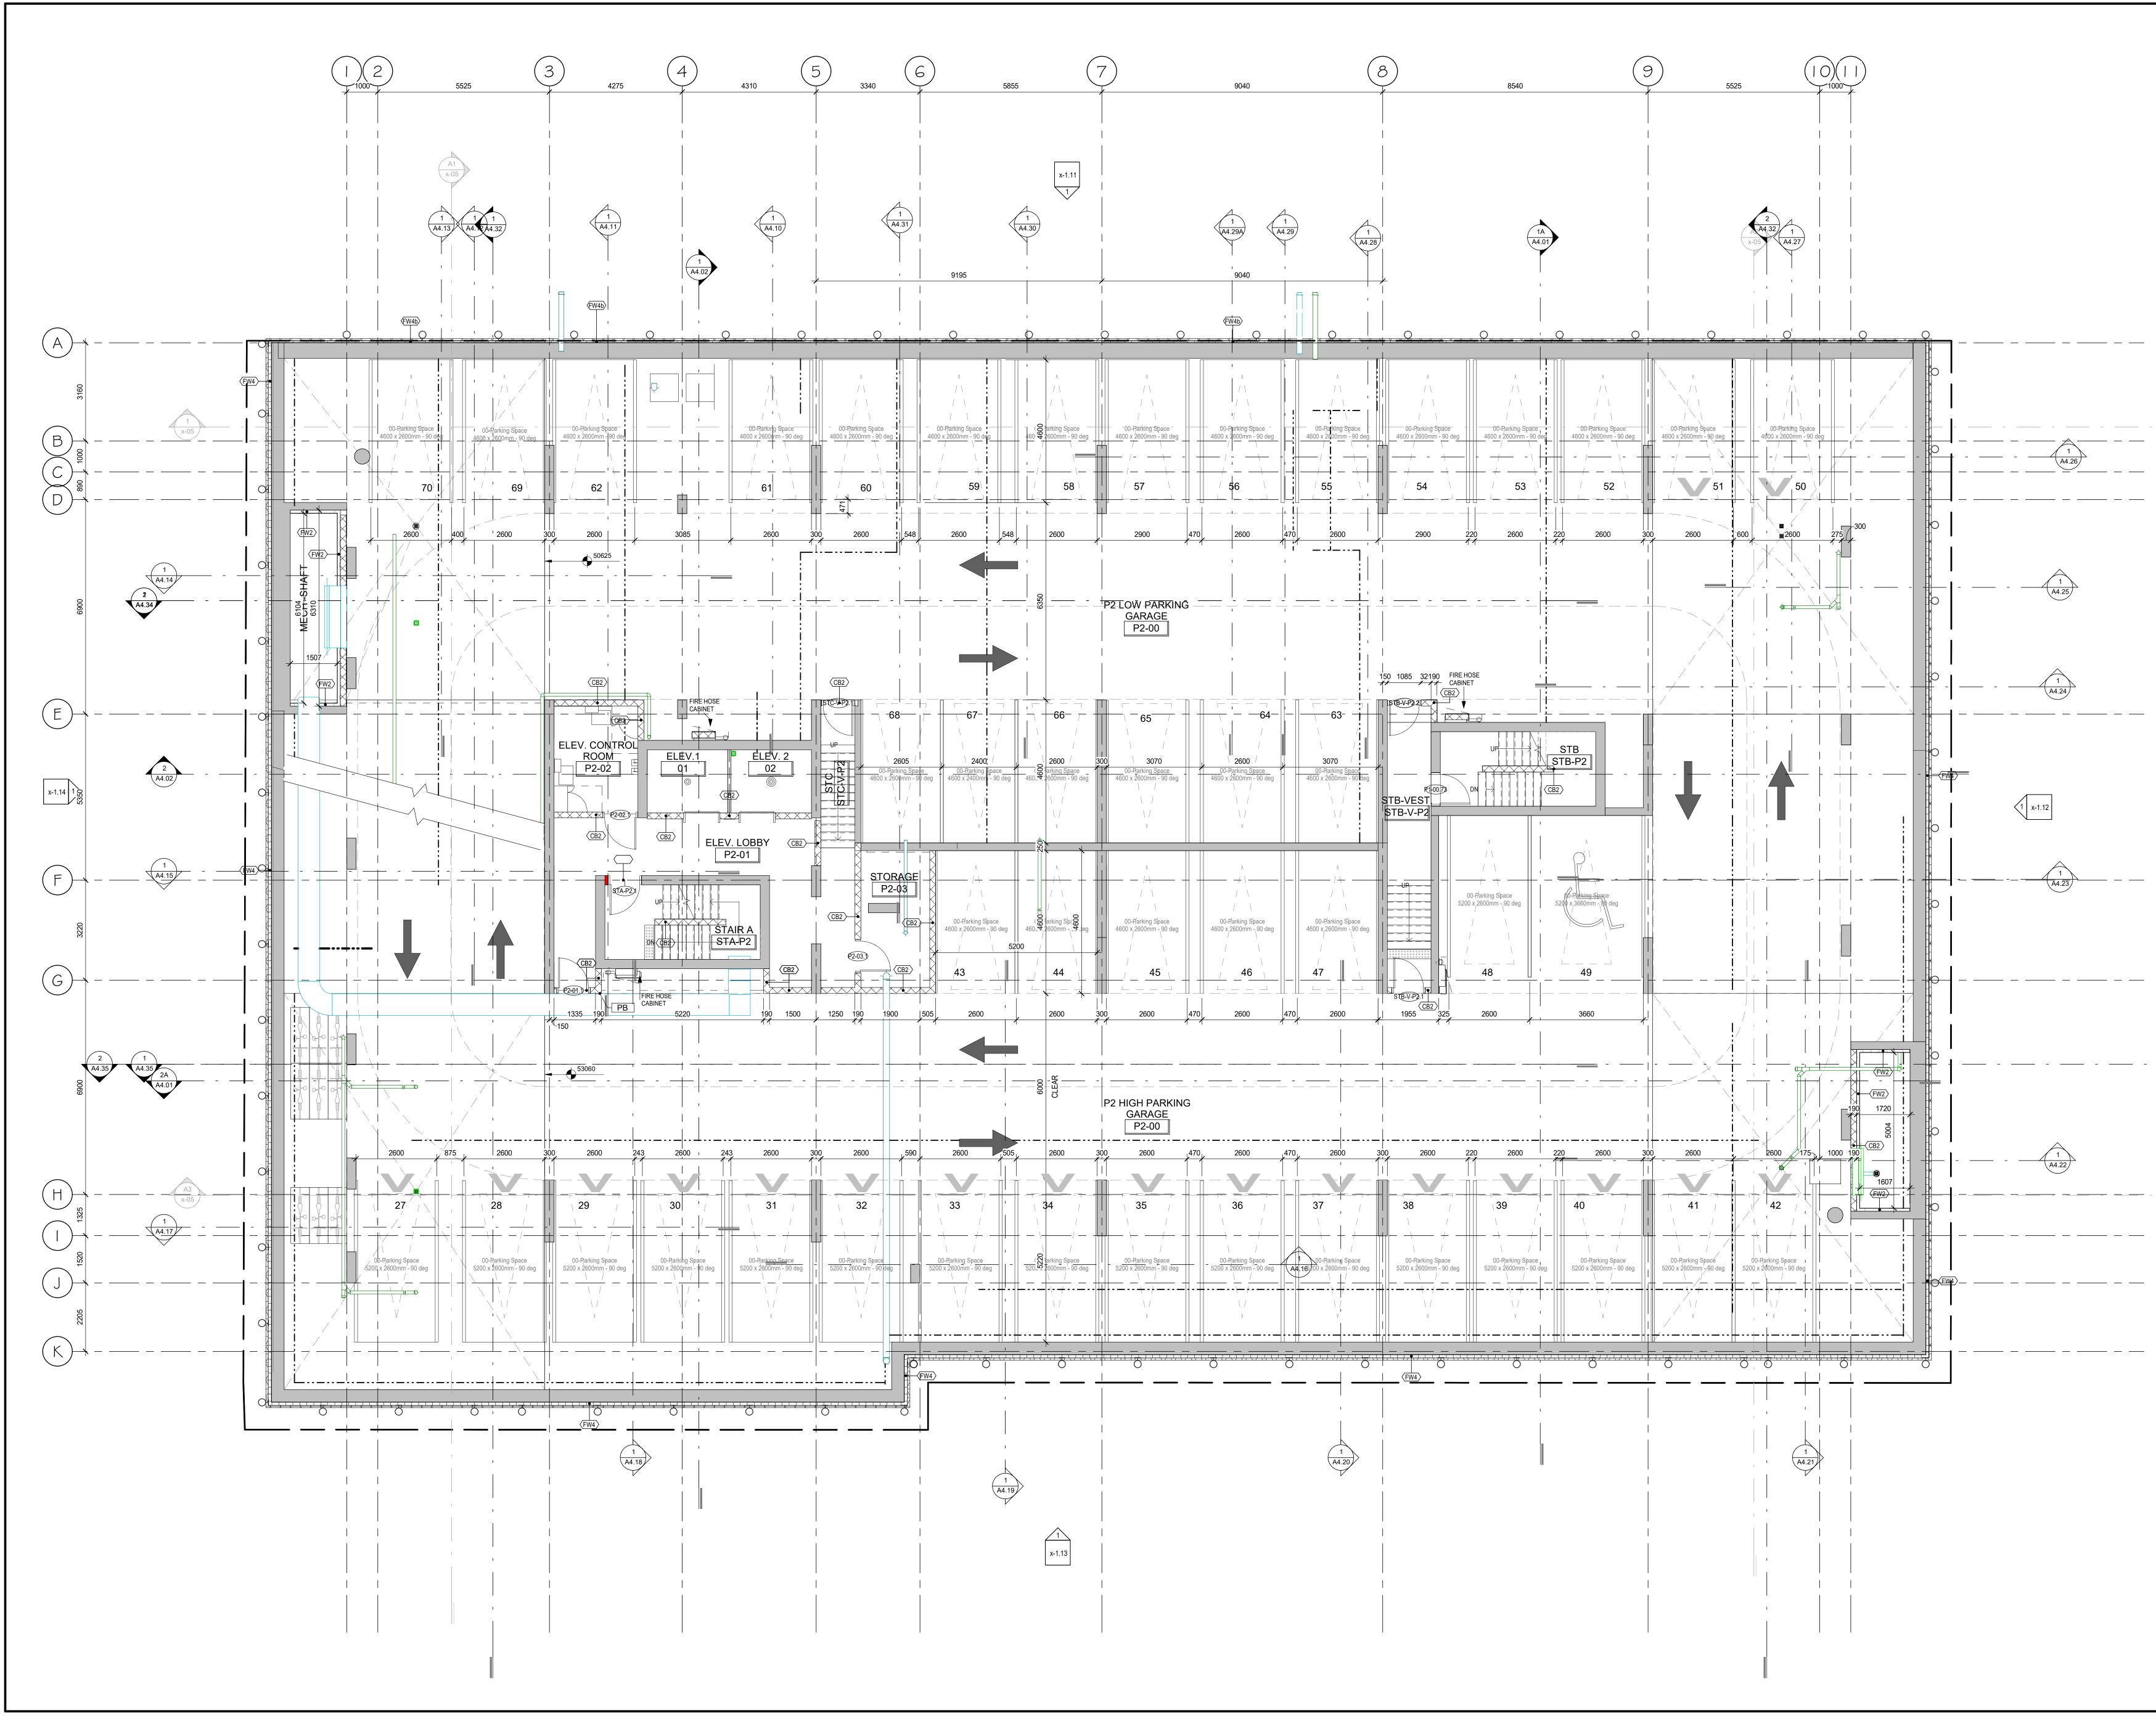
Image: Construction of the appropriate
 contractor to check and verify all dimen- sions on site and report all errors and/ or omissions to the engineer. All contractors must comply with all Do not scale drawings. This drawing may not be used for construction until signed. Copyright reserved.
Hobin Architecture Incorporated 63 Pamilla Street Ottawa, Ontario Canada K1S 3K7 T: 613-238-7200 F: 613-235-2005 E: mail@hobinarc.com
hobinarc.com Architecture PROJECT 36 ROBINSON AVENUE 36 ROBINSON AVENUE DRAWING TITLE LEVEL P2 - PARKING DRAWN DATE SCALE
Author XX/XX/XXXX 1 : 75 PROJECT a4.29B DRAWING NO. A2.02 REVISION NO. C

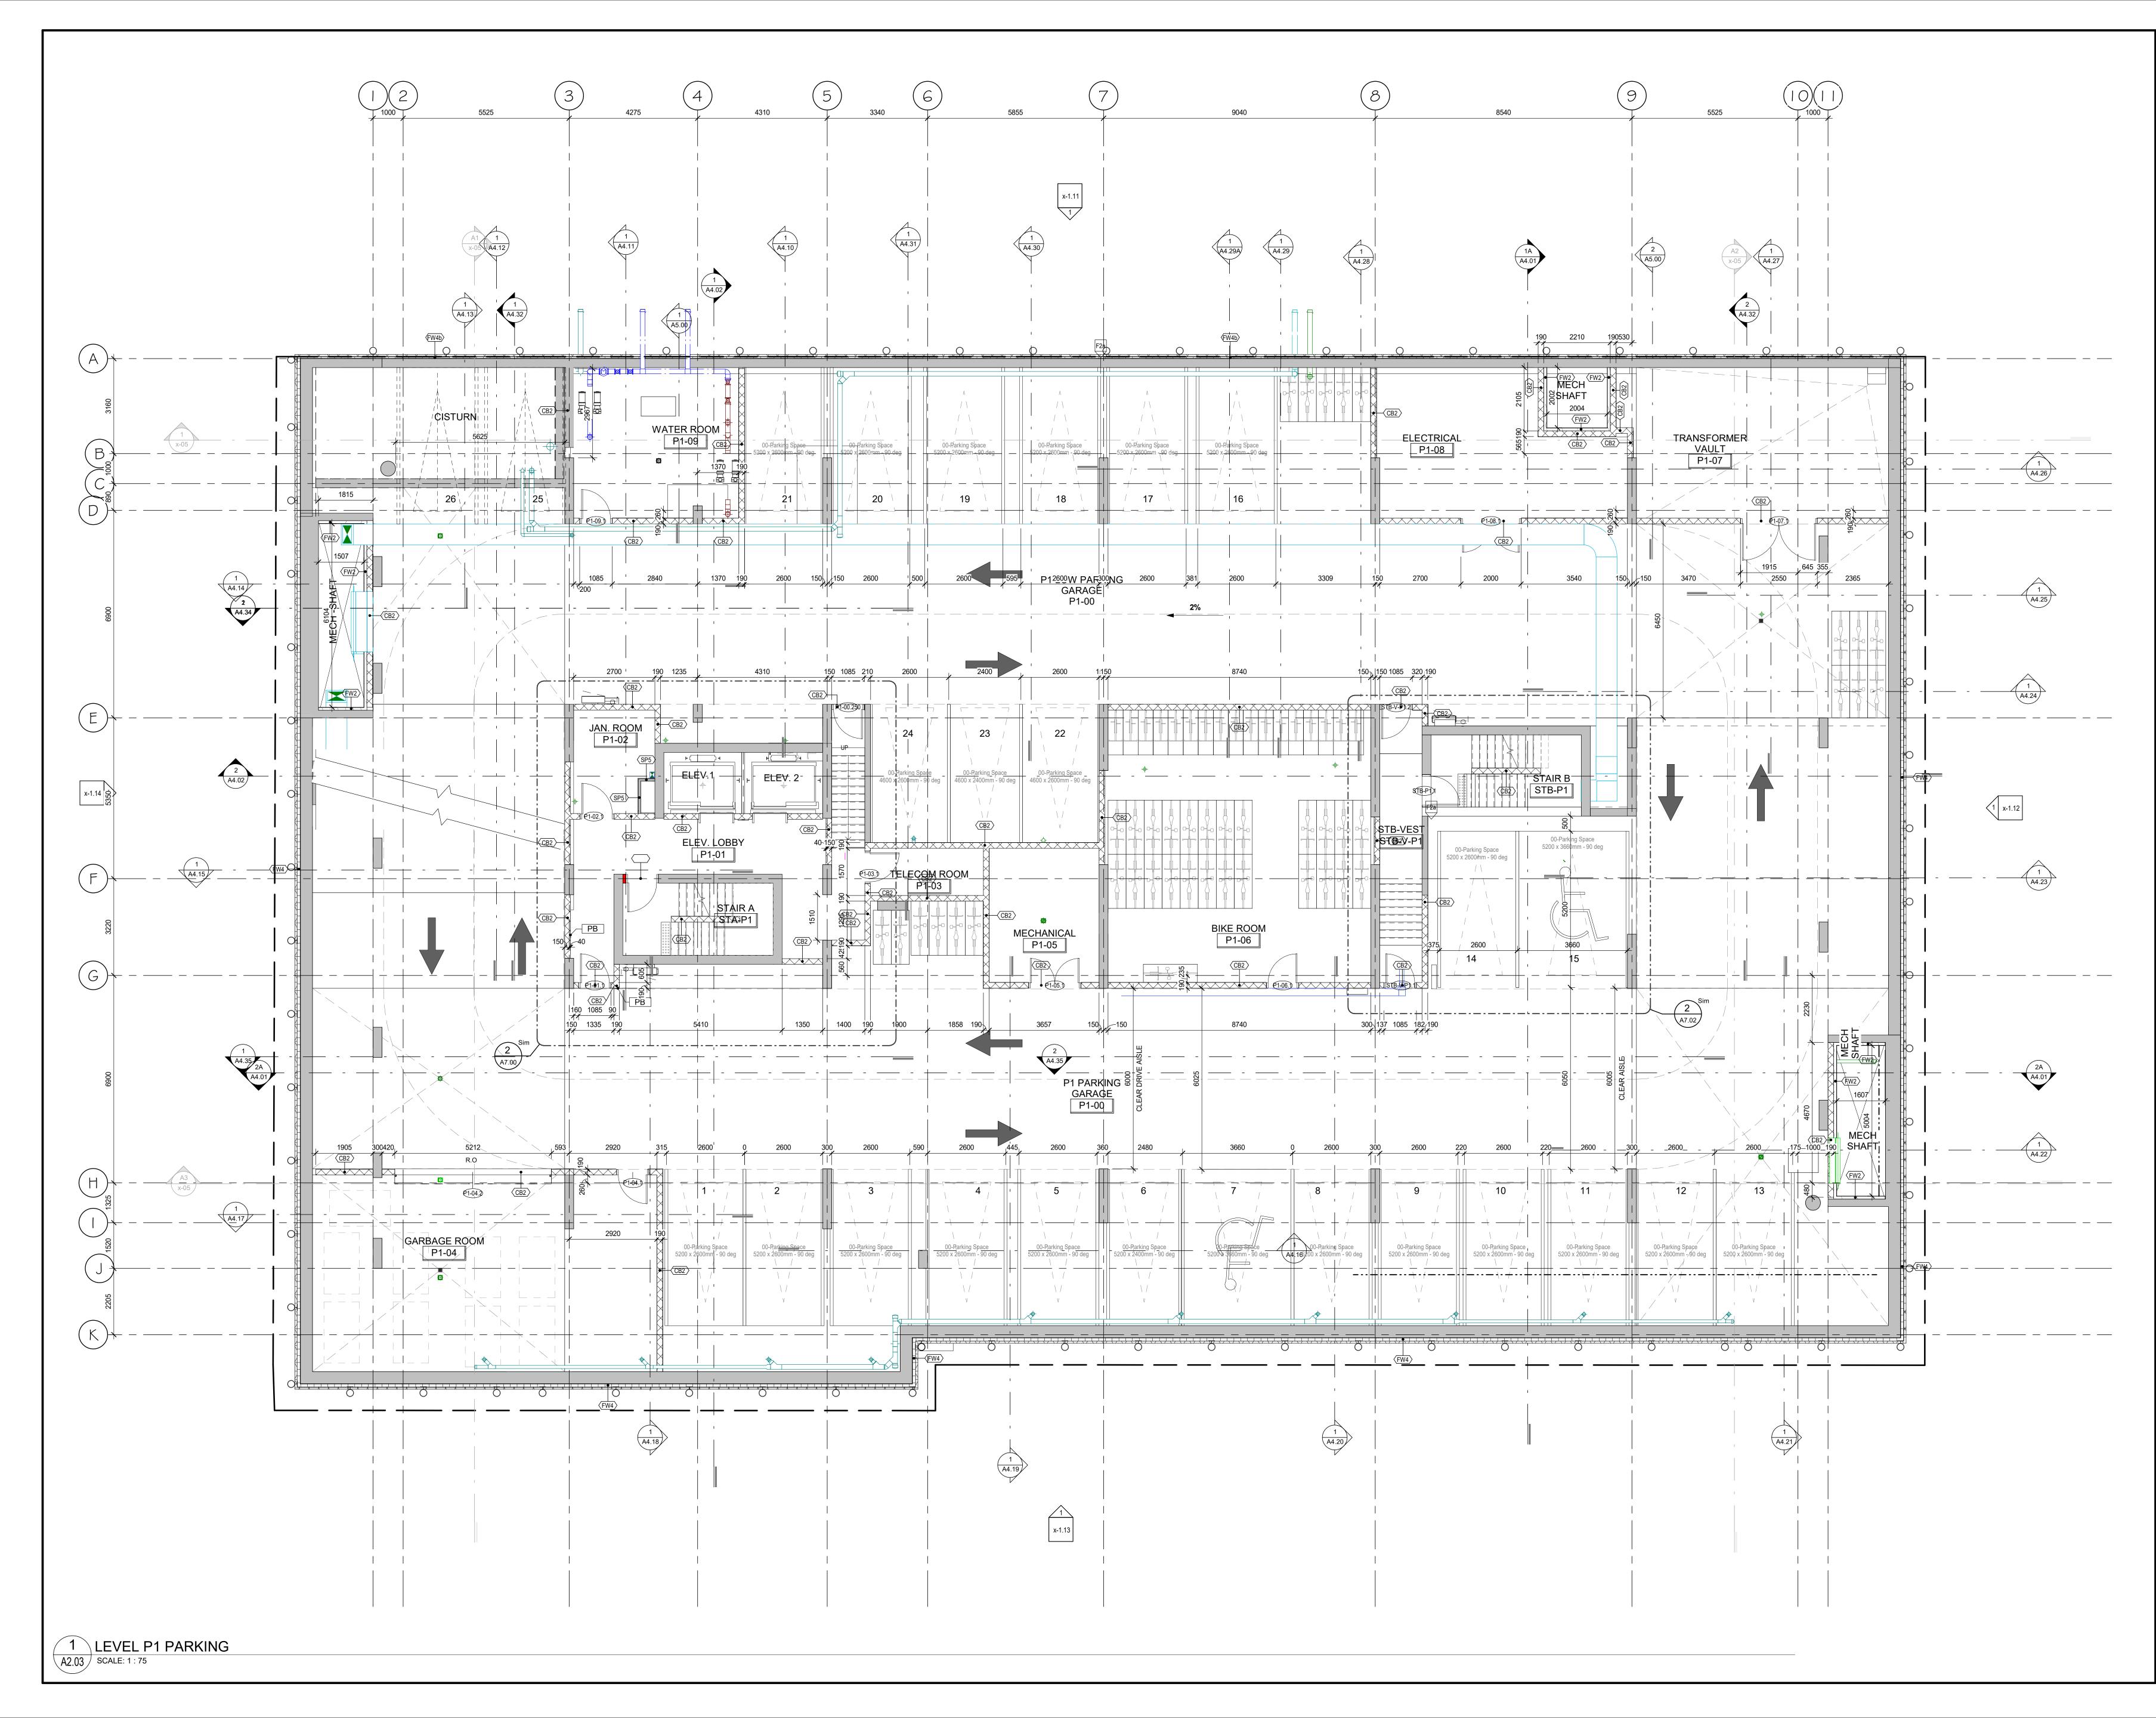
Г			
B A no.		ISSUED FOR EXCA FOUNDATION PERM ISSUED FOR REVIE revision	1IT
co sic or	ntractor ons on s omissior	esponsibility of the to check and ve ite and report a ns to the engine cors must compl	erify all dimen- Il errors and/ er.
Do Thi	not scc is drawin	ile drawings. g may not be u n until signed.	
	pyright r		
]	Hobin Archi Incorporate 63 Pamilla Sti Ottawa, Ontar	d reet	
	Canada K1S T: 613-238-72 F: 613-235-20 E: mail@hobin	00	OBIN
	hobinarc . Djec t	COM AR	CHITECTURE
	36 R	OBINSON A	
DR/	awing titl	EL P1 - PA	RKING
	AWN hor	DATE 06/13/19	SC ALE 1 : 75
			PROJECT a4.29B DRAWING NO.
			A2.03
L			REVISION NO. B

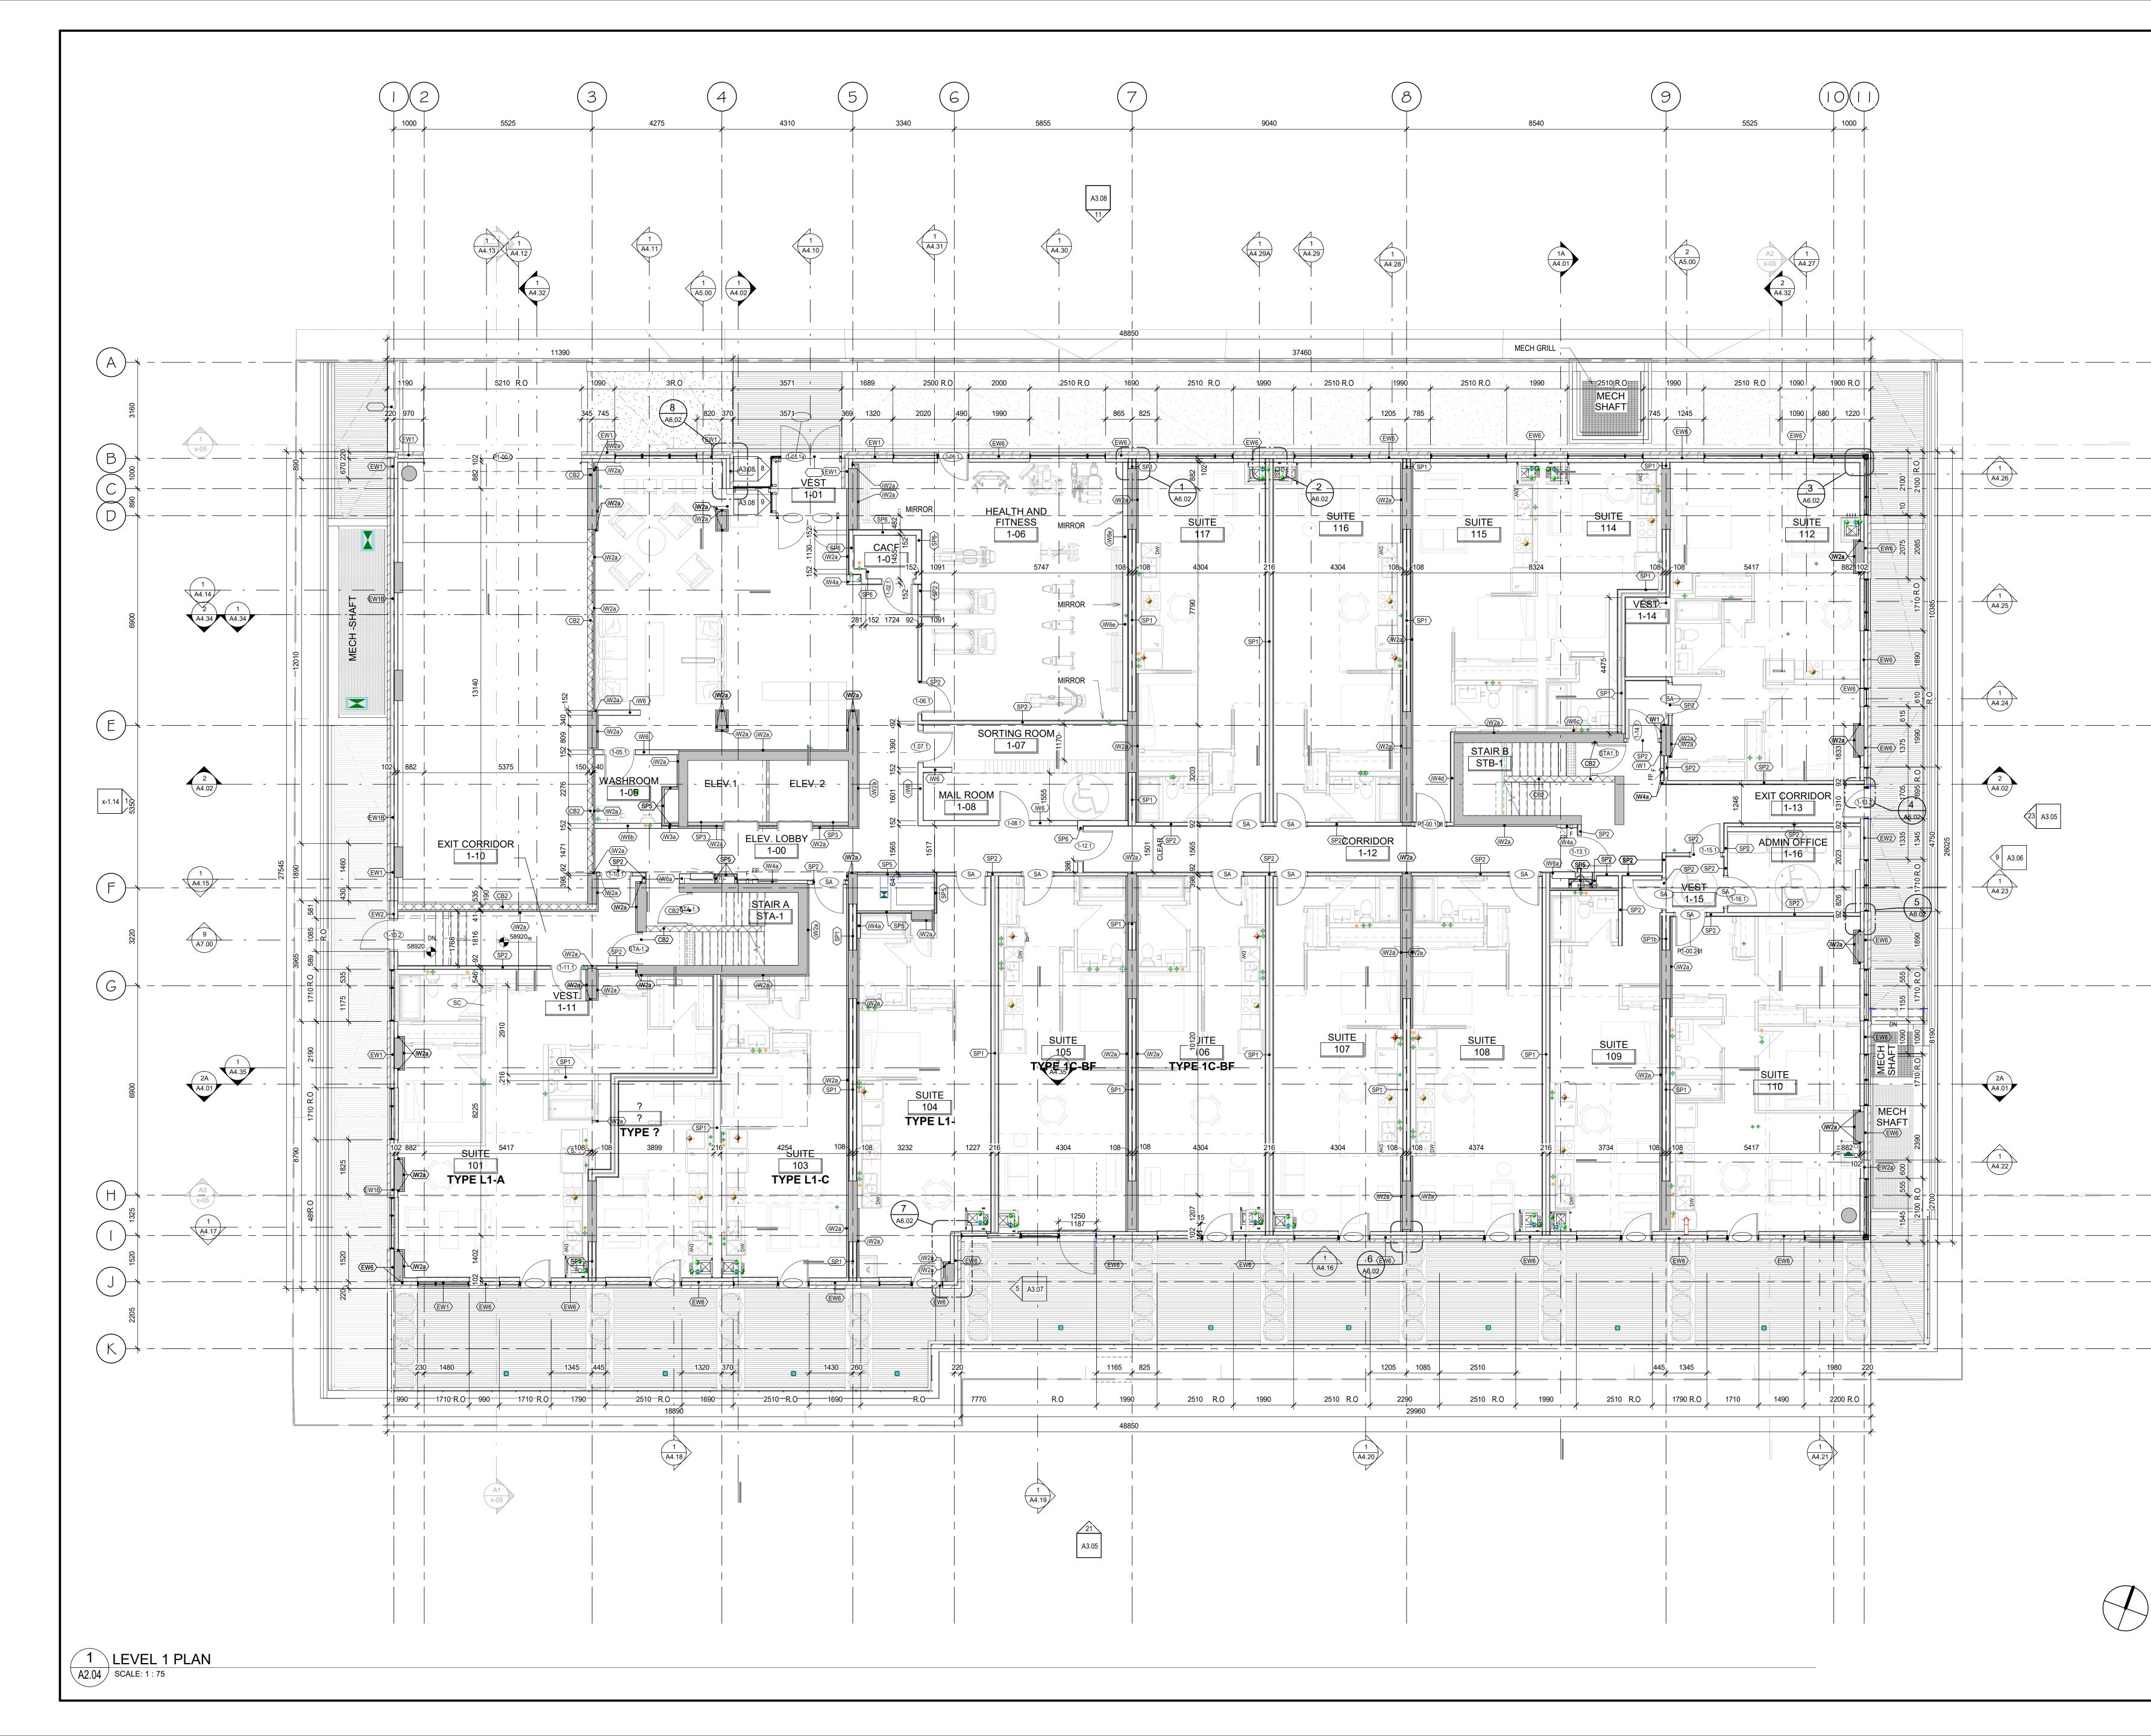
B A no.		ISSUED FOF FOUNDATION ISSUED FOF revisio	R REVIE	IIT
It co sic	is the re ntractor ons on s	esponsibility to check (v of th and ve port a	ne appropriate erify all dimen- ll errors and/ er.
Do	not sco	tors must ale drawing	s.	
со	nstructio	g may not n until sign reserved.	be uned.	sed for
	Hobin Arch Incorporate	d		
	Ottawa, Onta Canada K1S T: 613-238-72 F: 613-235-20	rio 3K7 00		
	E: mail@hobin hobinarc			OBIN CHITECTURE
PR	36 R	OBINS	ON A	AVENUE
DR/	awing titi FLO			ENUE
	AWN	DATE XX/XX/X	(XXX	SCALE 1 : 75
				PROJECT a4.29B DRAWING NO.
				A2.04
				revision no. B

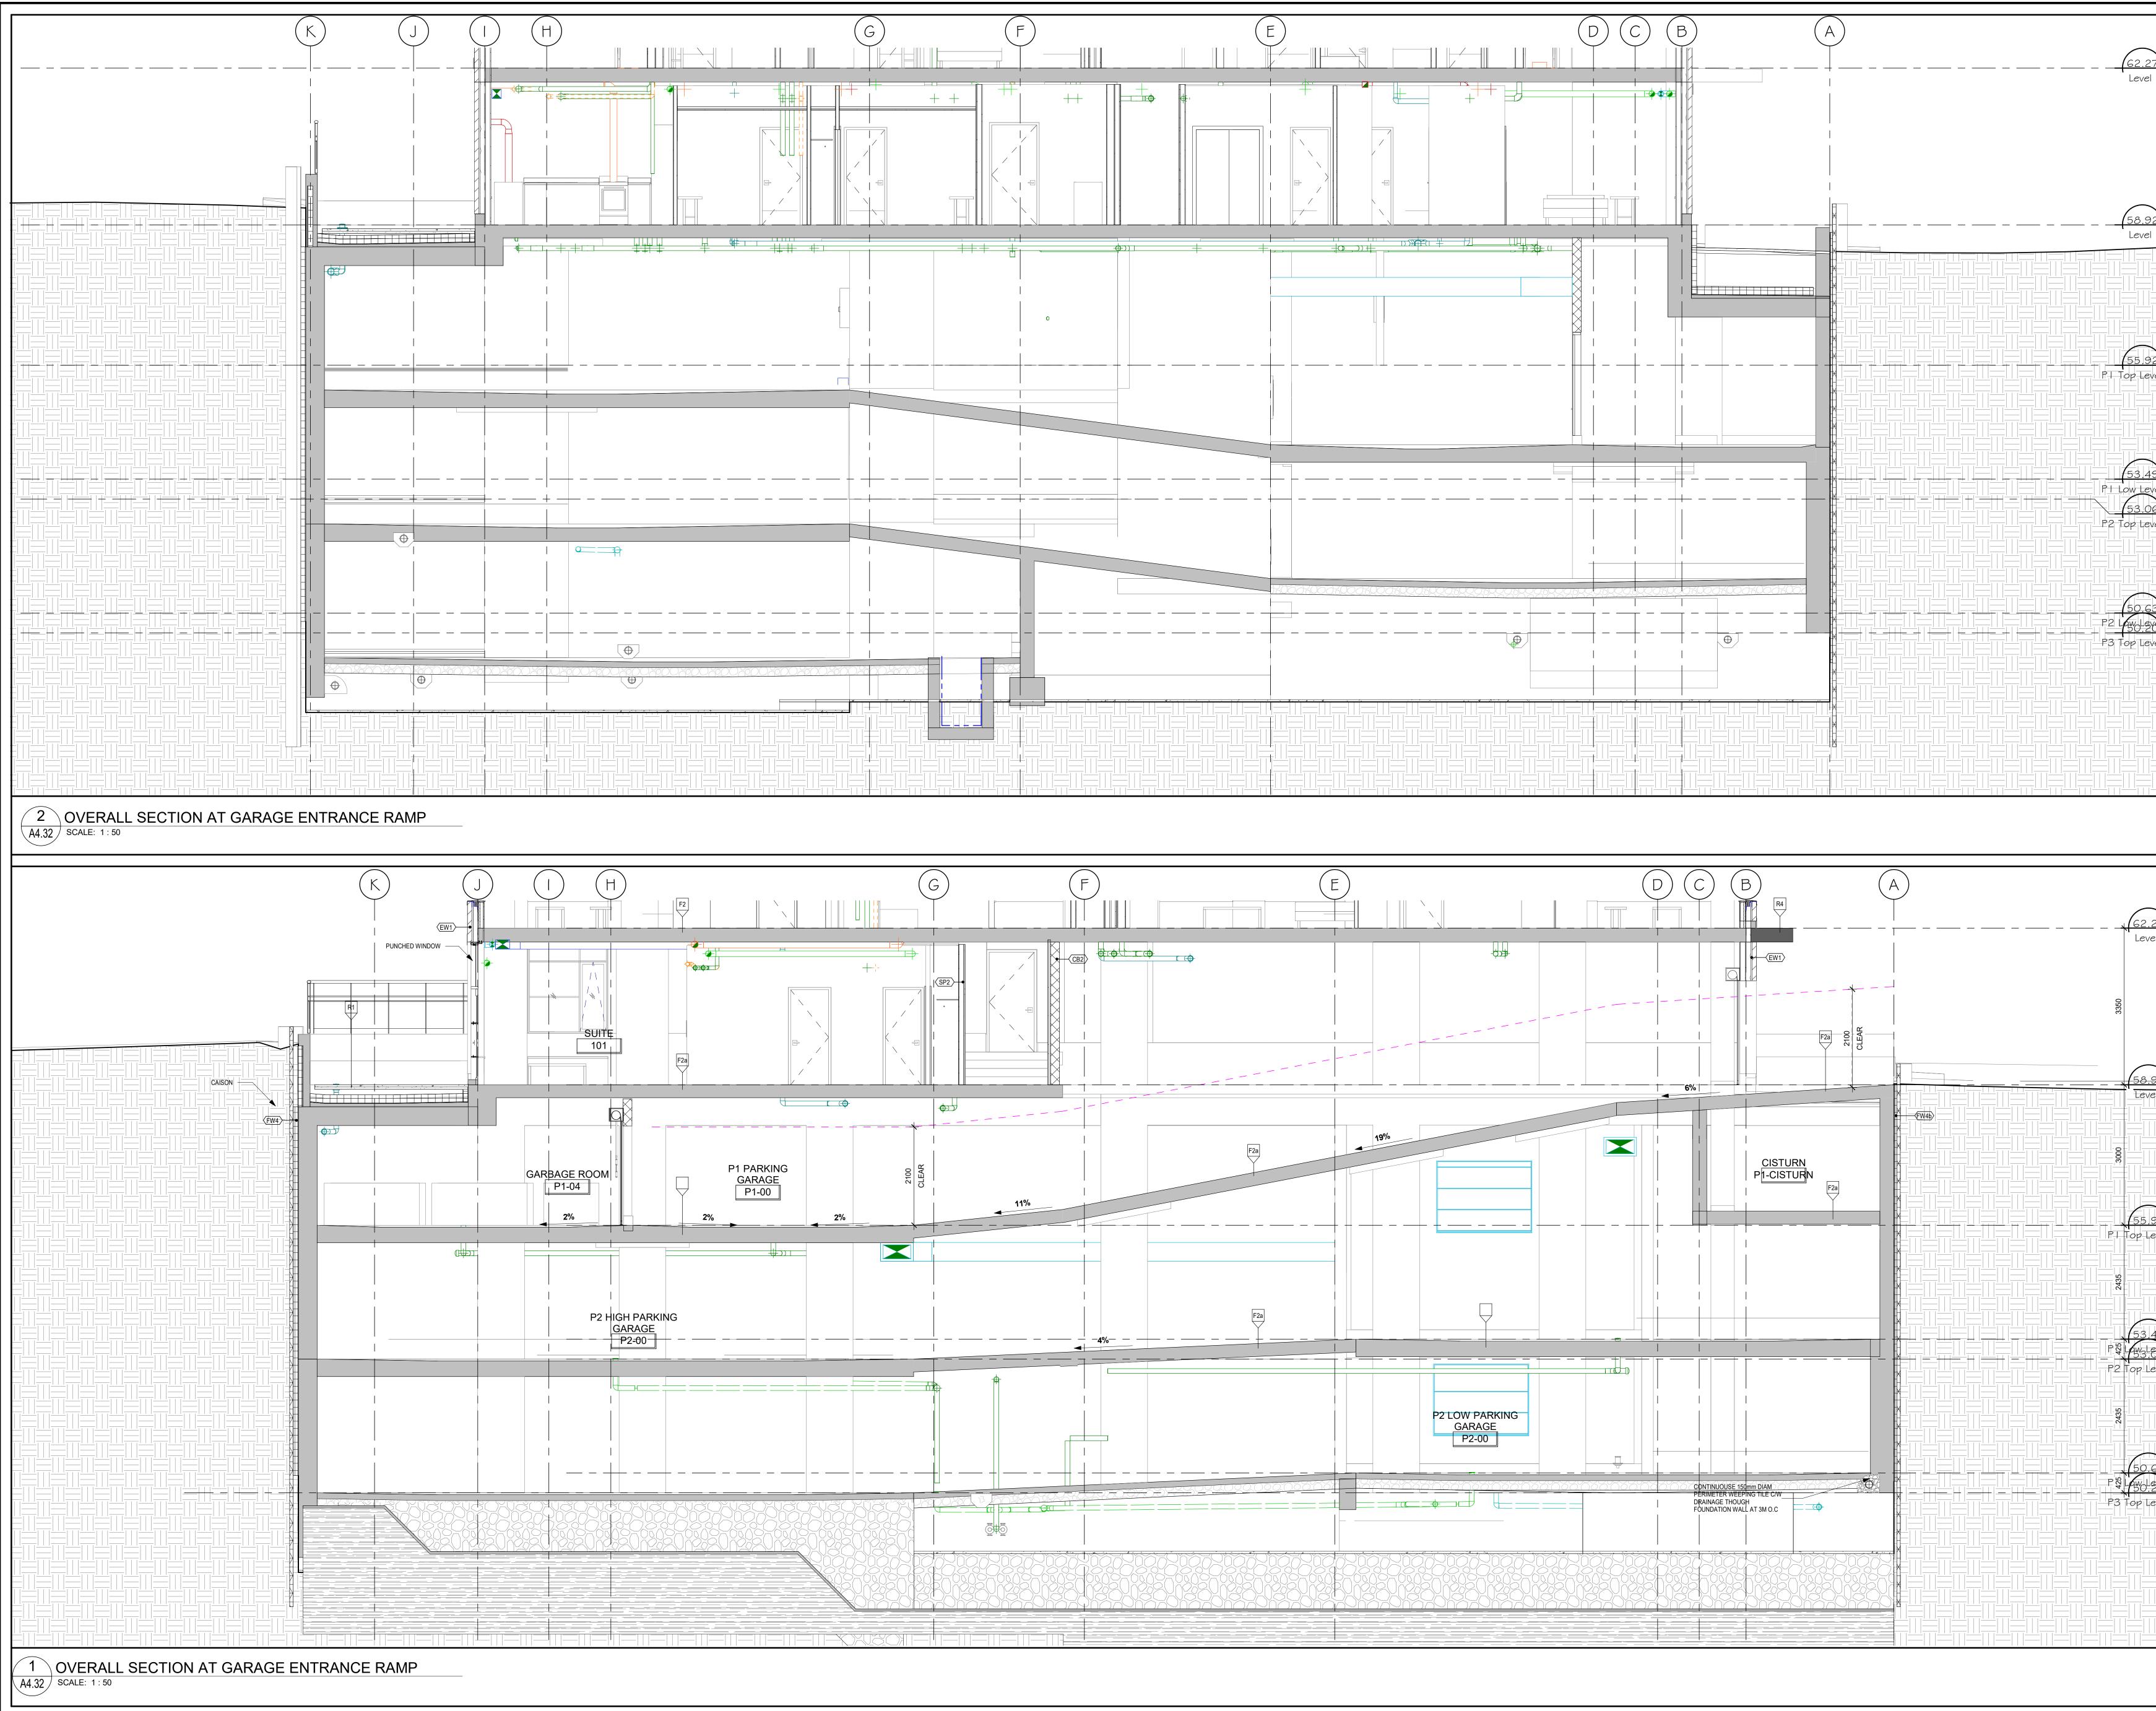
27		
2		
<u>2</u>		
.27		
rel 2		
	A 20.01.31 ISSUED FOR EXCAV	'ATION & T
.92	no. date revision It is the responsibility of th contractor to check and ver sions on site and report all or omissions to the enginee	rify all dimen— errors and/
re 	All contractors must comply Do not scale drawings. This drawing may not be us	
	Copyright reserved.	
92		
	Hobin Architecture	
49 66 evel	Incorporated 63 Pamilla Street Ottawa, Ontario Canada K1S 3K7	
		DBIN CHITECTURE
63	PROJECT 36 ROBINSON A	VENUE
evel 	36 ROBINSON AVE DRAWING TITLE SECTION THRO GARAGE RAM	OUGH
	DRAWN DATE Author 12/02/19	SCALE 1 : 50
		PROJECT a4.29B DRAWING NO.
		A4.32

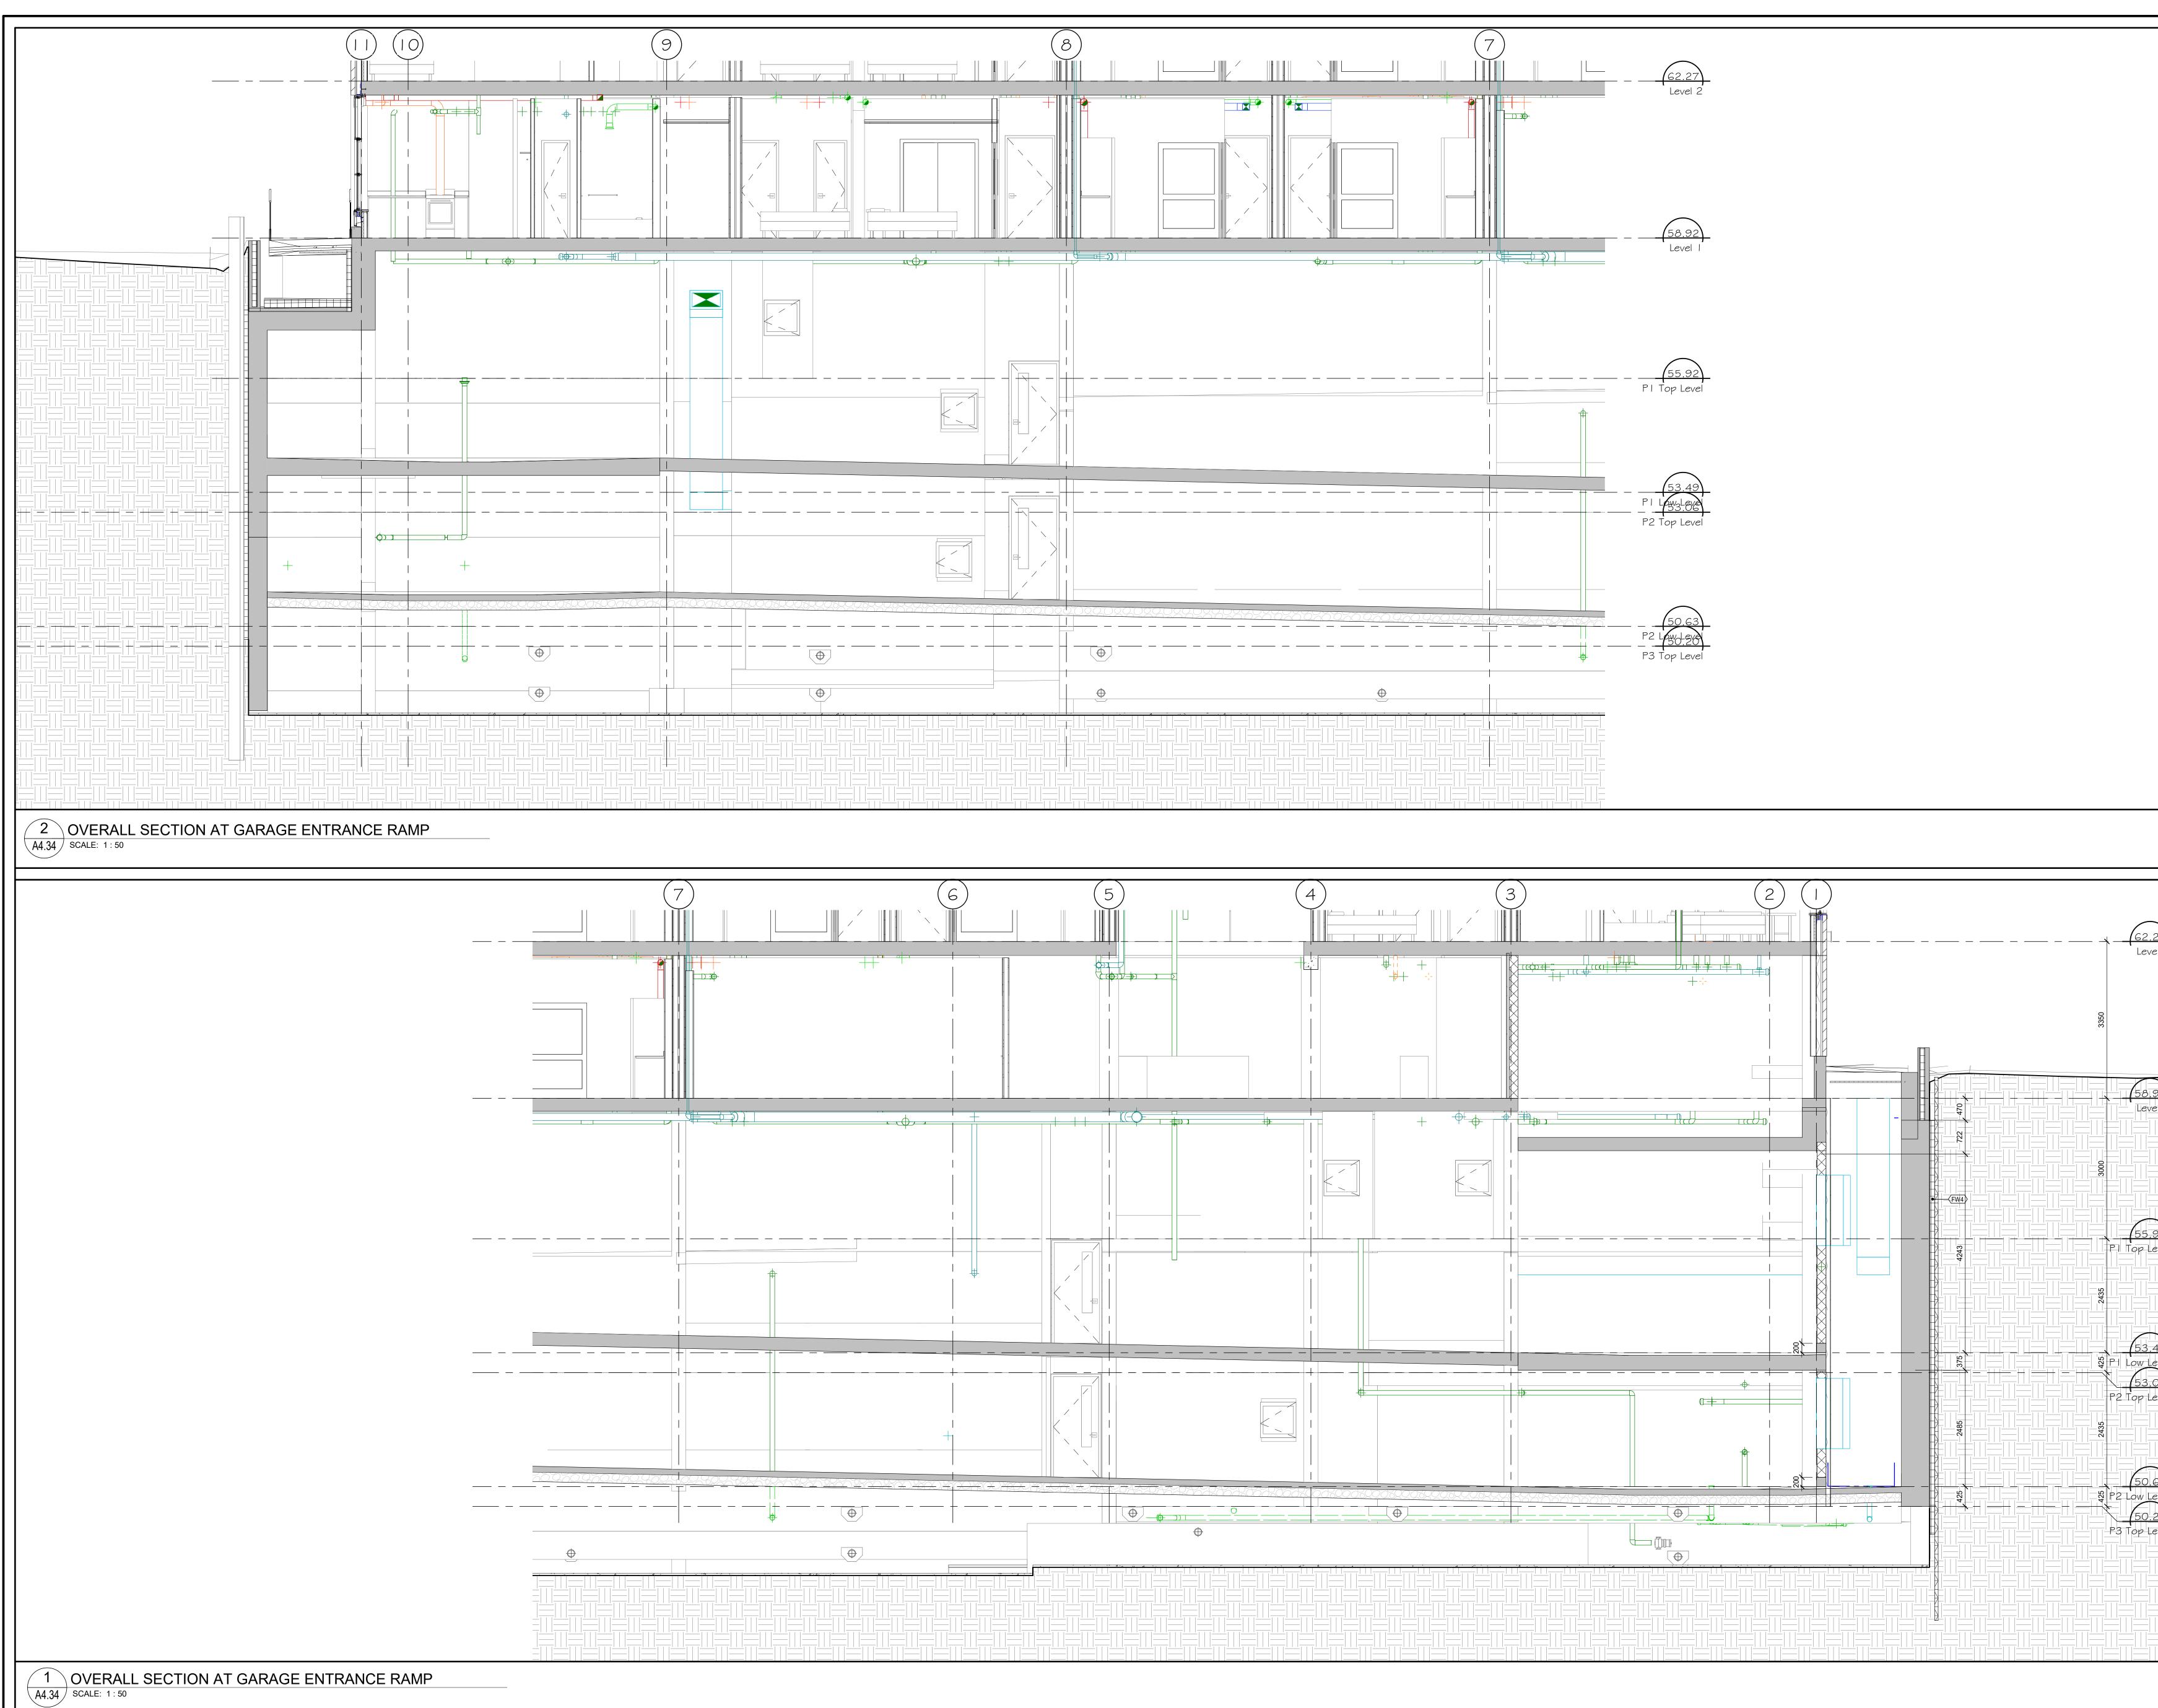
27	
	no. date revision It is the responsibility of the appropriate contractor to check and verify all dimen- sions on site and report all errors and/
	or omissions to the engineer. All contractors must comply with all Do not scale drawings. This drawing may not be used for
	construction until signed. Copyright reserved.
	Hobin Architecture Incorporated 63 Pamilla Street Ottawa, Ontario
	Canada K1S 3K7 T: 613-238-7200 F: 613-235-2005 E: mail@hobinarc.com hobinarc.com ARCHITECTURE
	PROJECT 36 ROBINSON AVENUE
20) 2vel 	DRAWING TITLE SECTION THROUGH GARAGE RAMP E-W
	DRAWN DATE SCALE Author 04/15/20 1 : 50 PROJECT a4.29B DRAWING NO.
	A4.34
_	REVISION NO.
