Hydrogeological Review

Proposed Multi-Storey Building 36 Robinson Avenue Ottawa, Ontario

Report PG5231-REP.02

Paterson Group Inc.

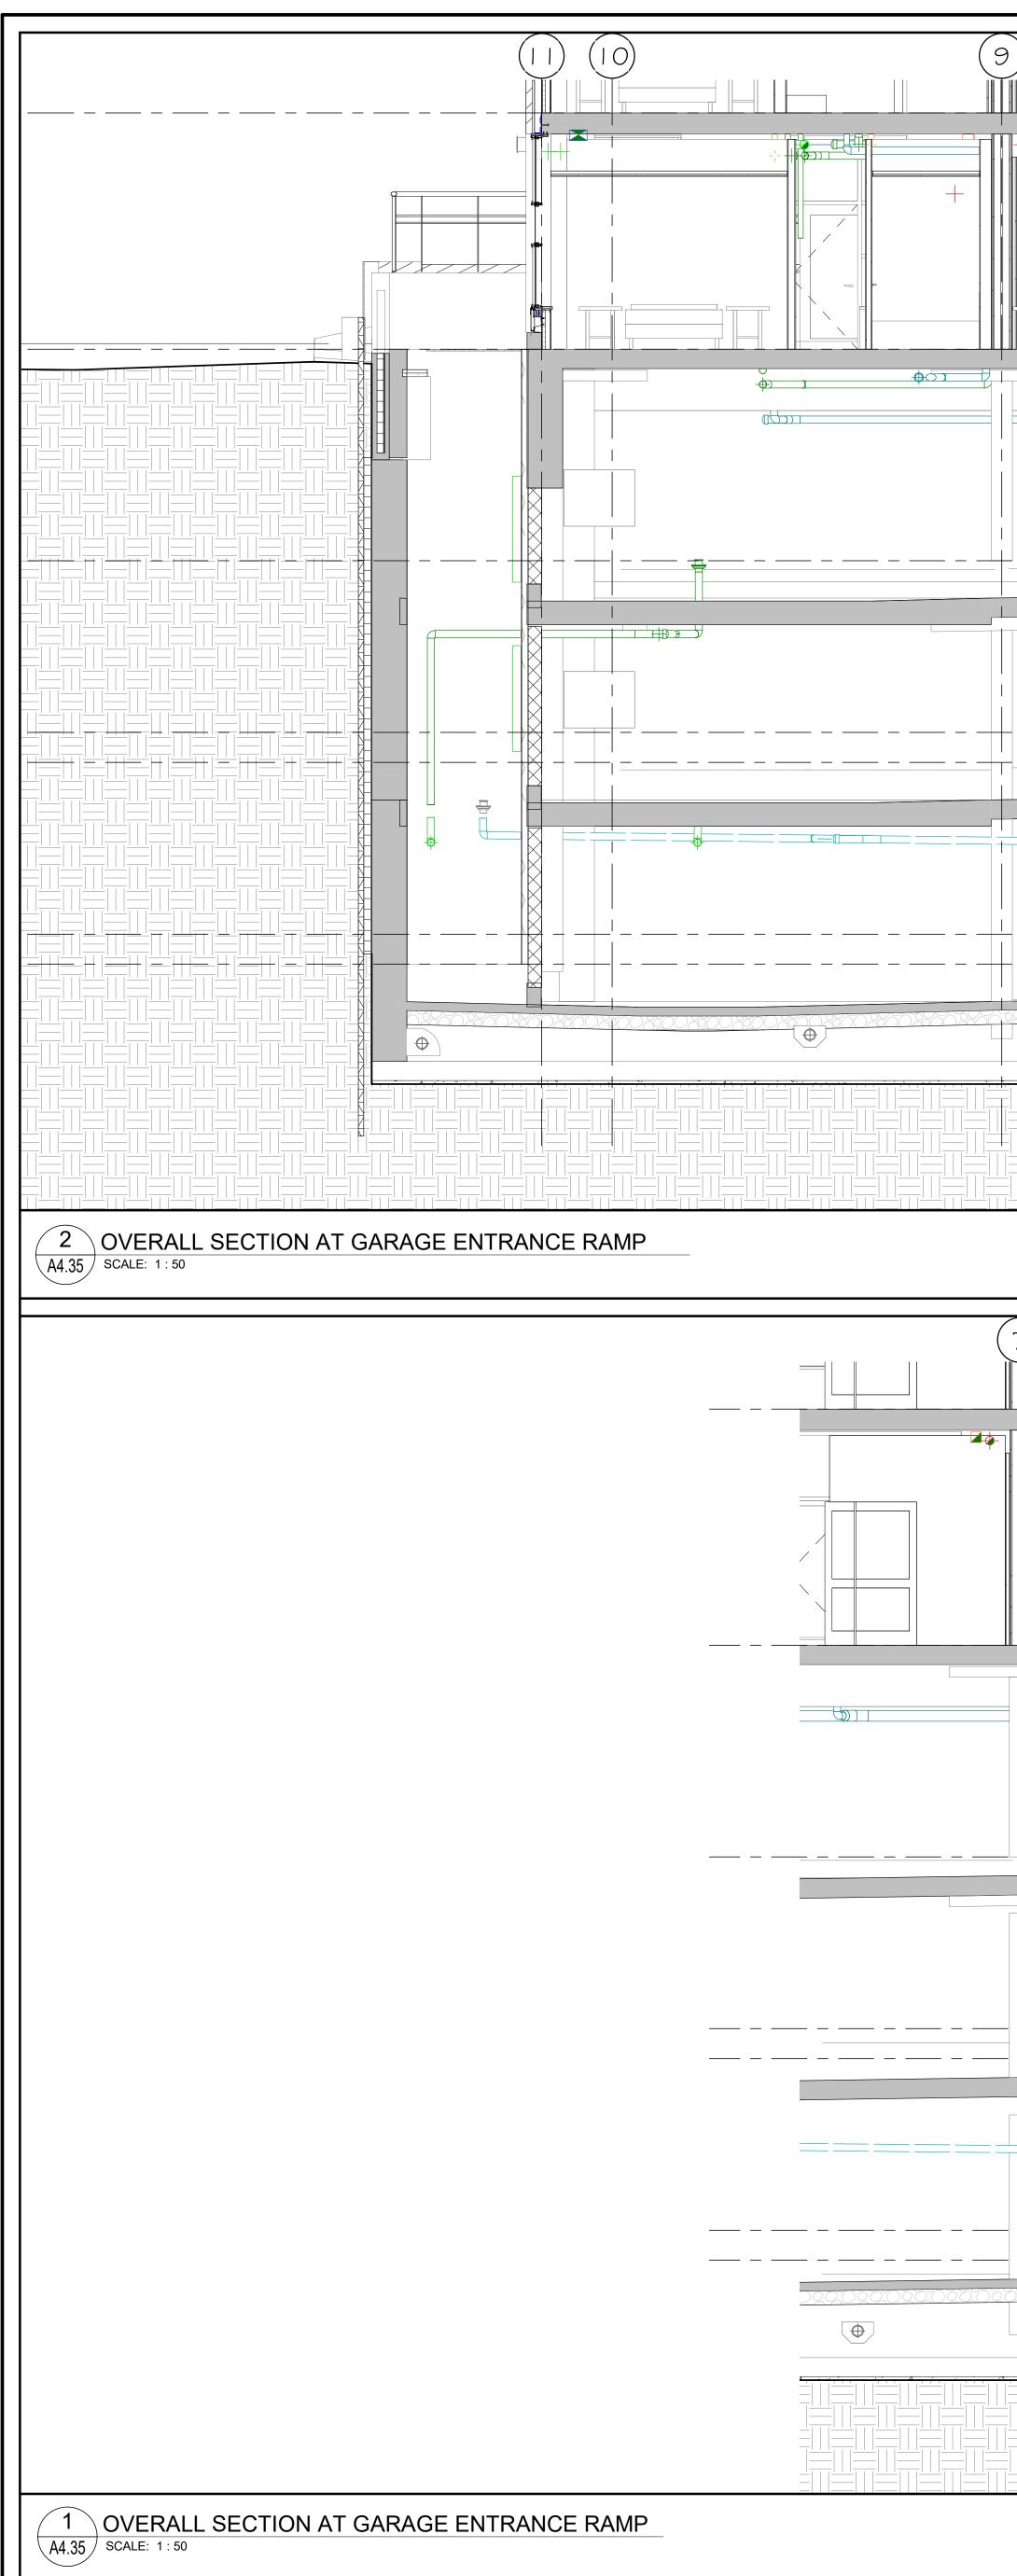
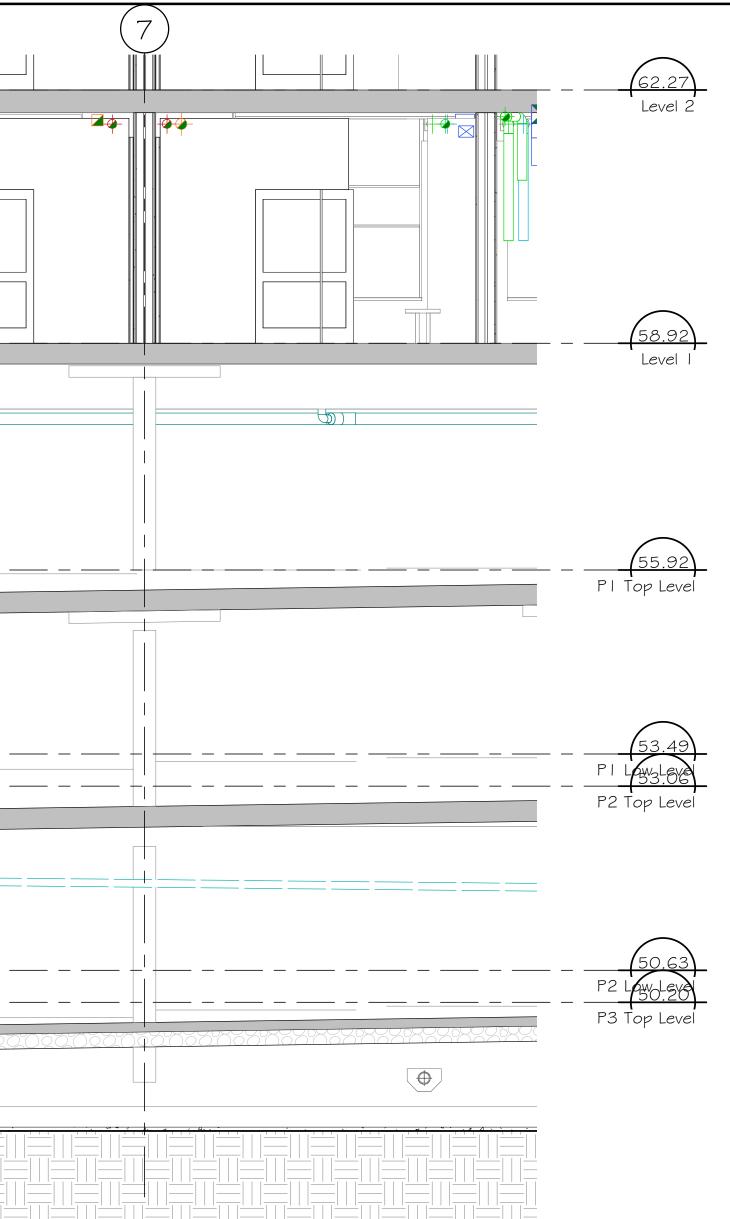
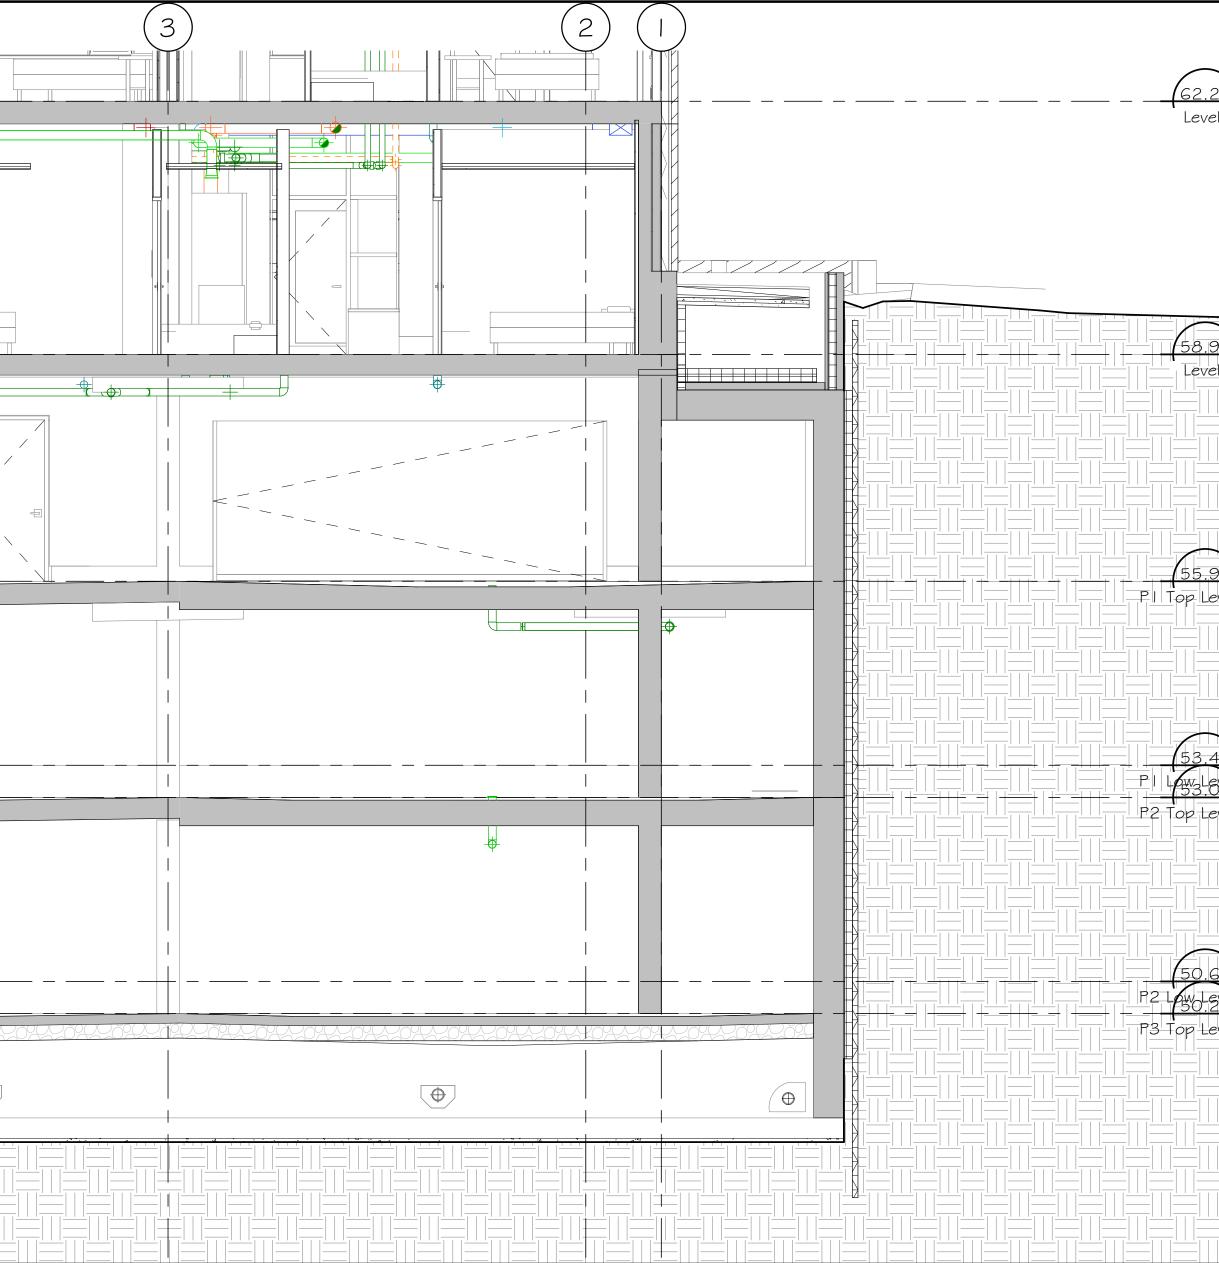
27 el 2	
92	no. date revision It is the responsibility of the appropriate contractor to check and verify all dimen- sions on site and report all errors and/
	or omissions to the engineer. All contractors must comply with all Do not scale drawings. This drawing may not be used for
	Copyright reserved.
92	
	Hobin Architecture Incorporated
evel	63 Pamilla Street Ottawa, Ontario Canada K1S 3K7 T: 613-238-7200 F: 613-235-2005
	E: mail@hobinarc.com hobinarc.com HOBIN ARCHITECTURE PROJECT
63 evel	36 ROBINSON AVENUE
	SECTION THROUGH GARAGE RAMP E-W
	Author 04/15/20 1 : 50 PROJECT a4.29B DRAWING NO.
	A4.35
	REVISION NO.
