**re: Construction Impact Assessment Report**  
**Proposed Mixed-Use Development**  
**951 Gladstone Avenue and 145 Loretta Avenue North - Ottawa**

**file:** PG5517-MEMO.02

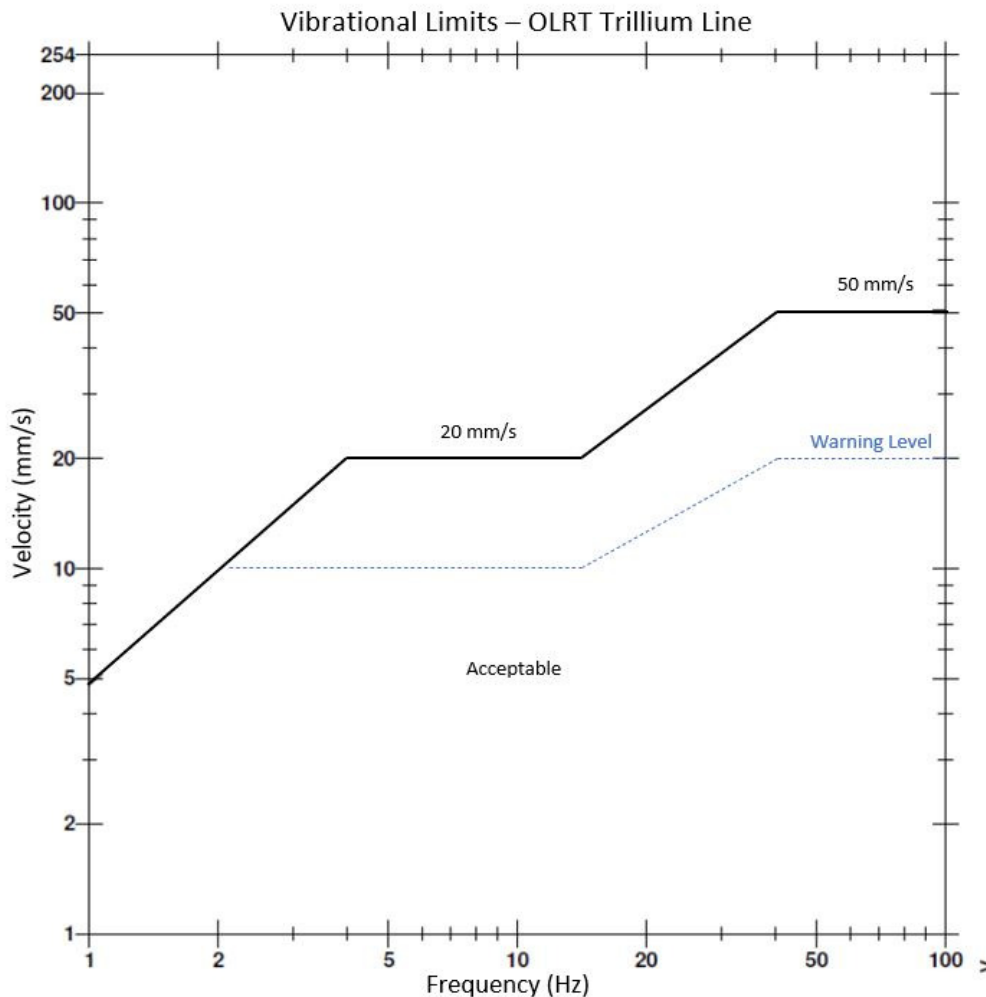
Vibration levels at the Trillium Infrastructure will be continuously monitored in real time during the excavation and blasting programs, and foundation work. The monitoring equipment will consist of a tri-axial seismograph, capable of measuring vibration intensities up to 254 mm/s at a frequency response of 2 to 250 Hz.

Figure 1 below outlines the vibration limits for the Trillium Infrastructure:

The same vibration limits provided above in Figure 1 for the Trillium Infrastructure could also be utilized for buildings adjacent to the site.

- Paterson will review all vibrations over the established warning level, illustrated by the blue line in the above figure, and;
