98 + 100 BEARBROOK LANDRIC HOMES
98 + 100 BEARBROOK ROAD
OTTAWA, ON, K1B 3B9

PRE-DEVELOPMENT VEGETATION

DRAWING TITLE: **POST-DEVELOPMENT VEGETATION**

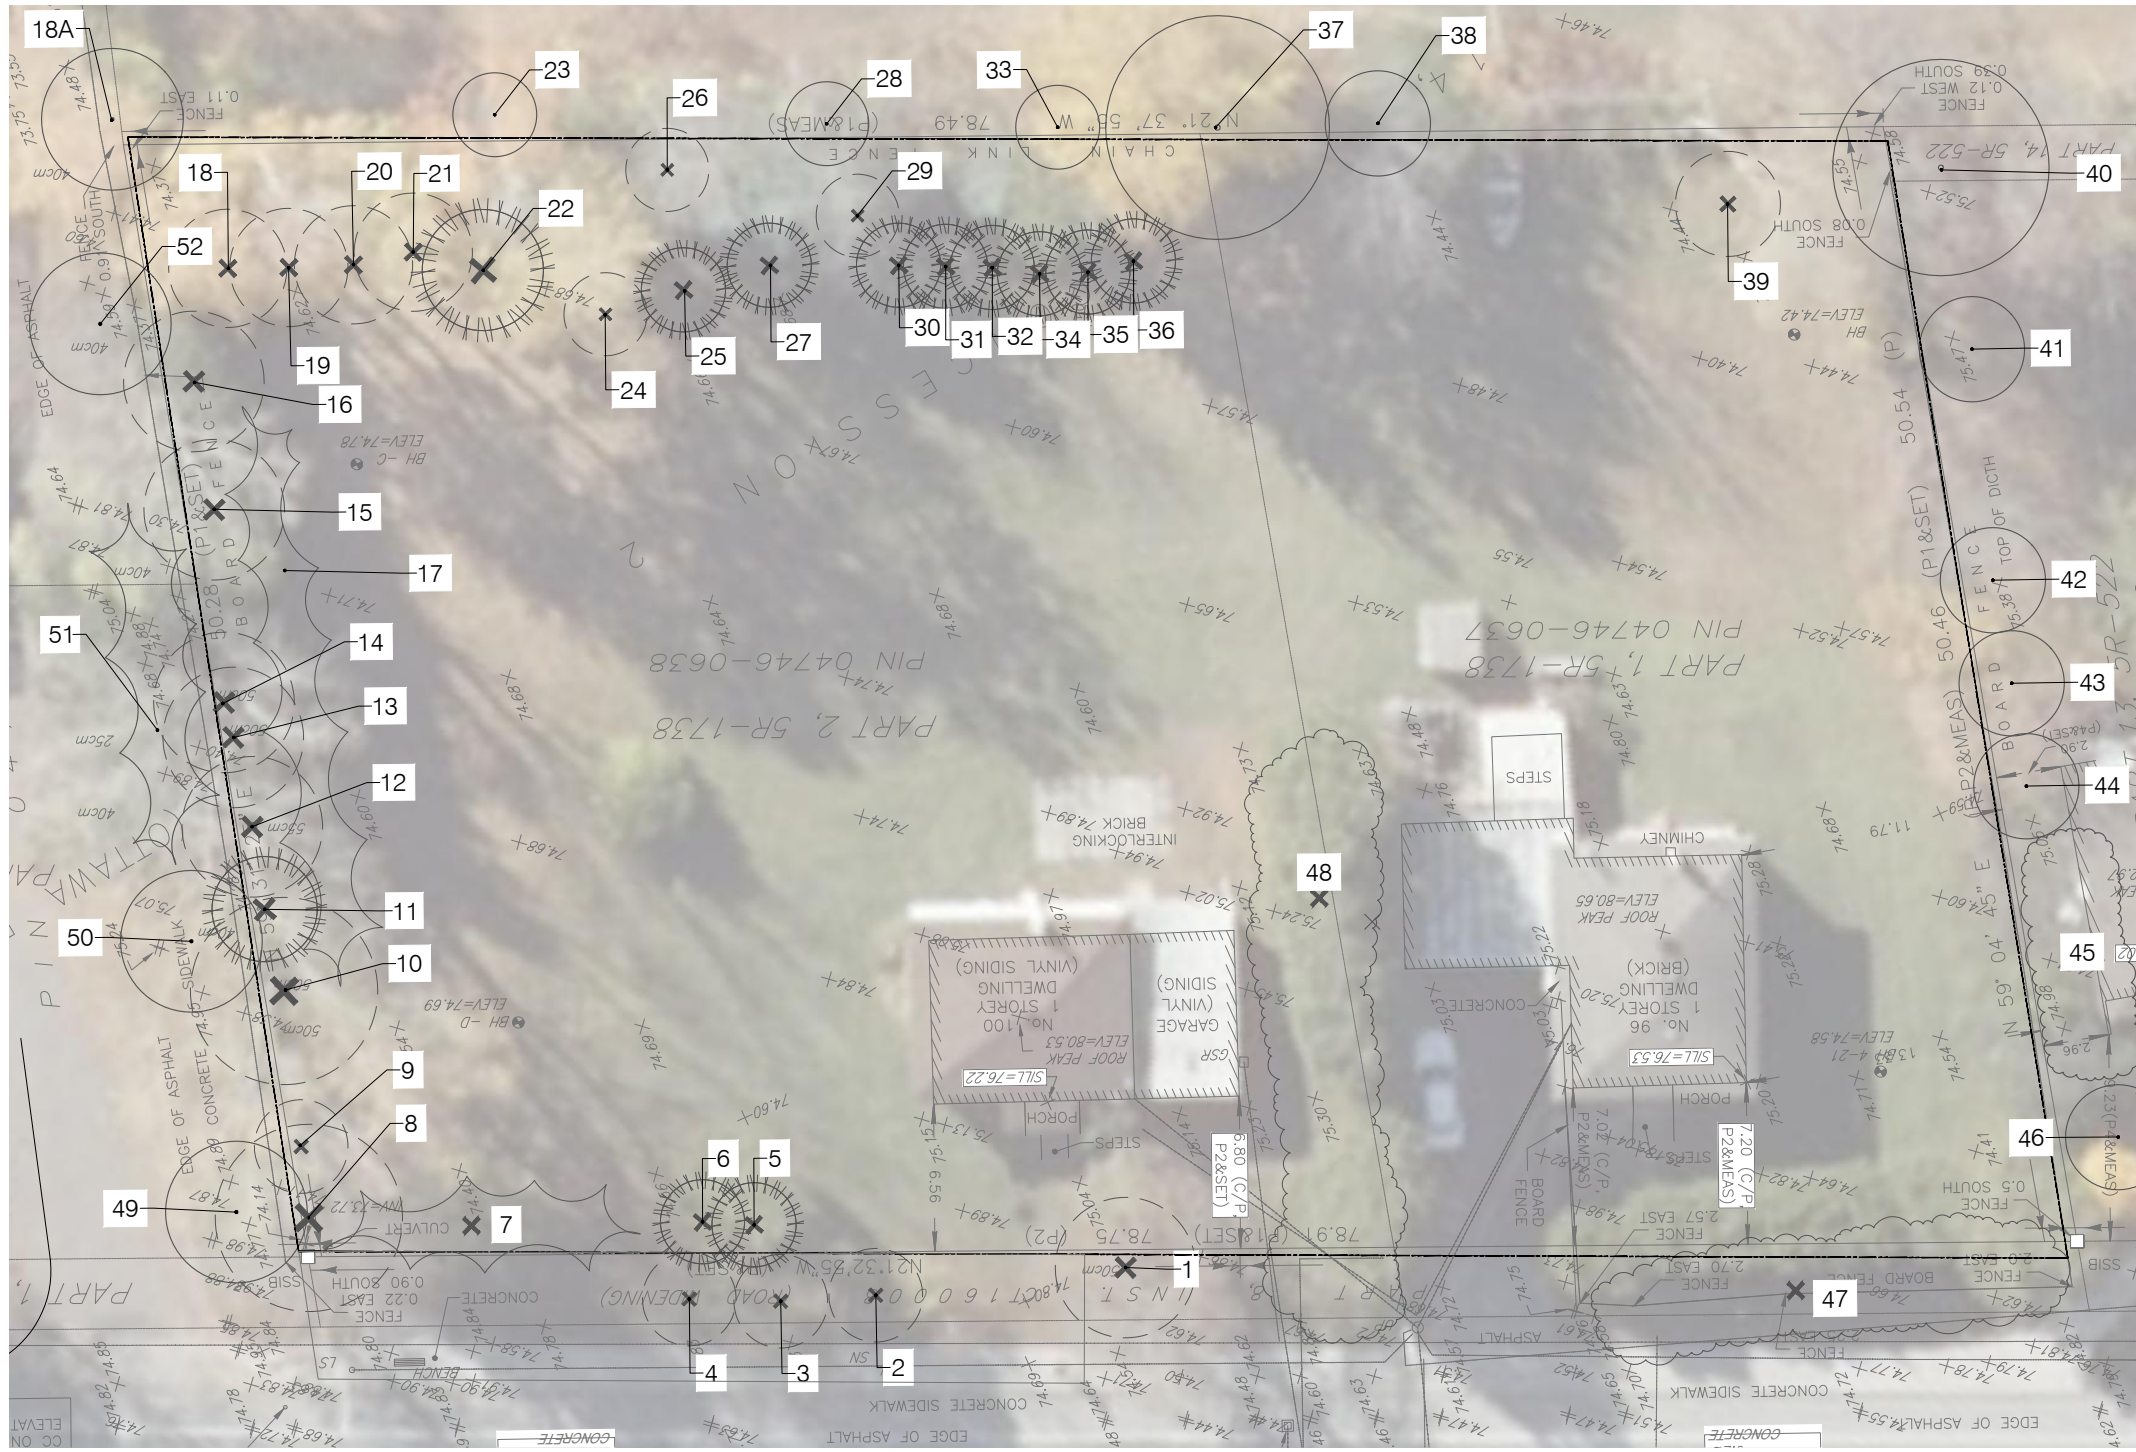
1 PRE-DEVELOPMENT PLAN

TREES ON PRIVATE PROPERTY TO BE REMOVED				
NO.	SPECIES	DBH (CM)	HEALTH	COMMENTS
5	Eastern White Cedar / Thuja occidentalis	19	Good	
6	Eastern White Cedar / Thuja occidentalis	20	Good	
7	Eastern White Cedar / Thuja occidentalis	8-14	Fair	Hedge
8	Silver Maple / Acer saccharinum	15,15, 20,26, 32	Fair	5 stems joined at 1.3m
9	Silver Maple / Acer saccharinum	10,13, 13,15	Fair	4 stems joined at base
10	Eastern Cottonwood / Populus deltoides	43,45	Good	2 stems joined at 1.0m
11	Eastern White Cedar / Thuja occidentalis	35	Good	
12	Eastern Cottonwood / Populus deltoides	64	Good

13	Eastern Cottonwood / Populus deltoides	53	Good	
14	Eastern Cottonwood / Populus deltoides	50	Good	
15	Crack Willow / Salix fragilis	23	Good	
16	Eastern Cottonwood / Populus deltoides	55	Good	
17	Eastern White Cedar / Thuja occidentalis	10-18	Fair-Good	Hedge
18	Trembling Aspen / Populus tremuloides	33	Good	
19	Trembling Aspen / Populus tremuloides	35	Good	
20	Trembling Aspen / Populus tremuloides	44	Good	2 Stems joined at base
21	Trembling Aspen / Populus tremuloides	35	Good	
22	Colorado Blue Spruce / Picea pungens	17	Good

24	Trembling Aspen / Populus tremuloides	28	Good	
25	Colorado Blue Spruce / Picea pungens	18	Good	
26	Trembling Aspen / Populus tremuloides	36	Good	
27	Colorado Blue Spruce / Picea pungens	19	Good	
29	Trembling Aspen / Populus tremuloides	17	Good	
30	Colorado Blue Spruce / Picea pungens	22	Good	
31	Colorado Blue Spruce / Picea pungens	32	Good	
32	Colorado Blue Spruce / Picea pungens	18	Good	
34	Colorado Blue Spruce / Picea pungens	22	Good	
35	Colorado Blue Spruce / Picea pungens	28	Good	
36	Colorado Blue Spruce / Picea pungens	25	Good	
38	Manitoba Maple / Acer negundo	39	Poor	Last of 3 stems, heavy lean
48	Eastern White Cedar / Thuja occidentalis	15-30	Fair-Good	38 Stem

TREES ON CITY PROPERTY TO BE REMOVED				
NO.	SPECIES	DBH (CM)	HEALTH	COMMENTS
1	Basswood / Tilia americana	46	Good	
2	Apple sp. / Malus sp.	33	Poor	Poor pruning / dieback
3	Apple sp. / Malus sp.	22	Poor	Poor pruning / dieback
4	Apple sp. / Malus sp.	14 / 15	Poor	Poor pruning / dieback
47	Eastern White Cedar / Thuja occidentalis	8-14	Poor-Fair	Hedge

TREES TO REMAIN				
NO.	SPECIES	DBH (CM)	HEALTH	COMMENTS
18	Trembling Aspen / Populus tremuloides	35	Good	Adjacent Property
23	Silver Maple / Acer saccharinum	20-30	Good	Adjacent Property
28	Red Maple / Acer rubrum	28	Good	Adjacent Property
33	Red Maple / Acer rubrum	45	Good	Adjacent Property
37	Red Maple / Acer rubrum	55-55	Good	Adjacent Property
38	Red Maple / Acer rubrum	35	Good	Adjacent Property
40	Manitoba Maple / Acer negundo	52	Fair	Adjacent Property
41	Manitoba Maple / Acer negundo	20	Poor	Adjacent Property
42	Red Maple / Acer rubrum	20	Good	Adjacent Property
43	Apple / Malus sp.	20,22, 18	Poor	Adjacent Property
44	Manitoba Maple / Acer negundo	33	Fair	Adjacent Property
45	European Buckthorn / Rhamnus cathartica	10-15	Fair	Adjacent Property, Hedge
46	Red Maple / Acer rubrum	16	Fair	Adjacent Property
49	Norway Maple / Acer platanoides	30	Poor	Adjacent Property
50	Norway Maple / Acer platanoides	30	Fair	Adjacent Property

51	Austrian Pine / Pinus nigra	20-28	Good	Adjacent Property, 4 Stems
52	Norway Maple / Acer platanoides	40	Good	Adjacent Property
