**Re: Parking Turning Movement Analysis at 439 Churchill Avenue North**

# Parking Turning Movement Analysis at 439 Churchill Avenue North

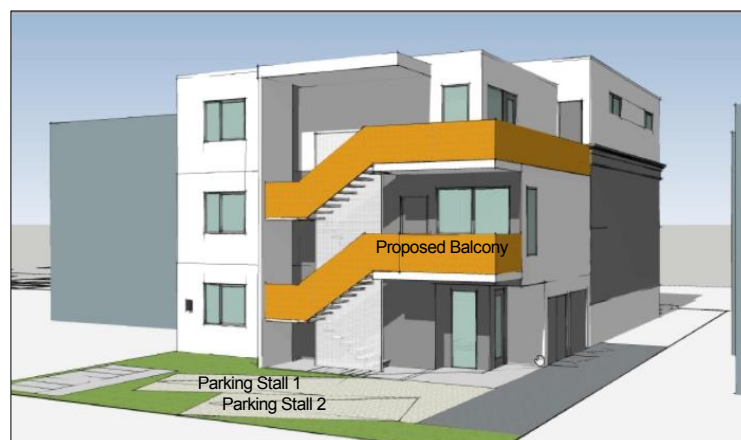
As illustrated in Figure 1 the proposed plans envision a balcony. The lower balcony at its lowest point in conflict with the parking stall offers a vertical clearance of approximately 2.1m at the pinch point.

**Figure 1: View of Back of Building, Balconies and Parking Areas**

- Tall vehicles such as cargo vans and heavy-duty pickups characterized by heights above 2m should not be allowed to access the western parking space. This is critical especially during the winter period when snow and ice buildup may reduce the available 2.1m vertical clearance. Signage should be provided to ensure that motorists driving tall vehicles are aware of the height limitation and to stay clear of the balcony/deck corners. A height restriction suspended sign/bar spanning the width of the shared driveway which could be used to provide advance warning for vehicles over 2m tall, (but this would require an agreement with the adjacent property owners).

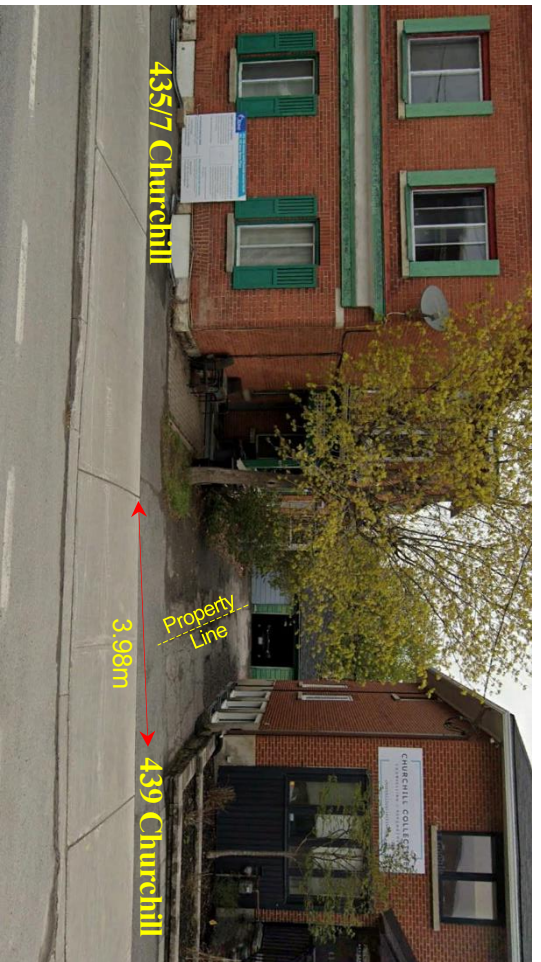
LEVEL 1  
SCALE: 1:100

**GROUND FLOOR PLAN**

Figure 4: Site Plans for 472 Byron Place Development

It is worthwhile to note that the existing driveway width belonging to the subject property is 2.5m in width between the already existing building and the property line. However, Figure 4 illustrates that both existing and future plans (See City Plans D02-02-19-0037) provide for a shared driveway lane with the adjacent property to the north that provides for a 3.98m wide laneway.
