# McCormick Park Development Inc

268 Carruthers Ave Ottawa, Ontario Job No.: 100306

## DRAIN CCTV INSPECTION REPORT

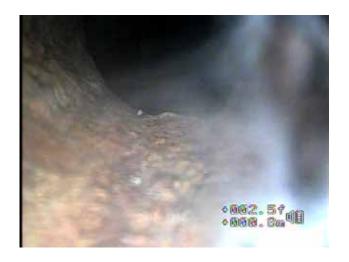
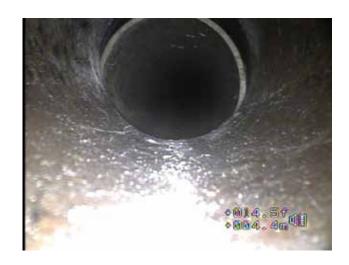
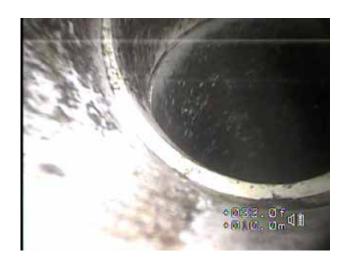
## VIDEO 1

DISTANCE (M)	CODE	INSPECTION COMMENTS	CODE AIF BKJ	DESCRIPTION ACTIVE INFILTRATION BROKEN JOINT
0.0	C/0	START OF INSPECTION – CLEANOUT	BSG	START OF SAG
0.6	MC	Material Change – Cast Iron to Clay	BWV C/O	BACKWATER VALVE CLEANOUT

0.6	DC	Diameter Change – 4" to 6"	CAL	CALCITE
4.4	MC	Material Change – Clay to PVC	CFL CRC	COLLAPSE CIRCULAR CRACK
10.0	LBD	Line Bends Down	DC DEB	DI AMETER CHANGE DEBRI S

10.0	MC	Material Change – PVC to Clay	DEF	PIPE DEFORMATION
11.0	END	END OF INSPECTION – City Sewer	EIF ESG	EVIDENCE OF INFILTRATION END OF SAG
11.0	END	END OF INSPECTION – City sewer	EXG	EXPOSED GASKET
			EXR F/D	EXPOSED REBAR FLOOR DRAIN
			FRC GRS	FRACTURE GREASE
			HOLE	HOLE IN PIPE
			LBD LBL	LINE BENDS DOWN LINE BENDS LEFT
			LBR	LINE BENDS RIGHT
			LBS LGC	LINE BENDS STRAIGHT LONGITUDINAL CRACK
			MAIN	MAIN SEWER IN BUILDING
			MC MH	MATERIAL CHANGE MANHOLE
			MSP	MISSING PIPE PIECE
			OBS OFJ	OBSTRUCTION IN PIPE OFFSET JOINT
			OPJ PFL	OPEN JOINT PARTIAL COLLAPSE
			PSC	PROTRUDING CONNECTION
			PUN RTS	PUNCTURE ROOTS
			SC	SERVI CE CONNECTI ON
			WYE	WYE CONNECTION
