Project:  
**RONALD MCDONALD HOUSE**  
 407 SMYTH ROAD  
 OTTAWA., ONTARIO

Drawing:  
**TREE CONSERVATION REPORT**

Scale: 1:400	Date: 20 NOV, 2020
Design By: PG	Drawn By: PG
Project Number: #18909	Sheet Number: TCR 1.1

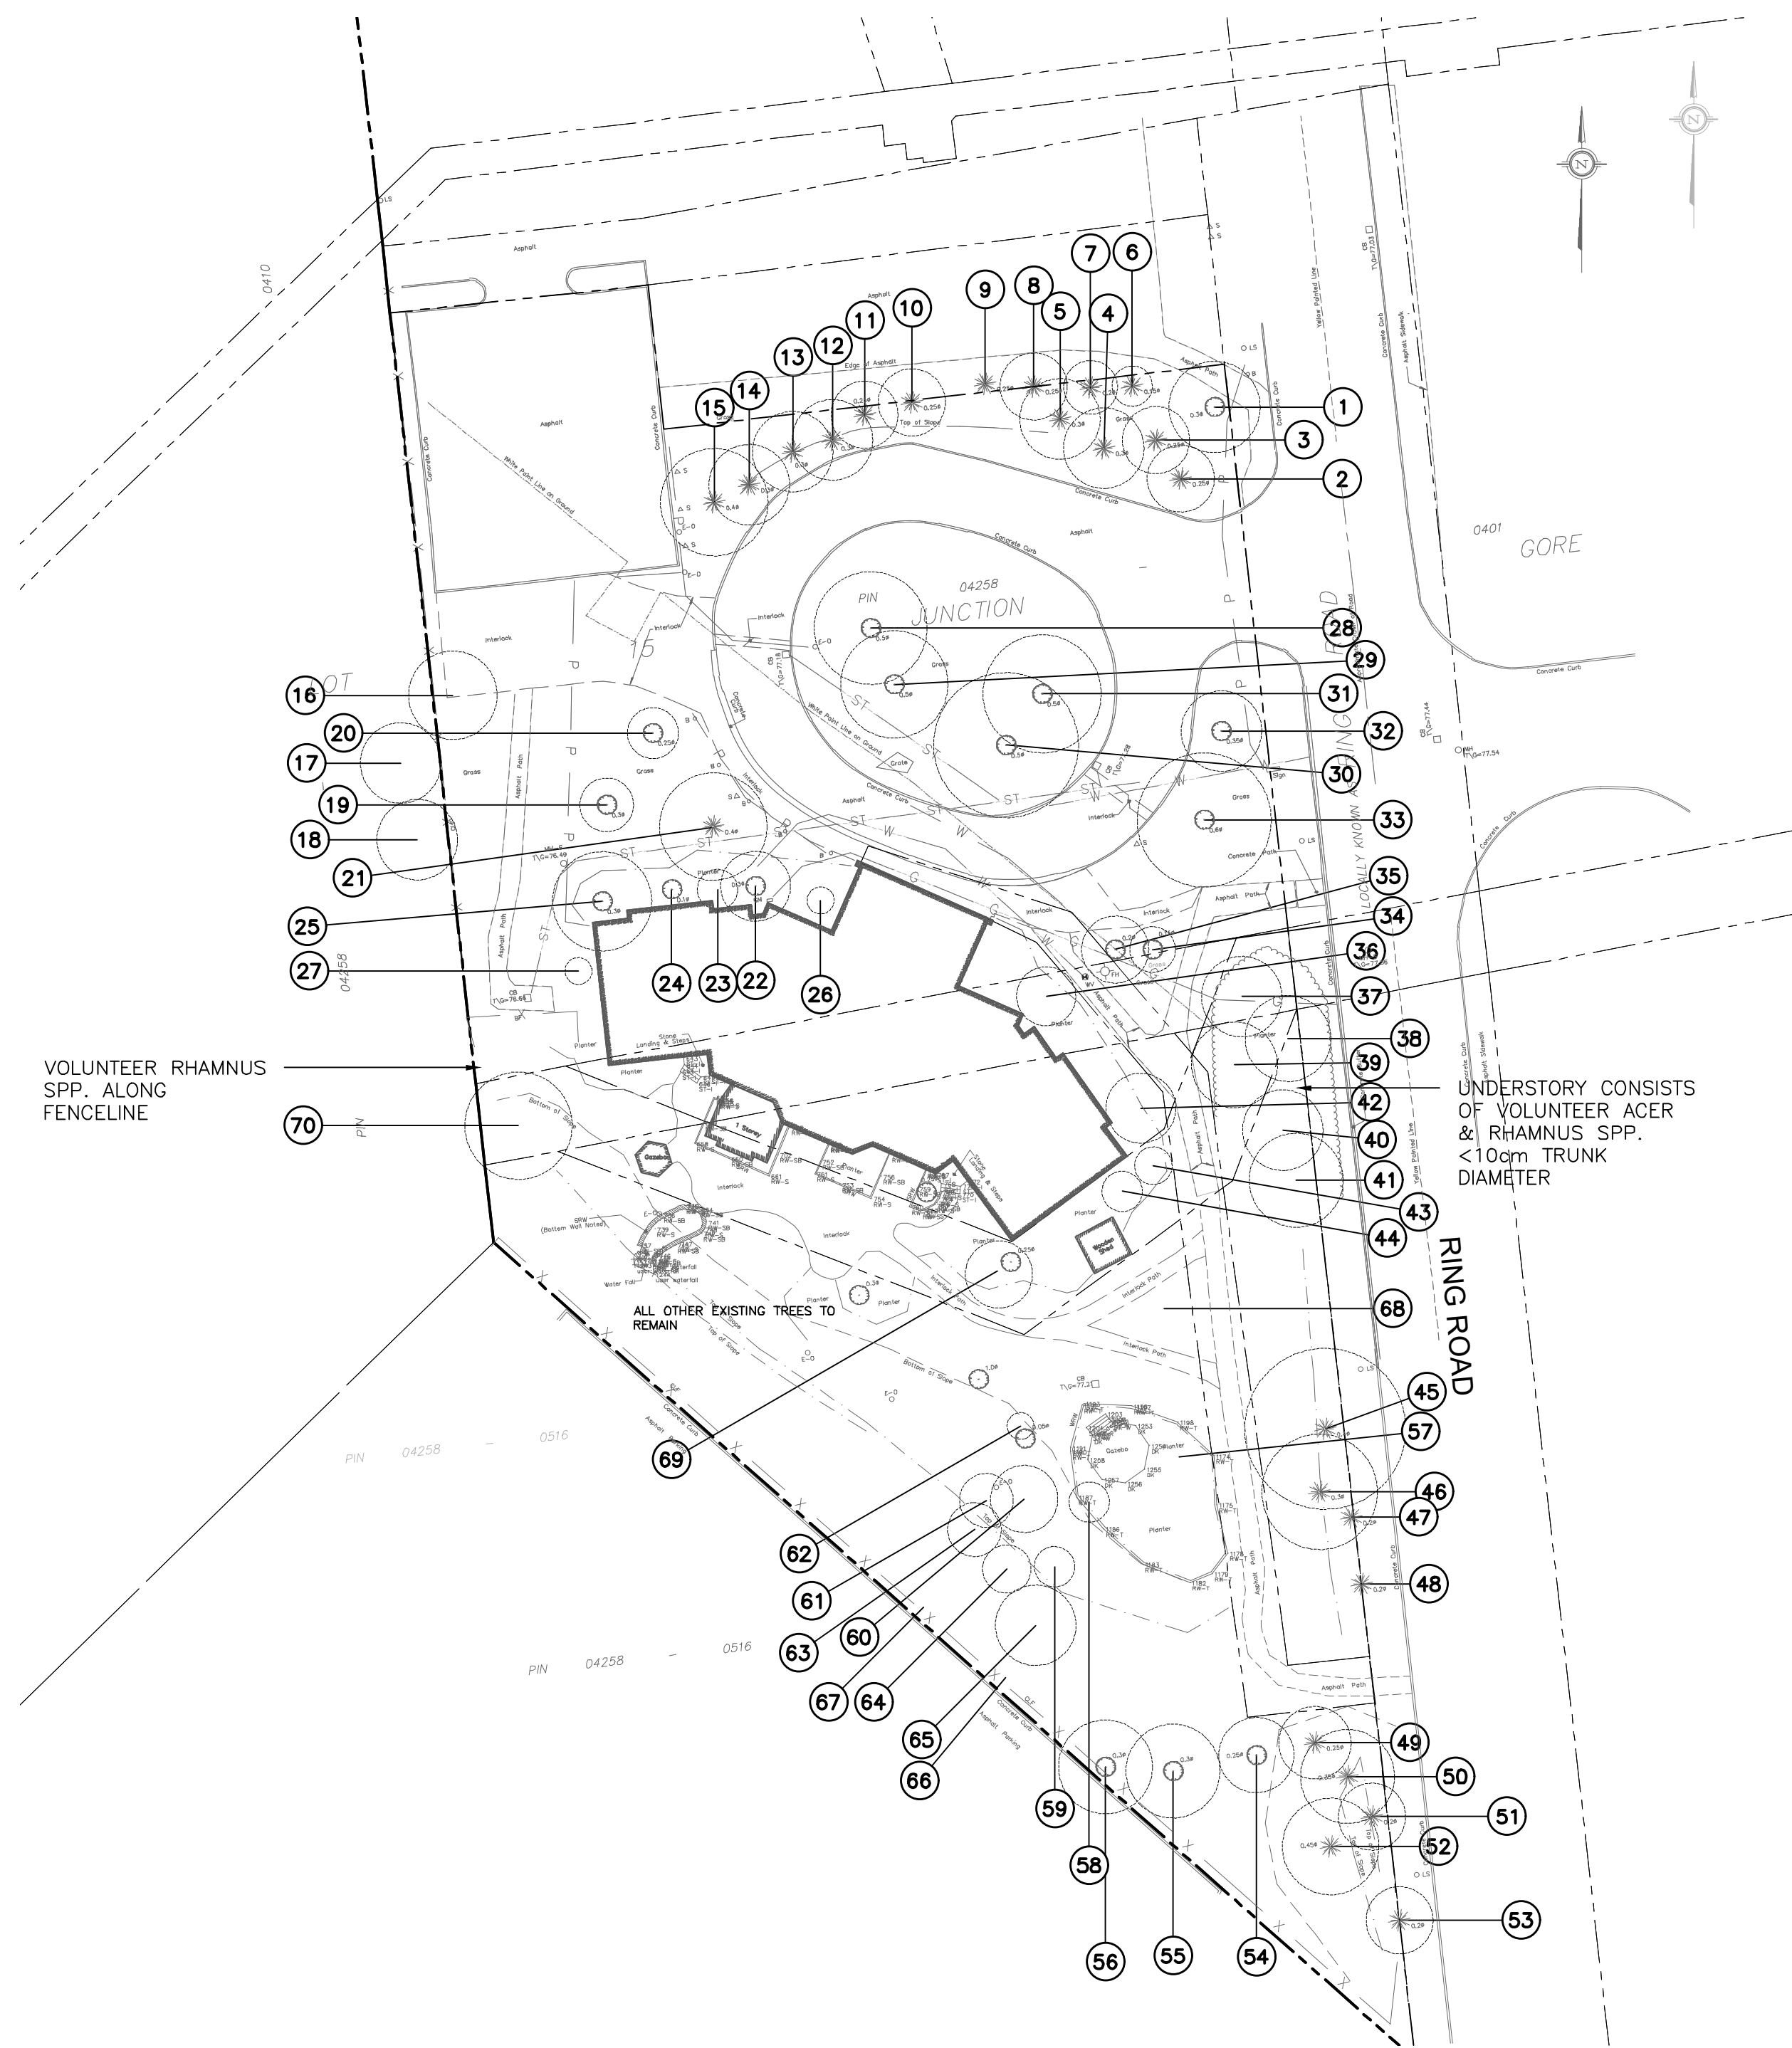
1 EXISTING VEGETATION

- NOTES:**
- THE EXISTING PROPERTY CONTAINS A 2-STORY BUILDING, SURFACE PARKING, AND OUTDOOR AMENITY SPACE. EXISTING VEGETATION CONSISTS OF PLANTED TREES, VOLUNTEER TREES (SUCH AS MAPLE AND BUCKTHORN SPECIES), SHRUBS, PERENNIALS, AND TURFGRASS. THE SITE IS FLAT IN PROXIMITY TO THE EXISTING BUILDING, WHEREAS THE EXTERIOR OF THE SITE HAS GENTLY SLOPED BERMS.

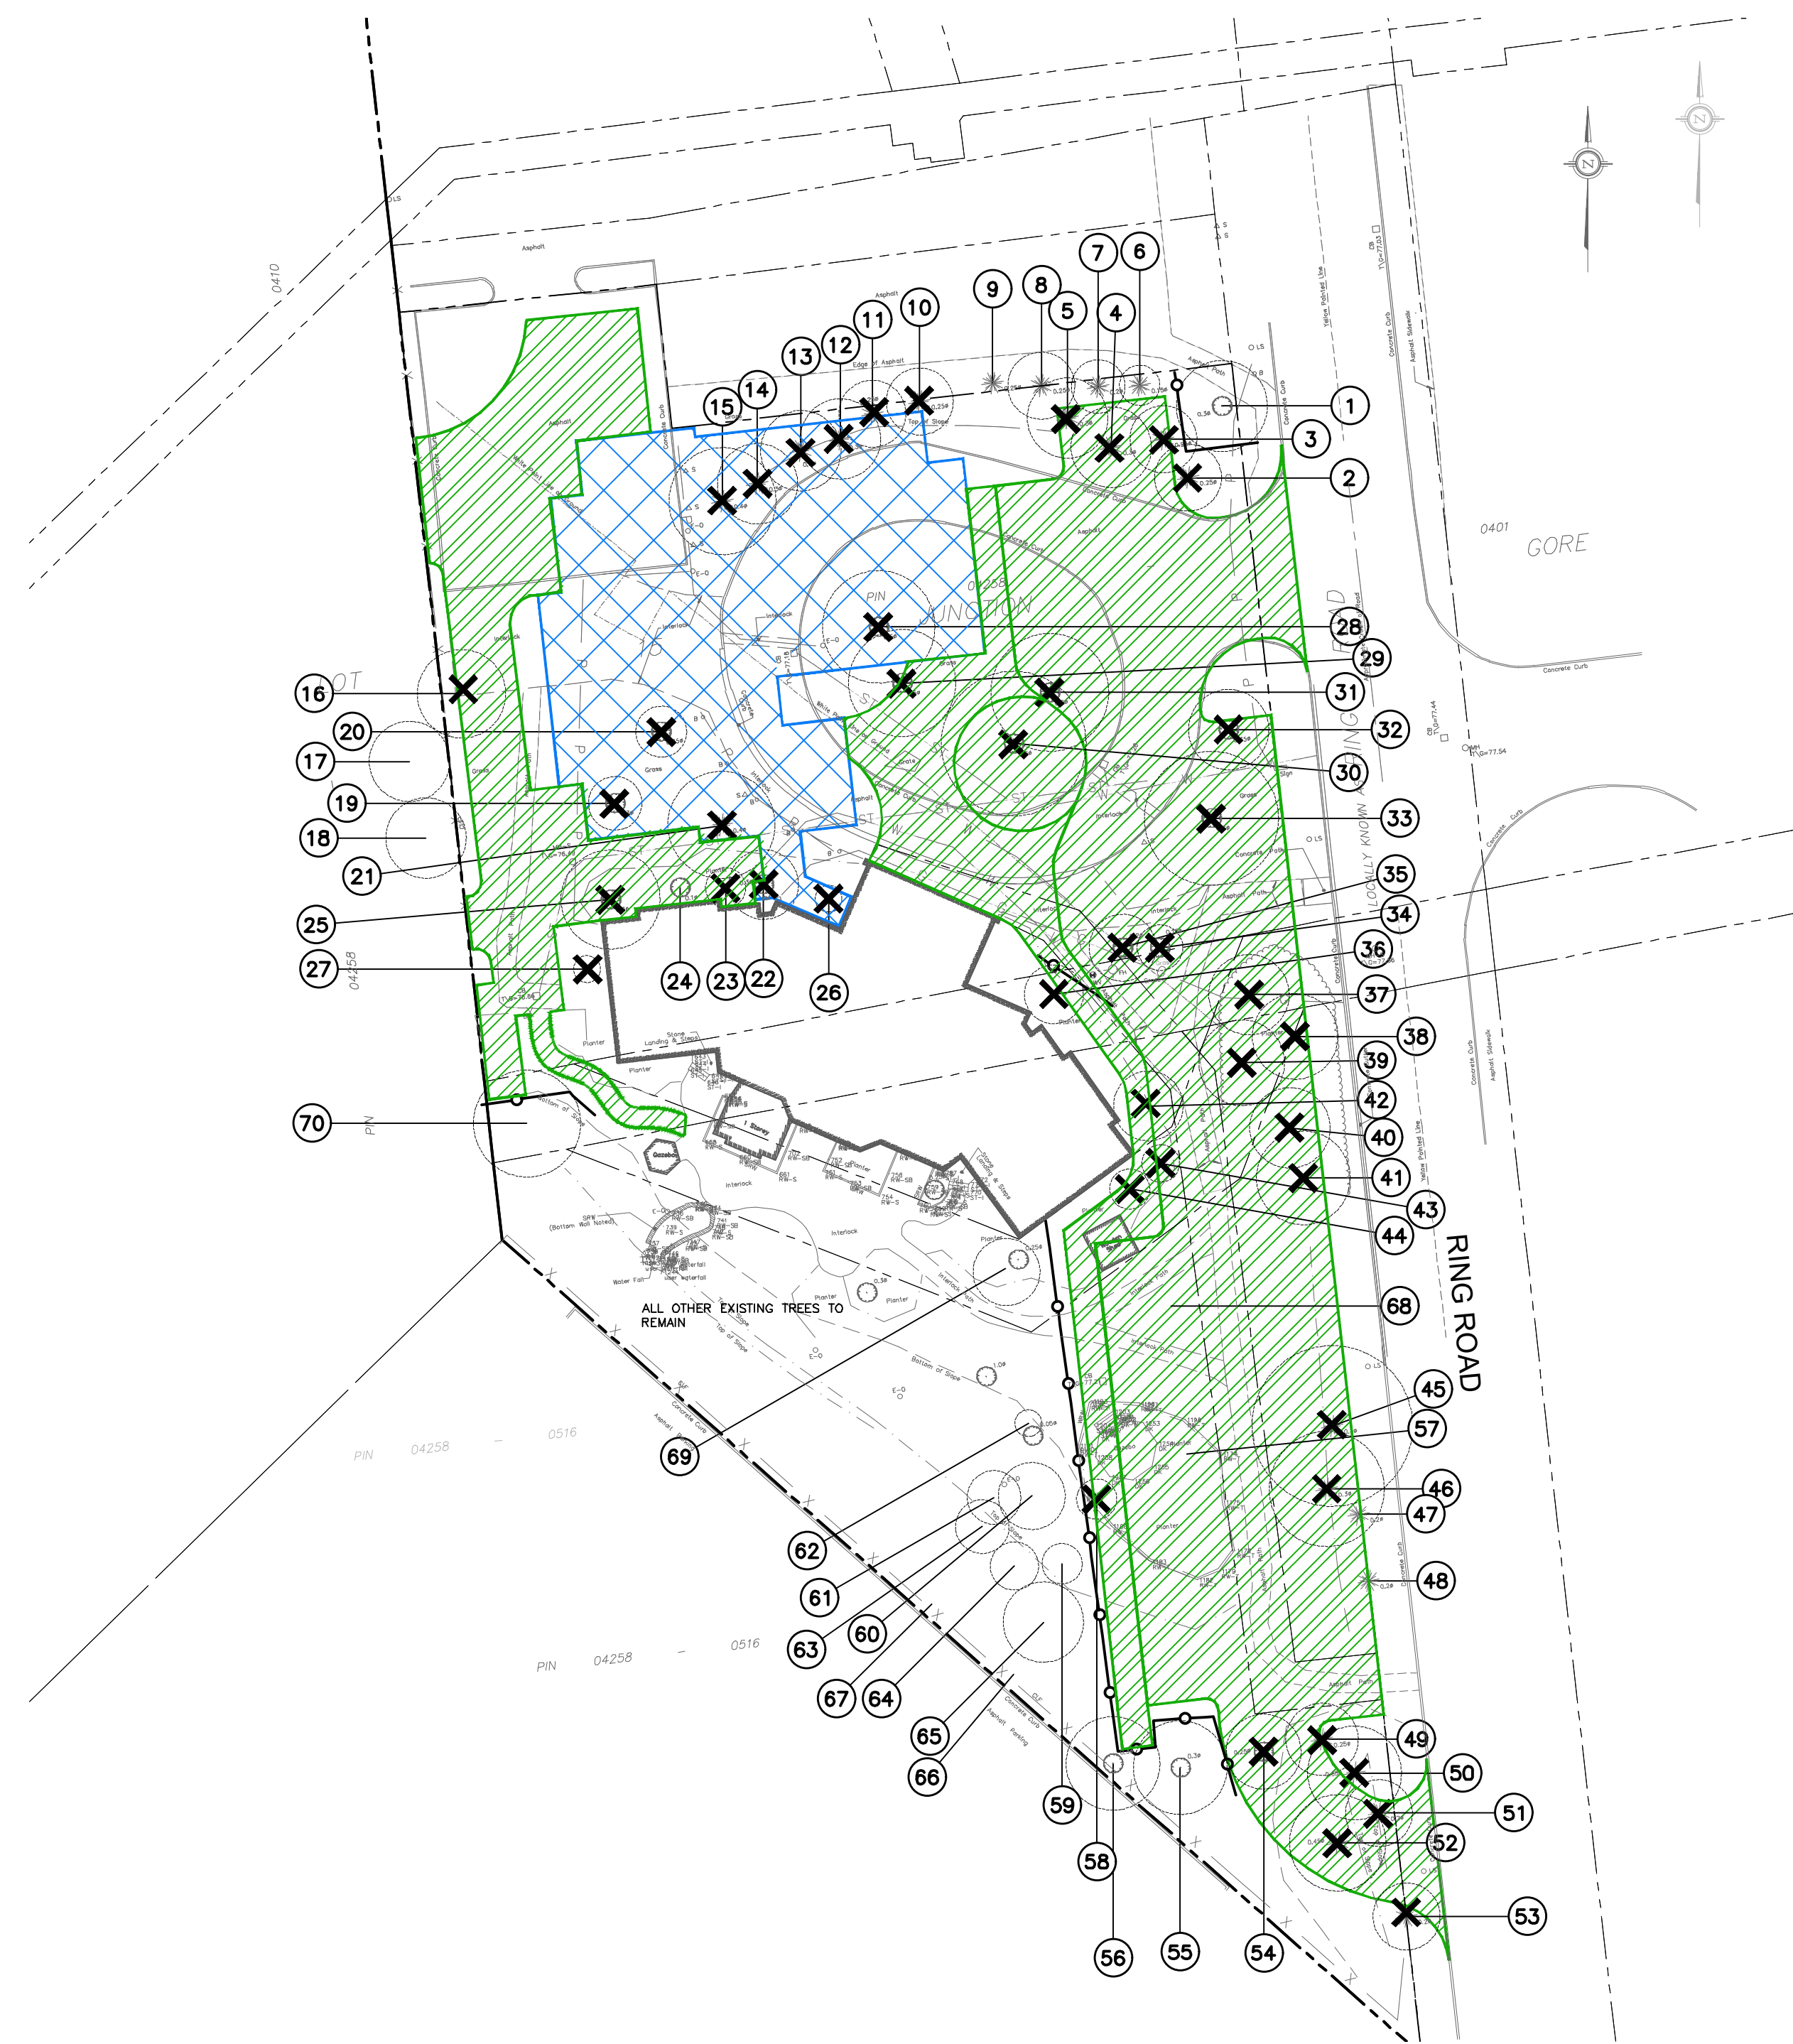
2 PROPOSED DEVELOPMENT

- APPROXIMATELY 620 m<sup>2</sup> OF THE SITE IS CURRENTLY OCCUPIED BY AN EXISTING BUILDING FOOTPRINT.
    - APPROXIMATELY 805 m<sup>2</sup> TO BE COVERED BY THE PROPOSED BUILDING FOOTPRINTS.

- APPROXIMATELY 2600 m<sup>2</sup> TO BE HARD SURFACES.
  - THE PROPOSED DEVELOPMENT REQUIRES THE REMOVAL OF FORTY-FOUR (48) TREES
    - 12 ARE DUE TO THE PROPOSED BUILDING.

- 26 ARE DUE TO REQUIRED PARKING AREA.
    - 10 ARE DUE TO PROPOSED LANDSCAPING.
  - FOR RETAINED TREES:
    - ERECT A FENCE AT THE CRITICAL ROOT ZONE (CRZ) OF TREES;

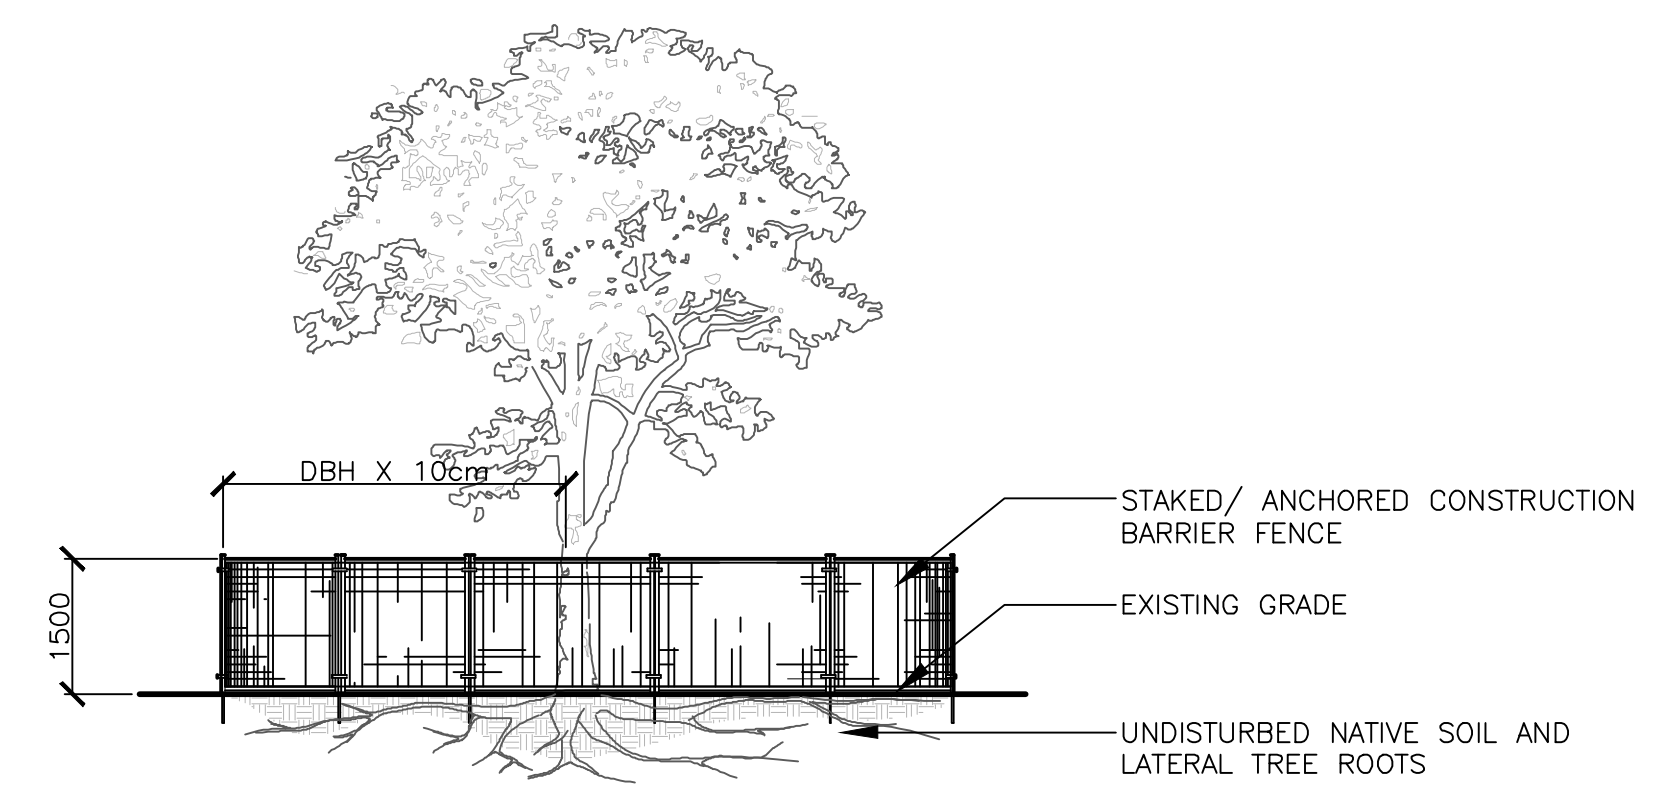
1 TREE PROTECTION FENCING N.T.S

THE FOLLOWING PROTECTION MEASURES MUST BE IMPLEMENTED FOR RETAINED TREES, BOTH ON SITE AND ADJACENT SITES, PRIOR TO ANY TREE REMOVAL OR SITE WORKS AND MAINTAINED FOR THE DURATION OF CONSTRUCTION ON SITE.

- UNDER THE GUIDANCE OF AN ARBORIST, ERECT A FENCE AT THE CRITICAL ROOT ZONE (CRZ) OF TREES WHERE THE CRZ IS ESTABLISHED AS BEING 10 CENTIMETERS FROM THE TRUNK FOR EVERY CENTIMETER OF TRUNK DIAMETER AT BREAST HEIGHT. THE CRZ IS CALCULATED AS DBH X 10cm.
- DO NOT PLACE ANY MATERIAL OR EQUIPMENT WITHIN THE CRZ OF THE TREE
- DO NOT ATTACH ANY SIGNS, NOTICES OR POSTERS TO ANY TREE
- DO NOT RAISE OR LOWER THE GRADE WITHIN THE CRZ WITHOUT APPROVAL
- TUNNEL OR BORE WHEN DIGGING WITHIN THE CRZ OF A TREE
- DO NOT DAMAGE THE ROOT SYSTEM, TRUNK, OR BRANCHES OR ANY TREE
- ENSURE THAT EXHAUST FUMES FROM ALL EQUIPMENT ARE NOT DIRECTED TOWARDS ANY TREE CANOPY
