Project:
RONALD MCDONALD HOUSE
 407 SMYTH ROAD
 OTTAWA., ONTARIO

Drawing:
TREE CONSERVATION REPORT

Scale: 1:400	Date: 20 NOV, 2020
Design By: PG	Drawn By: PG/SC
Project Number: #18909	Sheet Number: TCR 1.1

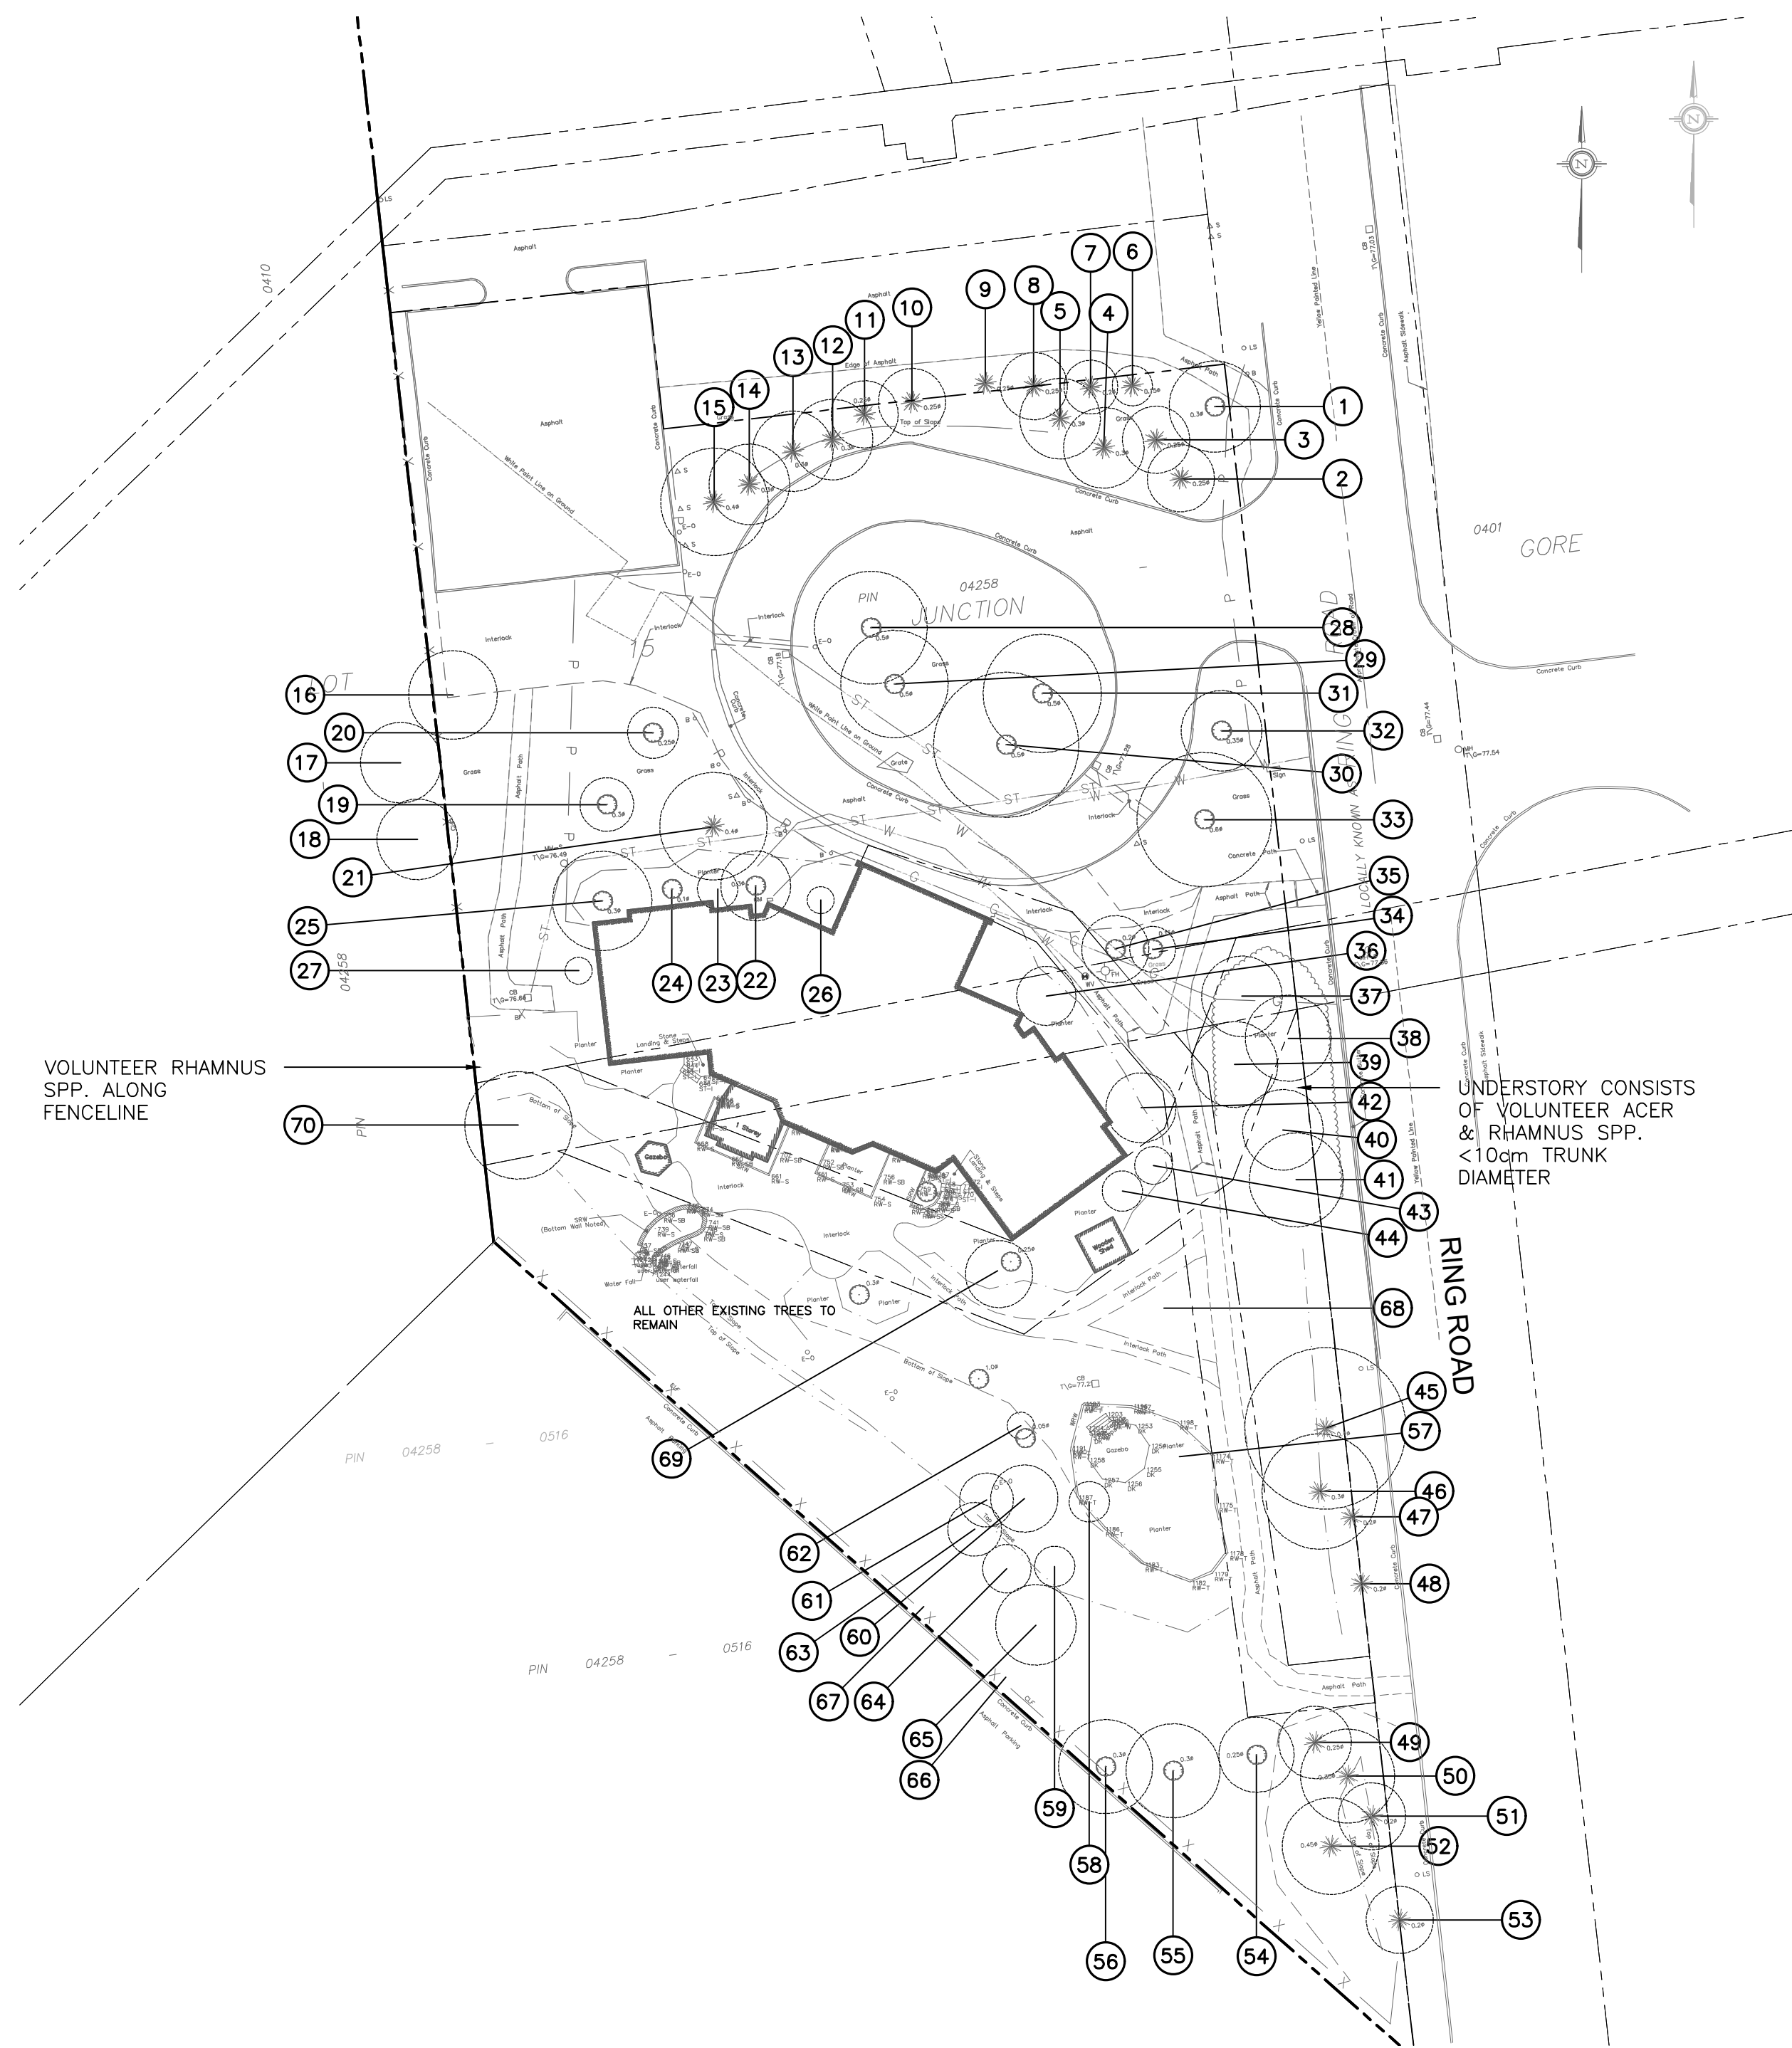
1 EXISTING VEGETATION

1.0 THE EXISTING PROPERTY CONTAINS A 2-STORY BUILDING, SURFACE PARKING, AND OUTDOOR AMENITY SPACE. EXISTING VEGETATION CONSISTS OF PLANTED TREES, VOLUNTEER TREES (SUCH AS MAPLE AND BUCKTHORN SPECIES), SHRUBS, PERENNIALS, AND TURFGRASS. THE SITE IS FLAT IN PROXIMITY TO THE EXISTING BUILDING, WHEREAS THE EXTERIOR OF THE SITE HAS GENTLY SLOPED BERMS.

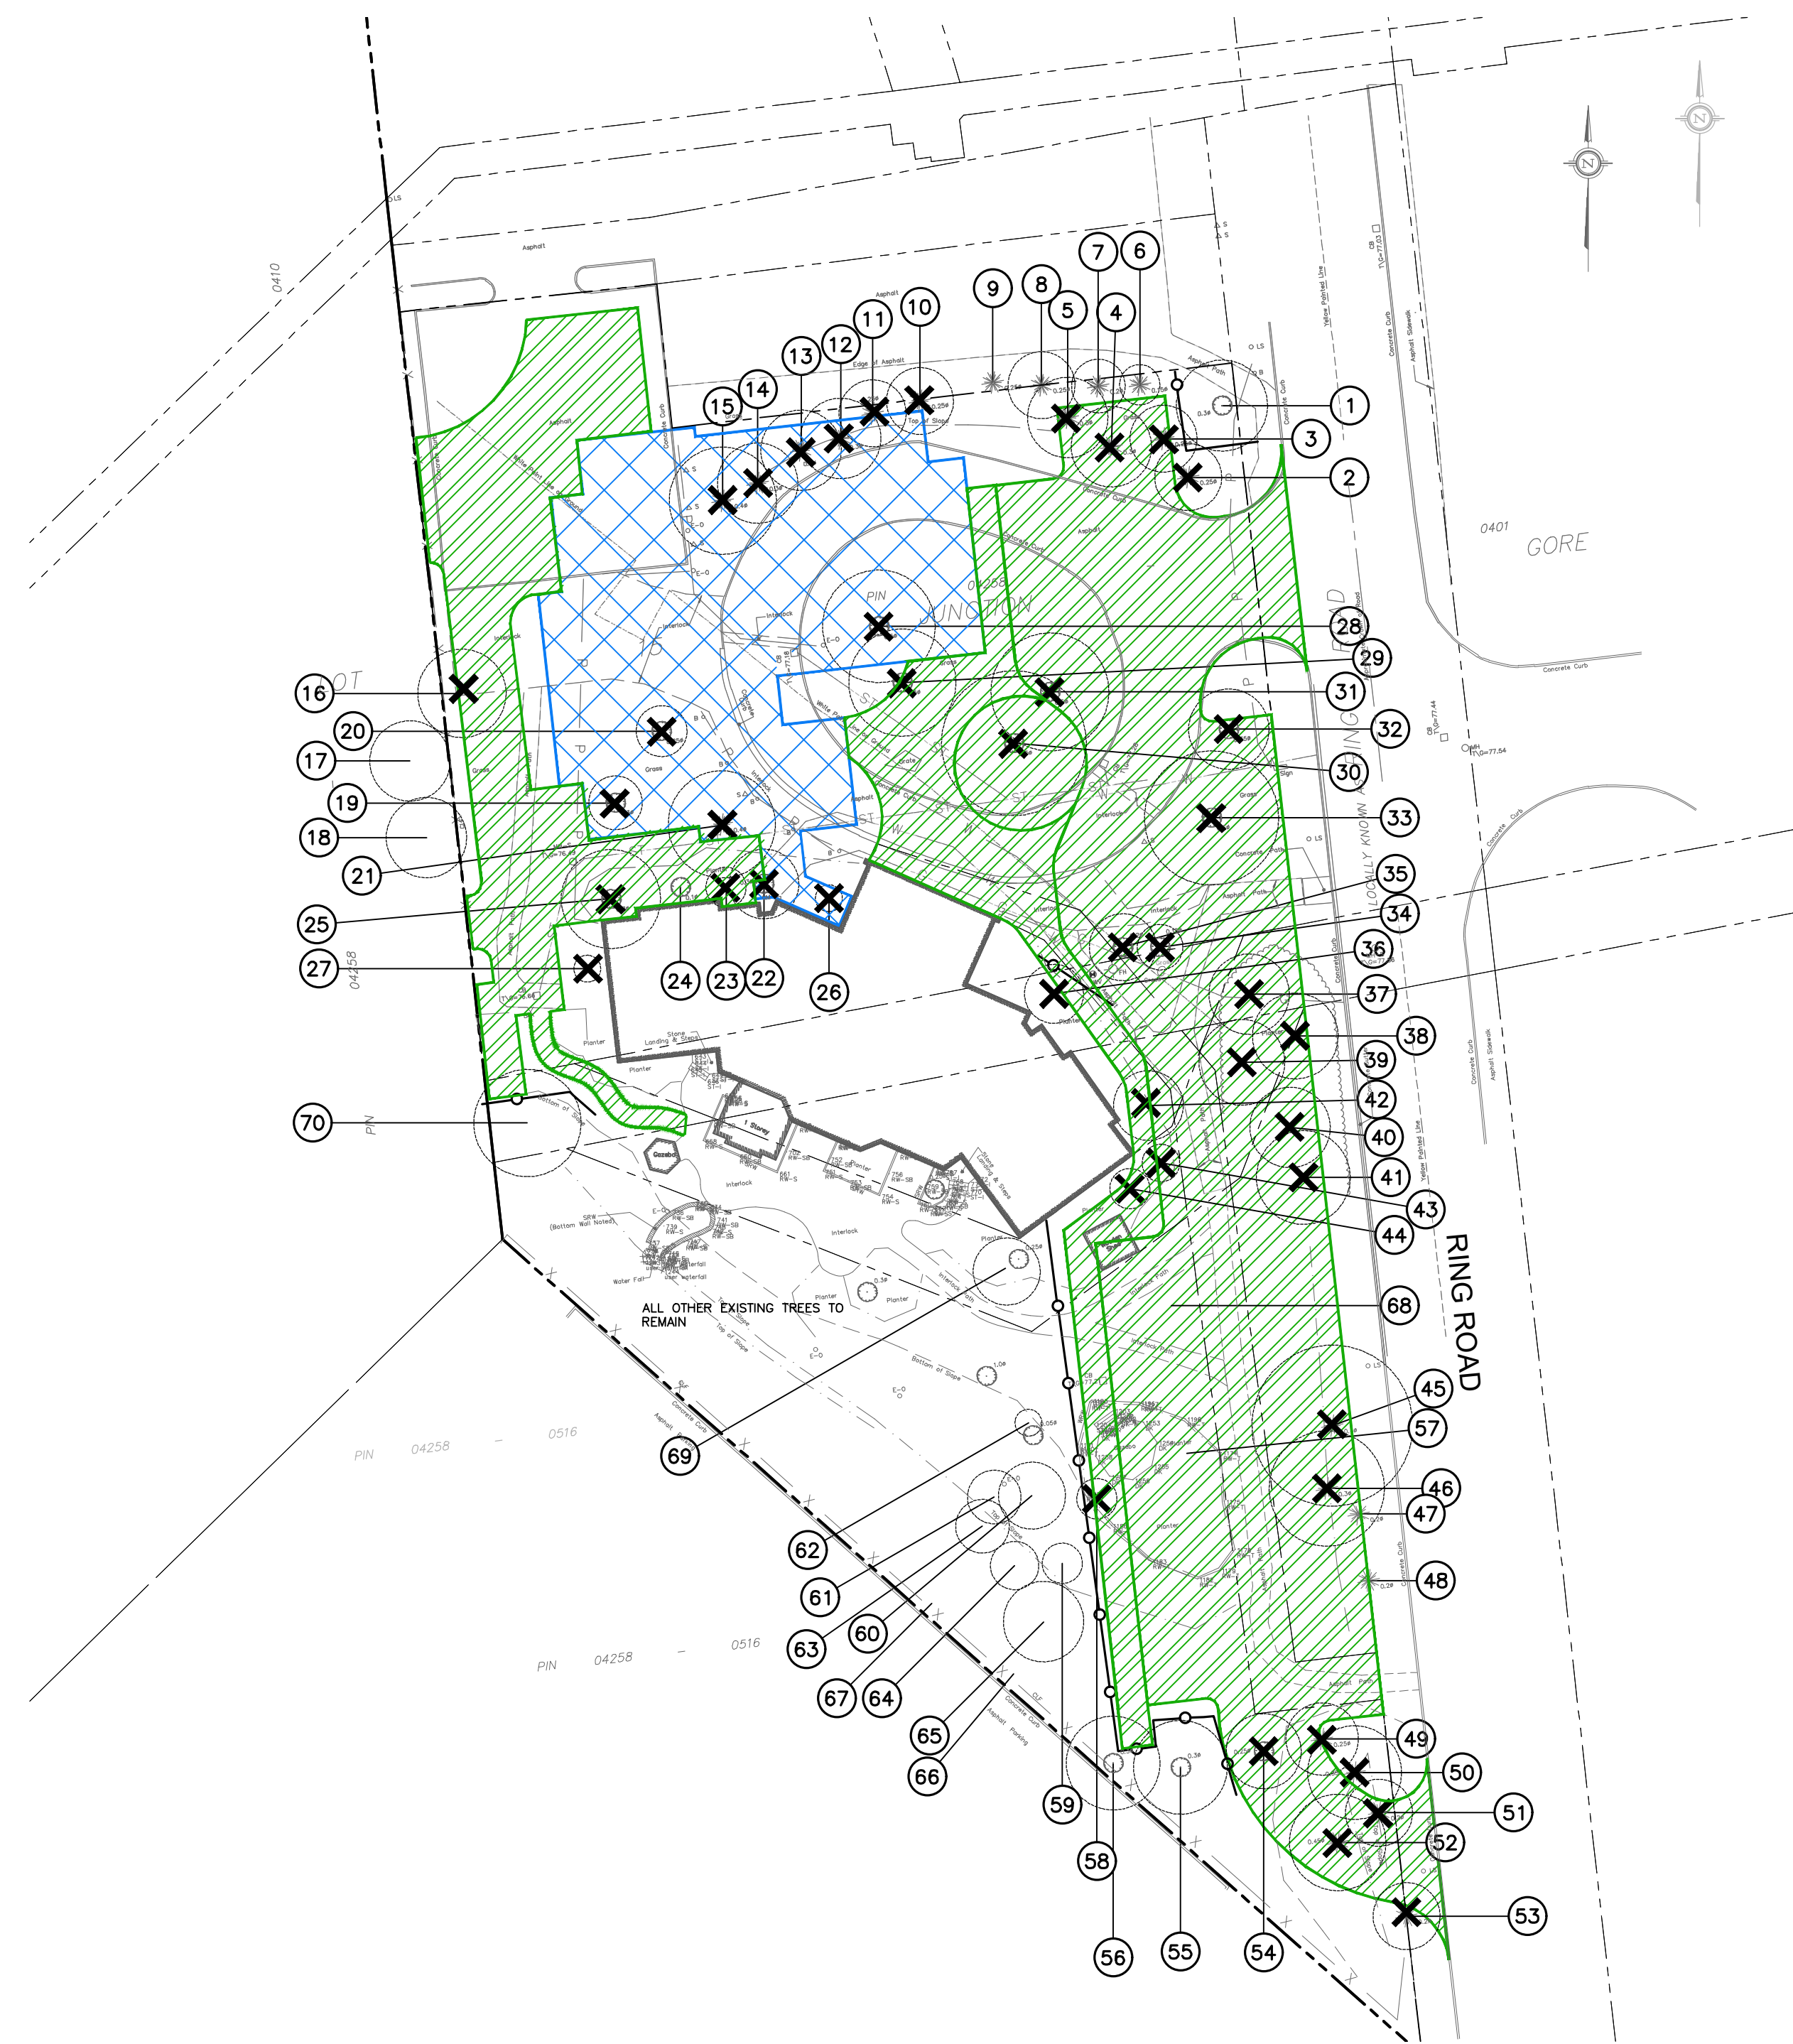
2 PROPOSED DEVELOPMENT

- APPROXIMATELY 620 m² OF THE SITE IS CURRENTLY OCCUPIED BY AN EXISTING BUILDING FOOTPRINT.
- APPROXIMATELY 805 m² TO BE COVERED BY THE PROPOSED BUILDING FOOTPRINTS.
- APPROXIMATELY 2600 m² TO BE HARD SURFACES.

2.0 THE PROPOSED DEVELOPMENT REQUIRES THE REMOVAL OF FORTY-FOUR (48) TREES

- 12 ARE DUE TO THE PROPOSED BUILDING.
- 26 ARE DUE TO REQUIRED PARKING AREA.
- 10 ARE DUE TO PROPOSED LANDSCAPING.

- ERECT A FENCE AT THE CRITICAL ROOT ZONE (CRZ) OF TREES;
- DO NOT PLACE ANY MATERIAL OR EQUIPMENT WITHIN THE CRZ OF THE TREE;
- DO NOT ATTACH ANY SIGNS, NOTICES OR POSTERS TO ANY TREE;
- DO NOT RAISE OR LOWER THE EXISTING GRADE WITHIN THE CRZ WITHOUT APPROVAL;
- TUNNEL OR BORE WHEN DIGGING WITHIN THE CRZ OF A TREE;
- DO NOT DAMAGE THE ROOT SYSTEM, TRUNK OR BRANCHES OF ANY TREE;
- ENSURE THAT EXHAUST FUMES FROM ALL EQUIPMENT ARE NOT DIRECTED TOWARDS ANY TREE'S CANOPY.
- CERTIFIED ARBORIST TO MONITOR WHEN EXCAVATING WITHIN CRZ TO AVOID DAMAGE TO ROOTS.

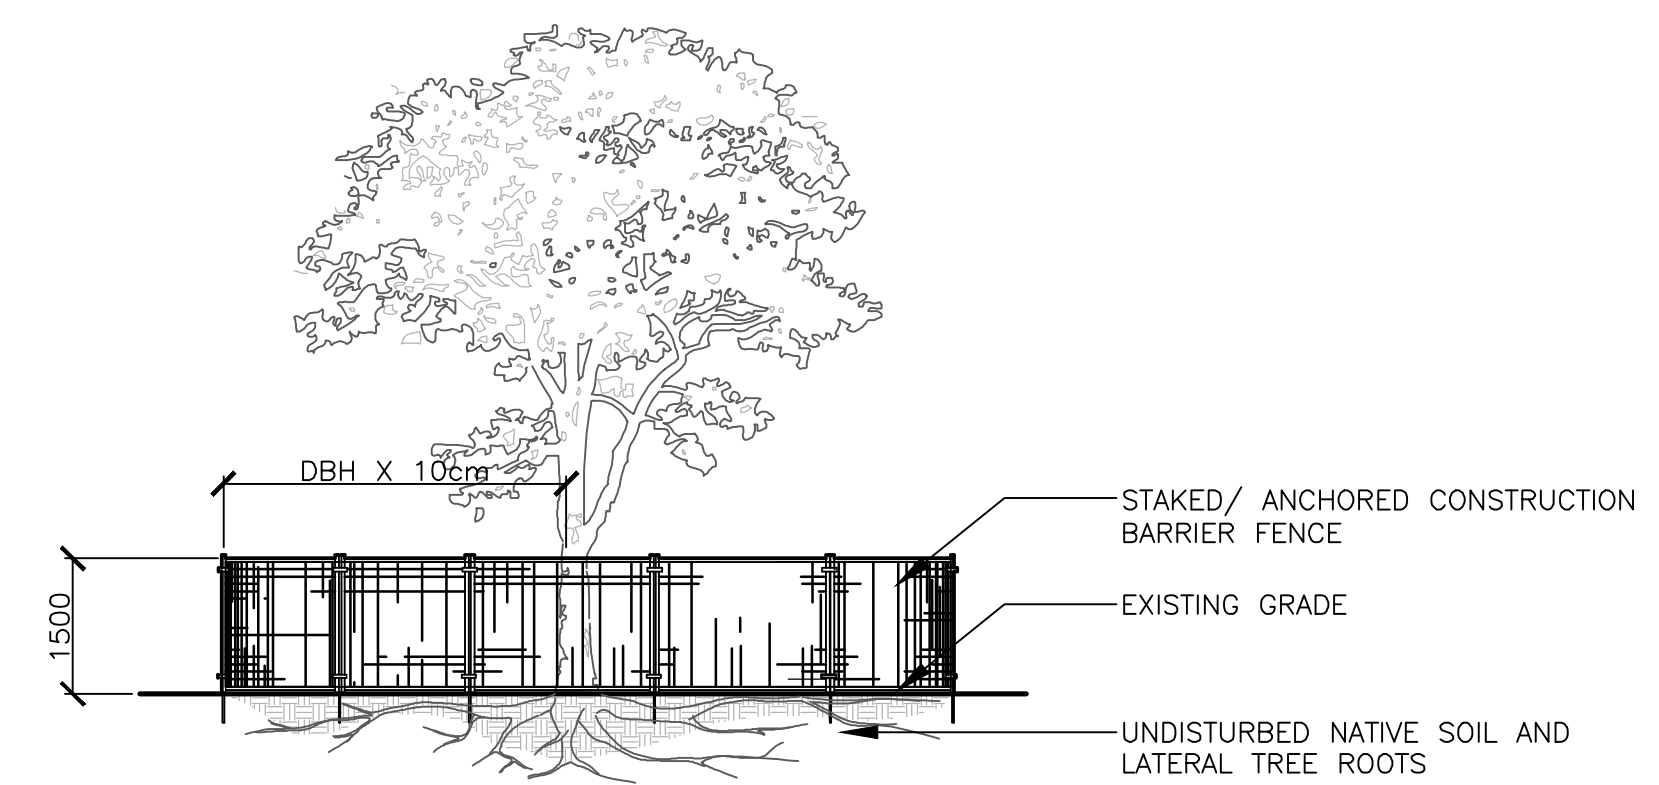
1 TREE PROTECTION FENCING

THE FOLLOWING PROTECTION MEASURES MUST BE IMPLEMENTED FOR RETAINED TREES, BOTH ON SITE AND ADJACENT SITES, PRIOR TO ANY TREE REMOVAL OR SITE WORKS AND MAINTAINED FOR THE DURATION OF CONSTRUCTION ON SITE.

- UNDER THE GUIDANCE OF AN ARBORIST, ERECT A FENCE AT THE CRITICAL ROOT ZONE(CRZ) OF TREES WHERE THE CRZ IS ESTABLISHED AS BEING 10 CENTIMETERS FROM THE TRUNK FOR EVERY CENTIMETER OF TRUNK DIAMETER AT BREAST HEIGHT. THE CRZ IS CALCULATED AS DBH X 10cm.
- DO NOT PLACE ANY MATERIAL OR EQUIPMENT WITHIN THE CRZ OF THE TREE
- DO NOT ATTACH ANY SIGNS, NOTICES OR POSTERS TO ANY TREE
- DO NOT RAISE OR LOWER THE GRADE WITHIN THE CRZ WITHOUT APPROVAL
- TUNNEL OR BORE WHEN DIGGING WITHIN THE CRZ OF A TREE
- DO NOT DAMAGE THE ROOT SYSTEM, TRUNK, OR BRANCHES OR ANY TREE
- ENSURE THAT EXHAUST FUMES FROM ALL EQUIPMENT ARE NOT DIRECTED TOWARDS ANY TREE CANOPY
