UPDATED CONSERVATION PLAN CHAMPLAIN OIL COMPANY SERVICE STATION 70 RICHMOND ROAD OTTAWA, ONTARIO

PREPARED BY: JOHN STEWART, COMMONWEALTH HISTORIC RESOURCE MANAGEMENT

Updated V3 June 2023

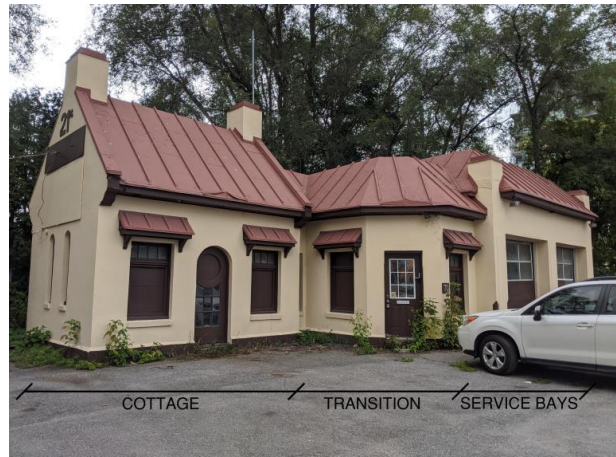
Figure 1: View of the Service Station with the 3 sections: cottage, transition (office), and service bays.

The elevation plan and pictures (Figure 2) document the condition of the interior partition wall. The demolition drawing submitted as part of the application to move recommends its demolition. The three sections of the building – cottage, office, and garage (Figure1) are defined attributes in the designation, but it is not clear if the interpretation requires them to be separate spaces. The wall is in very poor shape. This wall is a load bearing wall and if it is removed support for the roof is required.

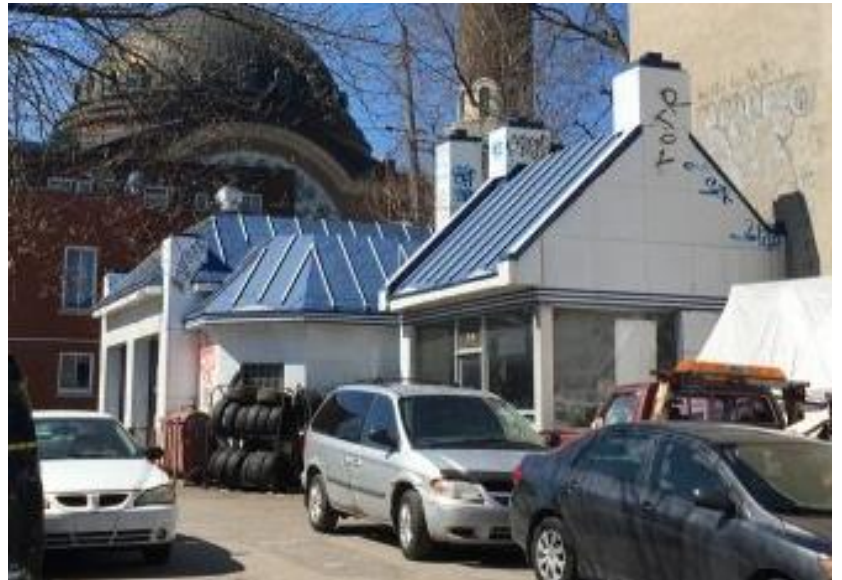
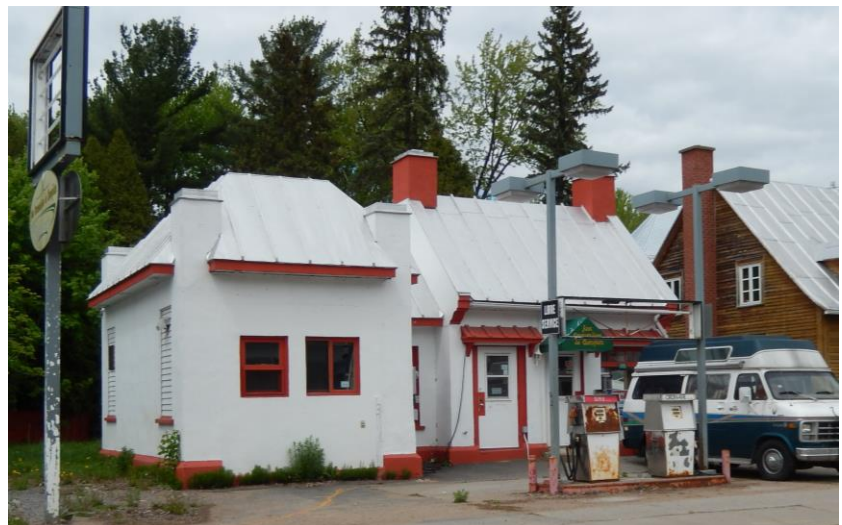
The 55 Saint-Viateur Street Station in West Montreal is a mirror image of the Service Station at 70 Richmond Road. Source: photo: Justin Bur 2017

Below the example from the Municipality of Champlain near Trois-Rivieres has a similar cottage form but only a single service bay and no display section. The cottage form with standing seam metal roofs would appear to be a branding feature. The garage door has been infilled.

Figures 3 & 4: The images are two comparative examples of former Champlain Service Stations.

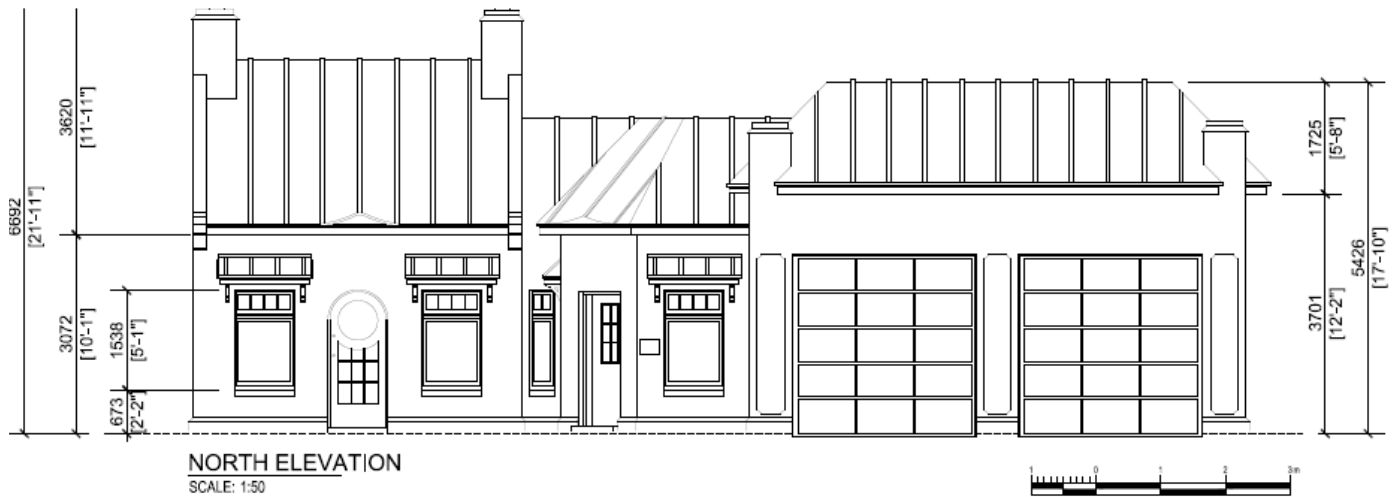
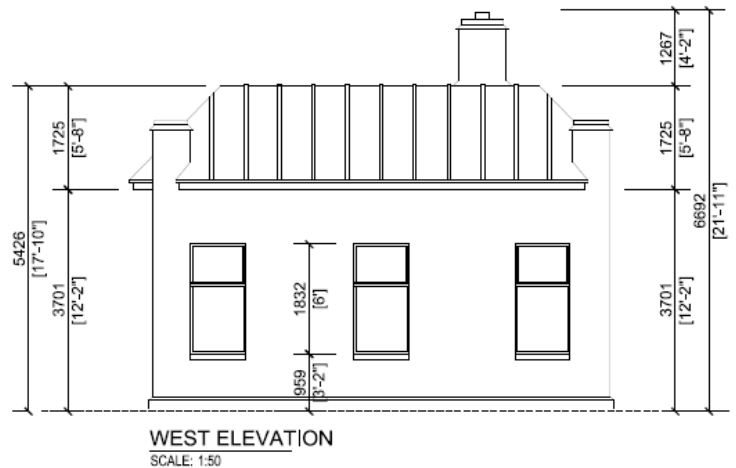
Figures 5, 6, and 7: Context plans illustrating the heritage building incorporated the ground floor with a GFA of just over 1000 sf. The south and west walls will be retained. Along the south the wall will cover up the section of the wall adjacent to the new build. . As-found plans have been completed. The property lines are delineated with dashed lines.

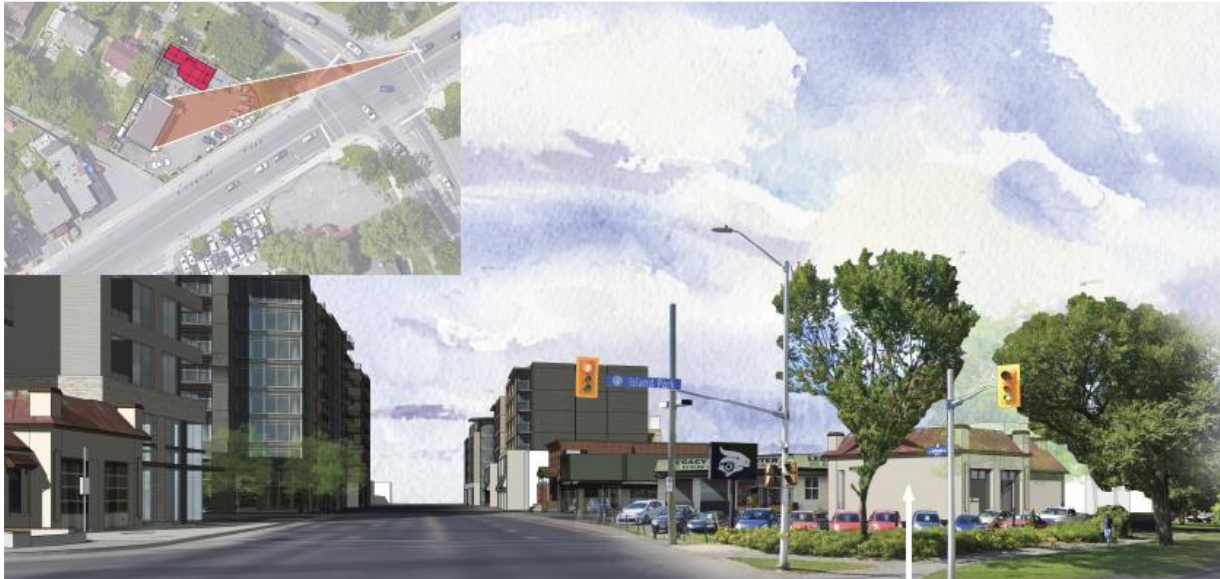
Figure 8: Plan and view illustrating the temporary location for storing the Service Station across from the Richmond Road site. In its temporary location the hydraulic wheels will be removed and the building set on cribbing.

The properties making up the development site are located at the intersection of Island Park Drive and Richmond Road within Richmond Road/Westboro neighbourhood in the Kitchissippi ward. They include a single storey, cottage form Service Station constructed in 1937 that will be moved and a single-family residence at 376 Island Park Drive that will be demolished. The Service Station, designated under Part IV of the Ontario Heritage Act, will be moved from its original location at the rear of the property to a temporary location across the street (see figures 8 and 9). It will be returned to the site once the new

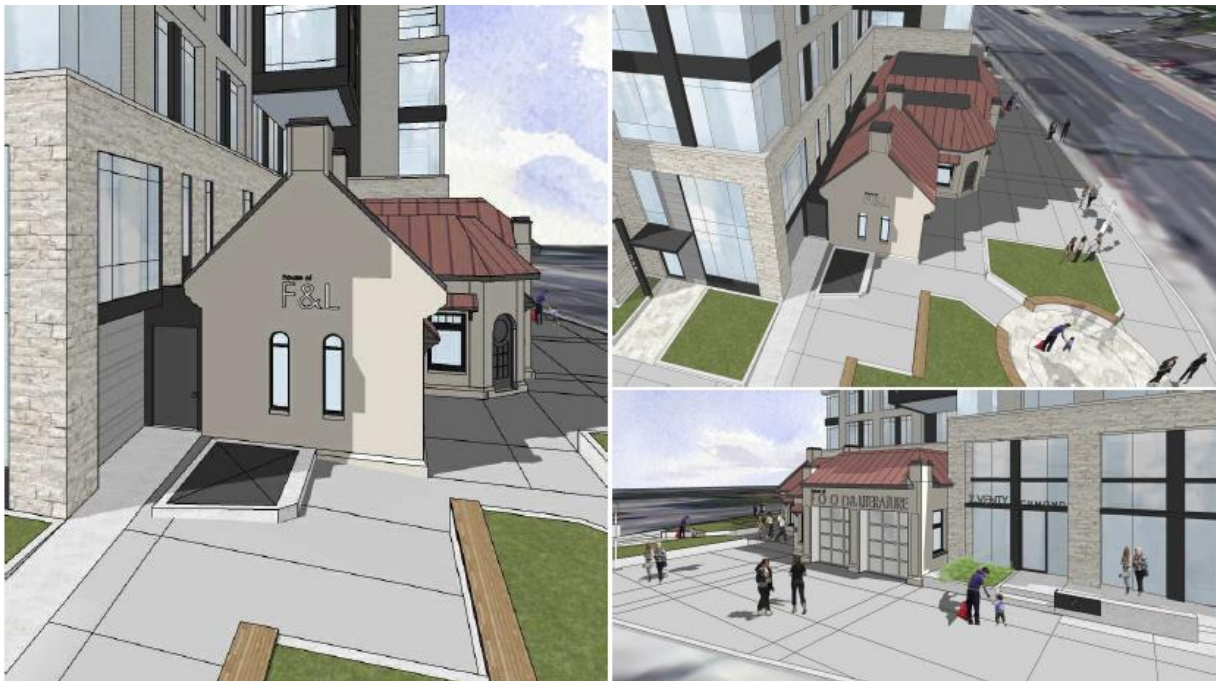
Figure 13: Views clockwise - 1. from the west illustrating the recessed link between the Station and the apartment, 2. Aerial view illustrating the massing and ability to interpret the entire building as a separate feature. 3. A view looking south east illustrating the side window. Source: Hobin architecture 2023.

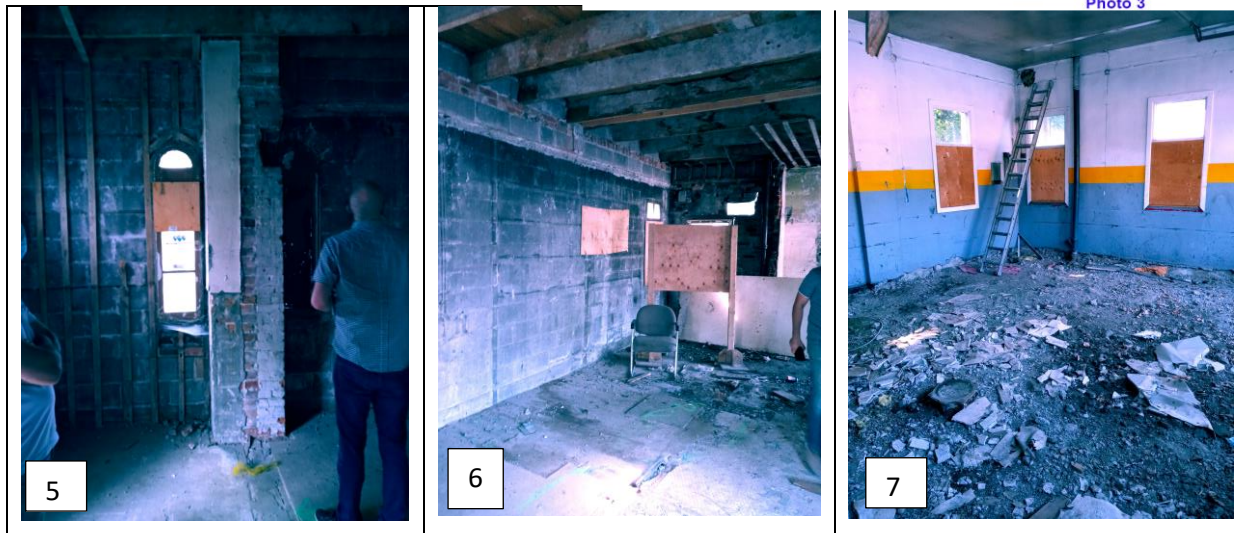
Figure 19: Interior views; 5. Looking towards the east wall with round headed windows on either side of the chimney. View 6. And 7. Interior views of transition area and the service bays. Source Commonwealth 2021

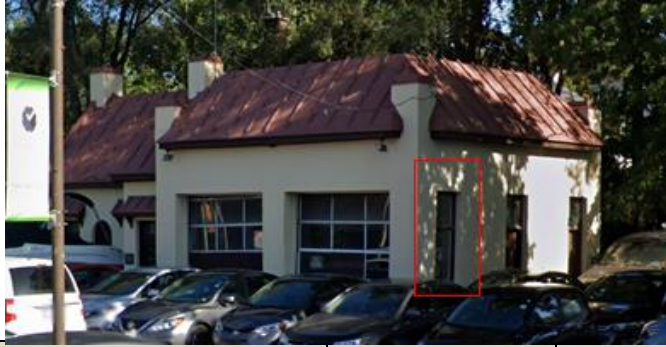
Figure 22: This view highlights in red the first of the three windows along the west side of the Service Station. The proposed midrise building has been set back and allows the side window to be interpreted from the exterior. Source: City of Ottawa.

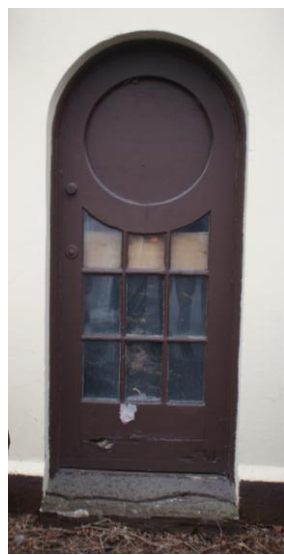
Figure 23 : Circa 1949 – 50. The historic view of the Service Station provides reference information supporting the conservation of the round headed doors at both entrances E-D1 and E-D 2. Other features include the stepped foundation with chamfered treatment at the base of the service bay entrances. Over time, the scale of the stepped foundation has been reduced as grade was raised with the addition of asphalt. Source: Ottawa Archives, John Newcomb Collection.

Entry Doors	Type	Dimension	Sill Height	Conservation Treatment
– 2 Wood round headed doors E-D1 and E-D1a	A glazed wood entry door with six lite lower pattern and upper round glazed units.			E-D1 Preservation: The existing round headed window is in poor to fair condition and will serve as a template for the reconstruction of E-D1a . Repairs as need along the lower rail. The existing glazing will be retained with circular glazing replced. New hardware modelled after the existing. The existing door will be discarded. A new Door will be constructed modelled after the existing unit and the round headed masonry to replace the existing header.

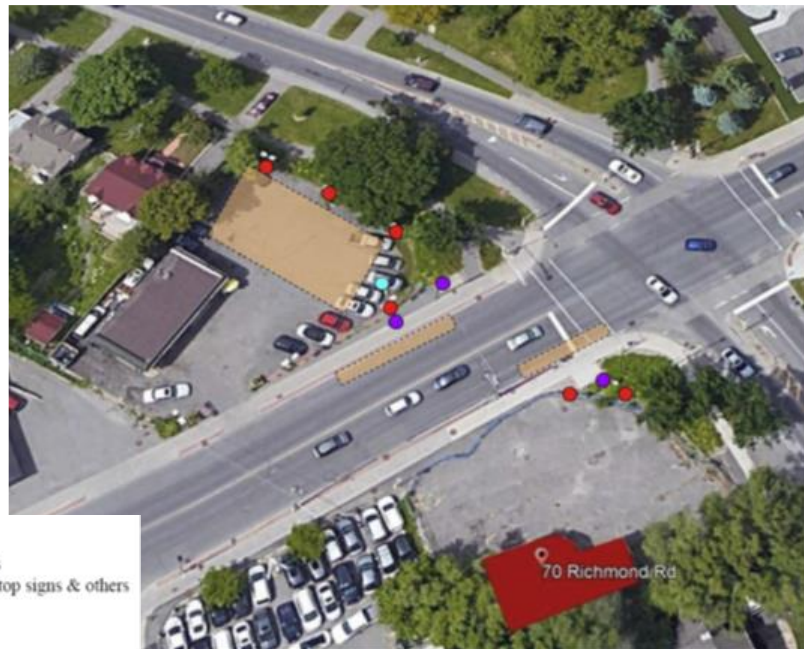
- Overhead wires, utility poles and light poles
- City of Ottawa benches, garbage bins, bus stop signs & others
- Gravel road buildups & pad
- Commercial sign

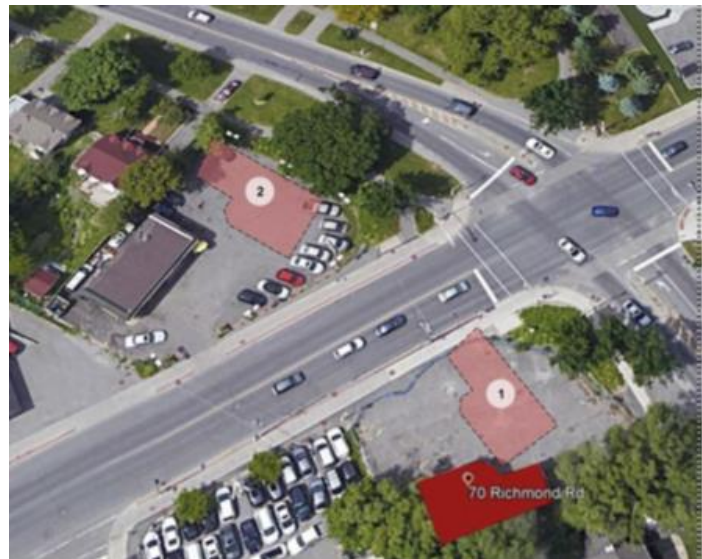
Pre-Construction Relocation Path: Movement of Heritage Building to 77 Richmond Rd.

1. 90° Turn at 70 Richmond Rd. to orient cottage section towards the north side.
1. Movement north in near-straight line across Richmond Rd. onto proposed resting location at 77 Richmond Rd. parking lot.

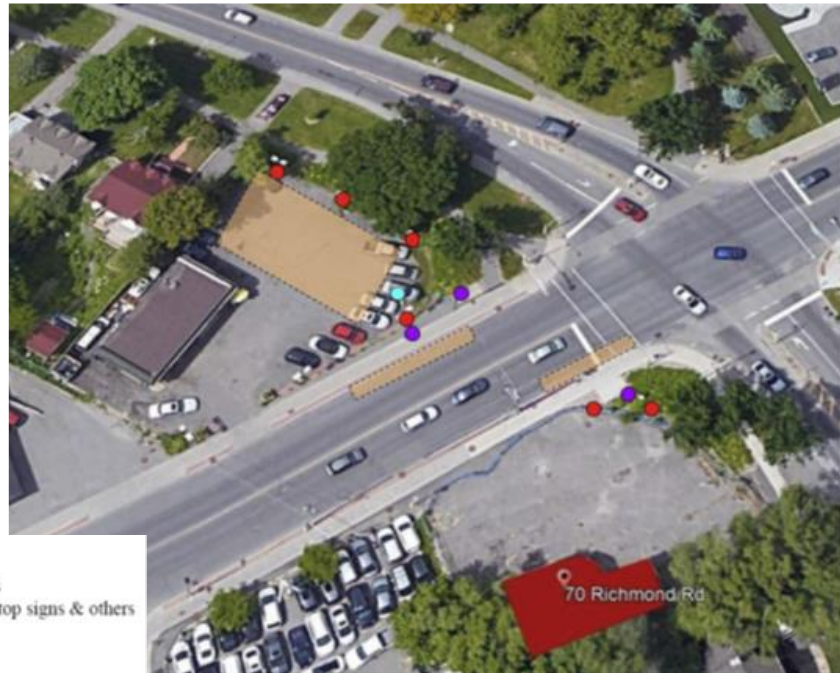
Travel Path Obstructions

- Overhead wires, utility poles and light poles
- City of Ottawa benches, garbage bins, bus stop signs & others
- Gravel road buildups & pad
- Commercial sign
