# REVISED HERITAGE IMPACT ASSESSMENT & CONSERVATION PLAN FOR 211-231 BANK

**Applications D02-02-22-0127 / D07-12-22-0188 and plan number 18910**

Revision 2: October 2024

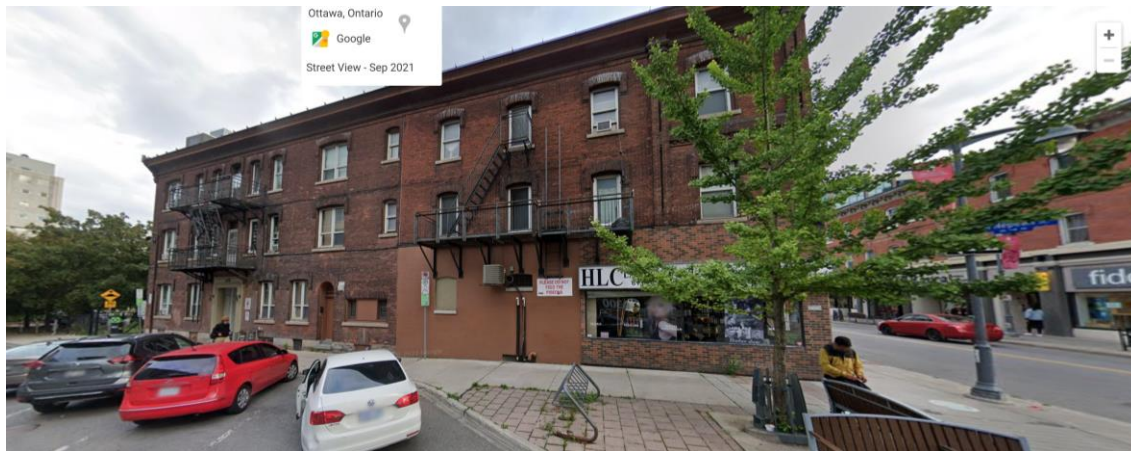
Figure 11: A view of the north elevation of 211 Bank/178 Nepean. The slightly different tone of brick delineates the two construction periods.

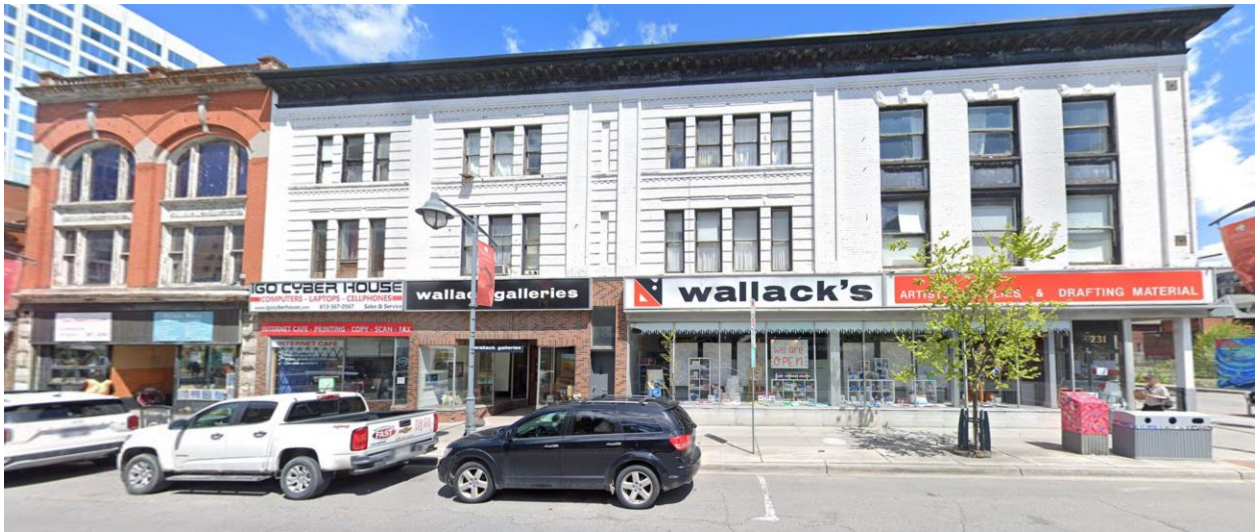
Figure 14: The painted brick commercial range 223-231 occupies the southern half of the block with the Wallacks Art Supply wrapping around the corner and extending along Lisgar Street.

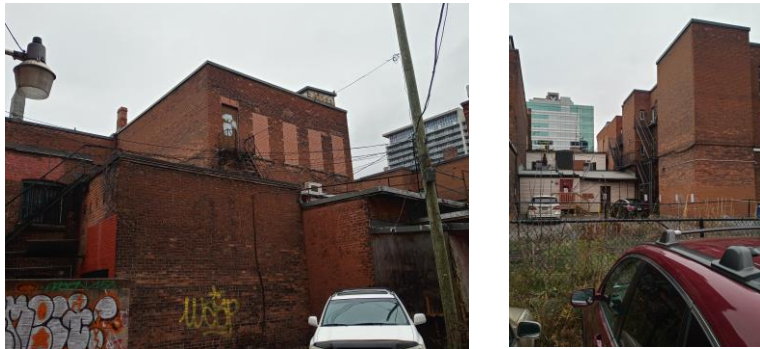
Figure 16: Views of the east façades (rear).

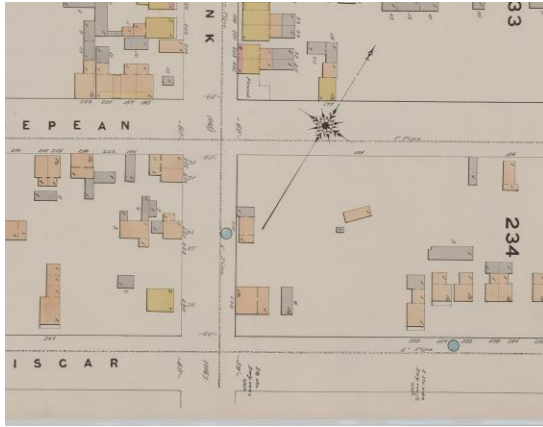
Figure 14: 1878 Fire Insurance Plan with Block 234 on the right. The plan illustrates the early development along Bank Street. In the block 234 bound by Nepean and Lisgar Streets, none of the properties had been constructed. Source: Collections Canada

The history of Centretown is outlined in the 2020 Heritage Conservation District Plan and the Centretown Heritage Inventory completed in 2020. The following maps (figures 12, 13, and 14) provide approximate dates for the development of this block on the east side of Bank Street. The earliest Fire Insurance plan 1878 provides the street survey. The section focusing on Block 34 documents that none of the existing buildings were constructed. The Fire Insurance Plan 1888 revised 1901 illustrates the properties at 211 (druggist) 213 (Grocer) as brick 3 storey with a collection of 1 and 1.5 storey wood structures occupying the back half of the site. A 2.5 storey frame with brick veneer occupies 215 occupied by a coffin maker. According to Fire Insurance plans, the block was fully built out between 1901 and 1912 with a variety of retail services. From left to right the retails included 211 -213 Jeweller, 215 Grocer, 217 Confectioner, 219-221 Moving Pictures, 223-225 Stationary, 227 Grocer, 229 Drug Store, and 231-233 Hardware. Source: Collections Canada.

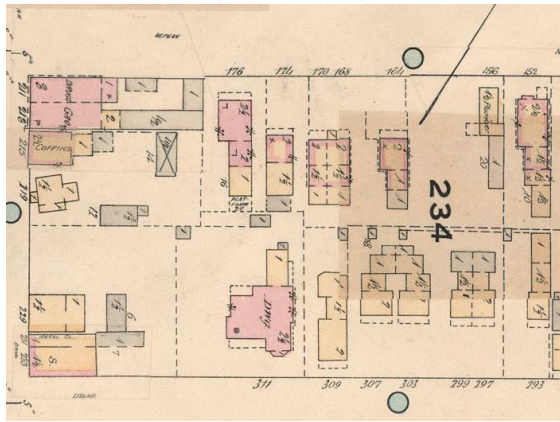
Figure 15: Fire Insurance Plan 1888 revised 1901 illustrates the properties at 211 (druggist) 213 (Grocer) as brick and 3-storeys in height with a collection of 1 and 1.5 storey wood structures occupying the back half of the site. Next to it is a 2.5 storey frame with brick veneer at 215-217 occupied by a coffin maker. The buildings on the southern half of the block appears as 1.5 storey wood and brick veneer separated by a vacant street frontage.

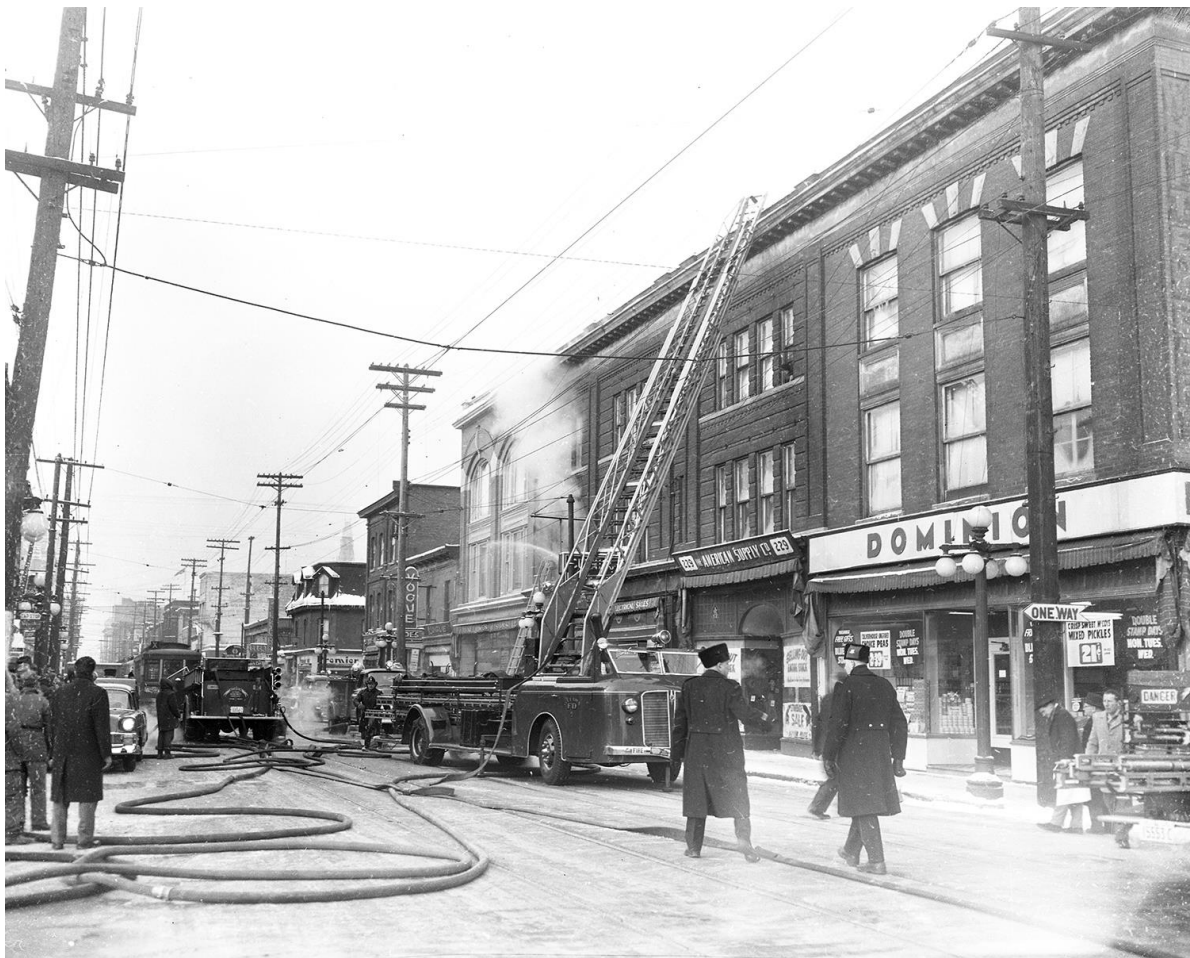
*Figure 18: A view of the 211-231 block with fire trucks in the street. Note the unpainted façades with the decorative keystone with spandrels between the 2<sup>nd</sup> and 3<sup>rd</sup> floors. The photo provides a record of the earlier retail storefronts. Although the shopfronts have been dramatically altered, elements such as the recessed shopfront at 227 Bank Street are still evident. The leaded transom and vaulted arch have been covered over. Based on the 1950 photo, it would appear that the three shopfronts at 215, 217 and 219 were similar with recessed entrances and decorative transoms. Source: City of Ottawa Archives, c. 1950.*

Over time, the storefronts along Bank Street have been altered with only fragments of original features remaining, whereas upper floors have maintained much of their original fabric. There are only a few period photos documenting the appearance of the buildings. The most informative view of the street is taken from the corner of Lisgar looking north. It has been estimated that the photo dates circa 1950 based on the fire truck with smoke billing out from what looks like the 219 Bank Street (figure 1.) In the foreground, the Wallack's Building shopfronts are intact, and the elegant polychromatic upper facade has not yet been painted. Since this photo, the street front has undergone extensive alterations and neglect. The Wallack's entrance has shifted to the corner and the Dominion Grocery Store signboard, which appears to wrap around the corner along Lisgar is still in place.

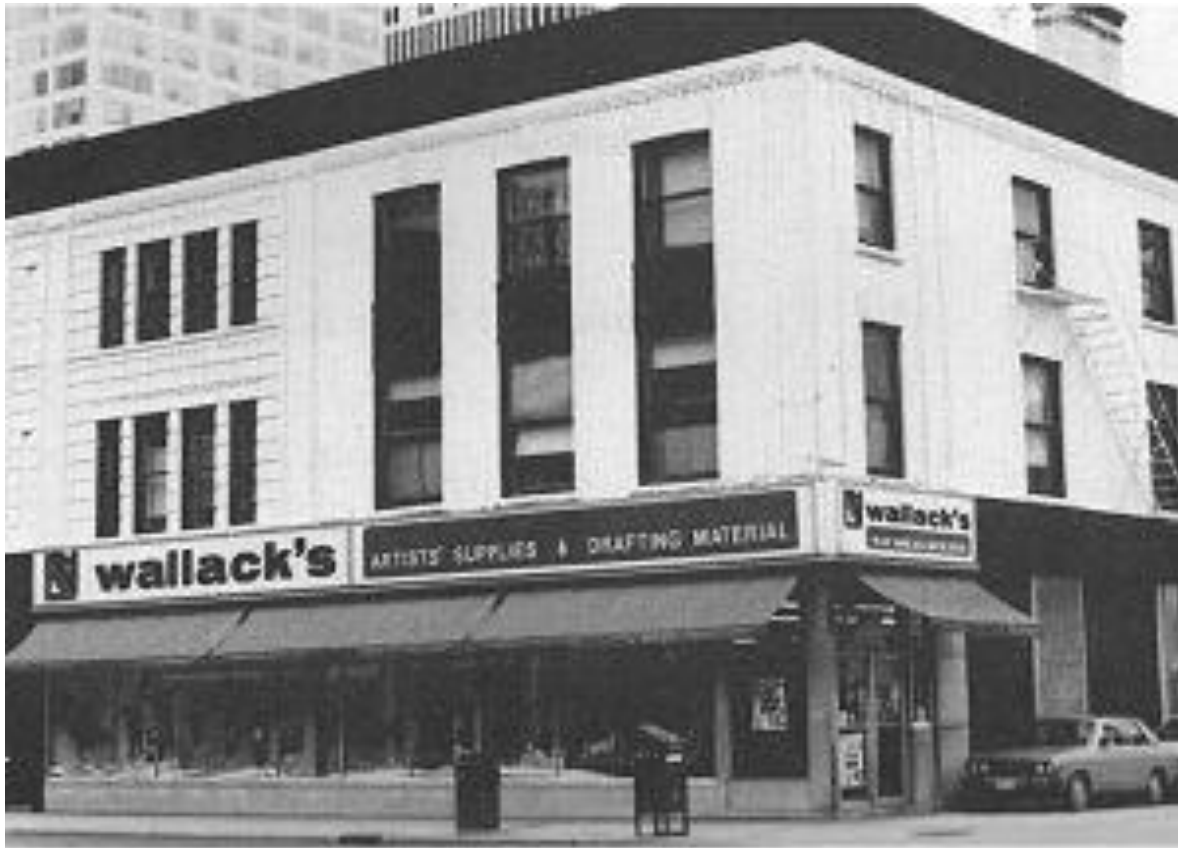
*Figure 19: A view of 231 with the retail entrance shifted from its original central location to the corner and the upper façade painted white. A black band can be seen between the ground floor retail and the upper floors.*

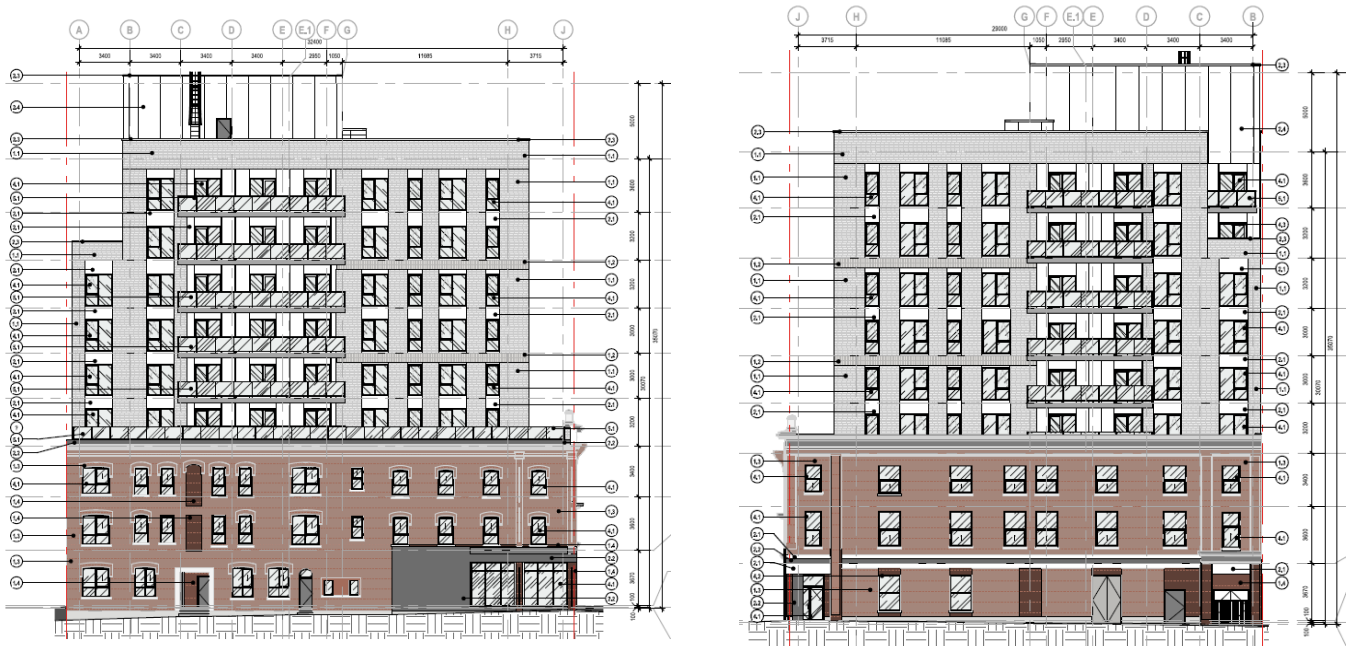
Figures 20, 21, 22, & 23: Nepean Street, Lisgar Street, Bank Street, and east (rear) elevations with the proposed 9-storey development.

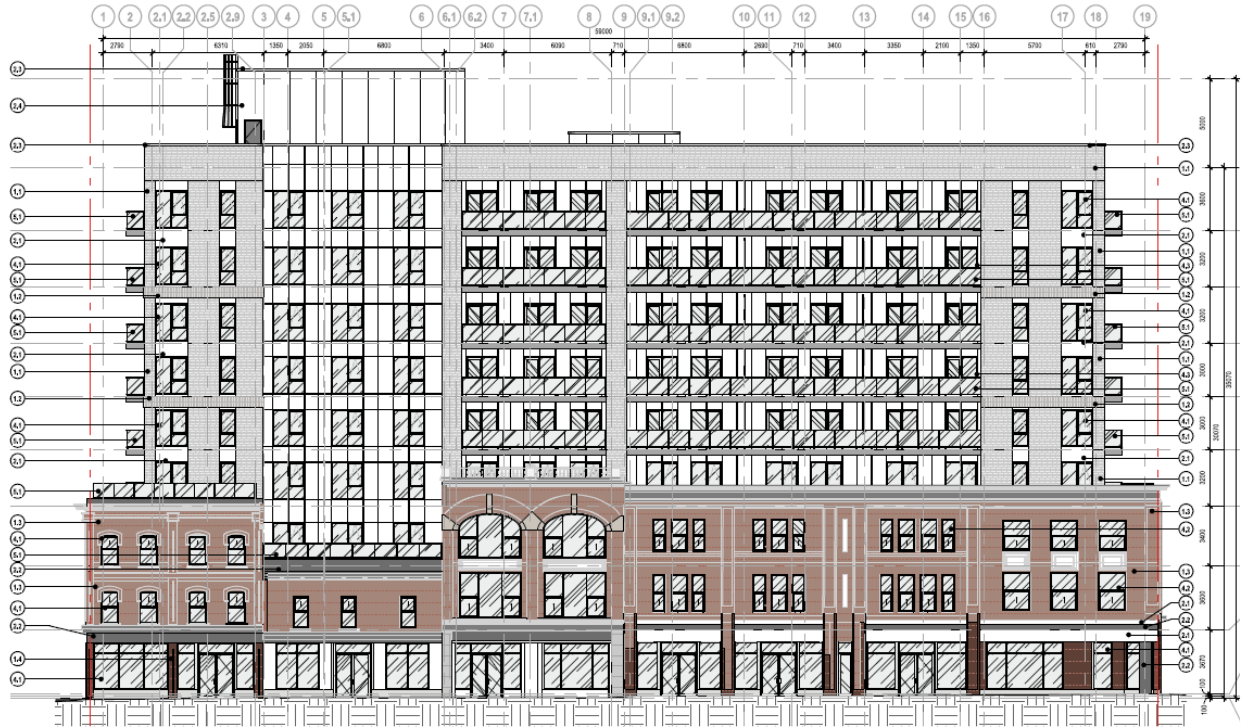
Figure 22: West Elevation and Figure 24 is the east elevation.

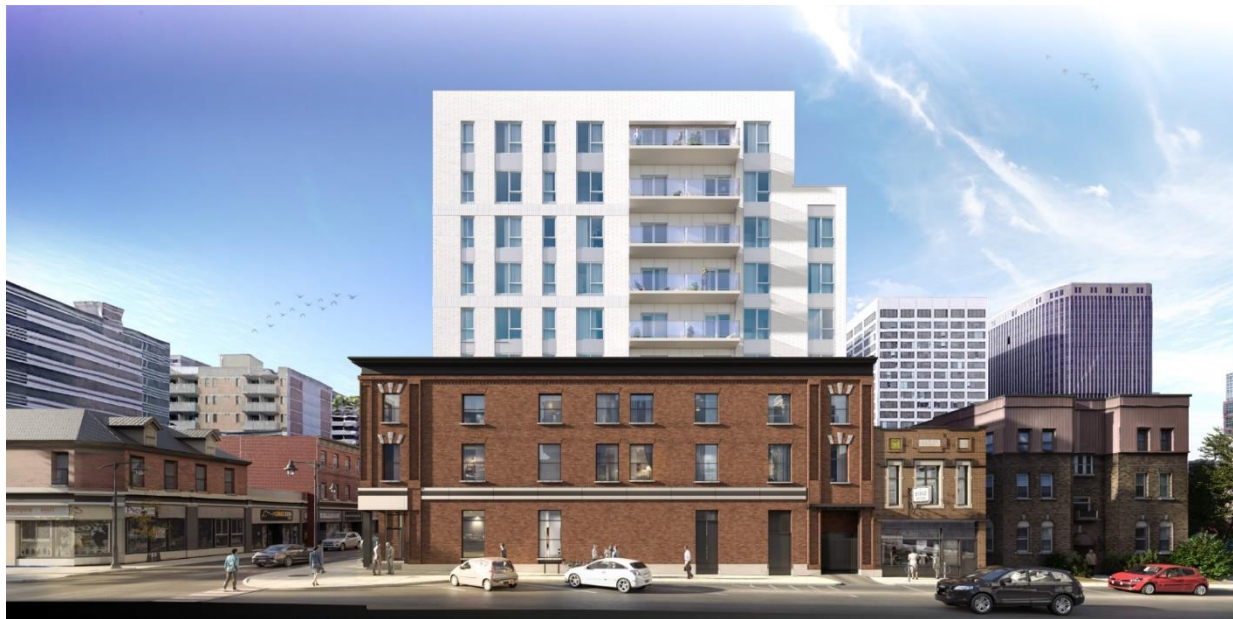
Figure 28: Lisgar Street (South) Elevation with the two existing buildings adjacent. The 6-storey new construction above is recessed, and the existing buildings continue to provide a pedestrian realm.

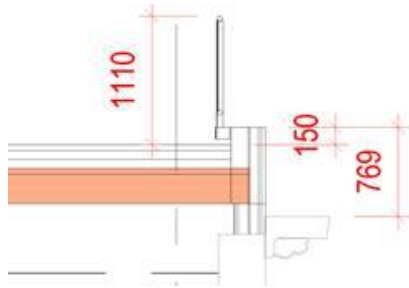
*The height of the third level has been increased to maintain headroom. The bulkhead and railing have been set back, with the cornice standing proud of the façade. As illustrated by the image, the level (orange) is located above the cornice, we need to add a wall in this area anyway.*

*If we go with the minimum amount of the extension of the wall (150 mm from the roof finish), we will need a 769 mm wall on top of the cornice, and the railing will be attached to the back of the wall.*

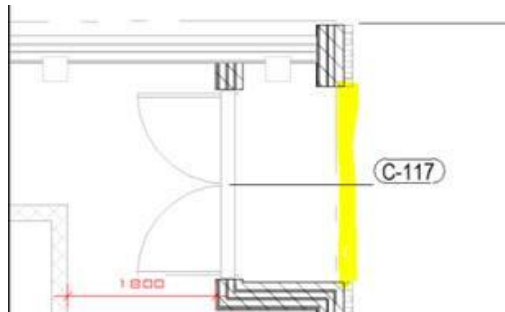
- Recess the Lisgar entrance to maintain the character of the carriageway. This feature was identified as a heritage attribute in the Conservation Plan and there are few left in the HCD, so should be respected.

*The doors have been set back but with the need for security and these alcoves being used for sleeping, would a metal grid used at night be acceptable (yellow highlight below)?*

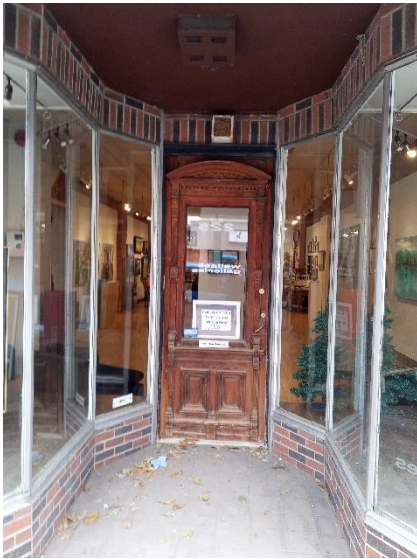
Figure 2: The remnant of the Art Nouveau storefront is being reinterpreted

the corner. At the other end of the block, the corner entrance at Bank and Lisgar Streets, interprets the Wallack entrance, which will offer a retail space extending from 223-231 Bank Street. Individual commercial/retail entrances will incorporate flared, recessed doorways to facilitate entrance/exiting and not block the sidewalk. As well, unused original entrances will be interpreted with fixed doors. Overtime, the shopfronts have been extensively altered in response to changing tastes and the desire to modernize. The recessed shopfront at 227 Bank Street is the only original commercial entrance still evident. The leaded transom and vaulted arch that can be seen in the c1950 photo have been covered over or removed, and the knee wall replaced with a brick treatment.

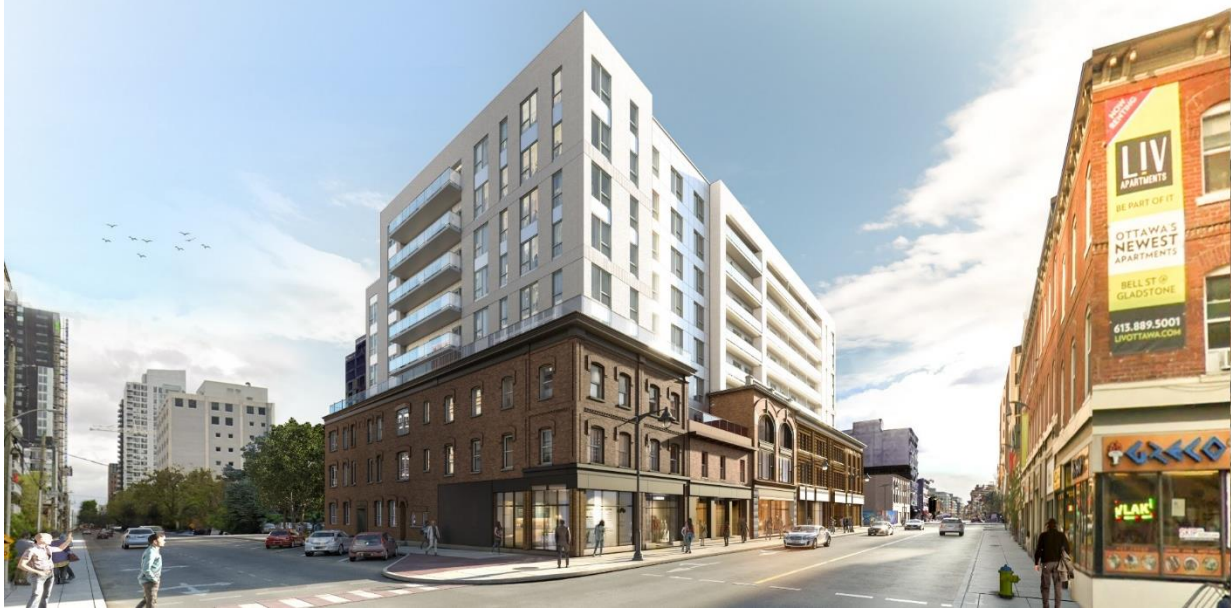
Figure 3: View looking south at the corner of Nepean and Bank Street, with the nine-storey development setback and the existing buildings standing proud. Source: Neuf Architects, August 2024.

The proposed 9-storey superstructure is distinguishable, and of sympathetic contemporary design. The existing buildings serve as a podium, with the new construction setback from the existing buildings by 3m. A palette of materials, and finishes that are neutral, light-coloured help focus on the heritage buildings. Decorative cornices, horizontal and vertical articulations, opening sizes, proportions, and datum lines have taken their cues from the historic buildings. The design respects and reflects the current urban grain and scale, visual relationships, and materials of the neighbouring buildings across the street on the west side of Bank Street. Below is a discussion of each of the existing buildings, identifying their individual character defining features and the work required to rehabilitate each building successfully.

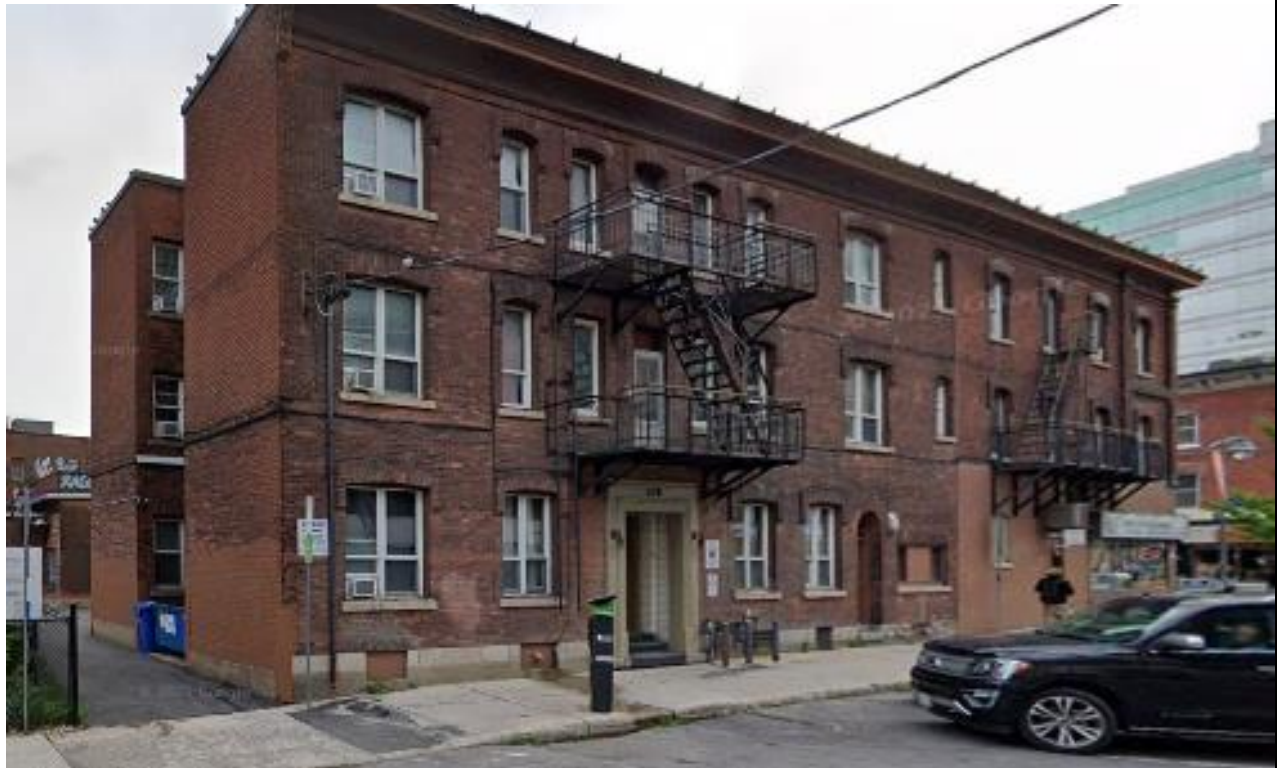
Figure 6. West Elevation

The building's footprint and upper storeys have not changed since the Nepean addition c.1922. The upper floors continue as residential apartments. The building appears to be in fair to good condition, requiring cleaning and repointing of masonry, some repairs to the metal cornice, and the renewal of windows. The ground floor commercial storefronts have been completely altered, with original features lost. The existing frontage replaced with a variegated brick infill, the shopfront's glazed transoms and large commercial glazing removed along with the ground floor cornice.

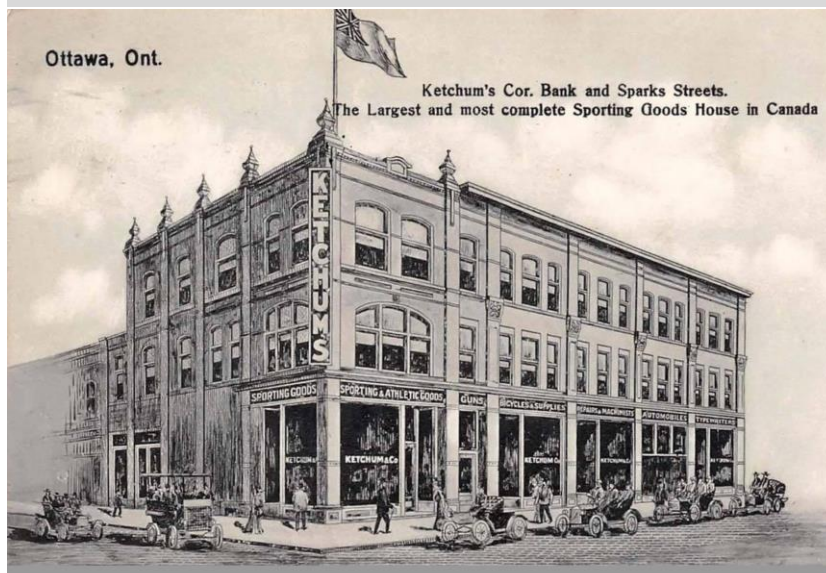
*This sketch of Ketchum's Bank at the corner of Bank & Sparks Streets provides an excellent example to model the replacement shopfront with the raised pilasters framing, commercial units, cornice, and signboard wrapping around the corner.*

9. Introduce a commercial cornice with signboard, knee wall at base, recessed flared entrance. See comparative illustration of Ketchum’s Bank at Bank and Sparks

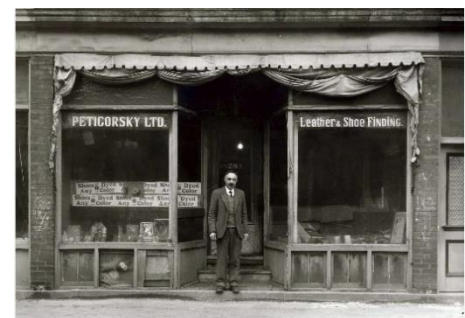
Three Storefronts along Bank Street dating from the turn of the century are models for the modest 2-storey building at 213-215 Bank Street. Note the flared recessed entrances, single entrance door, knee wall, and masonry piers framing the retail units.

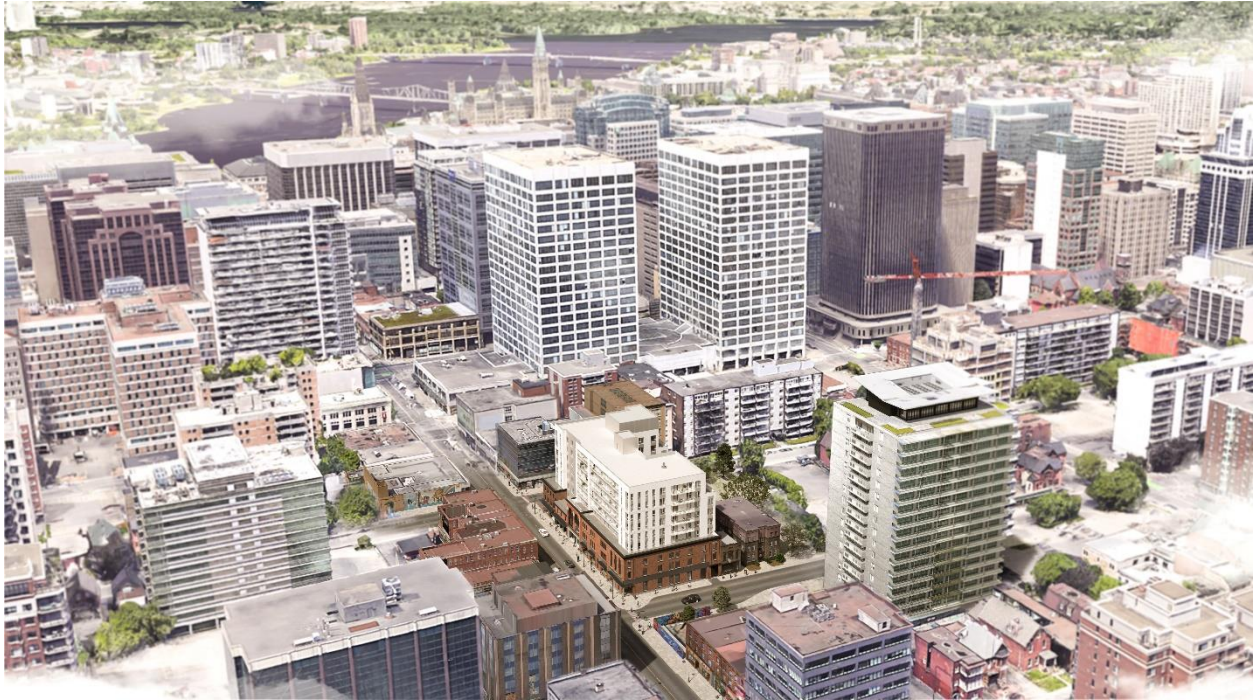
*An Artist's rendering of the restored block with the paint removed and the ground floor commercial units. The illustration below positions the properties within the downtown neighbourhood. Source: Neuf Architectes, September 2024.*
