### CONCEPTUAL SITE MODEL 3610 INNES ROAD, OTTAWA, ON

GLENVIEW HOMES (INNES) LTD.

PROJECT NO.: 17M-01348-00 DATE: FEBRUARY 11, 2021

# 1 PHASE TWO CONCEPTUAL SITE MODEL

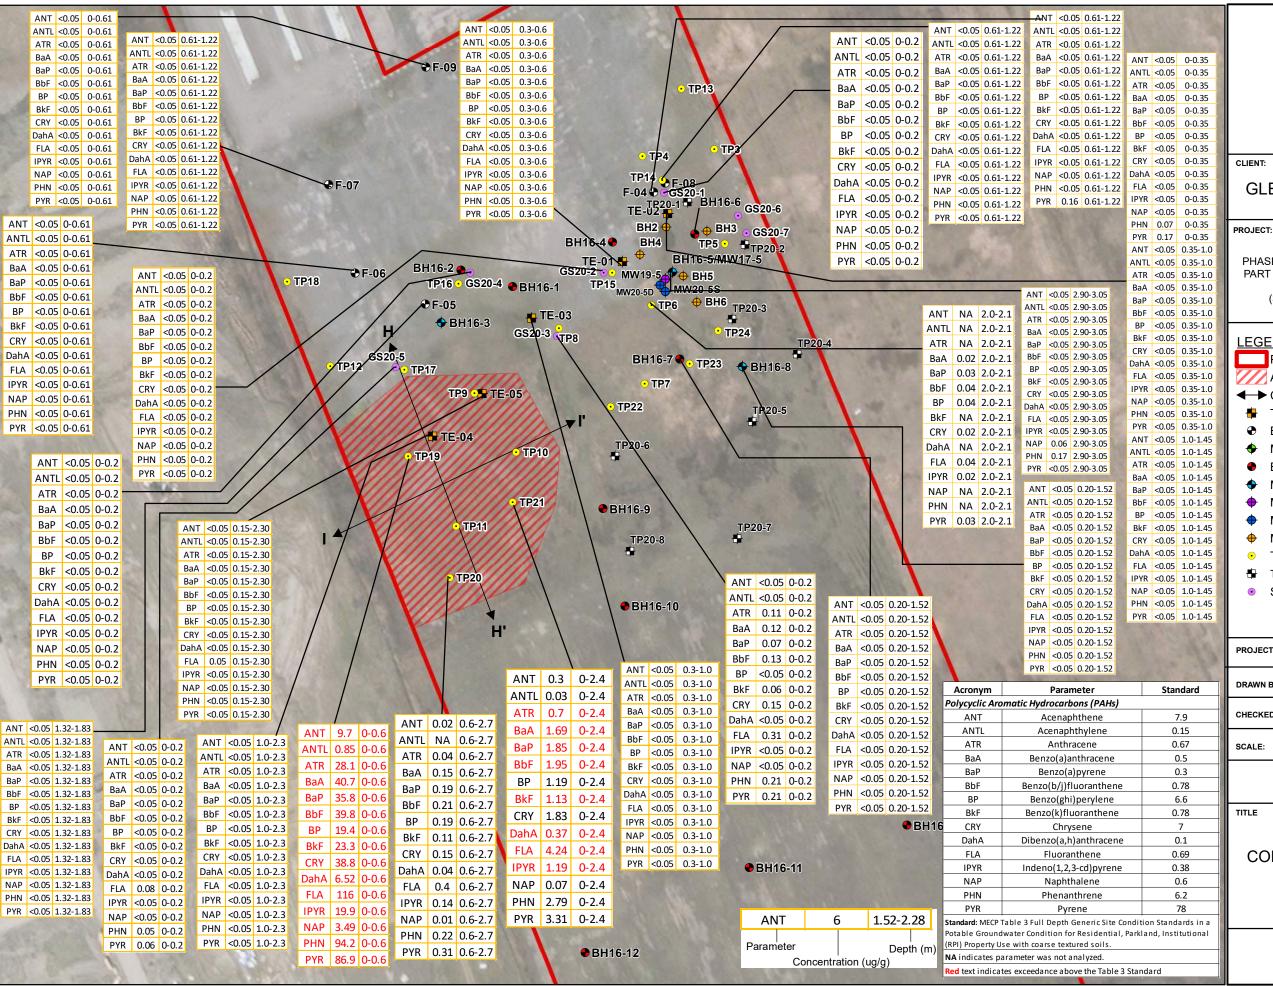
FIGURE 5

CONTAMINANT DISTRIBUTION OF PAHS IN SOIL

The PAHs at TP19 and TP21 (**Figure 5**) are associated with fill that could have included asphalt pieces placed in a pile on the western boundary of the Site. The concentrations are consistent with asphalt and the presence of contamination was limited to two samples in the fill as shown in cross sections included as **Figure 5-1** and **Figure 5-2**. It was confirmed through verification sampling after remediation (Area 1 in Section 1.10) that impacts did not extend to the base of the pile and groundwater impacts were not anticipated, as the contamination was from contaminants with low solubility in soil placed above grade on the Site.

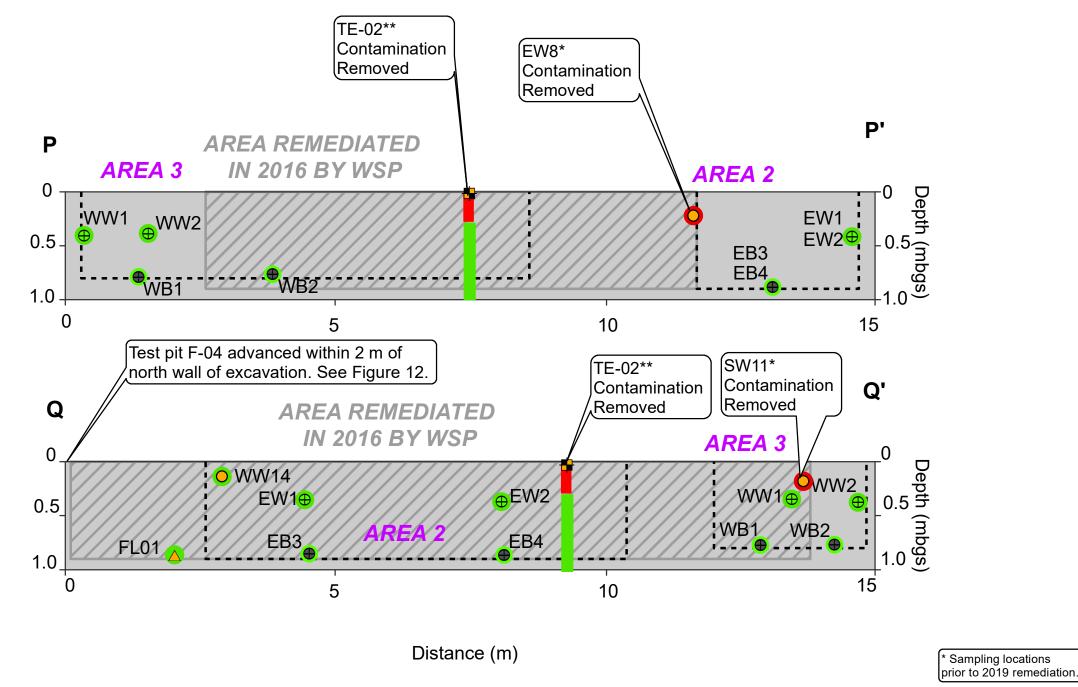
FIGURE 12-1

### **AREA 2 AND 3 CROSS SECTIONS**

SCALE: 1:70 (Horizontal) 1:35 (Vertical)

Note: See contaminant concentrations on Figure 12.

Areas 2 and 3 (**Figure 12**) were excavated to remove residual contaminants after the 2016 remediation at TE-02. Concentrations remained that met ICC SCS but exceeded MECP Table 3 SCS for RPI land use. Soil to the depth approximately 0.9 mbgs (**Figure 12-1** shows the cross section) was removed in this area and confirmation sampling (EW1, EW2, EB3, EB4, WW1, WW2, WB1 and WB2) at the locations shown on **Figure 12** and **Figure 12-1** confirmed that PHC impacts did not remain at this location.

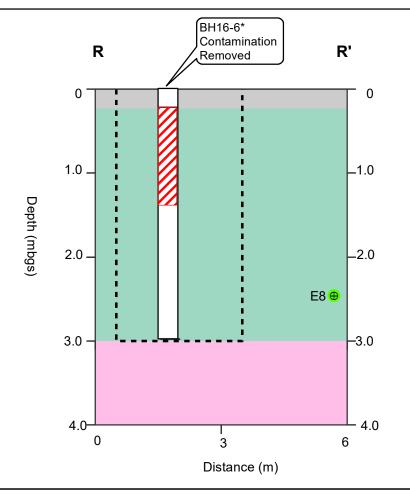
AREA 4 CROSS SECTION

HORIZONTAL SCALE: 1:90 VERTICAL SCALE: 1:45

Areas 4 and 5 were excavated to remove SAR at BH16-8 and EC at BH16-8, prior to identifying that the SAR and EC were related to the application of salt for vehicular or pedestrian safety and was, therefore, exempt from being identified as a contaminant. During excavation in Area 4 (to a depth of 3.0 mbgs), stained and odorous soil was

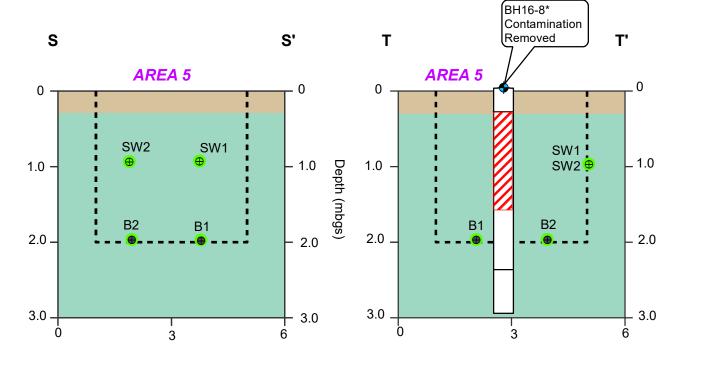
AREA 5 CROSS SECTIONS
HORIZONTAL SCALE: 1:100
VERTICAL SCALE: 1:50

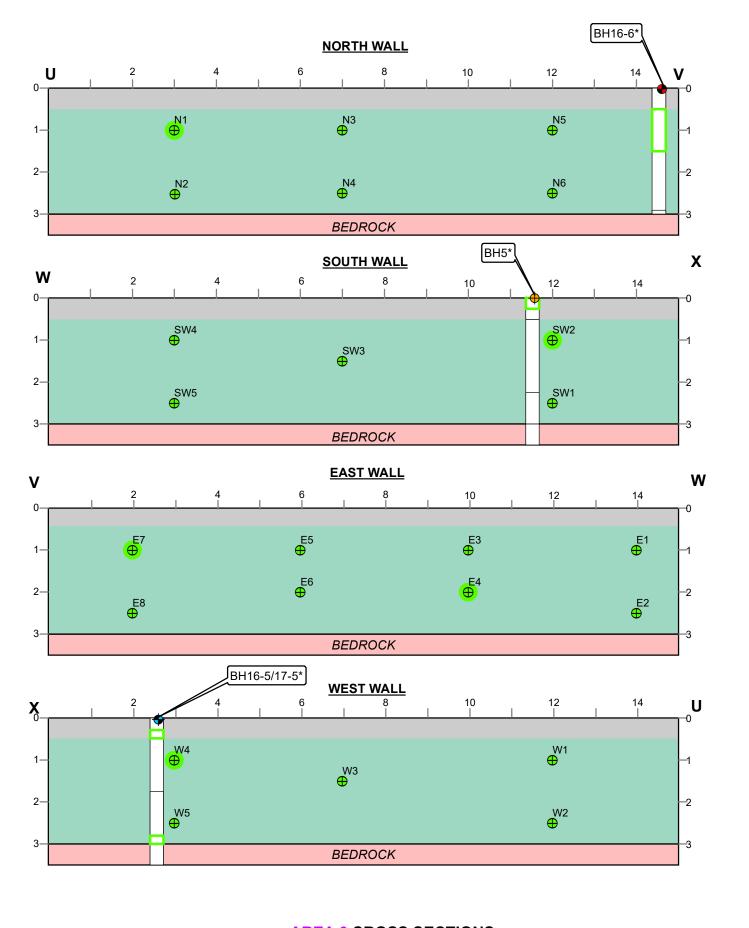
FIGURE 14

**REMEDIATION AREA 6** PHCs & BTEX IN SOIL

Area 6 extended from Area 4, which was initiated to remove SAR impacts (prior to recognizing the exemption) at BH16-6. Stained soil was unearthed at the base of the excavation and was found to extend to the south and west, toward MW17-5. The excavation for Area 6 (**Figure 14**) extended to bedrock, as indicated on the cross section (**Figure 14-1**). Field monitoring was conducted on the sidewalls (N1 to N6, SW1 to SW5, E1 to E8 and W1 to W5) and samples N1, SW2, E4, E7 and W4 were selected as worst-case conditions and submitted for analysis of PHCs F1-F4 and BTEX. Results were in compliance with MECP Table 3 SCS, with only PHC F1 measured at detectable concentrations and these were less than 10 ug/g, compared to the MECP Table 3 SCS of 55 ug/g.
