## Memorandum

**Date:** June 26, 2025  
**To:** RioCan Holdings Inc.  
**From:** Berend Velderman, Geosyntec Consultants International, Inc.  
**Subject:** **Supplemental Hydrogeological Memorandum**  
**1309 Carling Avenue, Ottawa, Ontario**

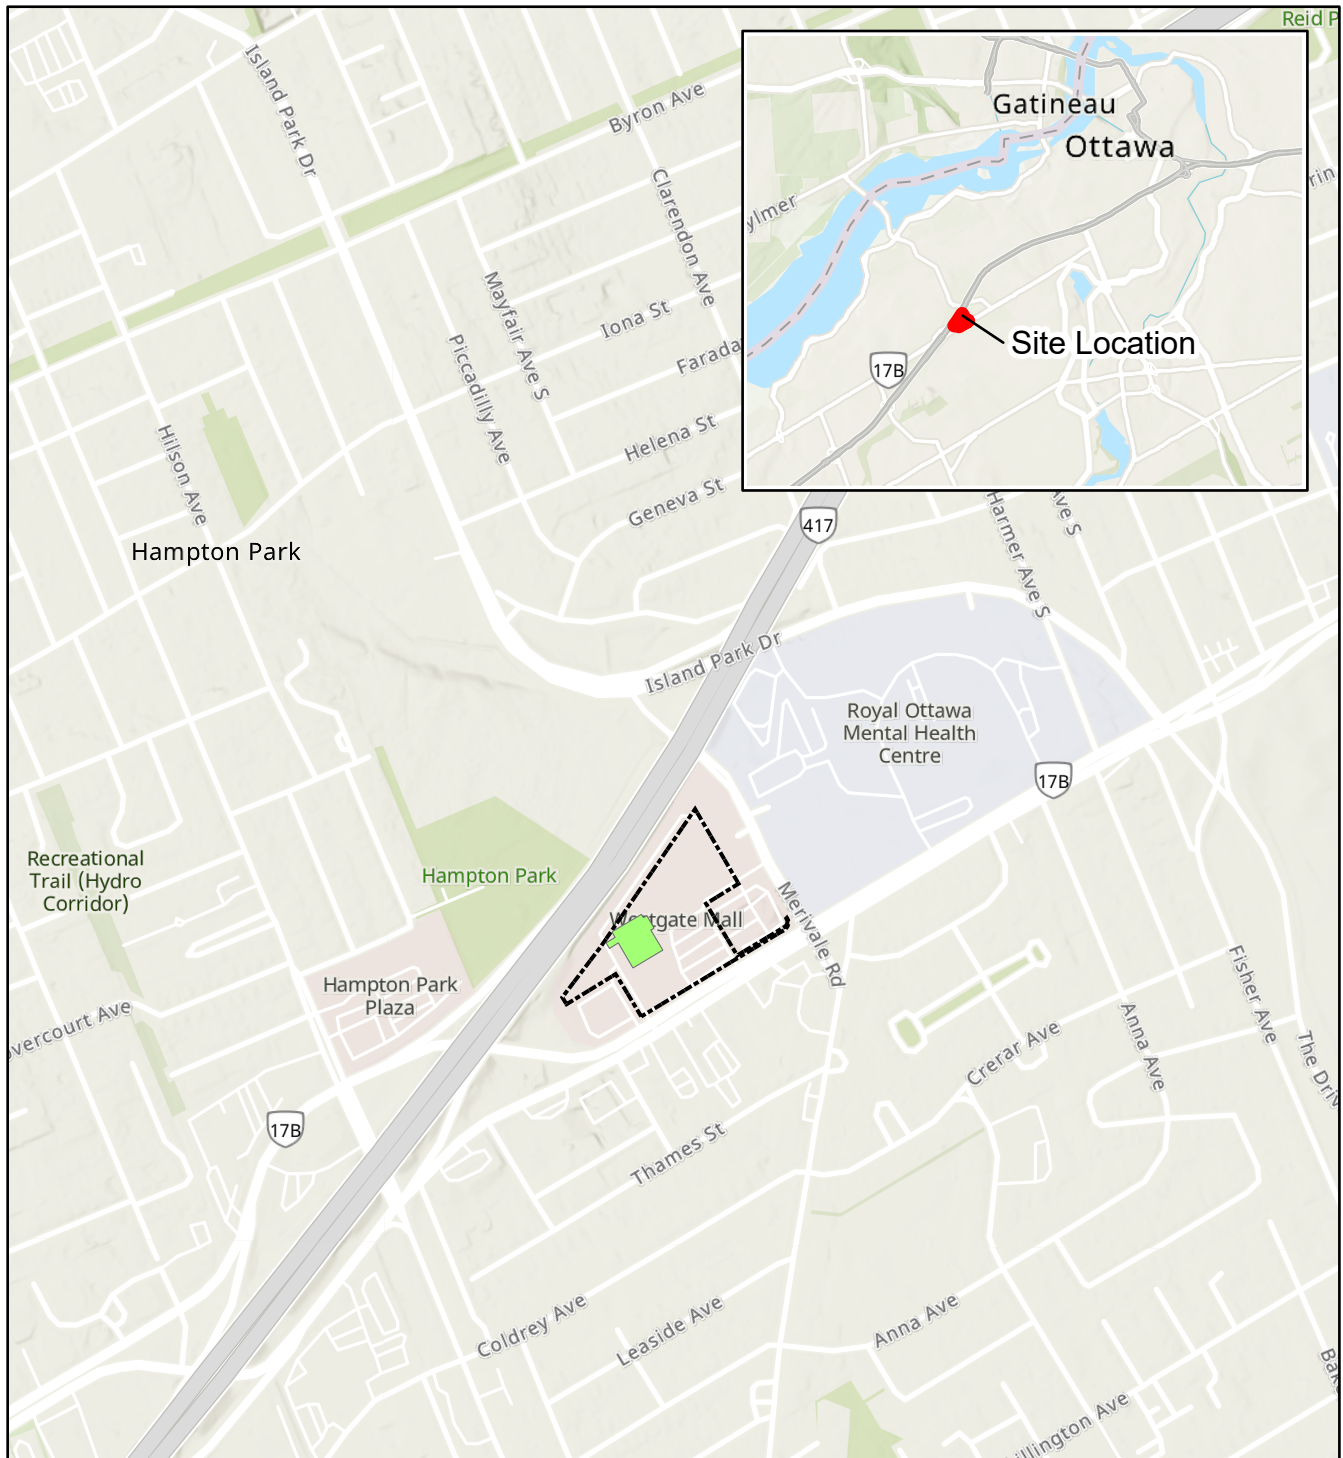
<b>Legend:</b> Phase Two Property Boundary Building Footprint - Geotechnical Investigation Target Area		<b>FIGURE 1</b> <b>PROPERTY LOCATION MAP</b>  1309 CARLING AVENUE, OTTAWA, ONTARIO	
<b>Notes:</b> 1) Map Projection: NAD 1983 CSRS UTM Zone 18N 2) Imagery Credits: World Topographic Map: Esri Community Maps Contributors, City of Ottawa, Province of Ontario, Ville de Gatineau, Esri Canada, Esri, TomTom, Garmin, SafeGraph, <small>The information and figures reflected in this document were prepared by Geosyntec Consultants, Inc. in relation to a specific scope of work and are the intellectual property of Geosyntec and its Client. Any use of the document or the information reflected therein, except by Geosyntec's Client in accordance with the terms of the agreement between the two, is not authorized.</small>		OFFICE LOCATION <b>WATERLOO</b> DATE PLOTTED 30-Apr-2025 APPROX. SCALE 1:10,000	DATE REVISED 30-Apr-2025 PAGE SIZE 8.5 x 11 in

In this memorandum, the overall Westgate Mall property is termed 'The Property' to distinguish between the location of the new building (The Site) and the remaining site area. **Figure 1** shows the Site and **Figure 2** the borehole locations. This hydrogeological memo interprets the geotechnical investigation results as they pertain to the hydrogeology information gleaned from the report.

Figures      Figure 1: Site Location  
                Figure 2: Borehole Location Plan

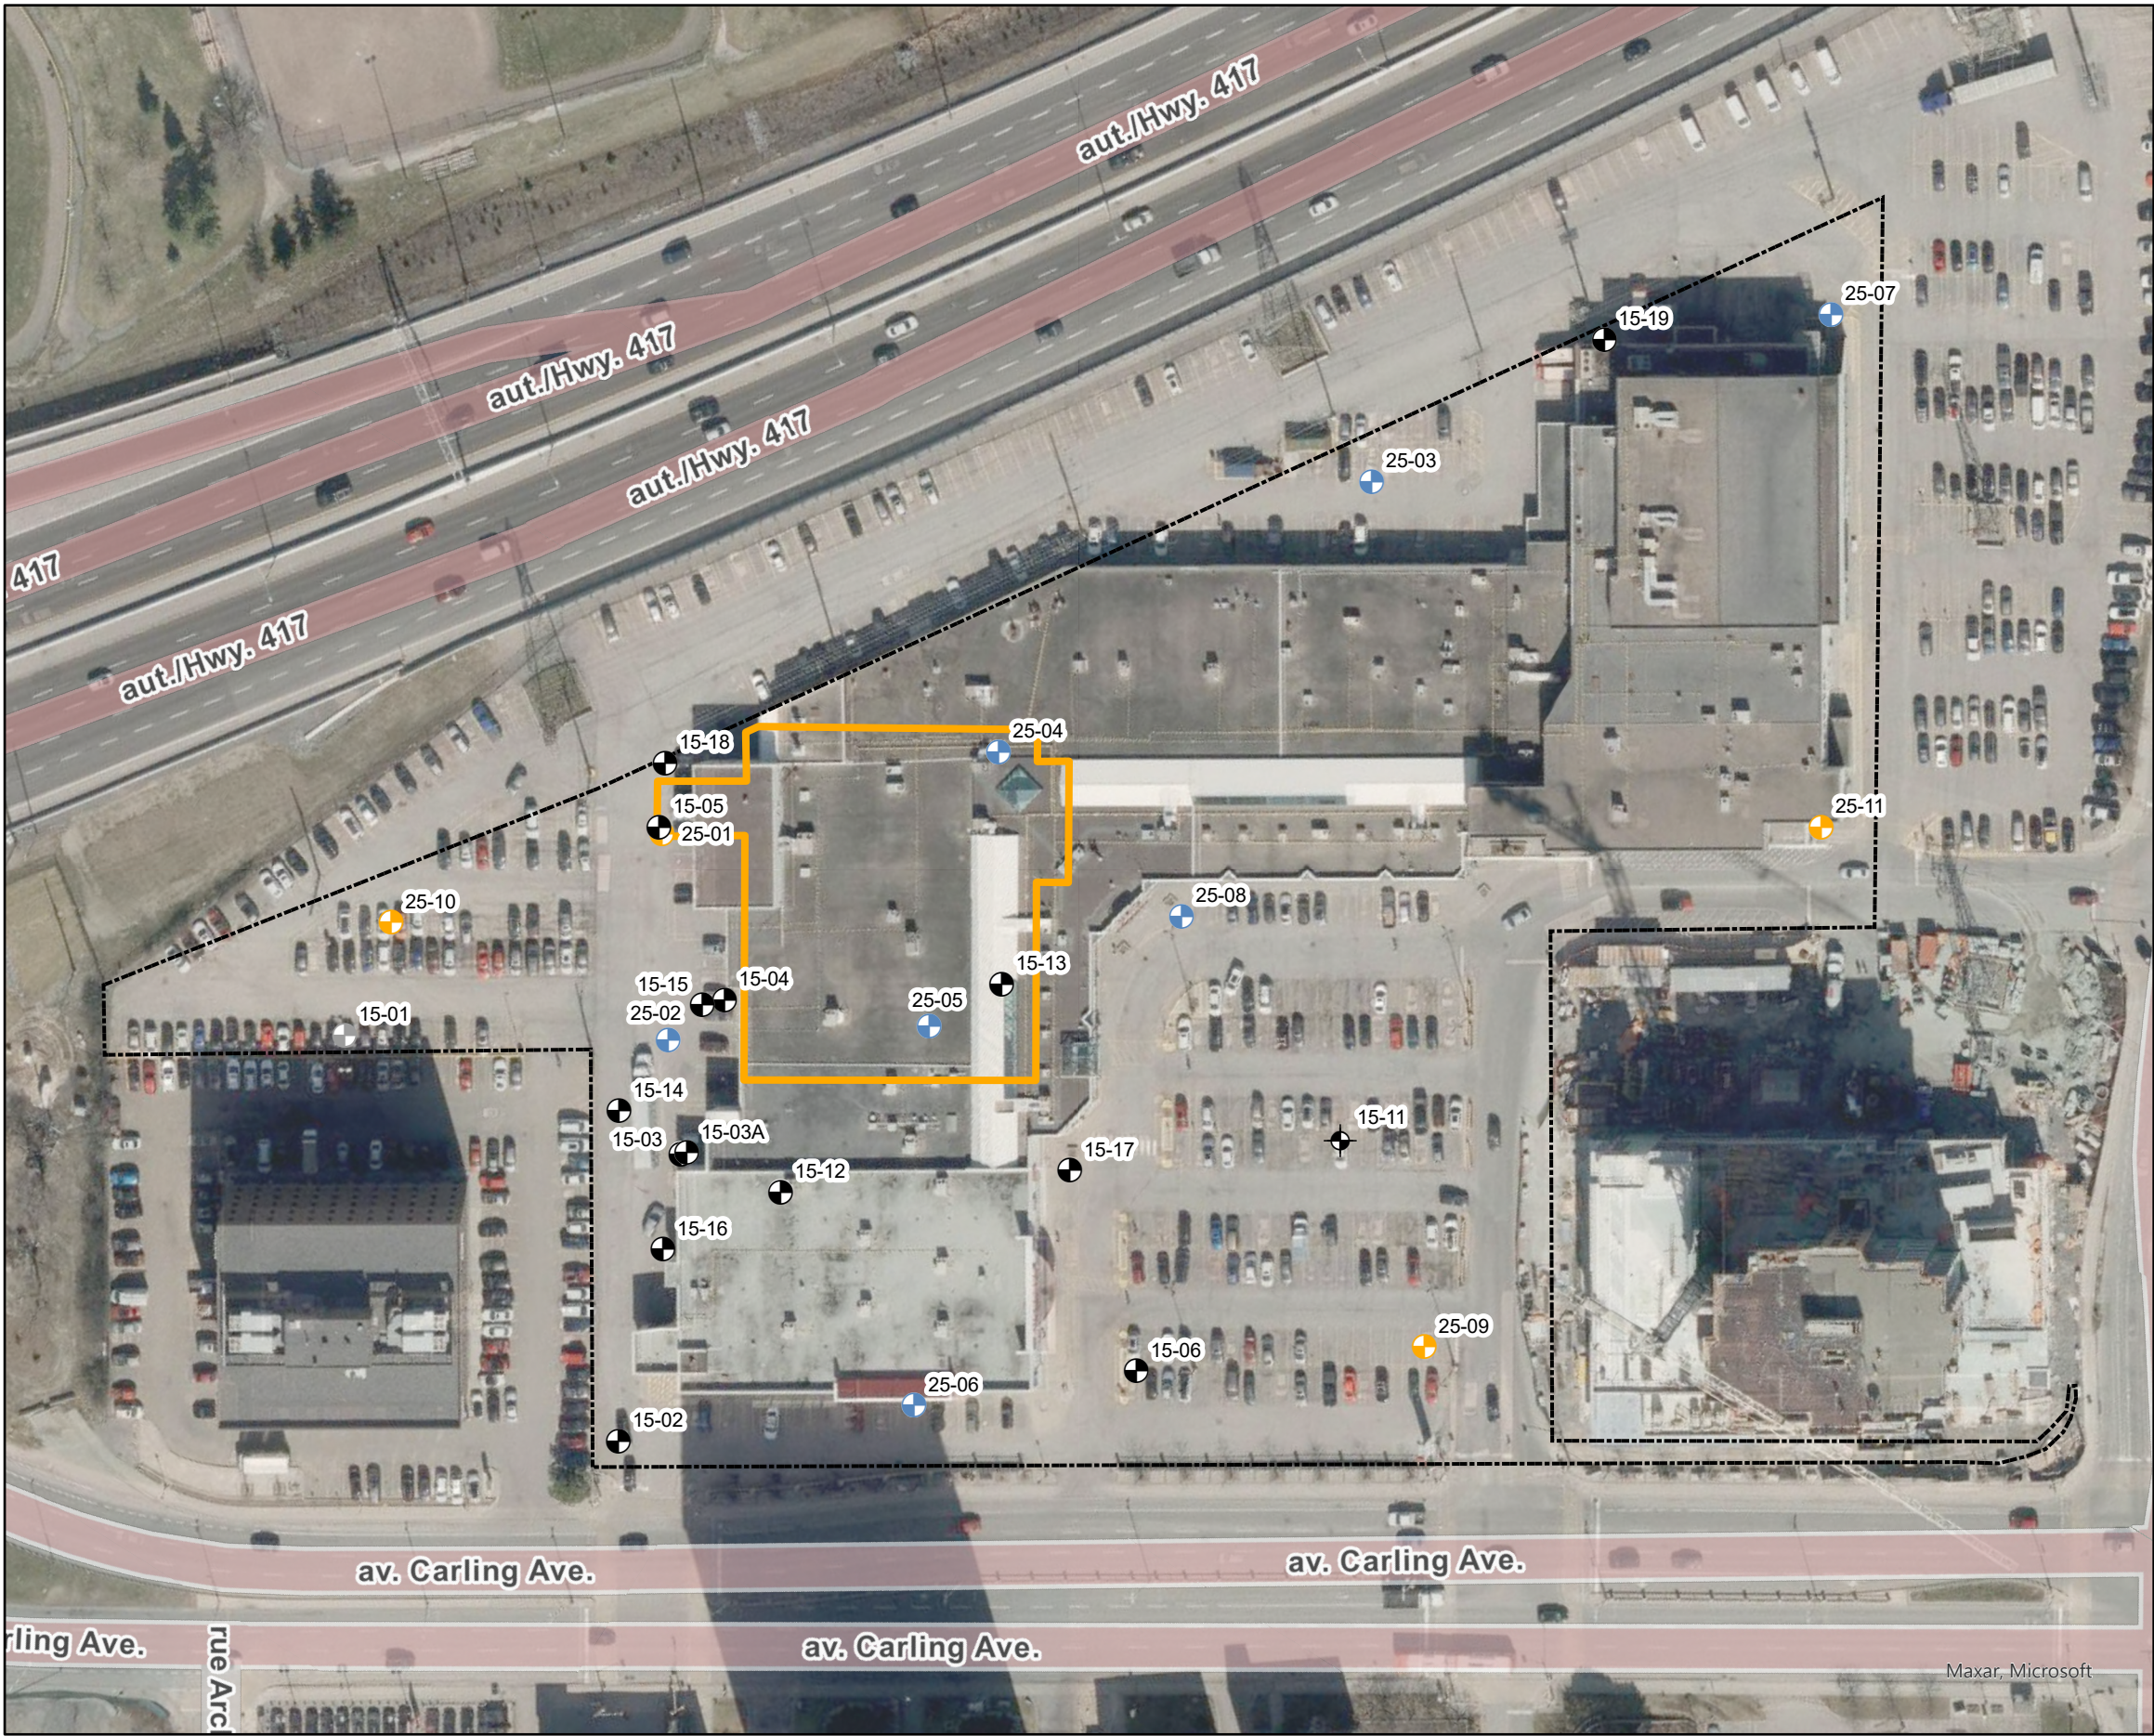
**FIGURE 2**  
**BOREHOLE LOCATION PLAN -**  
**PHASE TWO ESA AND GEOTECHNICAL**  
**INVESTIGATION**  
1309 CARLING AVENUE  
OTTAWA, ONTARIO

- Legend:
- Borehole (Geosyntec)
  - Monitoring Well (Geosyntec)
  - Previous Borehole (Golder)
  - Previous Monitoring Well (Golder)
  - Unlocatable Previous Monitoring Well (Golder)
  - Phase Two Property Boundary
  - Building Footprint (approximate)

Four monitoring wells were installed in the completed geotechnical boreholes located near or within the proposed building footprint. Additionally, three monitoring wells installed as part of the environmental site assessment, located elsewhere on the property, are also referenced in this memorandum. These monitoring wells were constructed using flush-threaded, Schedule 40, clean polyvinyl chloride (PVC) casings with slotted well screens. The exterior wells had a diameter of 50-millimeter (mm) (2 inches), except for well 25-02, which had a 38 mm (1.5 inches) diameter PVC casing. The interior wells had a diameter of 31 mm (1.25 inches). The screens ranged from 0.61 to 3.0 meters (m) in length and were installed to intersect the water table. Detailed information about the installed monitoring wells can be found in the relevant borehole logs in **Appendix A**.

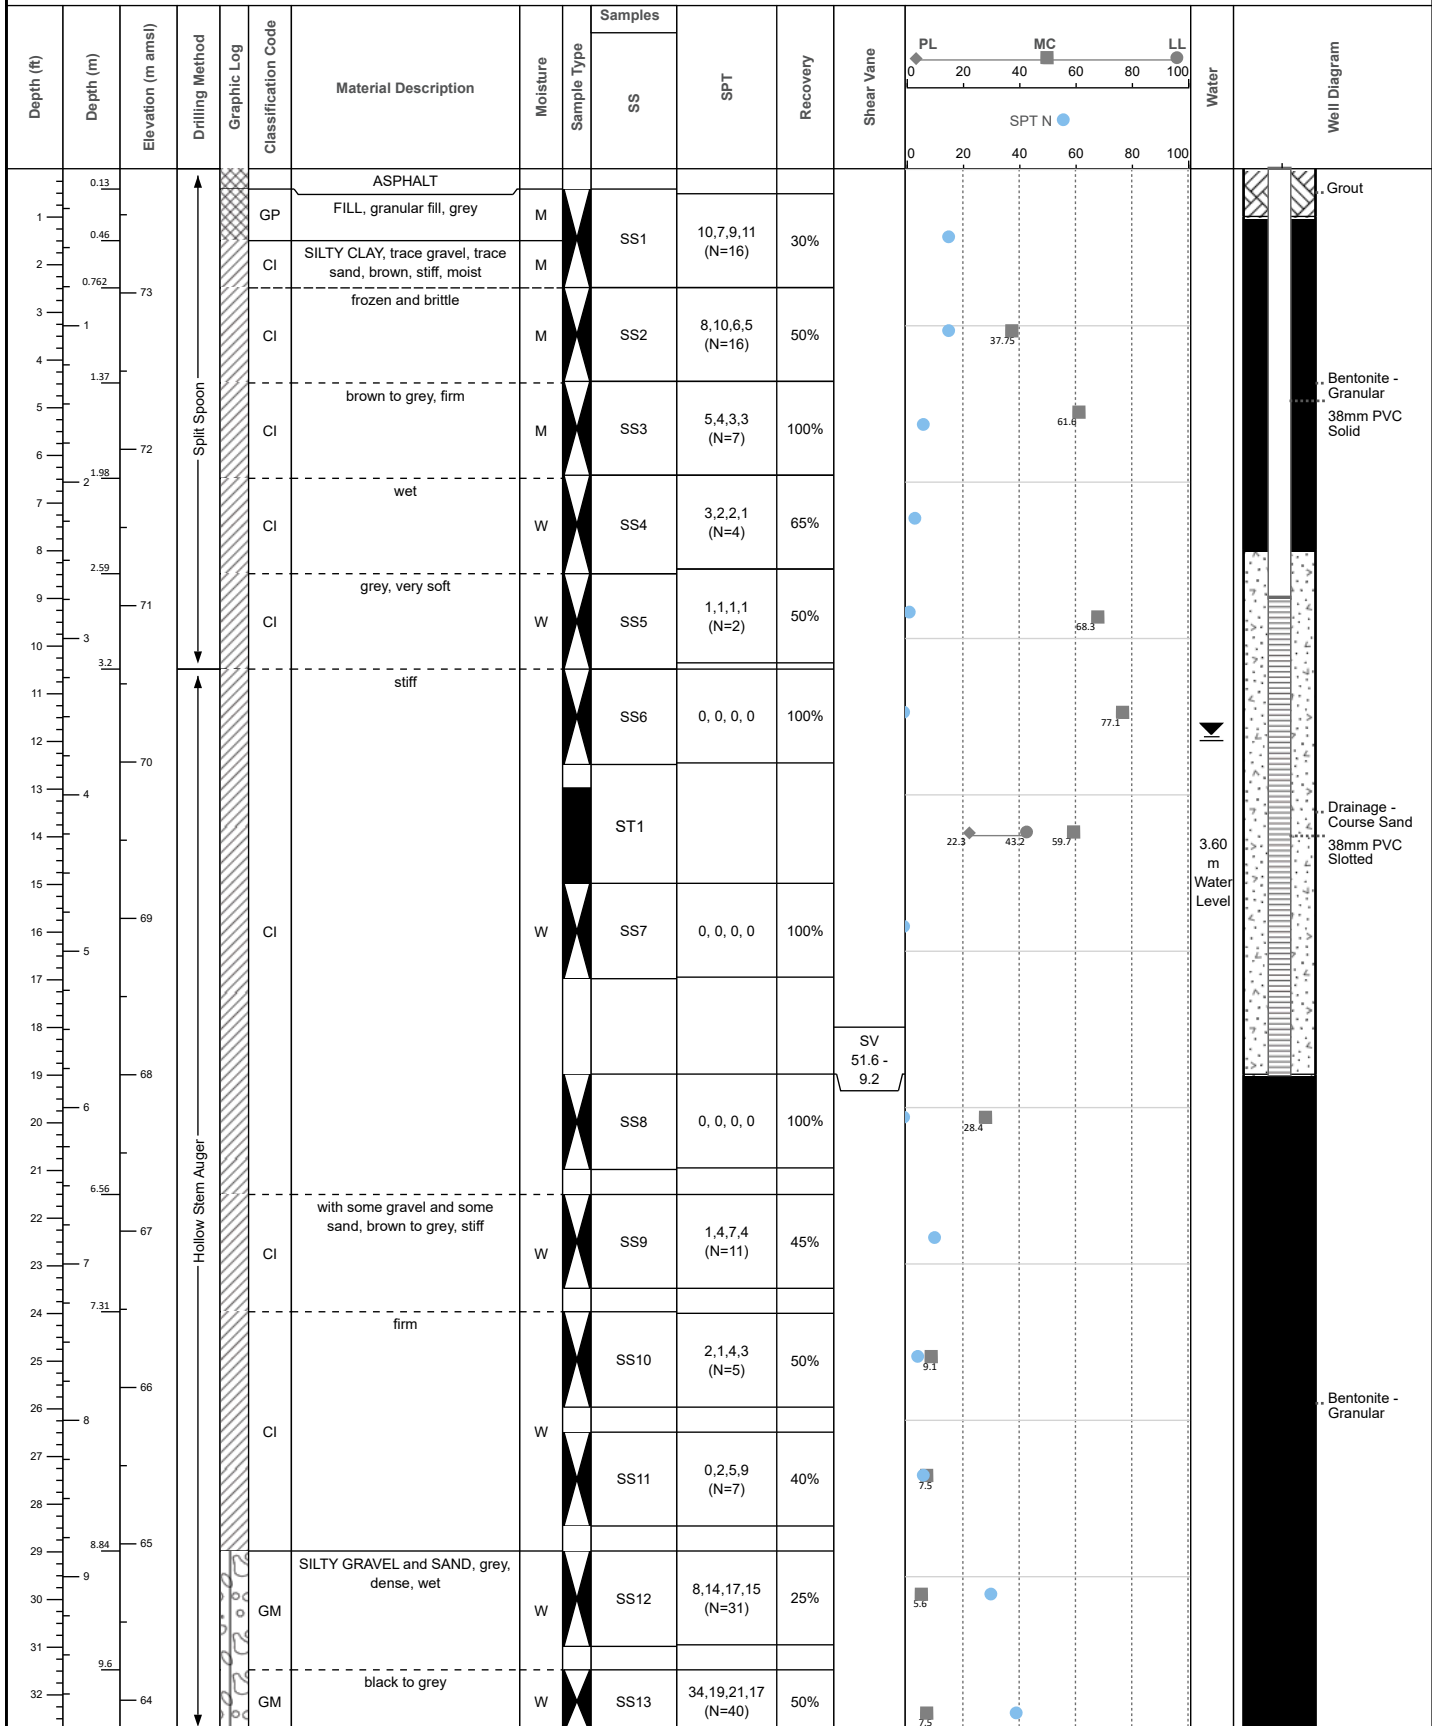
<b>MTM</b> : 9 <b>Easting</b> : 364645.68 <b>Northing</b> : 5027656.31 <b>RL</b> : 73.791(m) <b>Total Depth</b> : 13.33 m	<b>Driller Rig</b> : CME 75 HT <b>Driller Supplier</b> : OGS <b>Logged By</b> : EN, TK <b>Reviewed By</b> : BV <b>Date</b> : 17/03/2025	<b>Job Number</b> : TR1363B <b>Client</b> : RioCan <b>Project</b> : RioCan Westage - 1309 Carling Ave <b>Location</b> : 1309 Carling Avenue, Ottawa, ON, Canada <b>Loc Comment</b> : Elevation is Top of PVC Casing (GCVD28)
---	---	--

Depth (ft)	Depth (m)	Elevation (m amsl)	Drilling Method	Graphic Log	Classification Code	Material Description	Moisture	Sample Type	SS	SPT	Recovery	Shear Vane	0 20 40 60 80 100					Water	Well Diagram
			↓ Hollow Stem Auger ↑										PL	MC	LL				
													SPT N						
													0	20	40	60	80	100	
34																			
35		63																	
36	11																		
	11.28

Depth (ft)	Depth (m)	Elevation (m)	Drilling Method	Graphic Log	Classification Code	Material Description	RQD% and TCR%	RQD	Water	Well Diagram
34		63						0 20 40 60 80 100		
35										
36	11									
37						<b>Commenced Coring at 11.28m</b>				
38					LIMST	LIMESTONE: grey limestone with black shale interbeds, fresh, fine grained, thinly to medium bedded, good quality, very strong	RQD = 82%			
38.736	11.81	62								
39						fractured zone, very poor quality				
40	12				LIMST					
41						excellent quality	RQD = 52%			
41	12.5									
42		61			LIMST					
43	13									
						<b>25-02 Terminated at 13.33m (upon reaching target depth. Monitoring well installed, details shown on the graph.)</b>

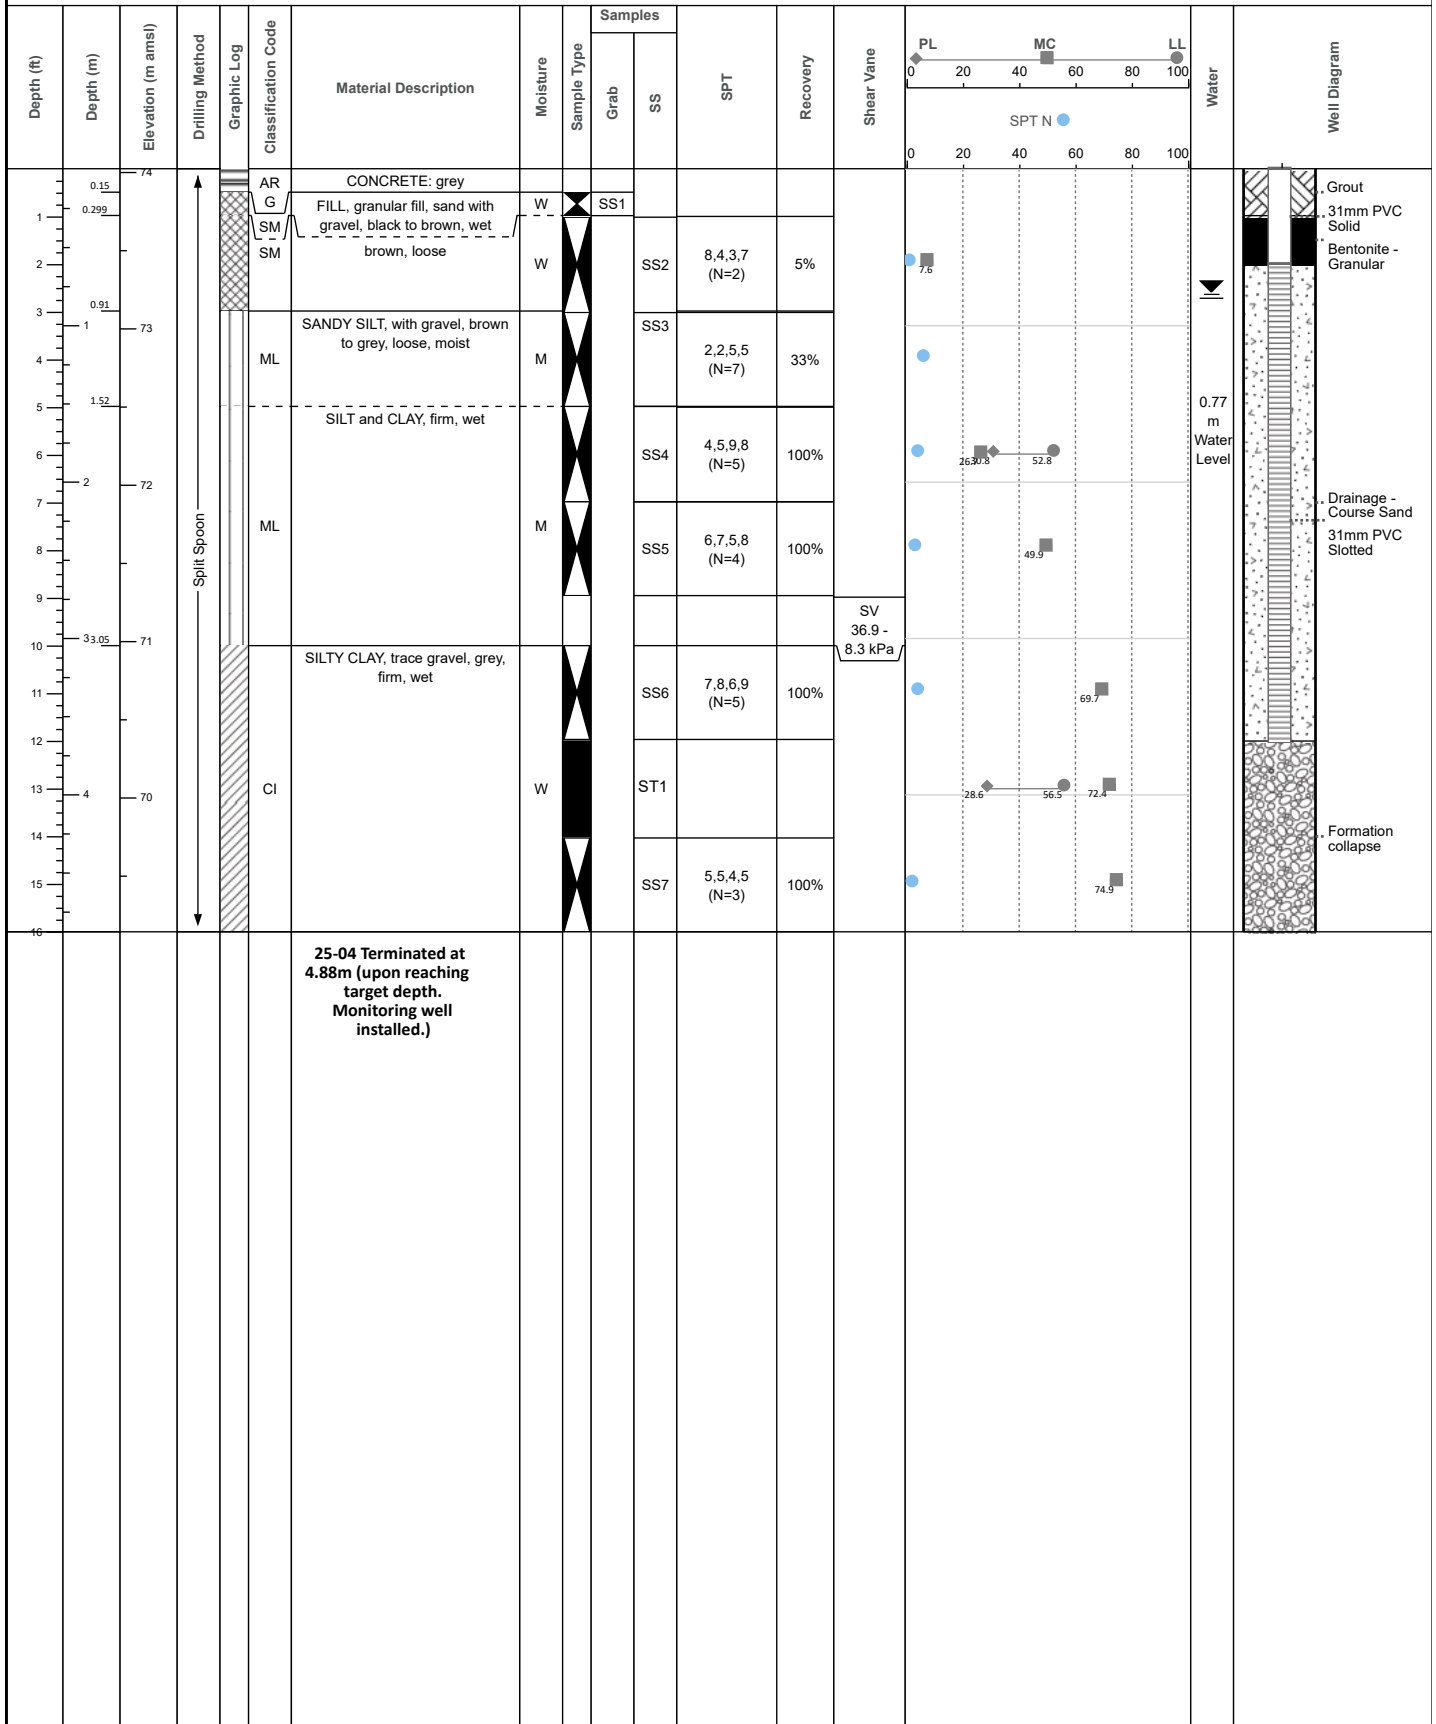
<b>MTM</b> : 9 <b>Easting</b> : 364665.65 <b>Northing</b> : 5027721.99 <b>RL</b> : 74.015(m) <b>Total Depth</b> : 4.88 m	<b>Driller Rig</b> : Hilti DD250 <b>Driller Supplier</b> : OGS <b>Logged By</b> : TK <b>Reviewed By</b> : BV <b>Date</b> : 24/03/2025	<b>Job Number</b> : TR1363B <b>Client</b> : RioCan <b>Project</b> : RioCan Westage - 1309 Carling Ave <b>Location</b> : 1309 Carling Avenue, Ottawa, ON, Canada <b>Loc Comment</b> : Elevation is Top of PVC Casing (GCVD28)
--	---	--

**Job Number** : TR1363B  
**Client** : RioCan  
**Project** : RioCan Westage - 1309 Carling Ave  
**Location** : 1309 Carling Avenue, Ottawa, ON, Canada  
**Loc Comment** : Elevation is Top of PVC Casing (GCVD28)

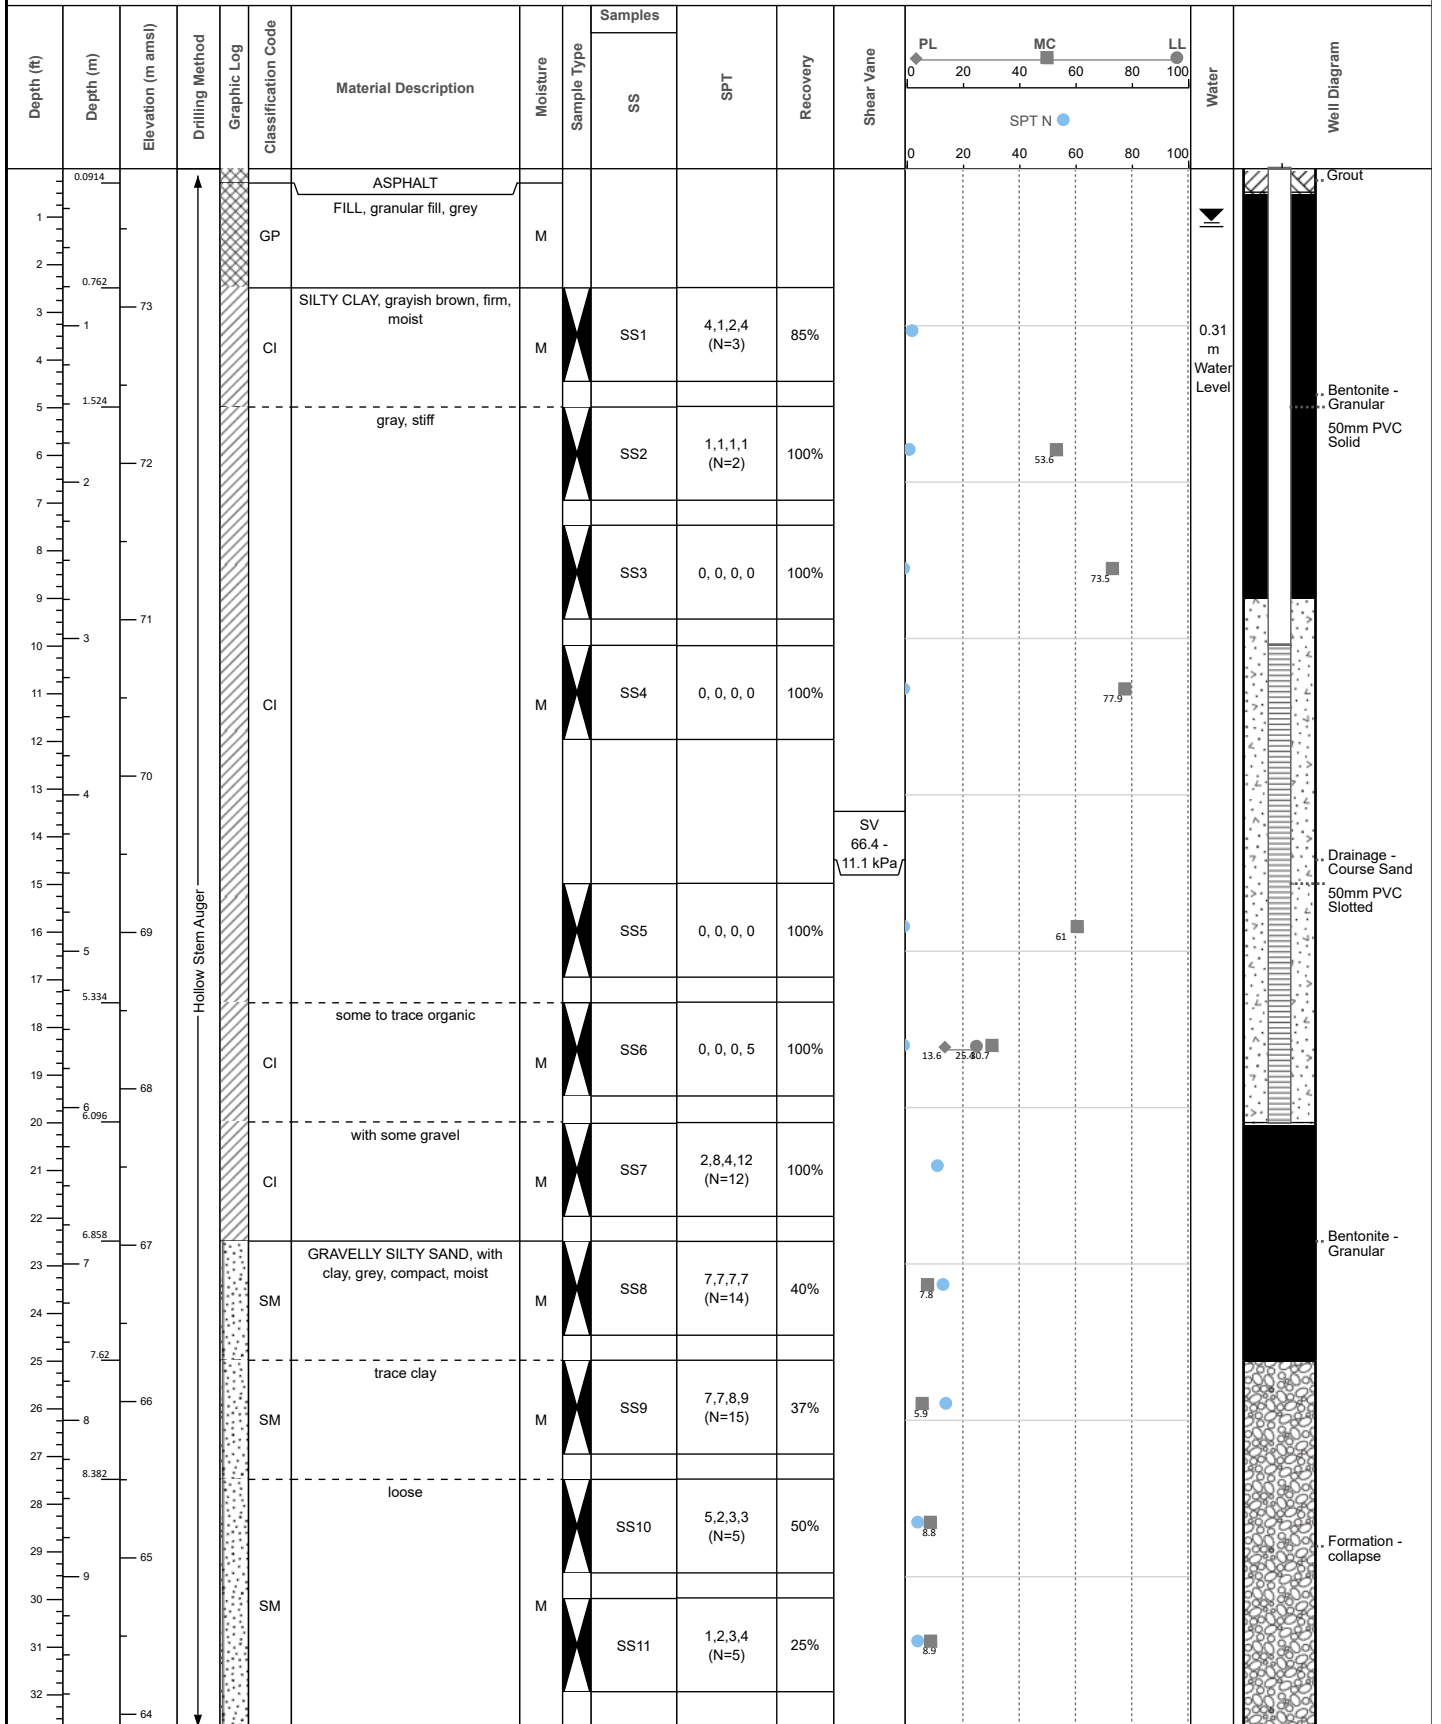
<b>MTM</b> : 9 <b>Easting</b> : 364703.62 <b>Northing</b> : 5027715.34 <b>RL</b> : 73.884(m) <b>Total Depth</b> : 20.57 m	<b>Driller Rig</b> : CME 75 HT <b>Driller Supplier</b> : OGS <b>Logged By</b> : EN, TK <b>Reviewed By</b> : BV <b>Date</b> : 11/03/2025	<b>Job Number</b> : TR1363B <b>Client</b> : RioCan <b>Project</b> : RioCan Westgate - 1309 Carling Ave <b>Location</b> : 1309 Carling Avenue, Ottawa, ON, Canada <b>Loc Comment</b> : Elevation is Top of PVC Casing
---	---	--

Depth (ft)	Depth (m)	Elevation (m amsl)	Drilling Method	Graphic Log	Classification Code	Material Description	Moisture	Sample Type	SS	SPT	Recovery	Shear Vane	PL	MC	LL	SPT N	Water	Well Diagram
34					SM	loose	M											
35	10.668	63			SM	compact, wet	W		SS12	4,9,12 (N=R)	60%		12.9					
36	11					boulder												
37	11.2776																	
38																		
39		62																
40	12				SM		W											
41																		
42		61																
43	13																	
44																		
45	13.72	60				GRAVELLY SAND, with some silt and trace clay, grey, dense, wet			SS13	18,16,22,8 (N=38)	40%		8.9					
46	14				SM		W											
47																		
48		59																
49	15																	
50																		
51	15.54					more gravel and less sand			SS14	8,11,19,17 (N=30)	25%		9.9					
52	16	58																
53																		
54					SM		W											
55		57																
56	17								SS15	15,19,33 (N=R)	50%		13.7
