3856, 3866 & 3876 Navan Road Tree Conservation Report

Proposed Church and Service Building Project No. 160410200

Prepared for: St. George and St. Anthony Coptic Orthodox Church

Prepared by: Stantec Consulting Ltd.

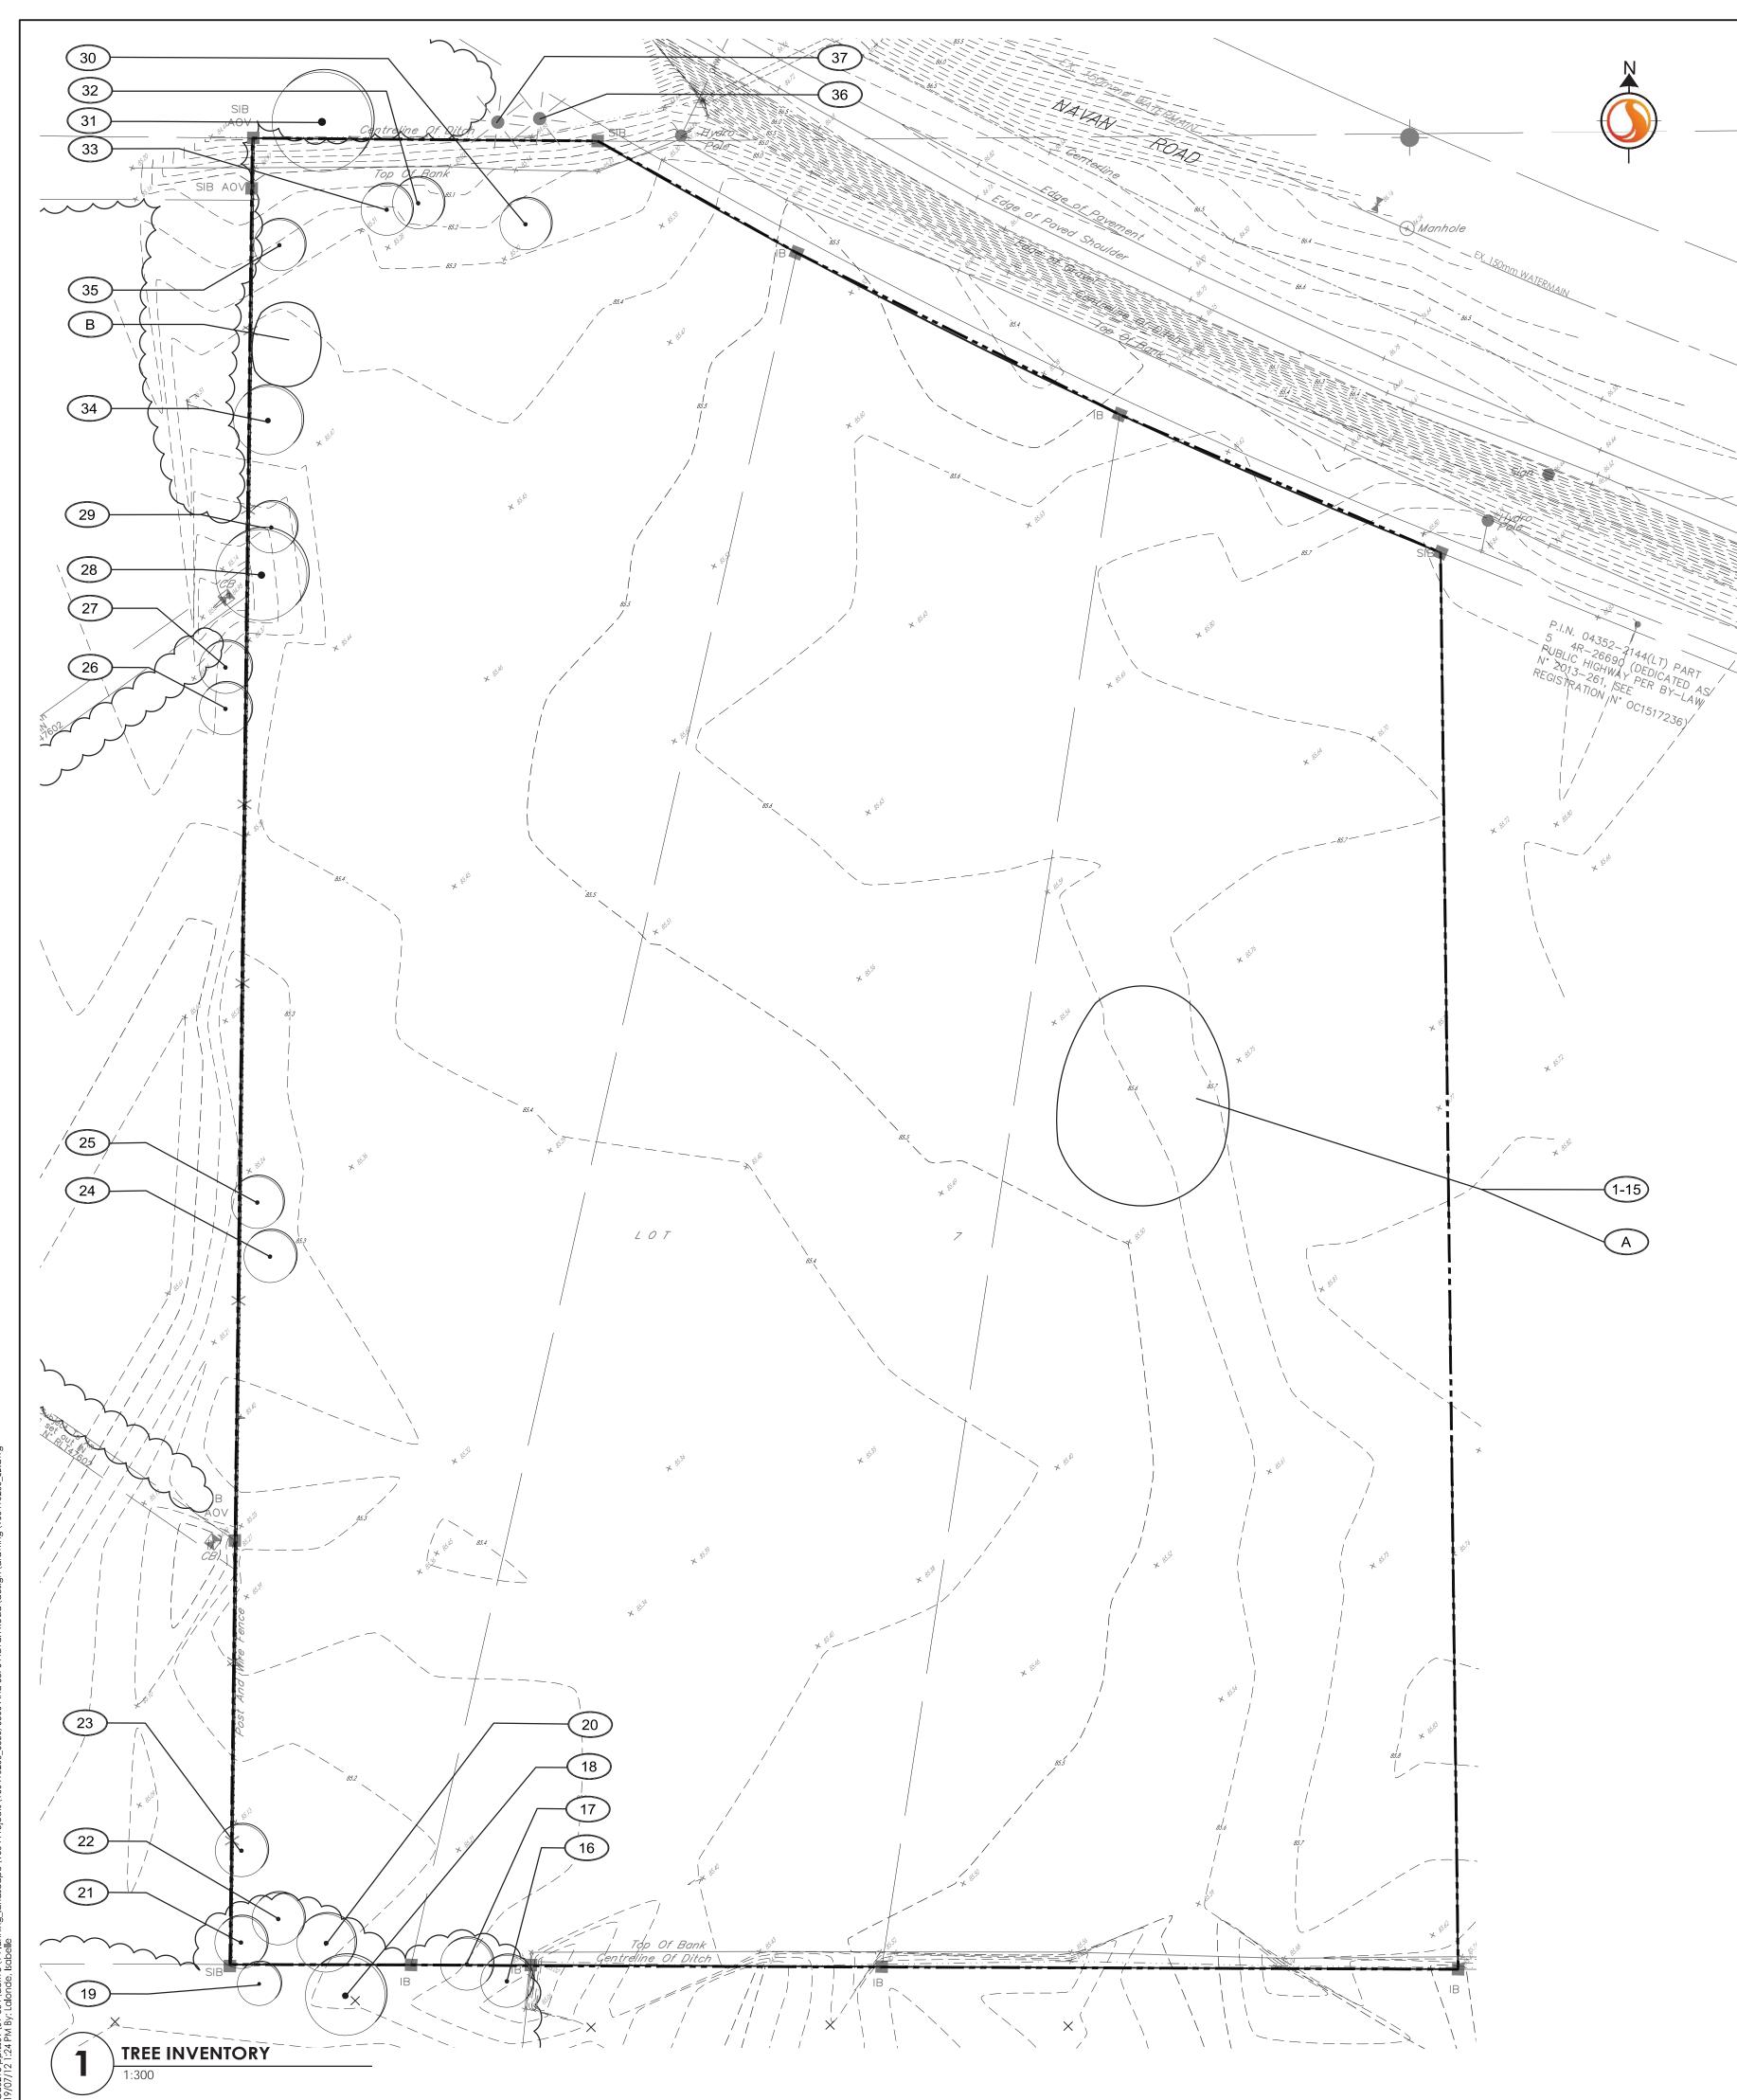
TREE INVENTORY

TREE ASSESSMENT CONDUCTED: August 9th, 2018 and August 22, 2018

In general, the trees inventoried on this property appeared in healthy condition, are of various sizes and show no significant signs of disease. A total of 37 trees and two (2) vegetation groups were assessed as part of this assessment. Tree species composition included mostly deciduous species with only three (3) coniferous trees. The complete list of all trees inventoried is described in the *Tree Inventory* table inserted on the *Current Vegetation Plan (TC-01)*. This table shall be read in conjunction with the Tree Inventory Plan and is inserted at the end of this report.

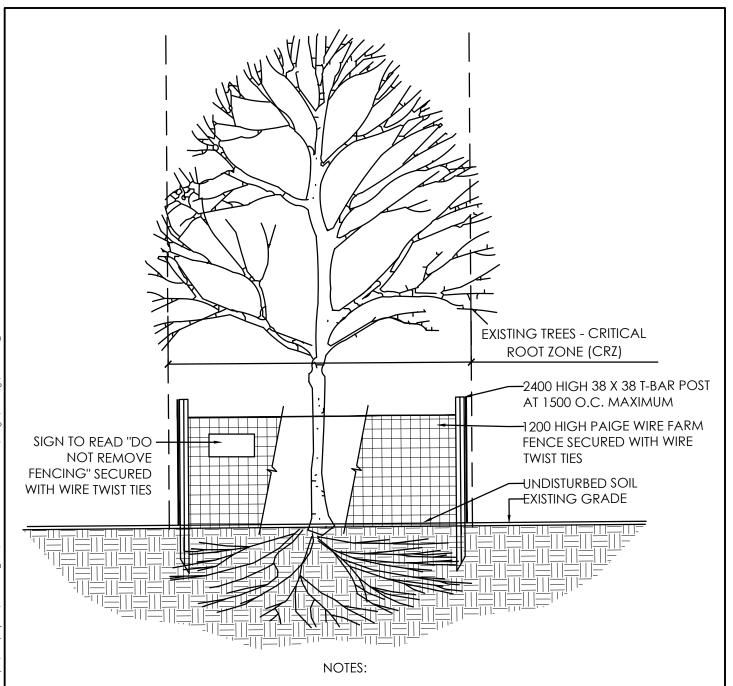
- GROUPS OF TREES TO BE PROTECTED SHALL BE TREATED IN A LIKE MANNER WITH FENCING AROUND THE ENTIRE STAND(S).
- 2. PRUNE BRANCHES TO REMOVE DAMAGED OR OBJECTIONABLE BRANCHES. DO NOT PRUNE LEADERS.
- 3. <u>TREE_PROTECTION_SHALL_REMAIN_UNTIL_SUBSTANTIAL PERFORMANCE OF THE PROJECT.</u>
- 4. IF TREES ARE BEING AFFECTED BY CONSTRUCTION, A WATER AND FERTILIZING PROGRAM WILL BE REQUIRED TO THE SATISFACTION OF THE CITY.
