KANATA GOLF & COUNTRY CLUB 2019 MONITORING AND HYDROLOGIC MODEL CALIBRATION REPORT

September 2019

J.F. Sabourin and Associates Inc. 52 Springbrook Drive, Ottawa, ON K2S 1B9 T 613-836-3884 F 613-836-0332

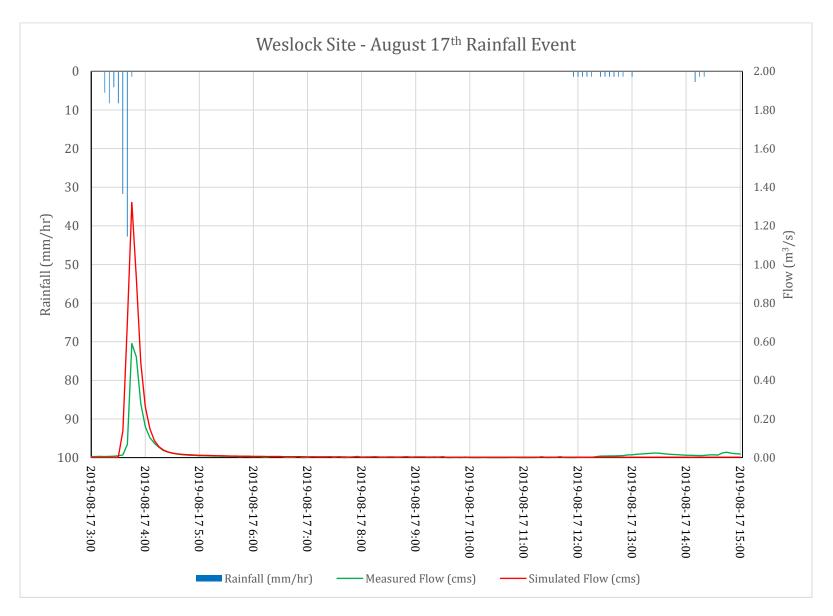
Appendix C – Measured vs. Simulated Flow at Manholes Kanata Golf & Country Club Monitoring and Calibration Report September 2019

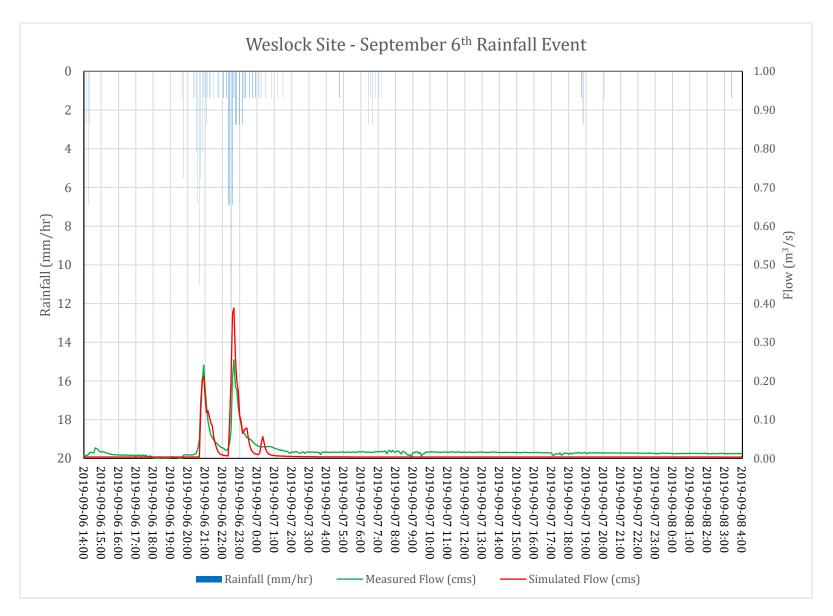
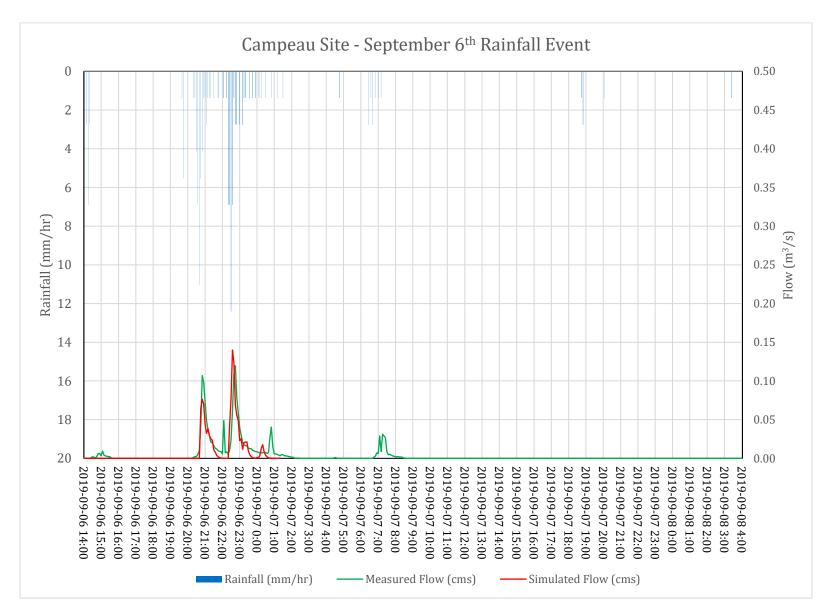
Appendix C – Measured vs. Simulated Flow at Manholes Kanata Golf & Country Club Monitoring and Calibration Report September 2019
