# **KANATA GOLF & COUNTRY CLUB 2019 MONITORING & HYDROLOGIC MODEL CALIBRATION REPORT**

**July 2020**

J.F. Sabourin and Associates Inc.  
52 Springbrook Drive,  
Ottawa, ON K2S 1B9  
T 613-836-3884 F 613-836-0332

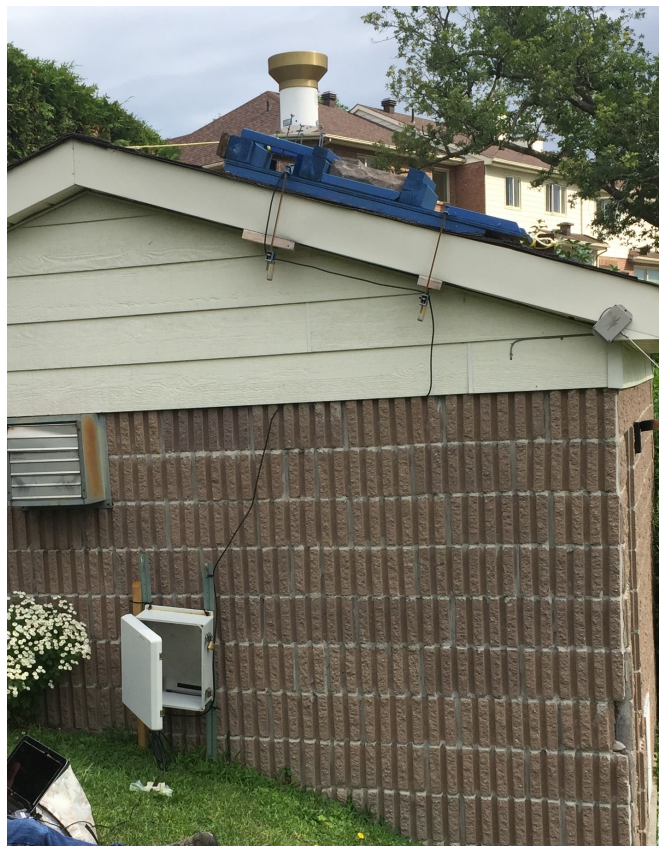
**Figure 2: 2019 Rain Gauge Setup**

A TE525-series tipping bucket rain gauge was installed on-site on April 30<sup>th</sup>, 2019 and was located on the roof of the pumphouse on the Kanata Golf and Country Club property. The gauge was installed on the roof to avoid any interruption to precipitation due to nearby vegetation or trees. The rain gauge was mounted on a device enabling a level placement and that would withstand large rainstorms and wind without shifting the rain gauge. The gauge was calibrated before it was initiated and the lip of the funnel was horizontal, and at least 30 cm above the ground. To avoid climbing on the roof during each download, the logger was placed in a waterproof box at ground level for easy access and locked with a padlock to ensure no interference. See Figure 2 below for a photo of the rain gauge setup.

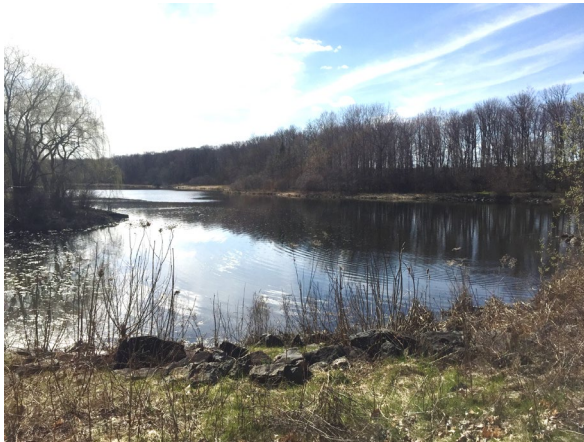
**Figure 4: April 30, 2019**

Below are photos taken from the field of the Beaver Pond throughout the monitoring period to validate the fluctuation of water levels.

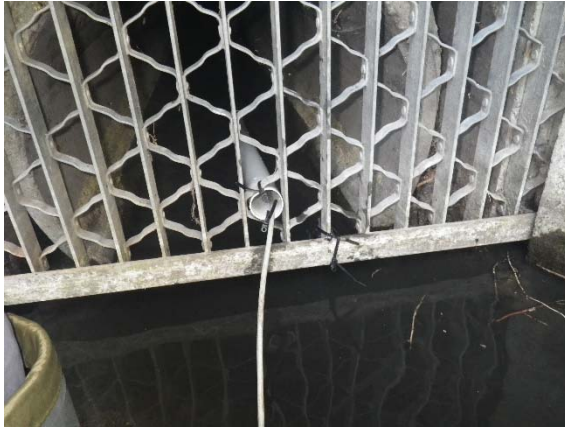
The level logger at Q1 was fixed to an existing steel grate at the outlet of the storm sewer. The Stingray Portable Level-Velocity Logger was placed approximately 1 m inside the culvert, through the use of a PVC pipe. The level logger at Q2 was installed within a perforated PVC pipe which was mounted to a concrete block and placed on the bottom of the head wall apron. The level logger at Q3 was placed flush against the upstream side of the inlet apron and fixed to an existing large timber grate. The barometric logger was also fixed to the timber grate near the Q3 level logger. A tipping bucket rain gauge was located on the pumphouse roof next to the pond on the 9<sup>th</sup> hole. This rain gauge was located away from any tall trees or structures, to minimize potential interference. **Figures 2a-2e** show the installation/configuration for all field equipment used in this study.

**Figure 2a:** Stingray and water level logger  
Installation on culvert grate at Q1

Flows at Q1 were calculated by simply taking the instantaneous velocity recorded by the Stingray and multiplying it by the flow cross-sectional area in the culvert obtained at the same time. The cross-sectional area was calculated by taking the water level depths recorded by the level logger at the culvert outlet.

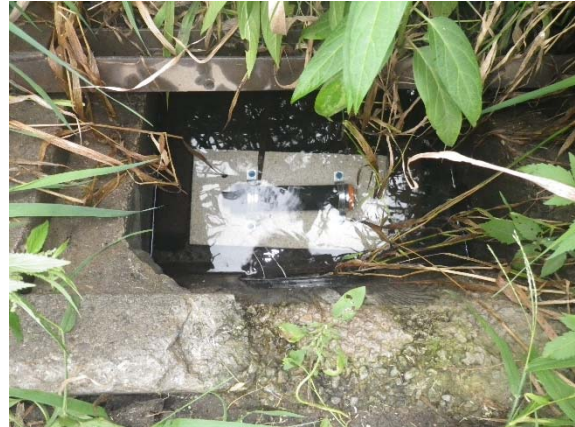
**Figure 2b:** Water level logger installation at Q2

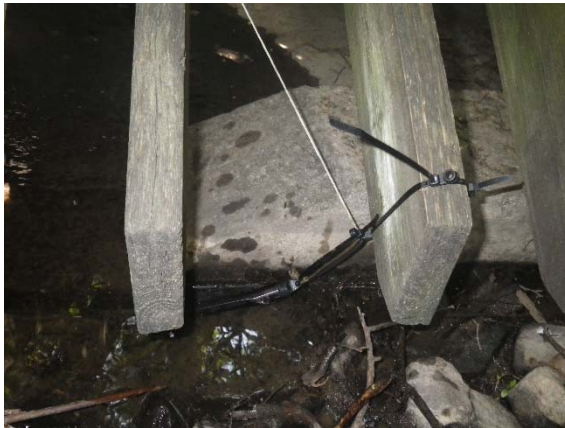
**Figure 2c:** Water level logger installation at Q3

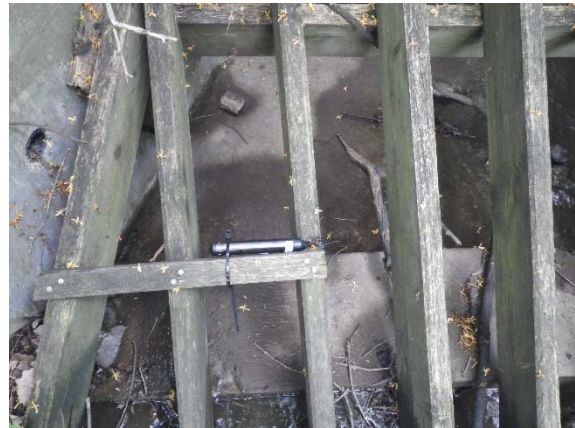
**Figure 2d:** Barometric Logger Installation at Q3

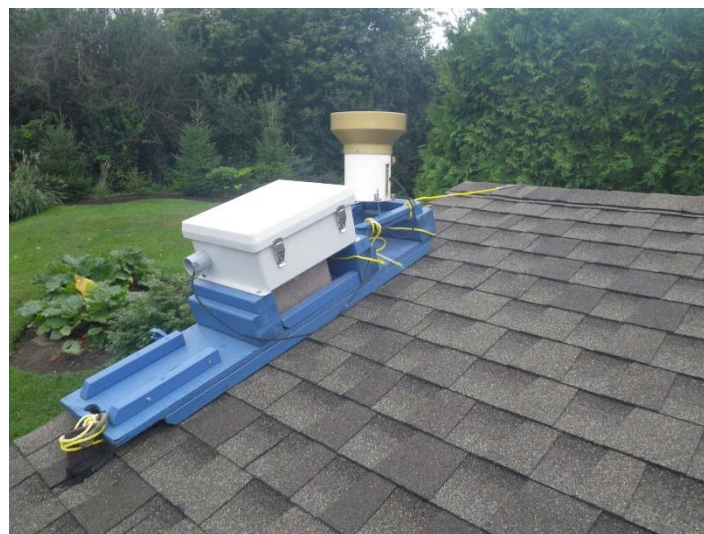
**Figure 2e:** Rain gauge installation

A tipping bucket rain gauge was installed on-site on May 14<sup>th</sup>, 2018 and removed on November 8<sup>th</sup>, 2018, providing 179 days of precipitation data for the year. The first instance of snowfall during this monitoring program occurred on October 27<sup>th</sup>, 2018. Considering that conventional tipping bucket rain gauges, like the one installed on site, are incapable of recording snowfall or determining snow water equivalent, the rainfall dataset has been truncated to a period of 166 days (May 14<sup>th</sup>, 2018 - October 27<sup>th</sup>, 2018). As the intended use of the data obtained from this monitoring program is to guide the calibration of a detailed hydrologic model of the existing subwatershed conditions, the subsequent level/flow monitor data obtained in the field has also been truncated to October 27<sup>th</sup>, 2018. **Table 2** is a summary of the rain gauge data collected in 2018 (from May 14<sup>th</sup> to October 27<sup>th</sup>) at Kanata Golf & Country Club.

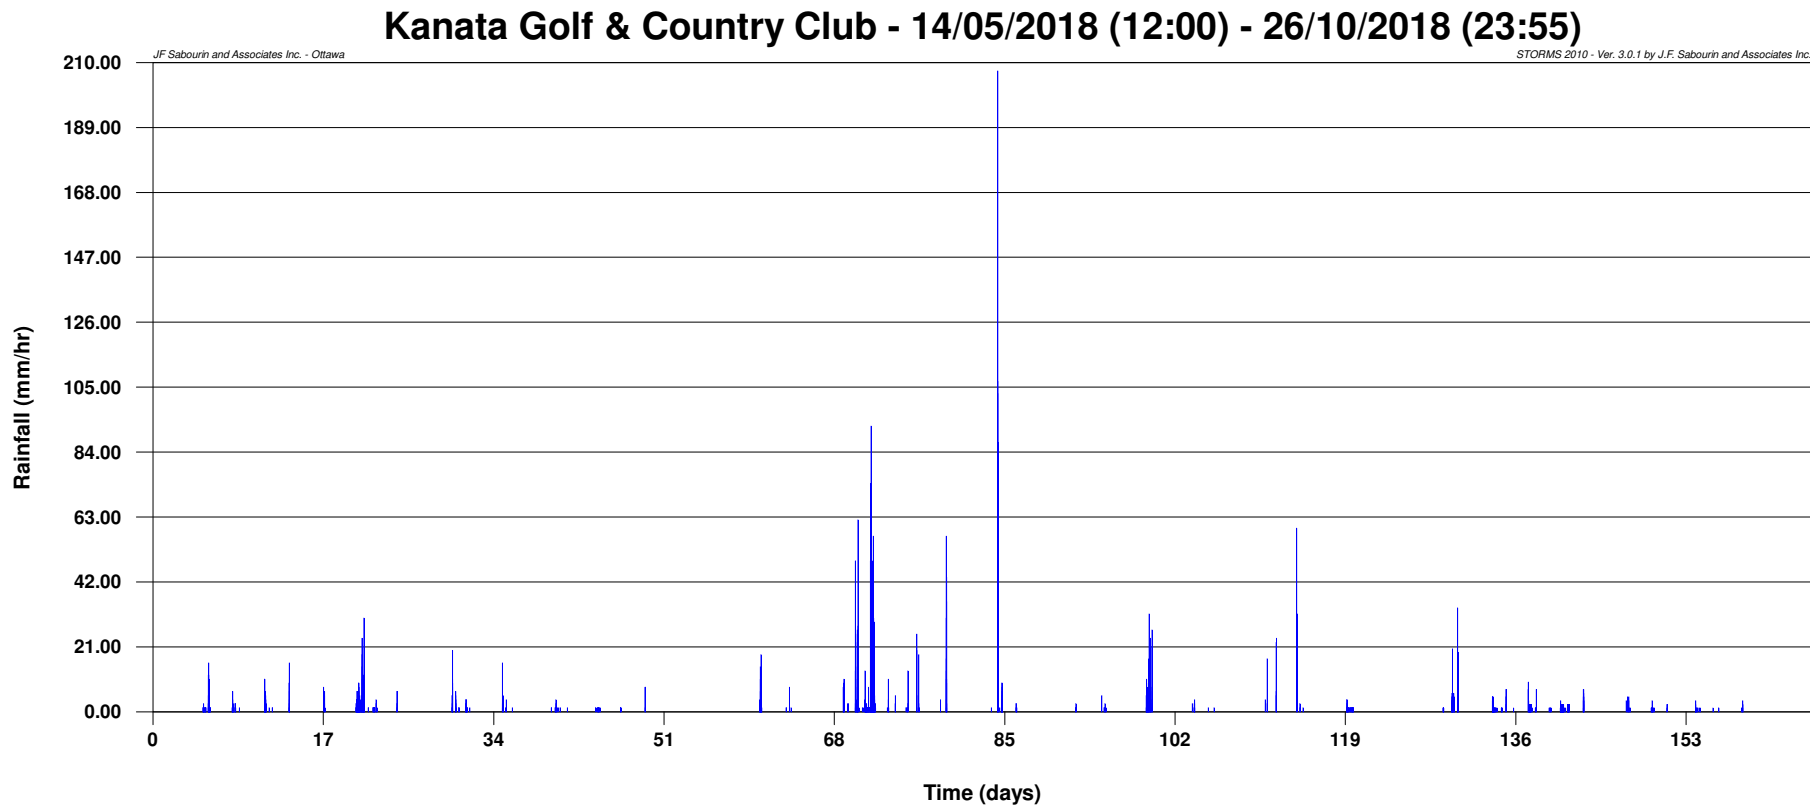
**Storm Statistics:**  
Storm Filename: T:\PROJ\1581-17\Design\Field\Rainfall Monitoring\Storm Files\20180514 - 20181026.stm  
Storm File Comment: Kanata Golf & Country Club - 14/05/2018 (12:00) - 26/10/2018 (23:55)

Total Rain = 490.86 (mm)  
Storm Duration (hrs) = 3972:05:00  
Time Step = 5 (minutes)  
Ave. Intensity = 0.12 (mm/hr)  
Max. Intensity = 207.24 (mm/hr) at 121415.00 (minutes)

Durations	5 min	10 min	15 min	30 min	1 hr	2 hrs	3 hrs	6 hrs	12 hrs	24 hrs
Max. Ave. Int. (mm/hr)	207.24	155.10	132.44	94.38	50.16	29.15	23.87	17.07	11.37	6.02

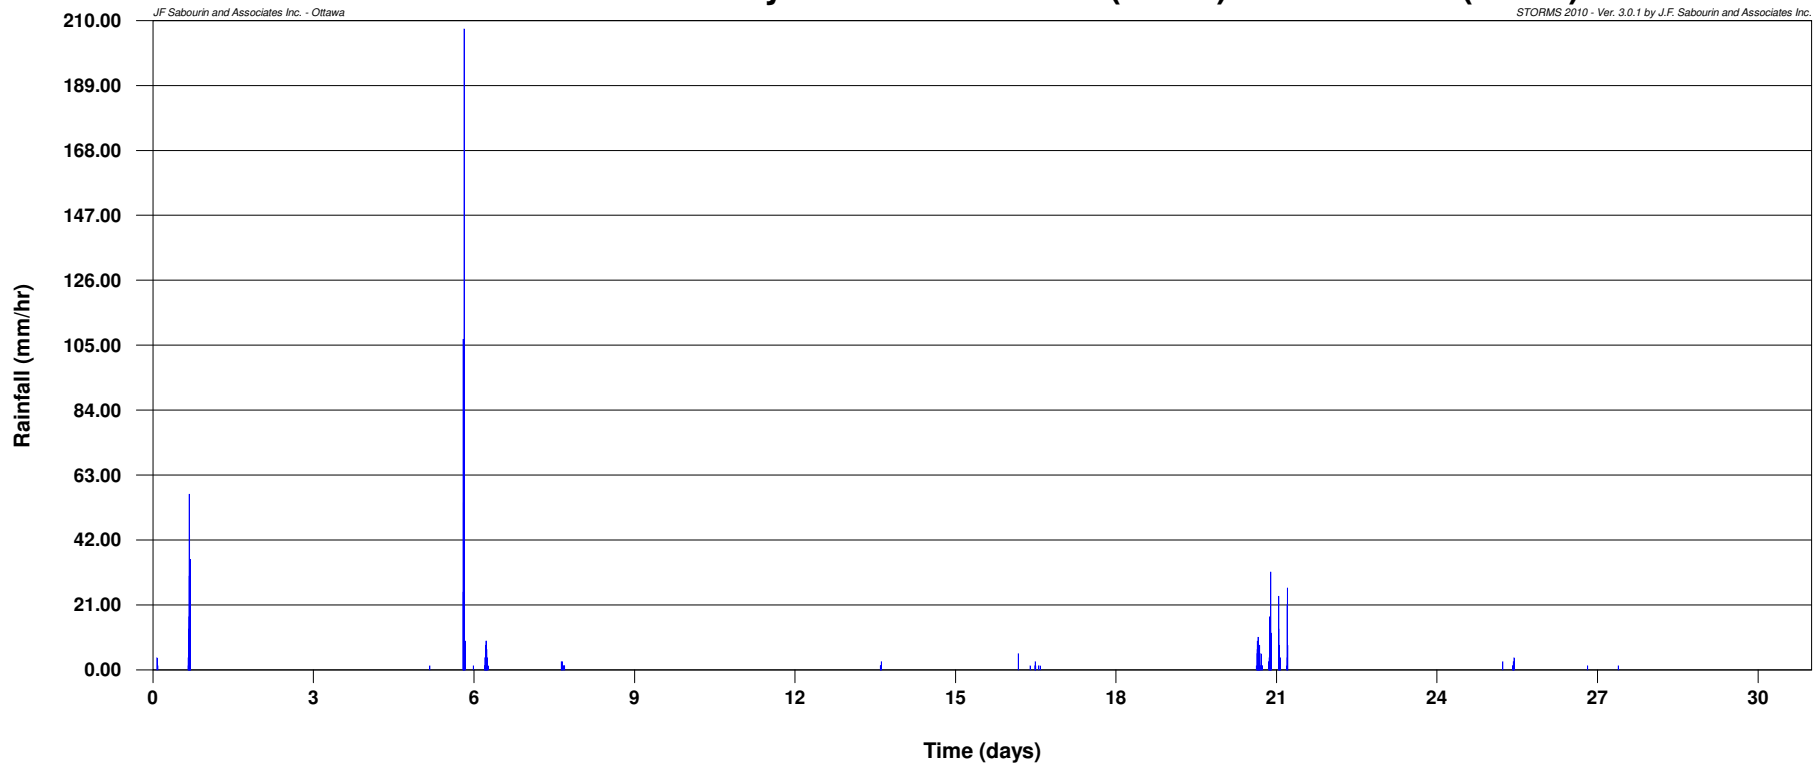
## Kanata Golf & Country Club - 01/08/2018 (00:00) - 31/08/2018 (23:55)

Storm Filename: T:\PROJ\1581-17\Design\Field\Rainfall Monitoring\Storm Files\20180801 - 20180831.stm

Durations	5 min	10 min	15 min	30 min	1 hr	2 hrs	3 hrs	6 hrs	12 hrs	24 hrs
Max. Ave. Int. (mm/hr)	207.24	155.10	132.44	94.38	50.16	25.47	16.98	8.51	4.69	2.35

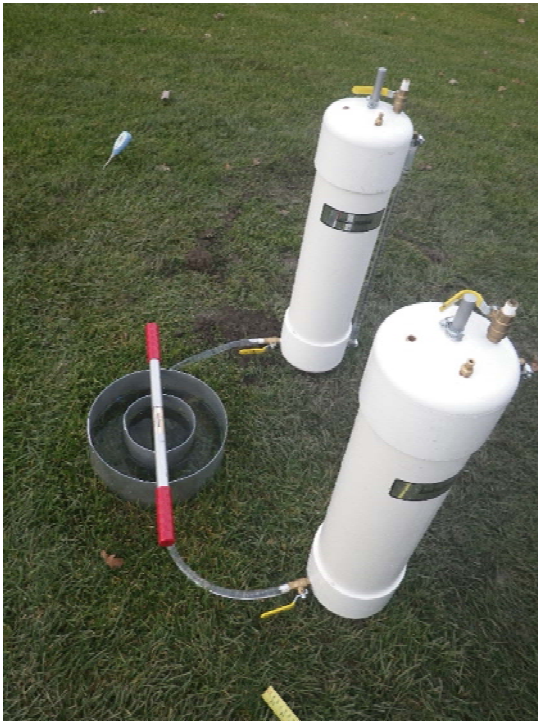
**Figure 2:** Double-Ring Infiltrrometer Setup  
(15/30 cm rings, two Marriotte bottles)

Surface infiltration testing at all four sites was conducted at the ground surface using a Double-Ring Infiltrometer (DRI), manufactured by Turf-Tec and shown in **Figure 2**. The DRI setup consisted of a set of concentric rings inserted into the soil connected to a water supply, wherein water is ponded on the soil and Marriotte bottles (also manufactured by Turf-Tec) were used to replenish infiltrated water and maintain a constant water depth in the rings. The volume of water needed to maintain a constant water level in the inner ring indicates the volume of water infiltrated over time. Water in the outer ring acts as a buffer as it infiltrates into the soil, limiting lateral spread of infiltrating water in the inner ring and encouraging vertical infiltration. Climate conditions prior to and during the test are provided on **Table 1**. Results of the DRI tests are provided on **Table 3**.

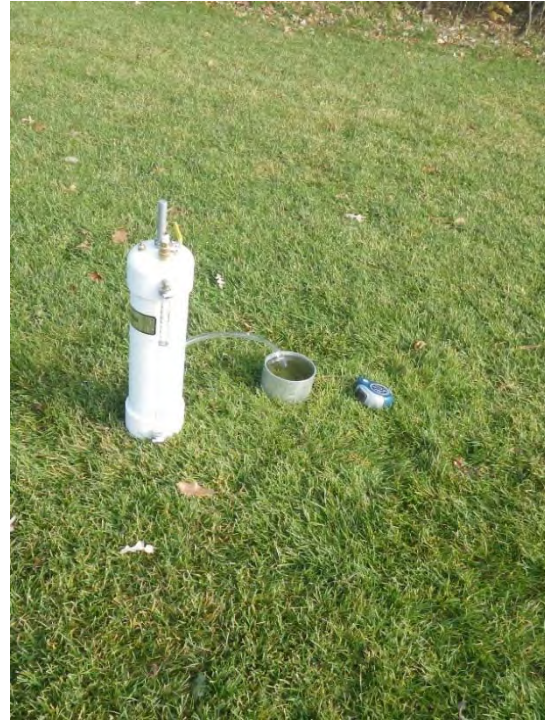
**Figure 3:** Single Ring Infiltrrometer Setup  
(12.7 cm diameter steel ring, single  
Marriotte bottle)

In addition to the DRI tests, Single-Ring Infiltrometer (SRI) surface infiltration tests were conducted at each of the four sites. See **Figure 3** for an example of the SRI setup. Marriotte bottles were used to maintain a constant head during SRI tests. At sites 1 and 2, constant head SRI tests were successfully run. At sites 3 and 4, field staff were not able to complete constant head SRI tests as a constant head of water could not be sustained. At all 4 sites, falling-head SRI tests were run in the same vicinity as the DRI tests. SRI and falling head tests were completed to provide alternative methods to measure infiltration rates and for comparison with the DRI results. Refer to the Test Methodology section of this memorandum for a more detailed description of how each of the test types was run.

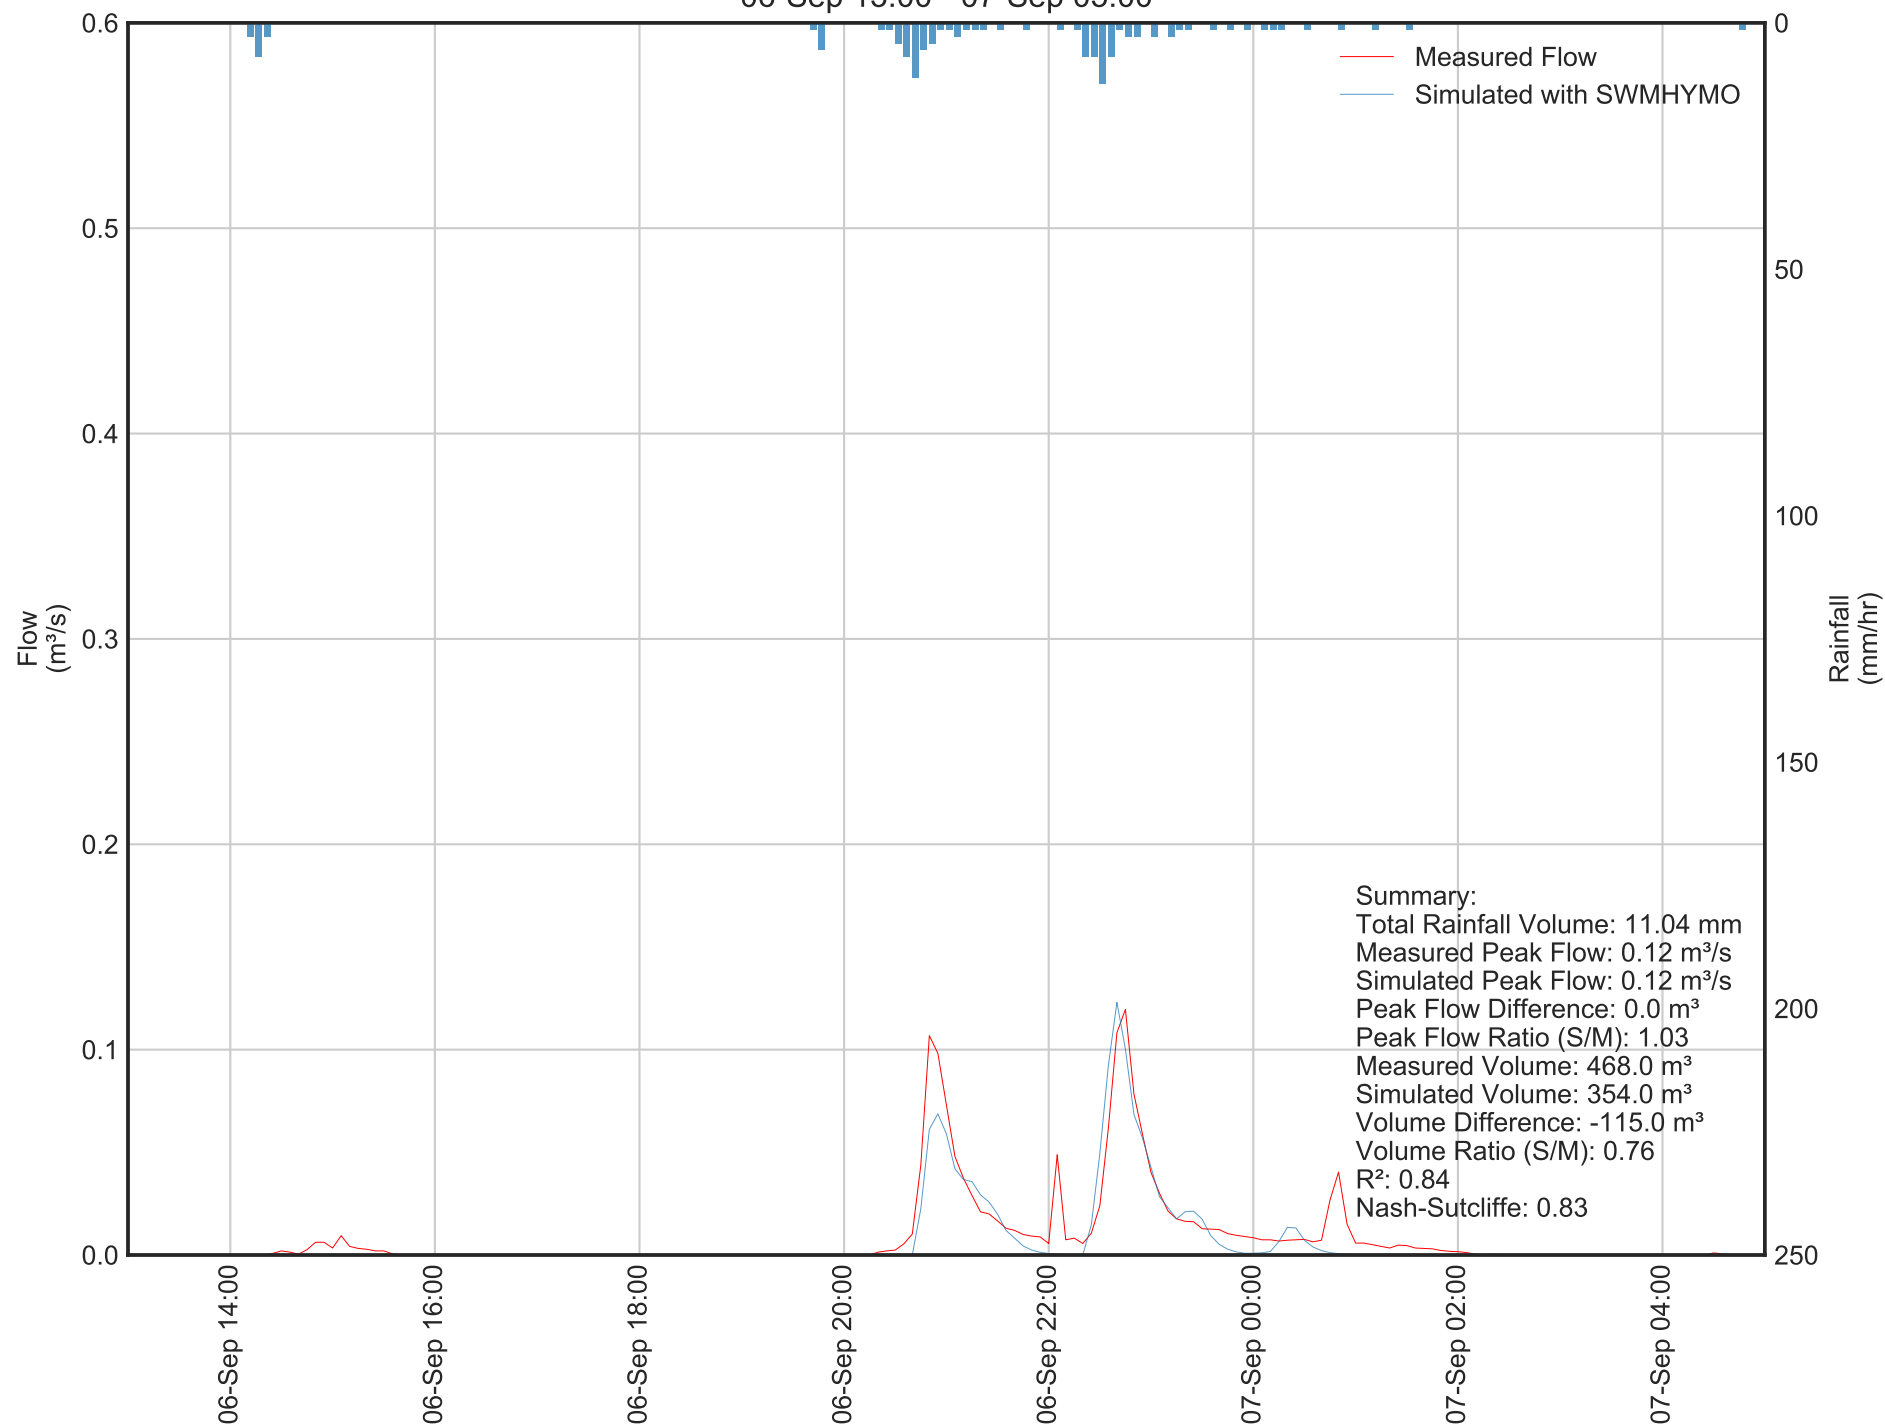
# JFSA SWMHYMO - Campeau Storm Sewer Flow Monitoring - 2019

06-Sep 13:00 - 07-Sep 05:00
