Tim Van Seters Ryerson University July 24, 2015

- Exfiltration system Princess Margaret Blvd
- Exfiltration system Queen Mary Drive
- Filtration System on Braecrest Avenue

- Summary of 1994 1995 Candaras Associates study
- Summary of 1996-1998 SWAMP Study
- Follow up monitoring in 2013 and 2014
- Other exfiltration system designs

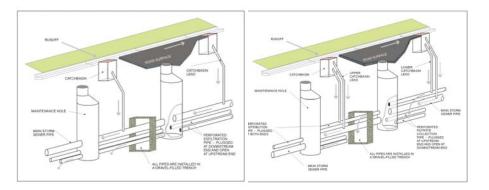
**Exfiltration System**

Filtration System

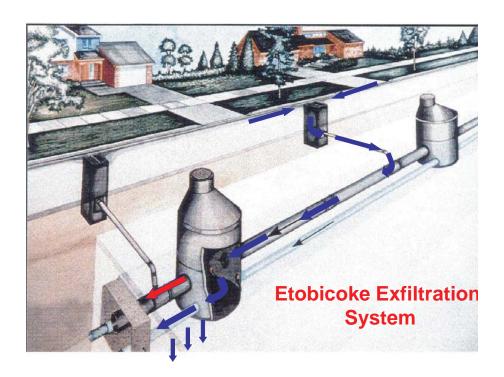
Exfiltration sewer system

- 30.5 ha low density residential
- · Clay to clay silt till over silty sand
- No groundwater interference
- Design storm was 15 mm, 1 hour AES storm, which was thought to be equivalent to the 90<sup>th</sup> percentile event
- Peak rainfall intensity = 56 mm/h or 4.7 mm/5 minutes

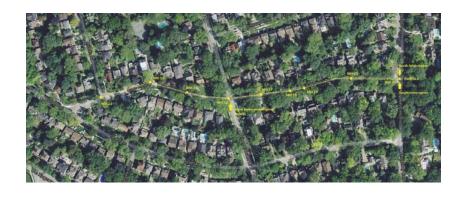
# Queen Mary's Drive Site Characteristics and System Design

- 13.3 ha low density residential
- Sand and silty sand native soils
- Roof and foundation drains directly connected to sewer
- Groundwater at 1.2 m from surface
