Environmental Impact Statement Phoenix Homes - Old Montreal Road

Updated Report

July 17, 2023

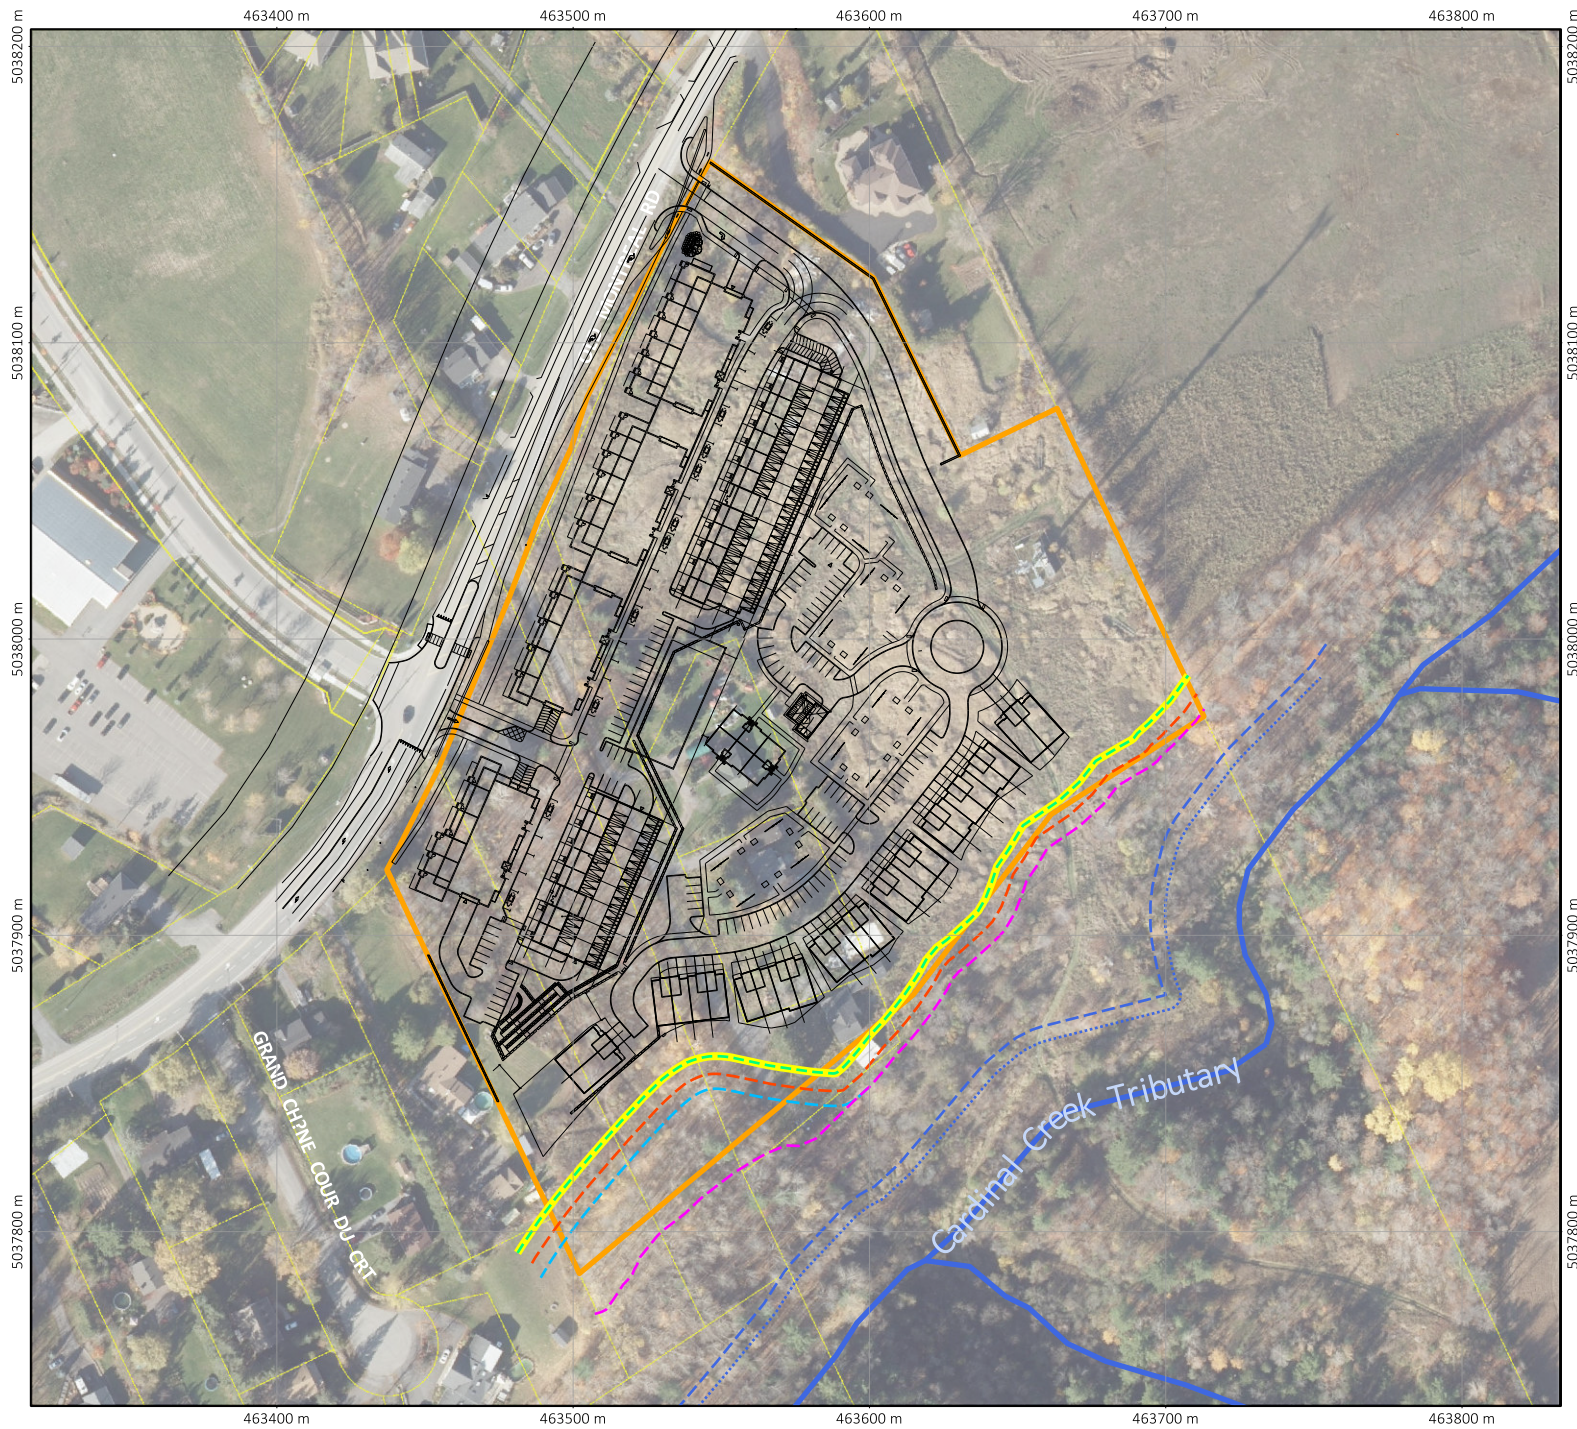
Figure4 Proposed development plan

- Development Area
- Creek Setback Review**
 - - - 30 m from NHWM
 - 25 m from Top of Bank
 - Crest of Slope
 - - - Additional Geotech Setback
 - - - Erosion Allowance
 - - - Erosion Access Allowance (Geotechnical Limit of Hazzard)
- **Greatest Setback Line to Cardinal Creek Tributary**

Phoenix Homes is proposing to develop the Site with a mix of medium and high-density residential development. The proposed site would combine low-rise apartment buildings, stacked and back-to-back townhouse condominiums, townhomes, and bungalows on municipal right of ways and private streets (Figure 3).

The proposed development respects the required setbacks for the Cardinal Creek Tributary for geotechnical limit of hazard lands, high water mark and top of bank; it is not anticipated that any property lots will encroach into the designated setbacks (Figure 3). There is no regulatory floodplain associated with the Cardinal Creek Tributary at this location. As such no negative impacts are anticipated to the Cardinal Creek Tributary.

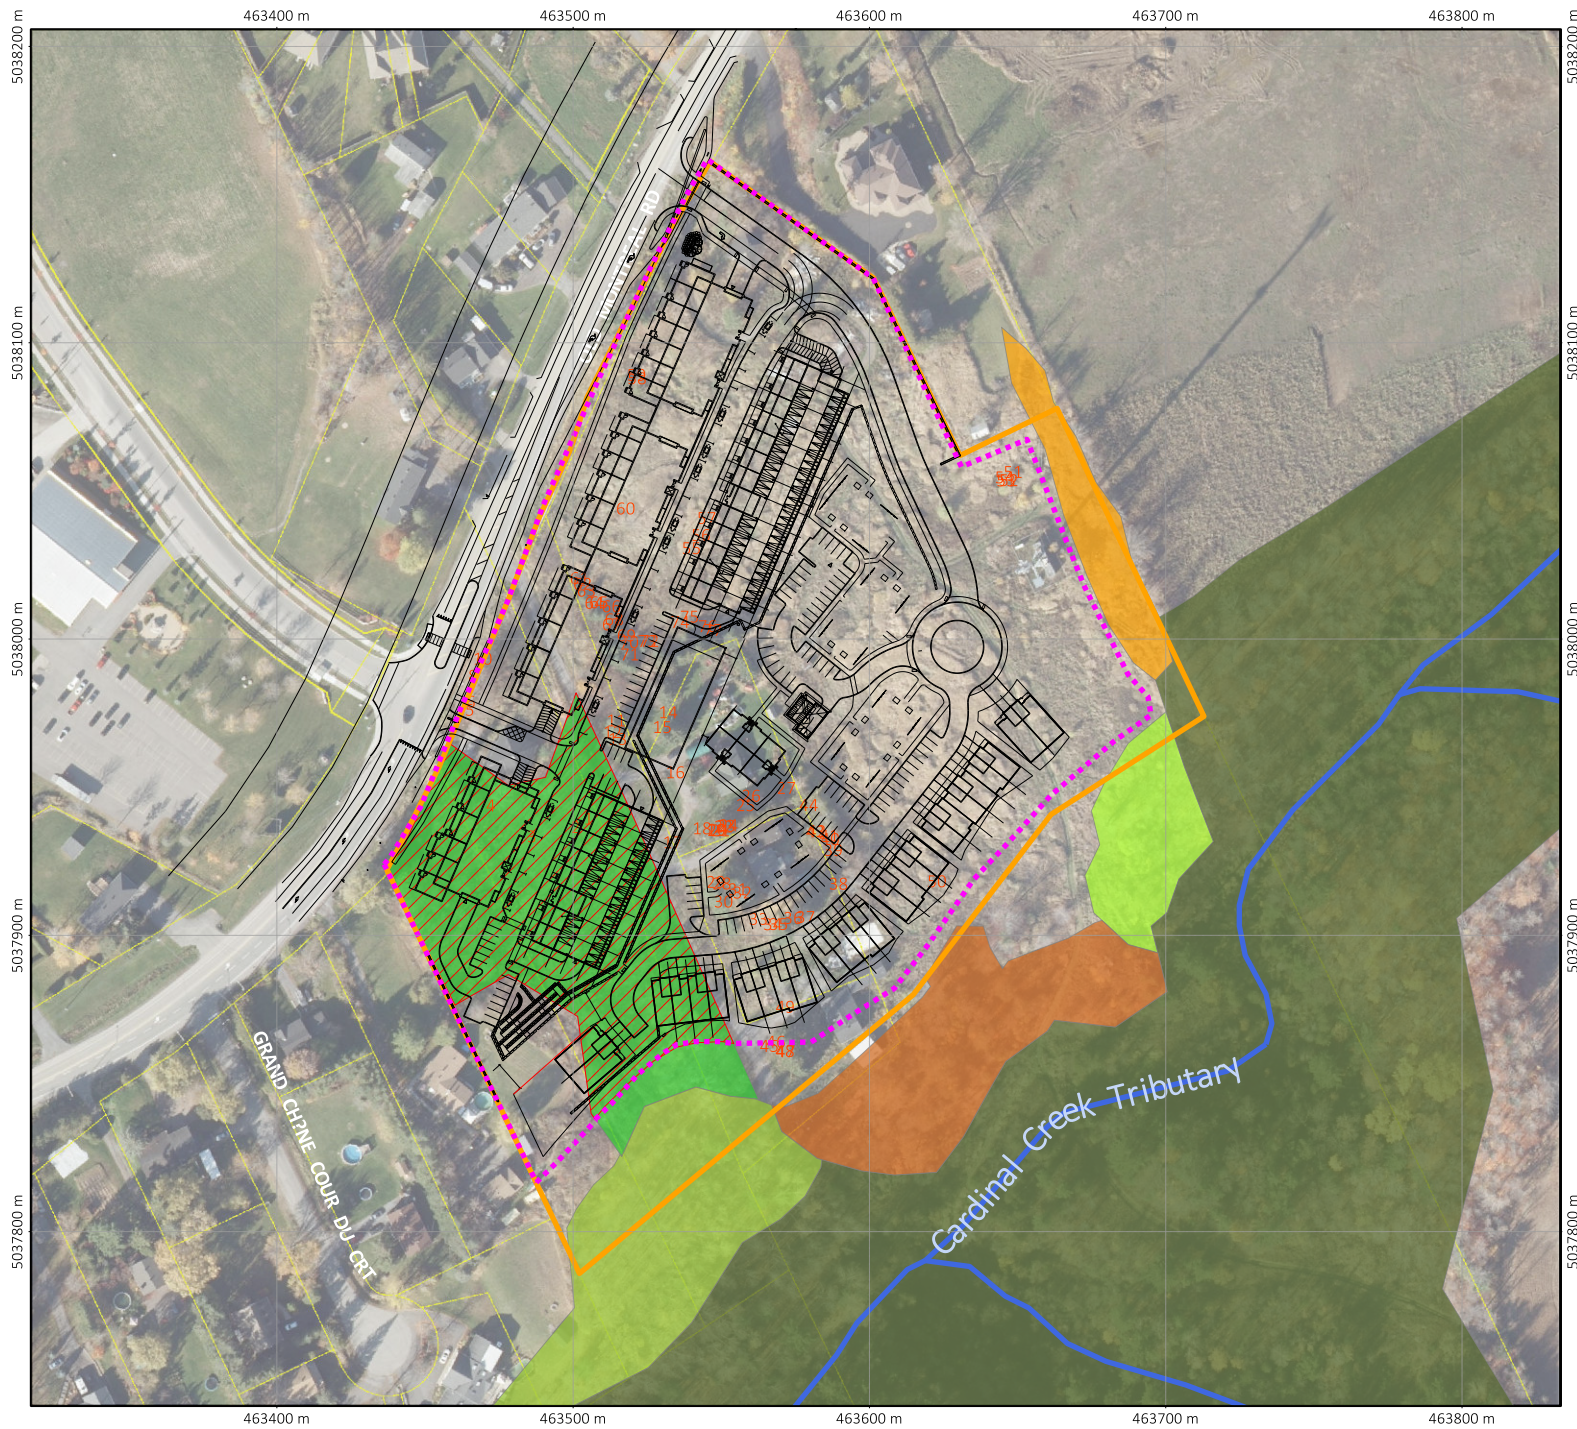
Figure 3 Proposed development plan

Phoenix Homes is proposing to develop the site with a mix of medium and high-density development. The proposed site would combine low-rise apartment buildings, stacked and back-to-back townhouse condominiums, townhomes, and bungalows on municipal right of ways and private streets (Figure 3).

Site development will require significant regrading and terracing of the steeply sloping properties that will necessitate the removal of all trees from the Site. Land clearing and construction are anticipated to begin in late 2023.
