Geotechnical Investigation

811 Gladstone Avenue
Ottawa, Ontario

Ottawa Community Housing Corporation

GHD | 179 Colonnade Road Suite 400 South Ottawa Ontario K2E 7J4 Canada
11140575 | A1 | Report No 1 | October 27, 2017

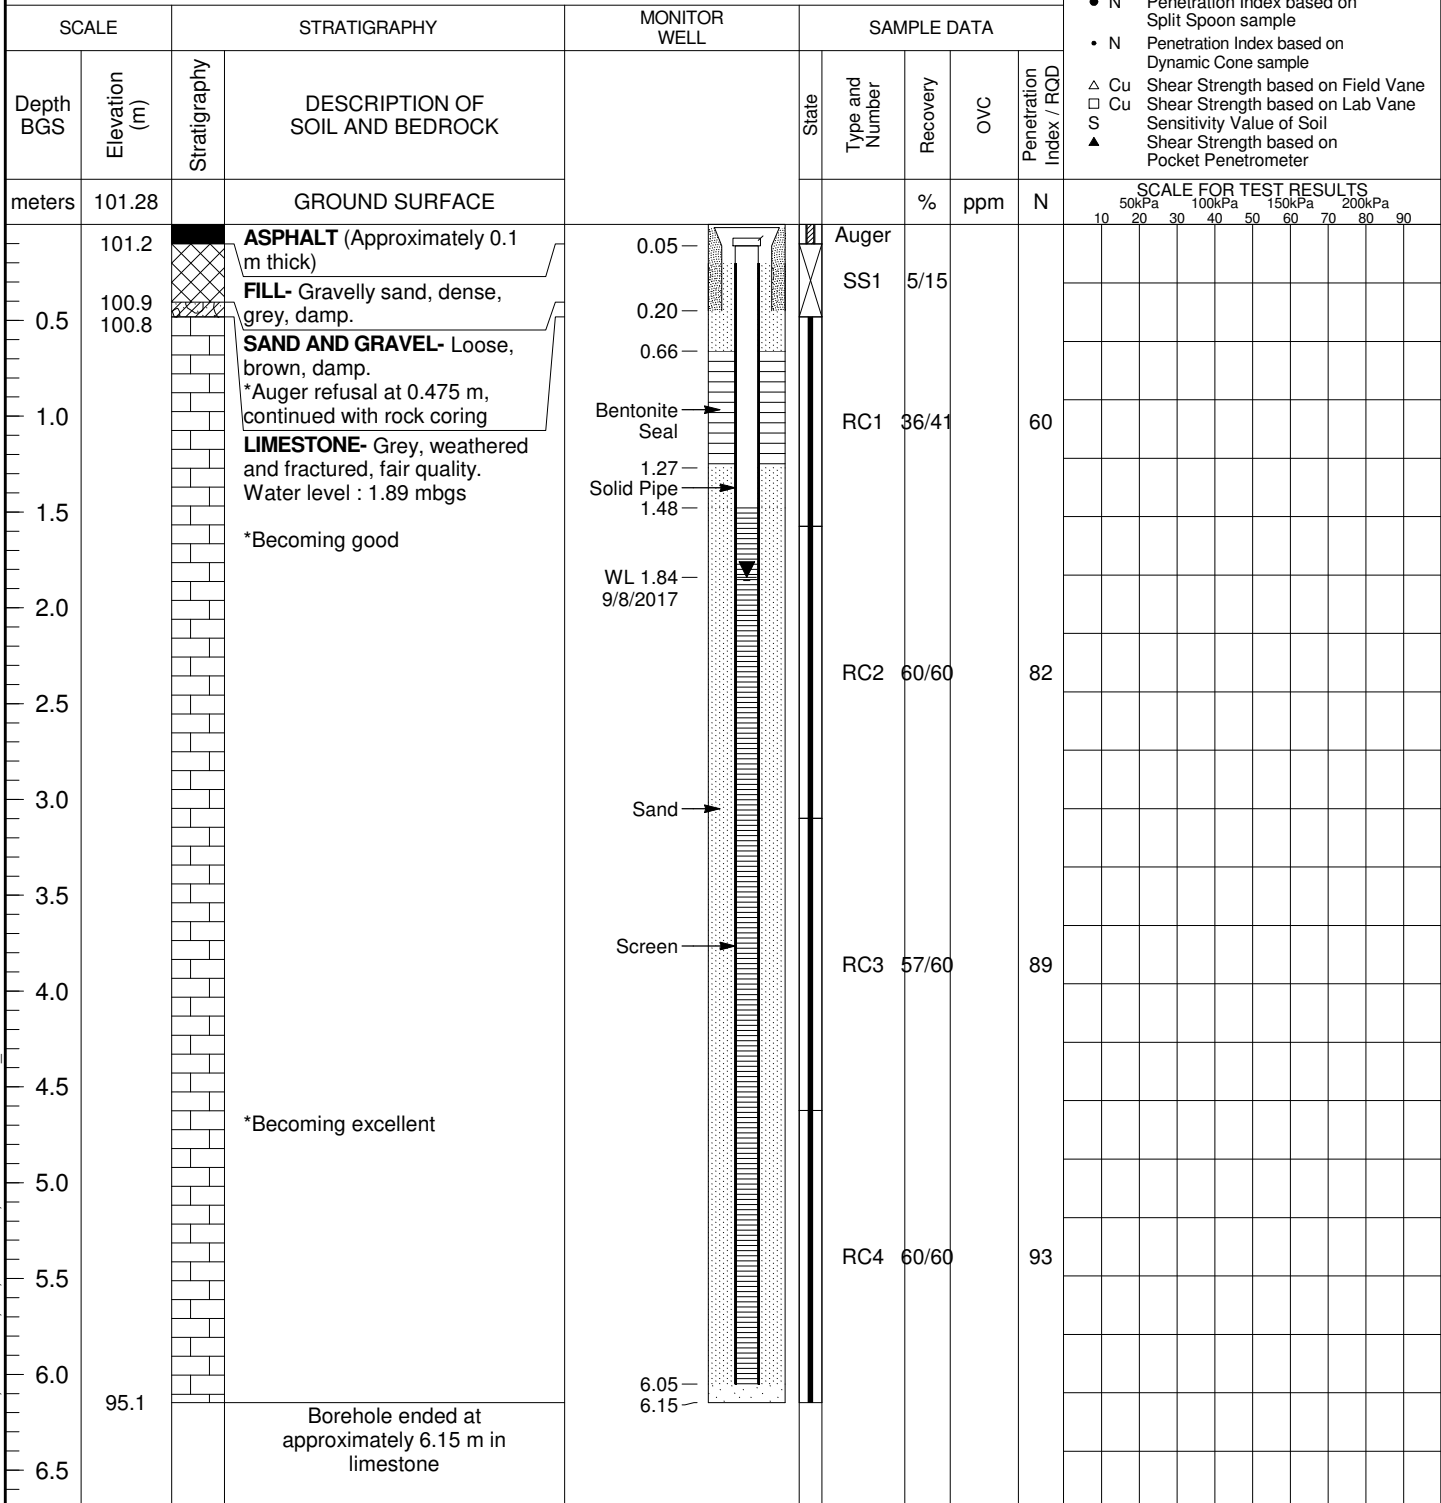
*Surveyed elevations are relative to Fire Hydrant FM175067M (SW Corner of Rochester/Balsam)

General descriptions of the subsurface conditions are summarized in the following sections, with a graphical representation of each borehole on the Borehole Logs. Notes on Boreholes are provided in Appendix A, at the end of this report.

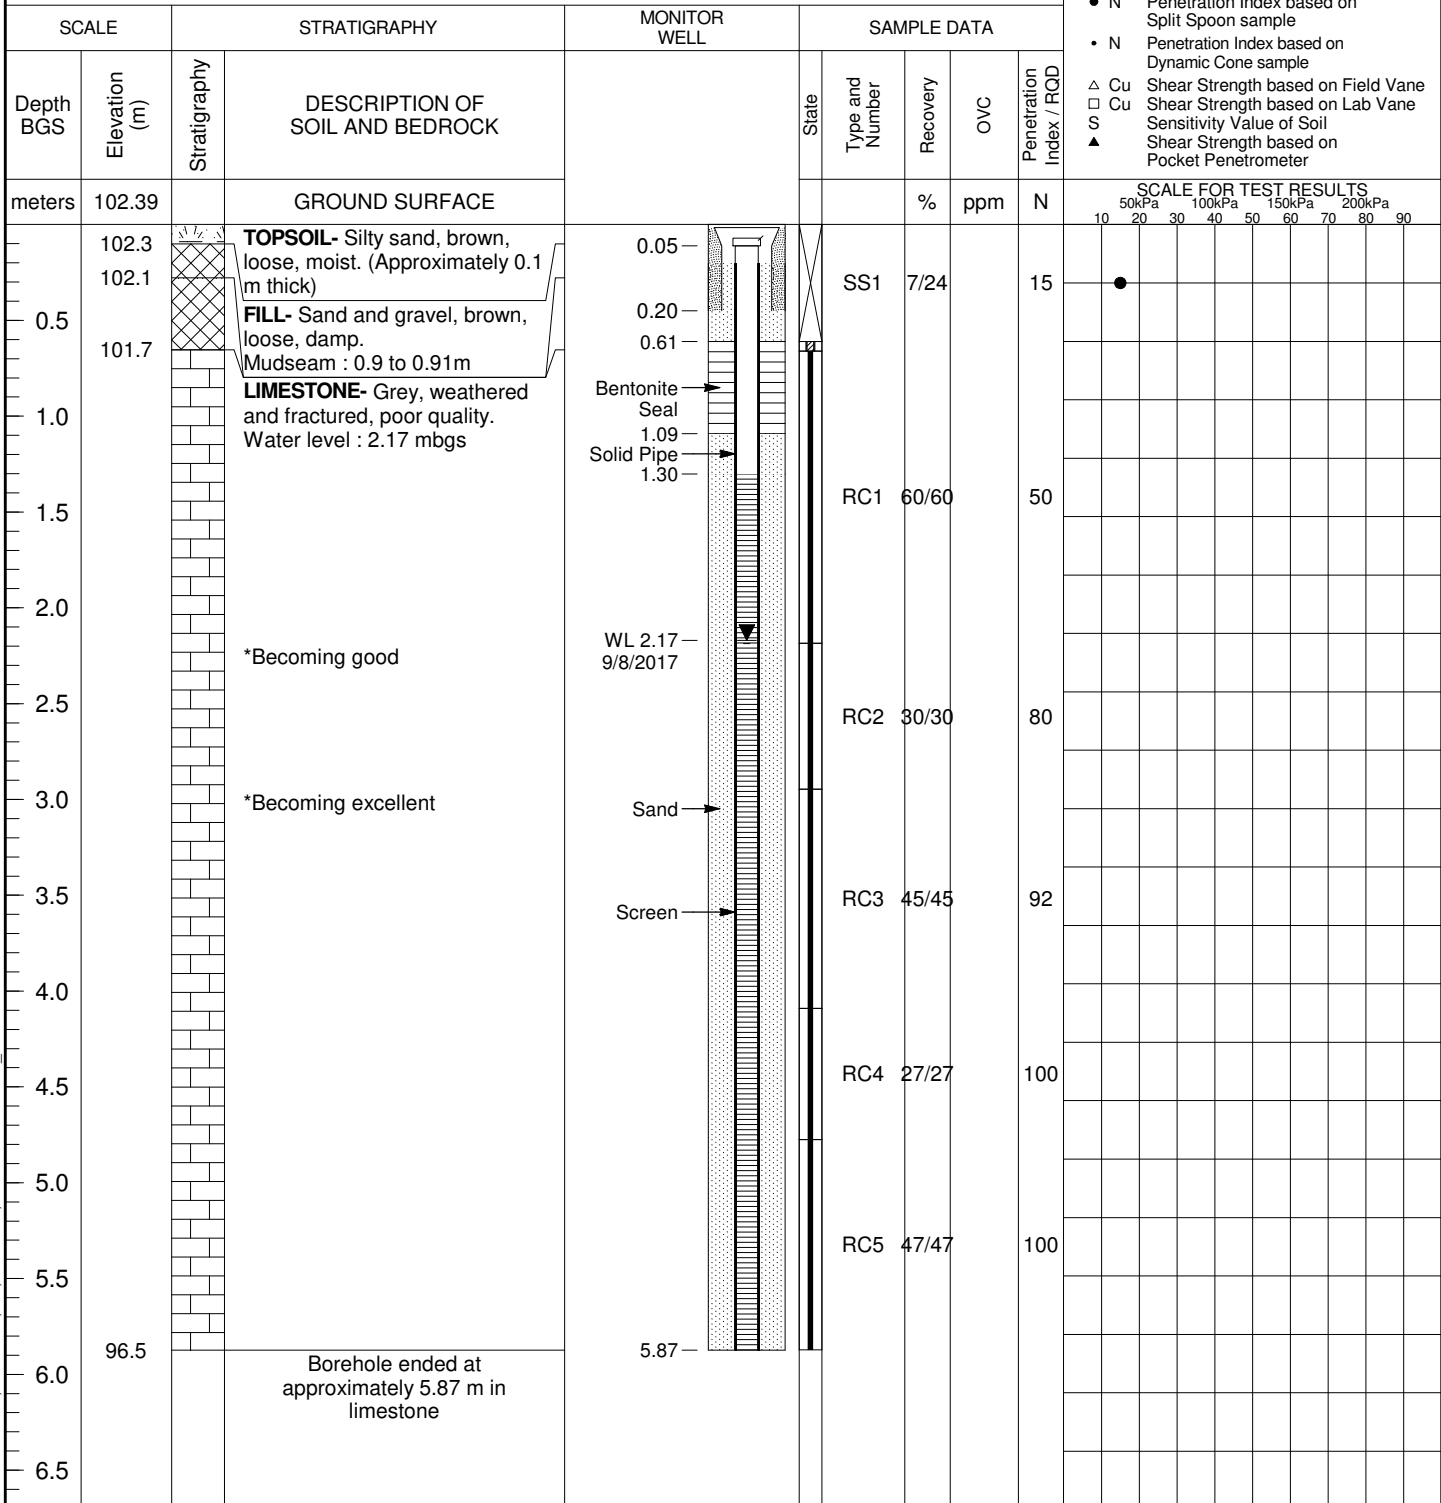
*Surveyed elevations are relative to Fire Hydrant FM175067M (SW Corner of Rochester/Balsam)
