A CULTURAL HERITAGE IMPACT STATEMENT & CONSERVATION PLAN 168 -174 MURRAY STREET, OTTAWA

Revised V4 June 2022

Commonwealth Historic Resource Management

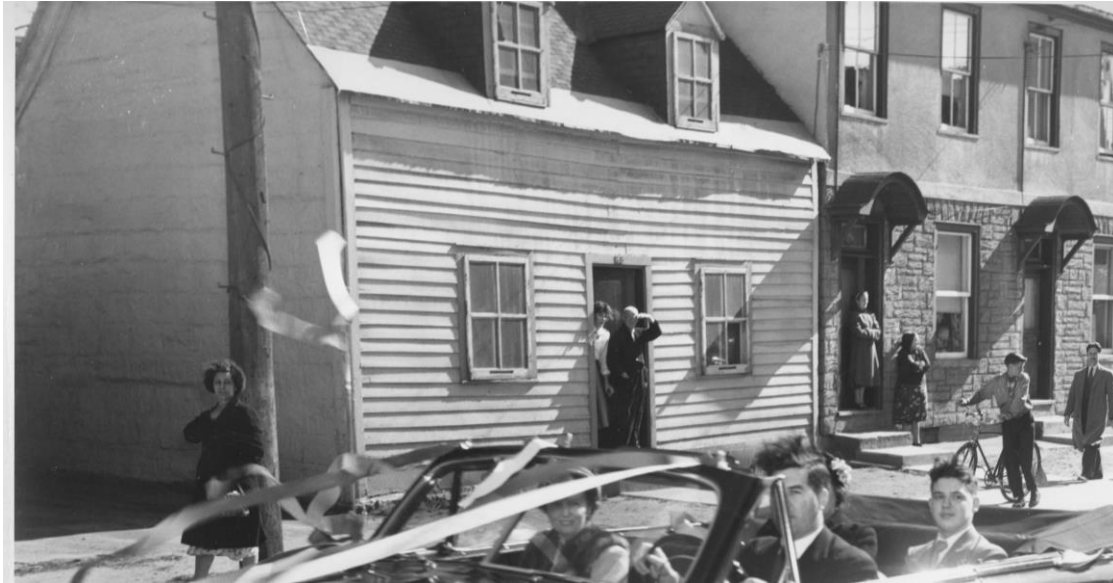
Figure 12: The house at 168 Murray appears in the background of the c.1949 parade. The house is a 1 1/2 storey side gable with two dormers facing the street, a centre front door with no canopy, horizontal siding on the front and squared timber chinked and whitewashed on the gabled side elevation. Source: Marc Aubin Collection

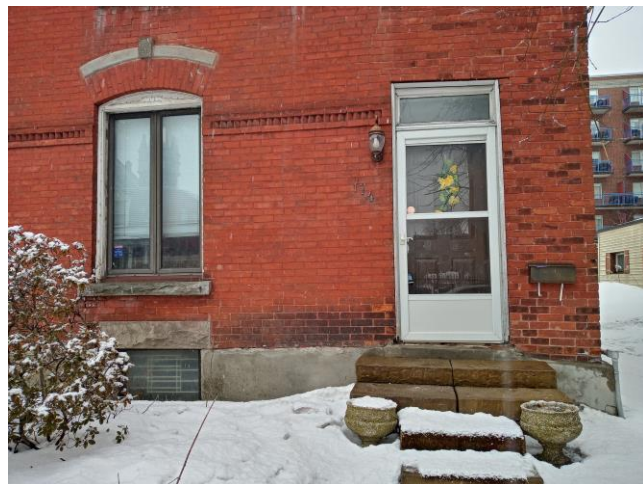
Figure 15 and 16: Two views 1992 and 2022 174 Murray (left) prior to the vinyl siding being removed and rehabilitated front. Note the different brick at the corner (both size and colour consistency) and the lack of corbelled banding and the transom treatment.

The 1992 view of the building retains its form, with the exterior re-clad with a vinyl siding. The finials and a portion of the cornice detail is retained. The offset door is evident in the 1949 picture but has been cover or altered. In the 2022 view the arched brickwork was not incorporated into the replaced brick at the corner.

A renovation post 1992, removed the siding revealing the original brick cladding, limestone window lintels, arch decorative headers and original galvanized metal cornice and detailing. Based on visual inspection the brickwork at the right-hand corner had been replaced. This would explain the lack of arched brick transom, over the front door and the discontinued corbelled brick banding on the right hand side next to the door. Along the front façade there is some bowing of the brick wall at the second floor suggesting that the tiebacks have separated.

Views of the building suggest that the west corner of the building had been rebuilt. The foundation slopes and the replacement brick is of a slightly different size with the transom over the front door and the corbelled band eliminated.

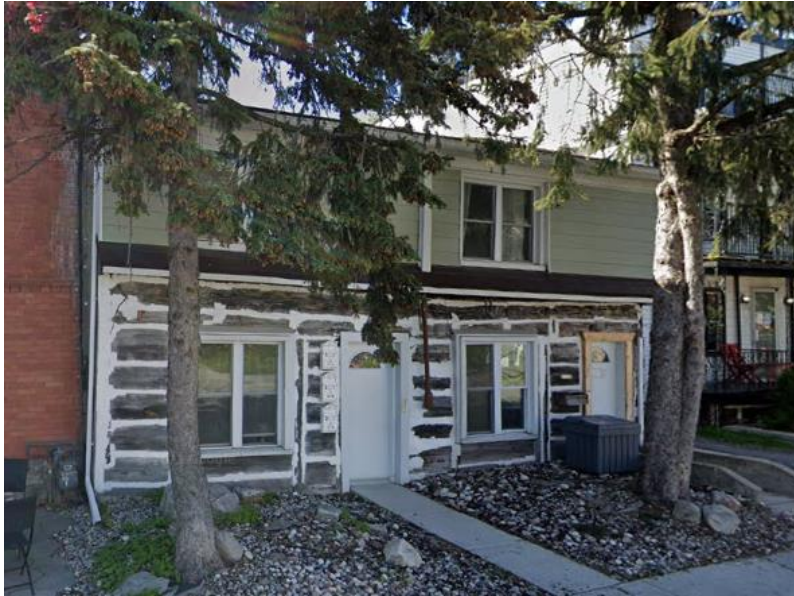
Figure 25: The example of a log cabin at 161 Guigues Avenue with the second-floor addition. Source: Luis Juarez

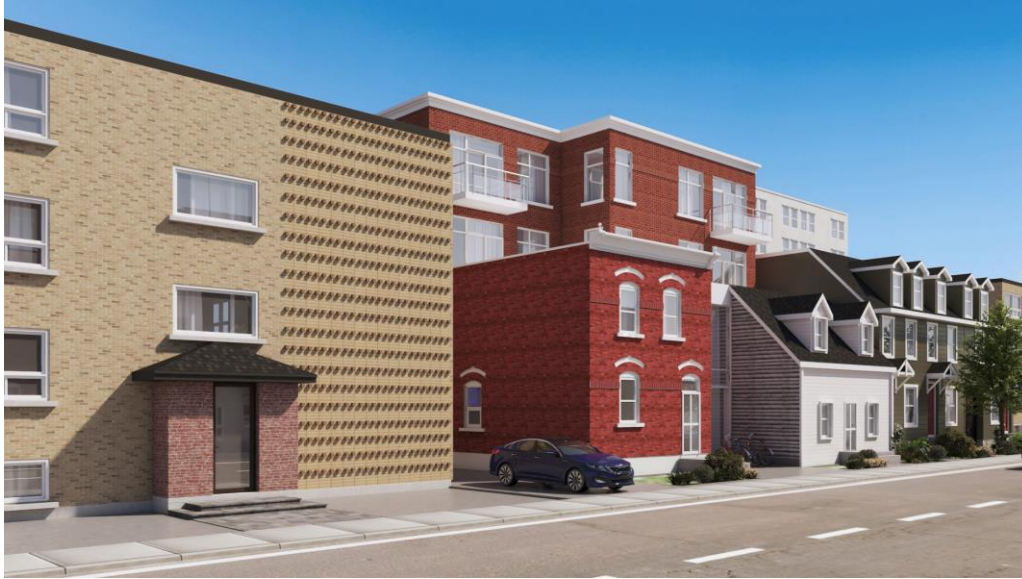
Figure 28: A view looking southeast with the proposed red brick 4-storey apartment positioned behind the heritage buildings. It fits comfortably with in the context of the streetscape and neighbouring built form. Source: Ottawa Carleton construction Inc.

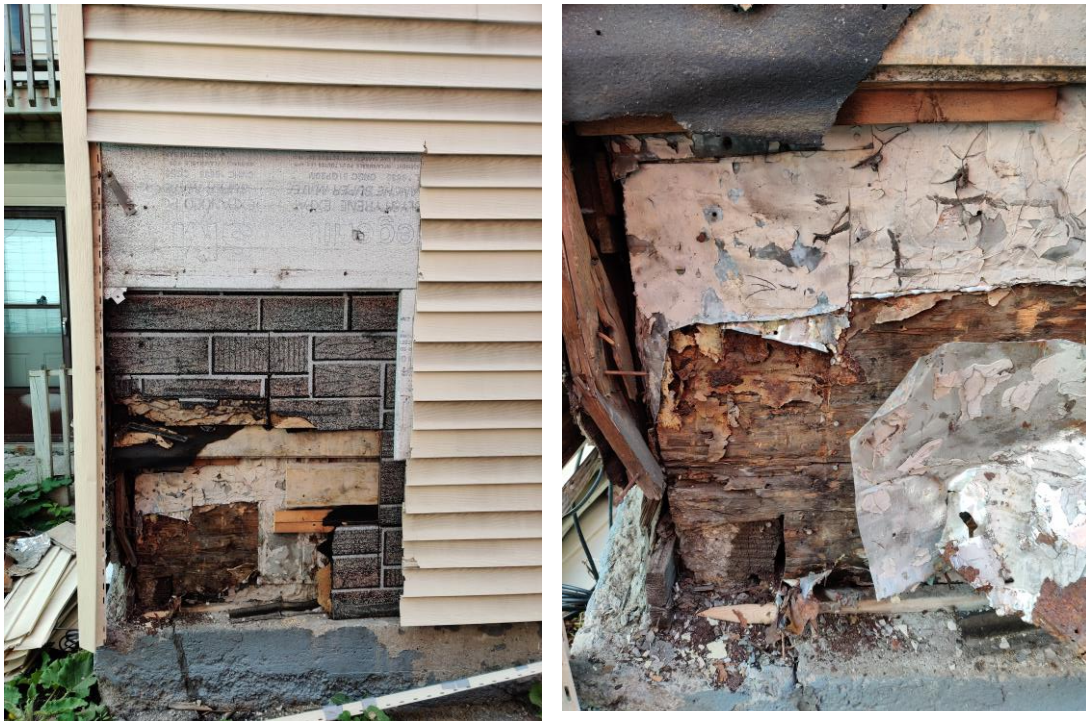
Figure 33: 1861 Census documents the McManus family owned a 66 x.99 lot at 168 Murray and were living in 1.5 storey log house. The Lowertown building inventory recorded that the building was constructed in 1876 based on Fire Insurance plans. The two views illustrate the multiple layers of finishes including squared timber, tin panels insulation, brick, ridged insulation, and vinyl siding. Source David Yoo 2022.

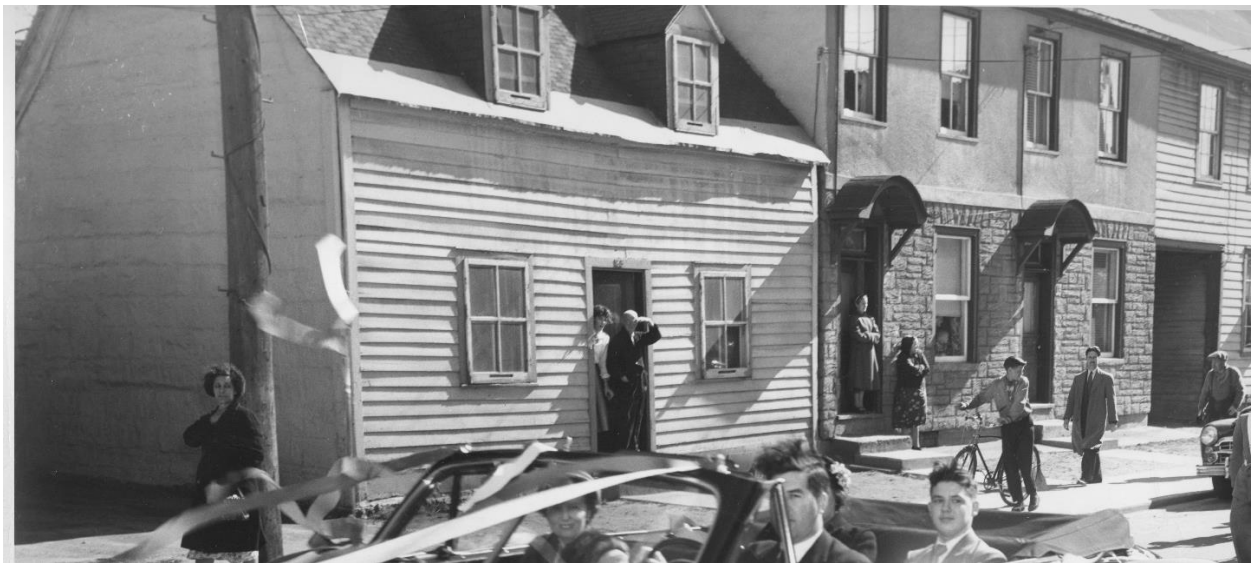
Figure 34: The house at 168 Murray appears in the background of the c.1949 parade. The house is a 1.5 storey side gable with two dormers facing the street, a centre front door with no canopy, horizontal siding on the front and squared timber chinked and whitewashed on the gabled side elevation. The covered carriage porch is common feature

as seen in the 2.5 -storey to the right. Source: Marc Aubin Collection

The building is a 1.5 storey squared log cottage with a side gable roof. Recording has been undertaken. Further investigation is required to determine its condition. The intention is to reinterpret the 1949 photo Figure 34 with the log sidewall exposed and the front façade dressed with a horizontal board siding. The façade of the building along the street and west façade will need to be stripped and taken down to the original structure. Historic documents suggest that the building is log, the 1949 photo and removals supports this record. A more aggressive assessment will be undertaken as part of the development phase of the project.

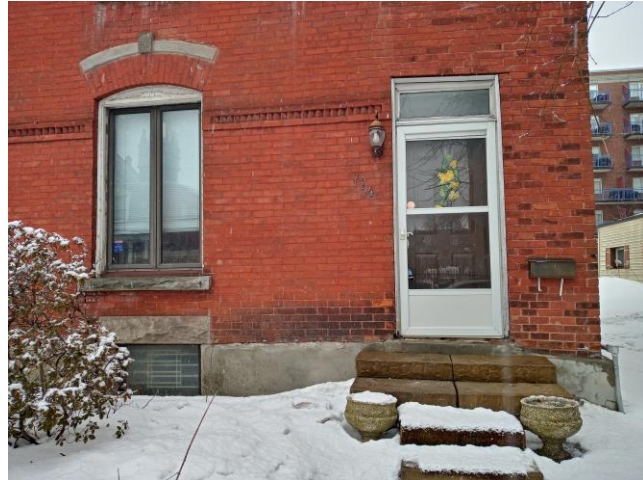
Figure 36 and 37: Two views 1992 and 2022 174 Murray (left) prior to the vinyl siding being removed and rehabilitated front. Note the different brick at the corner (both size and colour consistency) and the lack of corbelled banding and the transom treatment.

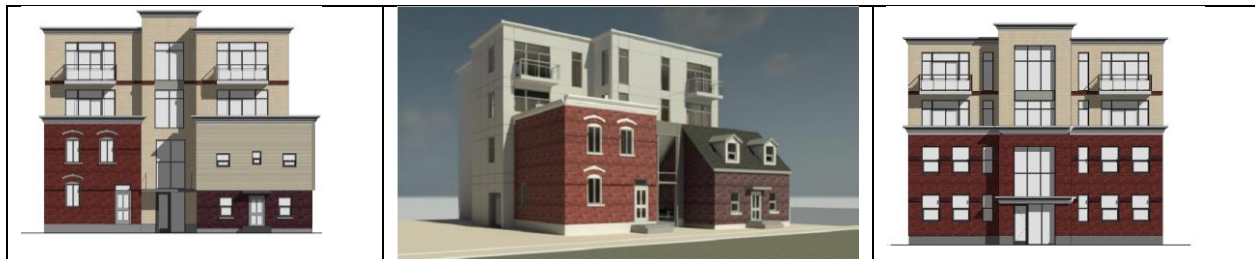
Through out the redevelopment process multiple mitigation measures and alternatives were considered and implemented in response to community and city suggestions, good conservation practise and the owner's expectations: Below are sketches of some of the alternatives.
