Combined Environmental Impact Statement & Tree Conservation Report (Revised) 788 March Road, Ottawa, Ontario

July 2018 Prepared for 10731854 Canada Inc.

MCKINLEY ENVIRONMENTAL SOLUTIONS

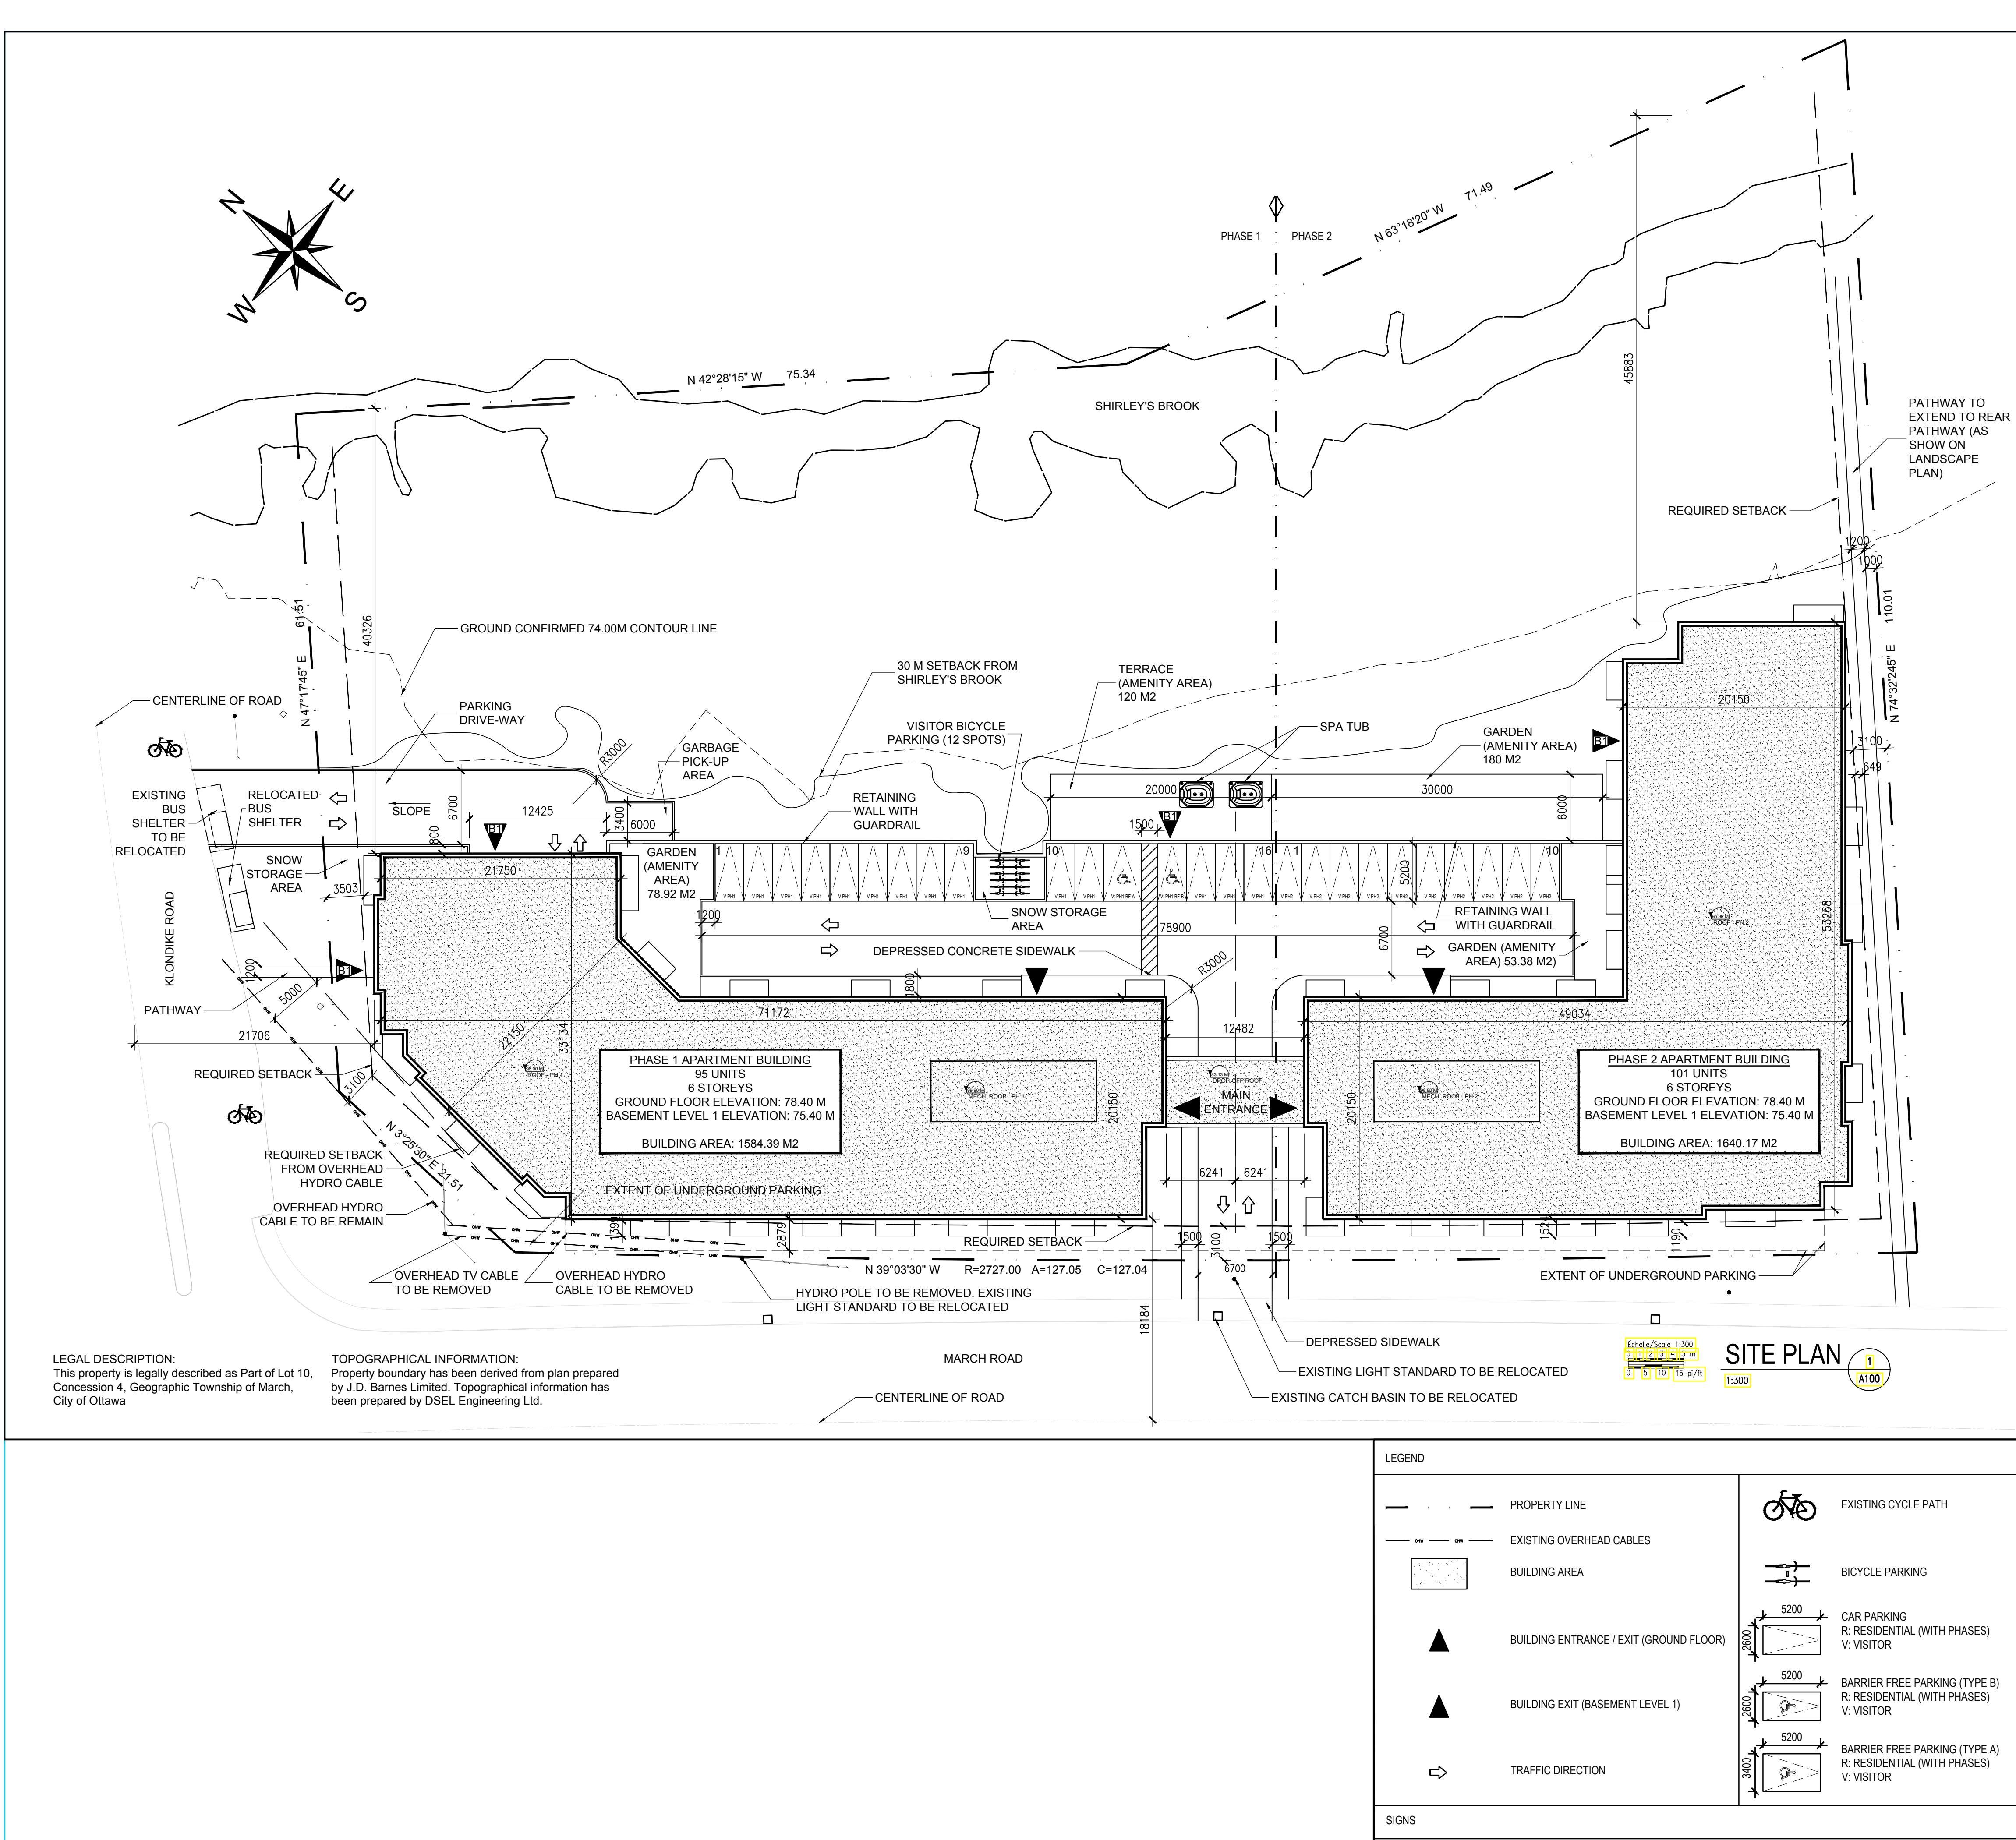
Site Plan (A100)

The proposed Site Plan is included below. The Site will be developed to include a six (6) storey residential building with approximately 196 units. The Site will be developed in two (2) phases, with the northern half of the Site developed first (Phase 1 – 95 units) and the southern half of the Site developed second (Phase 2 – 101 units). Phase 1 will include approximately sixteen (16) surface parking spaces and Phase 2 will include approximately ten (10) surface parking spaces. Two (2) levels of underground parking will be included below the building. Vehicle entrances to the Site will be provided from Klondike Road and March Road, with pedestrian access from March Road. The Site Plan includes a 30 m setback from the normal high-water mark of Shirley's Brook. All existing vegetation within the 30 m setback will be retained. The Site will receive municipal sewer and water. Stormwater will be directed to the existing March Road storm sewer, which outlets to the existing SWMP Pond No.1 – West. The existing SWMP Pond No.1 - West was sized to provide quantity and quality control for the Site.

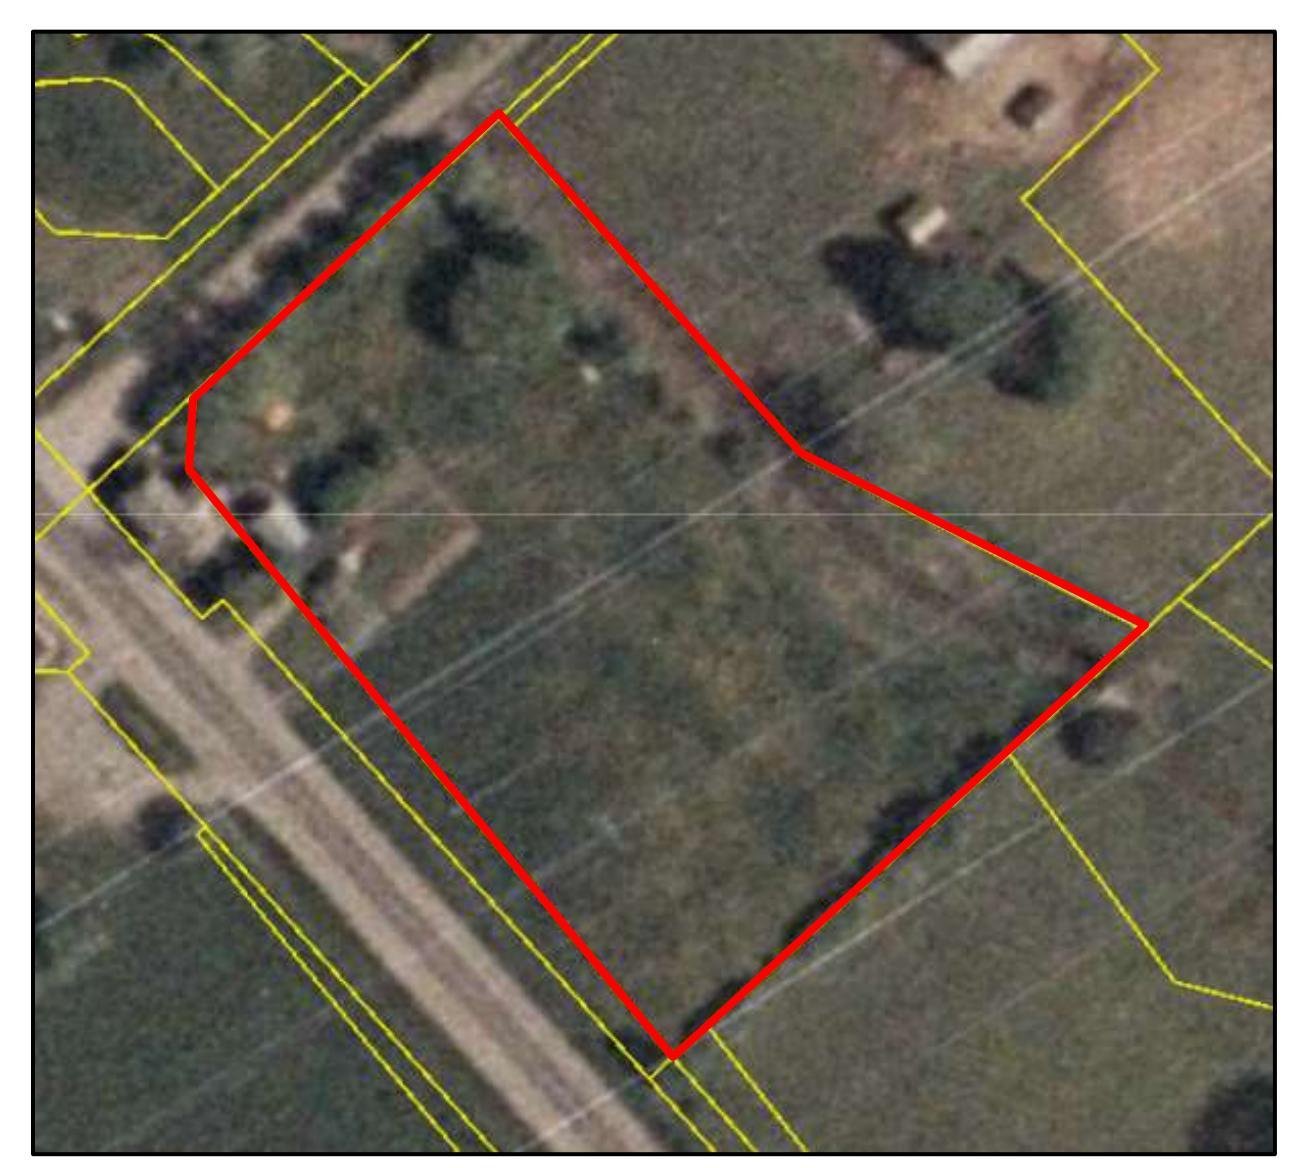
Historic Air Photograph 1: Historic Air Photo from 1976 (Site limits shown in red). Note the Site appears to be farmed and tree cover appears to be limited to hedgerows along the northern and southern property boundary in 1976. Tree cover is also present along the west side of Shirley's Brook in the northern part of the Site. The large Bur Oak found east of Shirley's Brook appears to be present in 1976. A farm house and agricultural buildings are also present in the northwest corner of the Site in 1976 (Photos from City of Ottawa 2018).

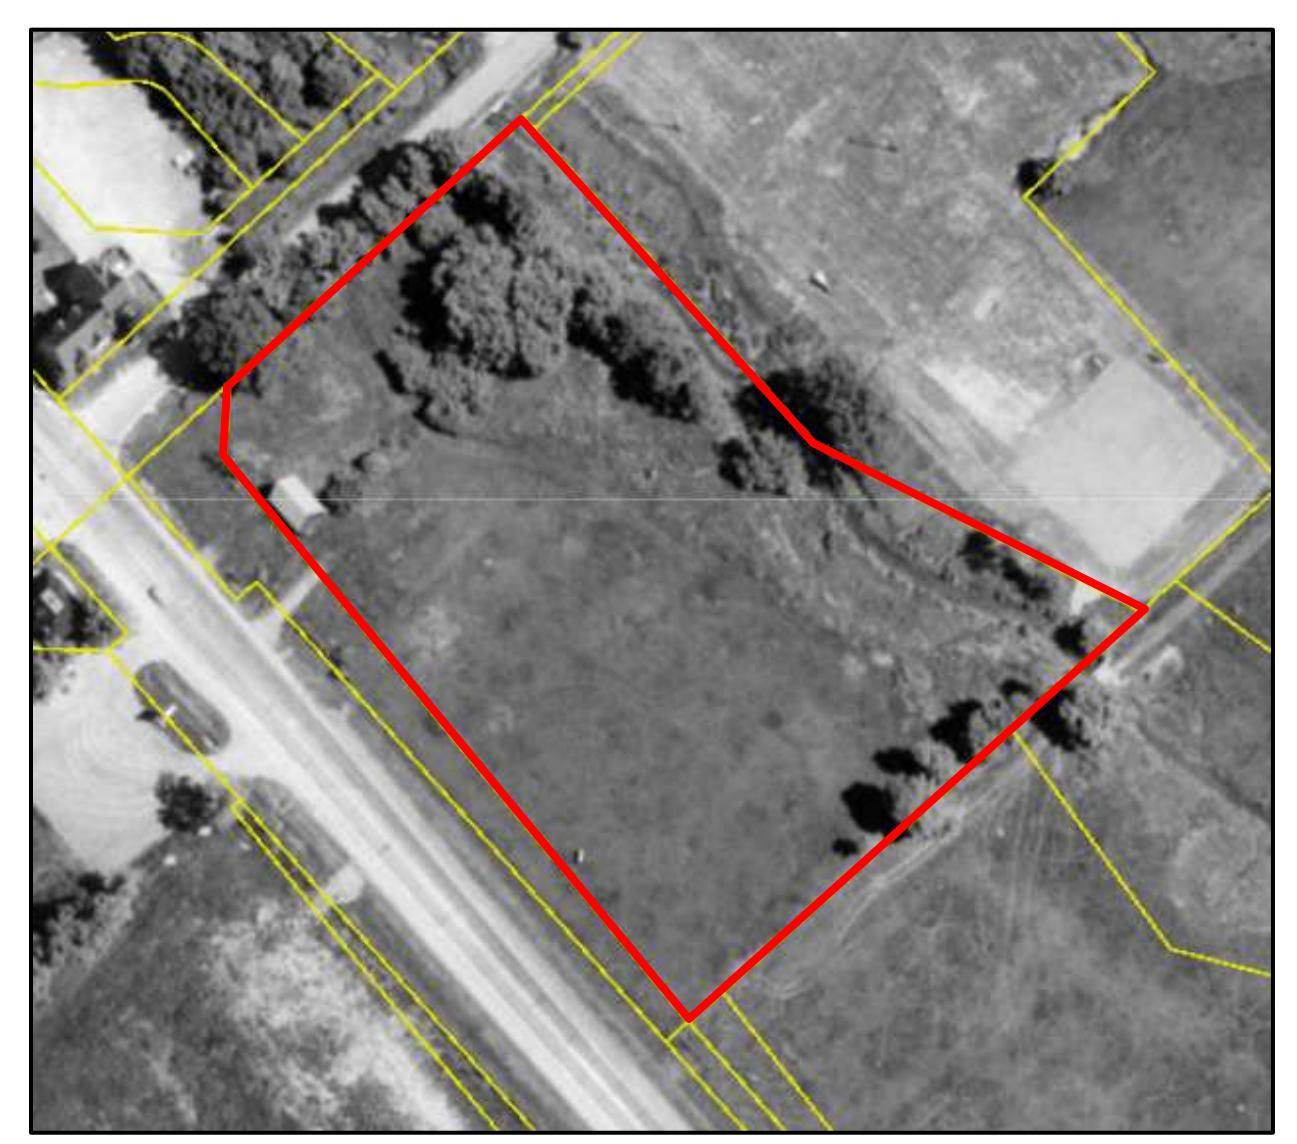
Historic Air Photograph 2: Historic Air Photo from 1991 (Site limits shown in red). Note the Site appears to be farmed and tree cover appears to be limited to hedgerows along the northern and southern property boundary in 1991. Tree cover is also present along the west side of Shirley's Brook in the northern part of the Site. The large Bur Oak found east of Shirley's Brook appears to be present in 1991. The farm house appears to have been demolished by 1991, although a barn remains (Photos from City of Ottawa 2018).

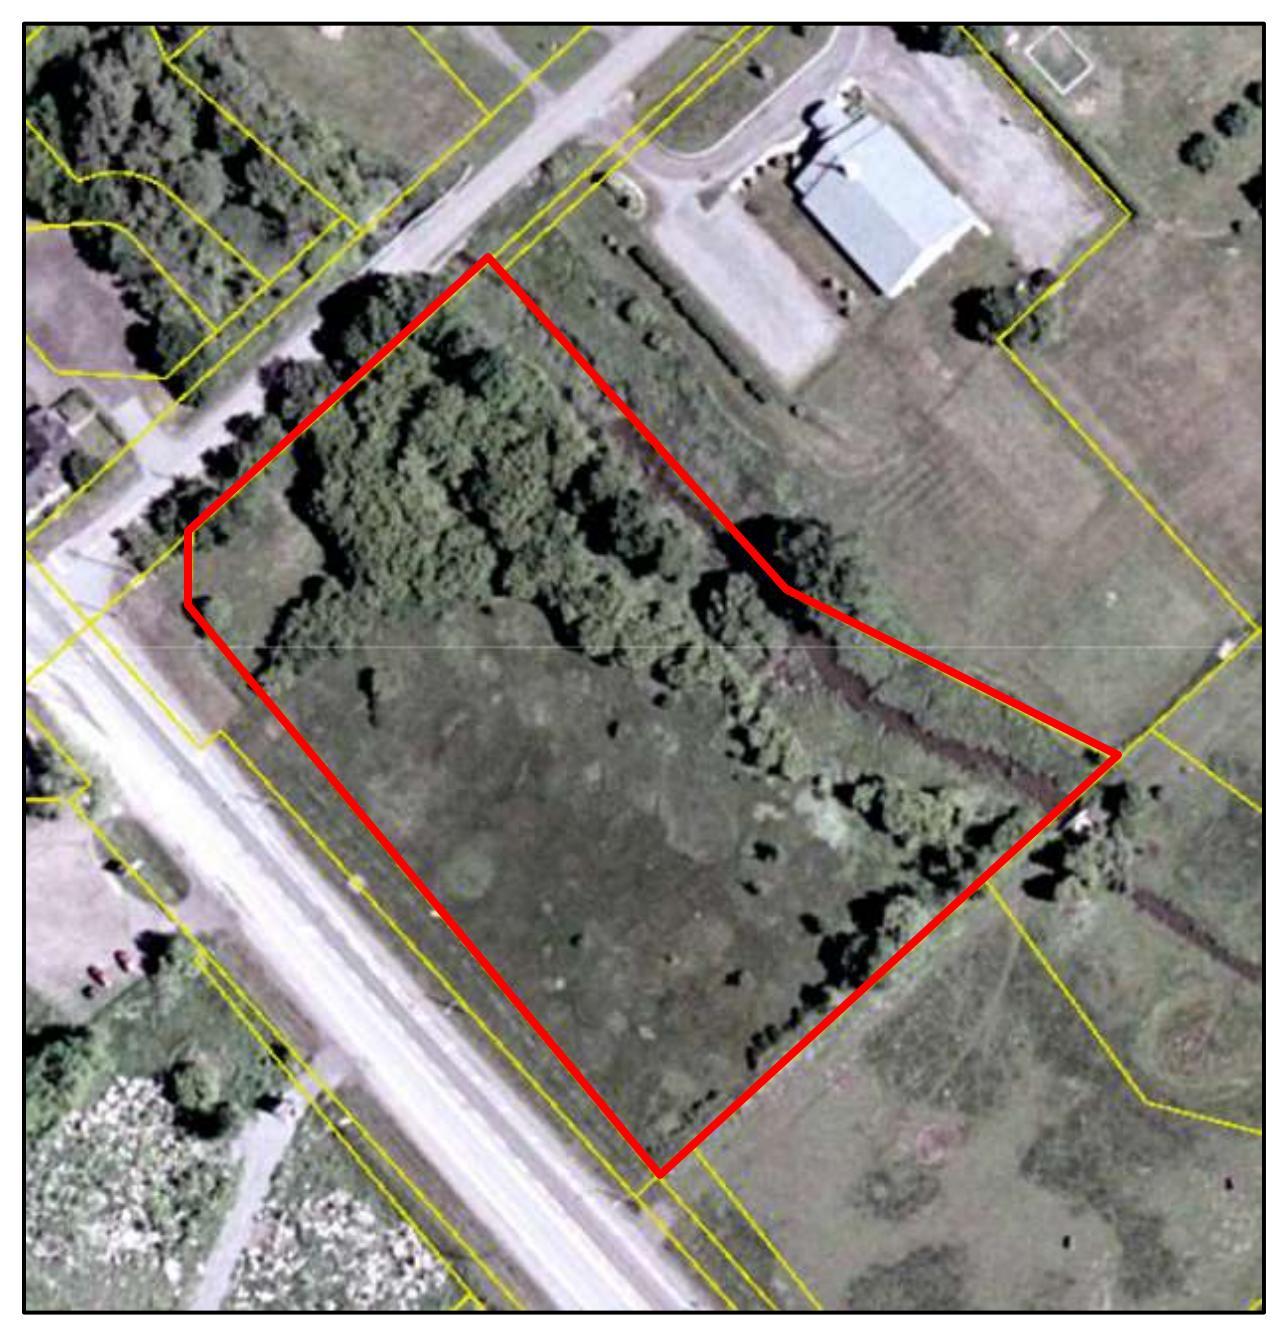
Historic Air Photograph 3: Historic Air Photo from 2005 (Site limits shown in red). Note the Site appears to be fallow and tree cover has expanded along the edge of Shirley's Brook and in the northern part of the Site. The large Bur Oak found east of Shirley's Brook continues to be present. All buildings within the Site have been demolished by 2005 (Photos from City of Ottawa 2018).

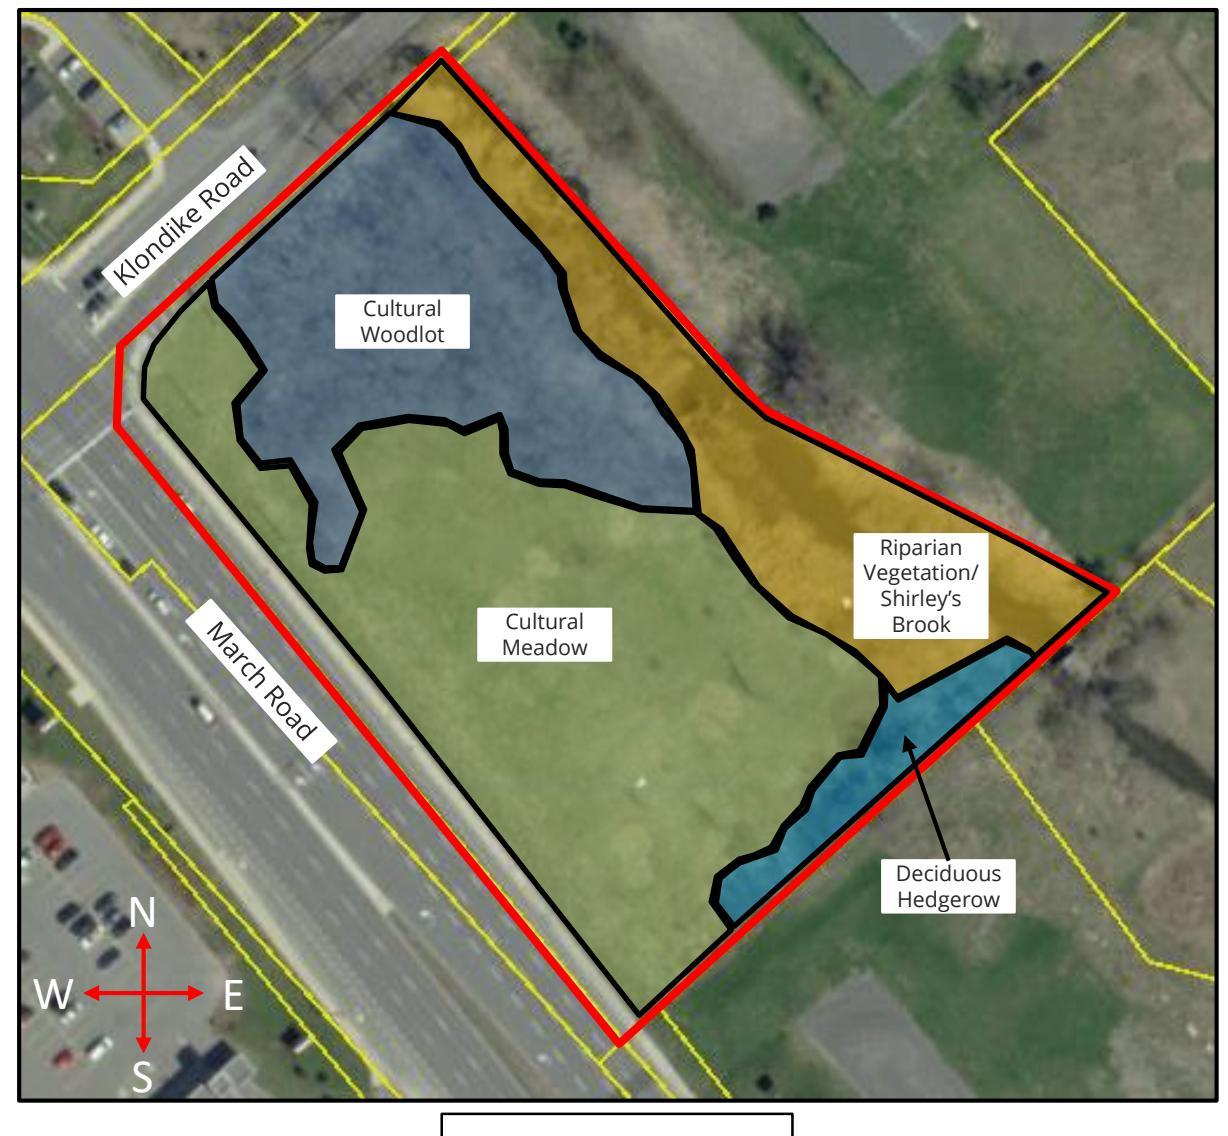
Vegetation communities found within the Site are shown in Figure 2. Refer to Appendix A for a list of plants found within the Site. The Site includes the following terrestrial vegetation communities:

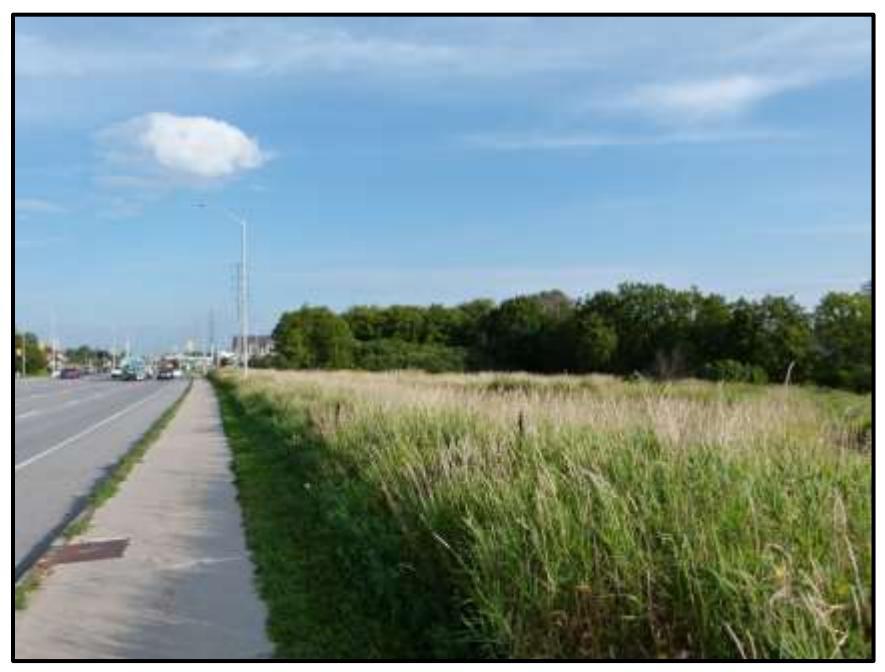
Photograph 1: Looking north along March Road (left). The Cultural Meadow (right) and the Cultural Woodlot (background) are shown (August 29th, 2017).

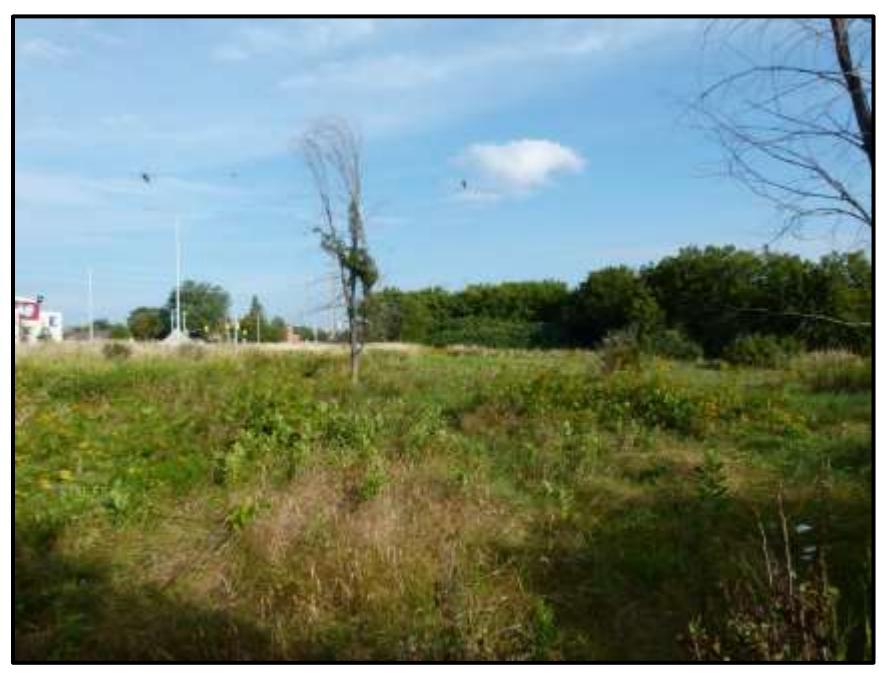
Photograph 2: Looking northeast at the Cultural Meadow and the Cultural Woodlot (background) (August 29th, 2017).

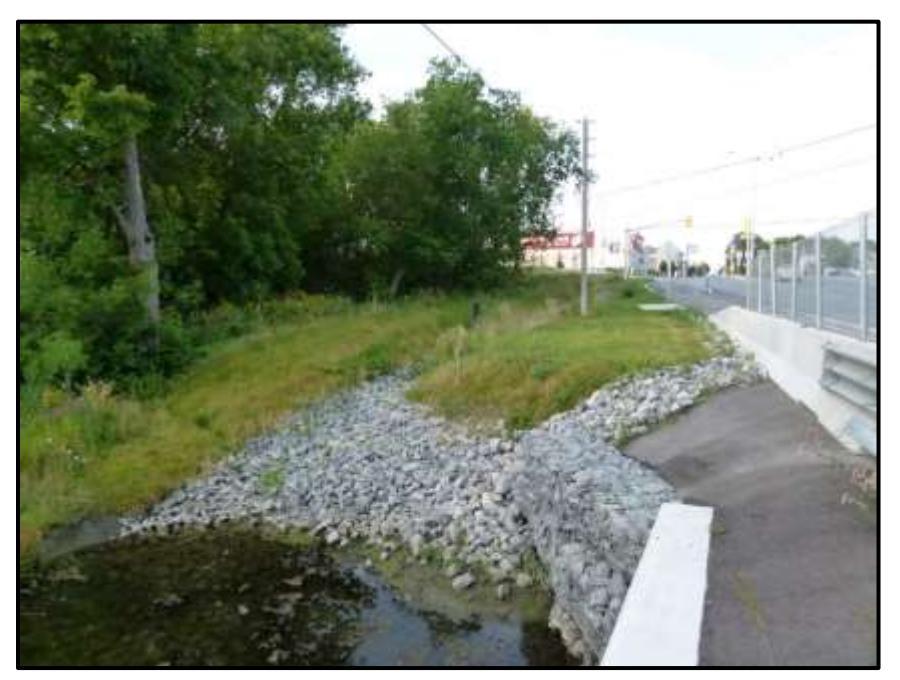
Photograph 3: Looking west from the culvert at Klondike Road (right). The Cultural Woodlot is on the left, a pool in Shirley's Brook at the Klondike Road culvert is shown in the foreground (August 29th, 2017).

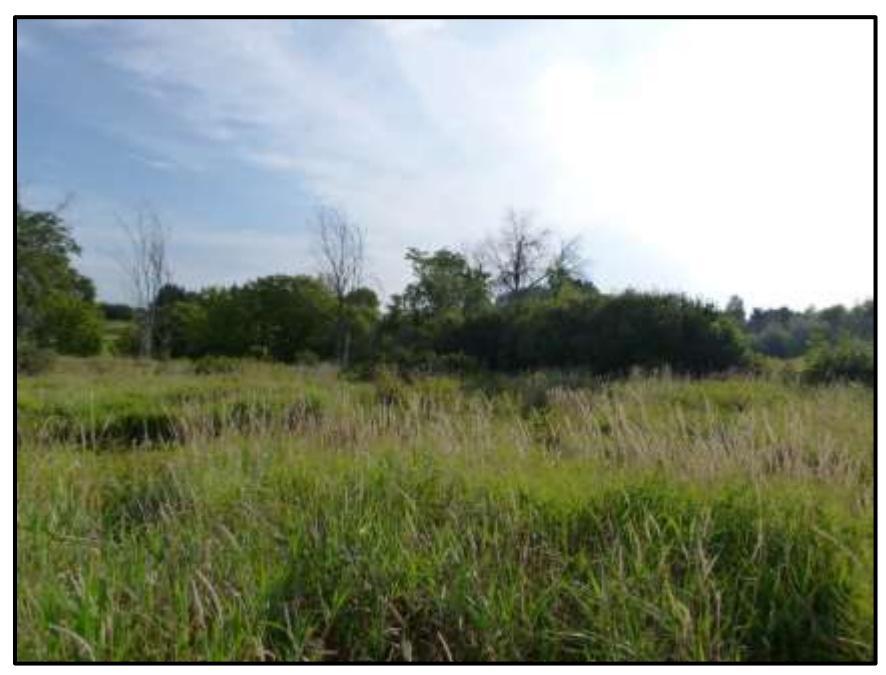
Photograph 4: Looking southeast at the Deciduous Hedgerow (August 29th, 2017).

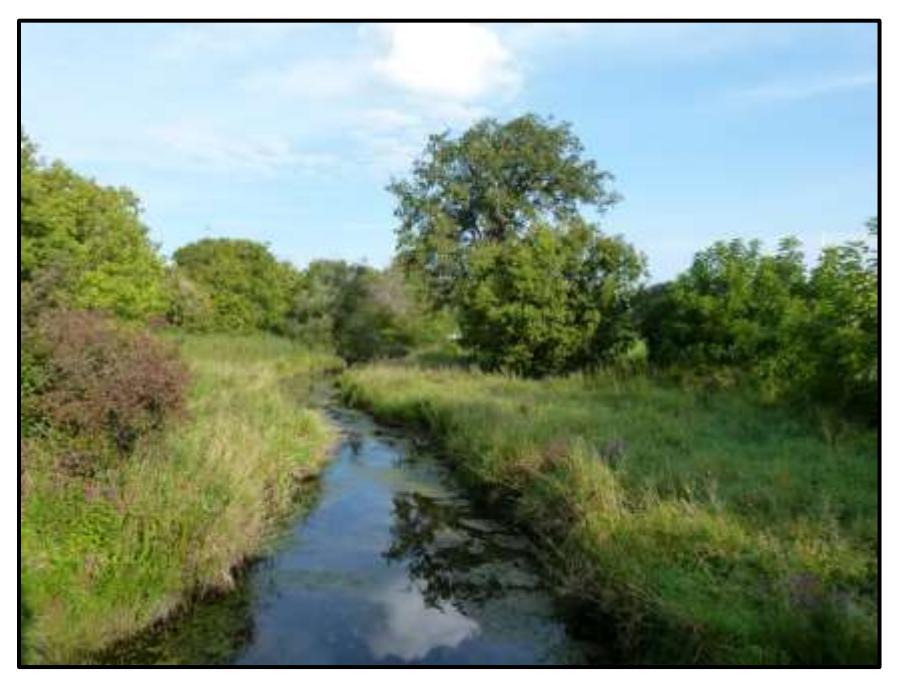
Photograph 5: Looking north along Shirley's Brook from the southern box culvert. Note the large Bur Oak on the east side of Shirley's Brook is visible on the right (August 29th, 2017).

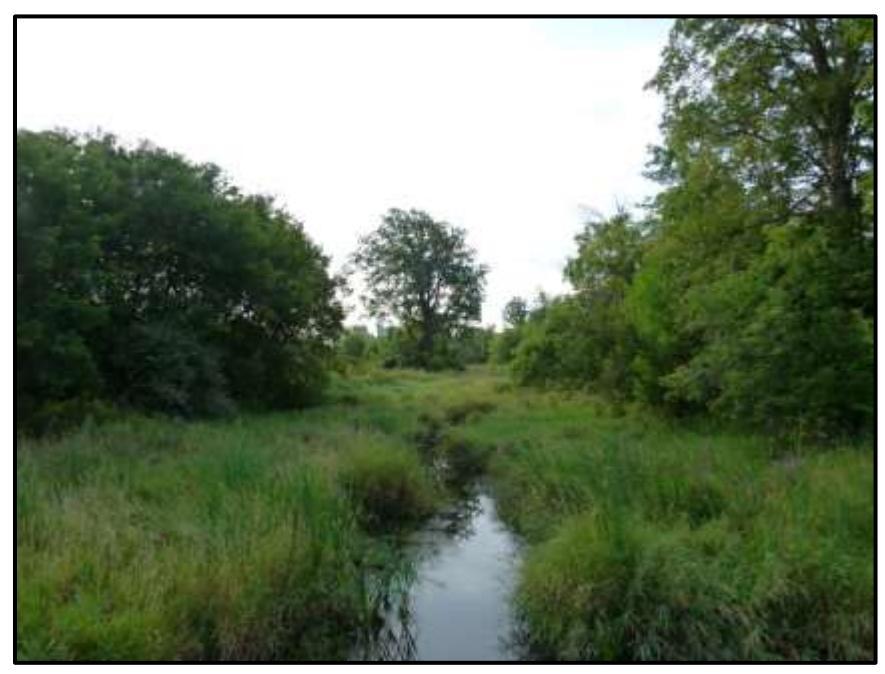
Photograph 6: Looking south along Shirley's Brook from the northern box culvert (Klondike Road). Riparian vegetation in the northern part of the Site is shown. Note the large Bur Oak on the east side of Shirley's Brook is visible in the center of the photograph (August 29th, 2017).

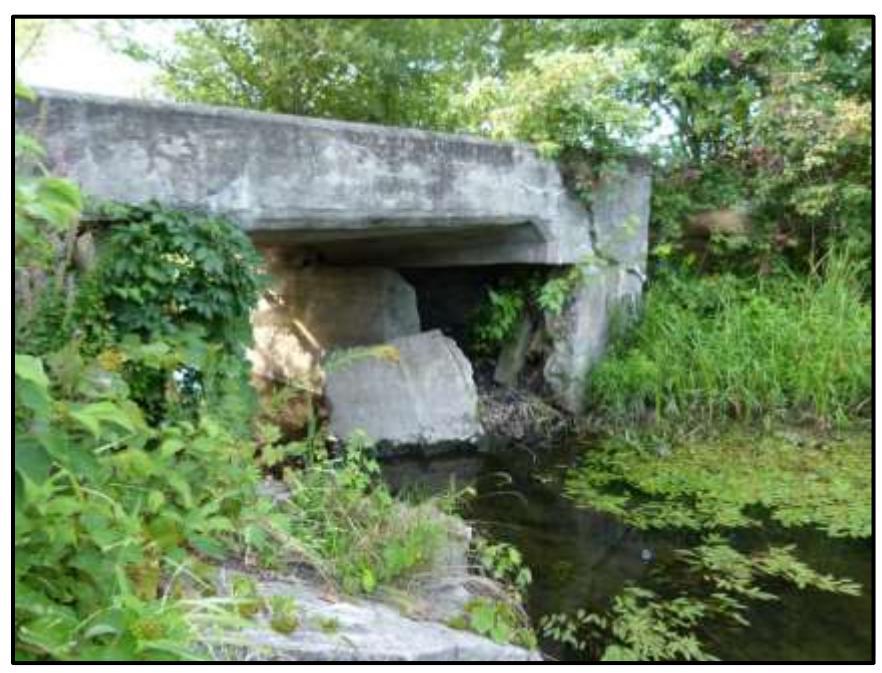
Photograph 7: The southern box culvert along Shirley's Brook (August 29th, 2017).

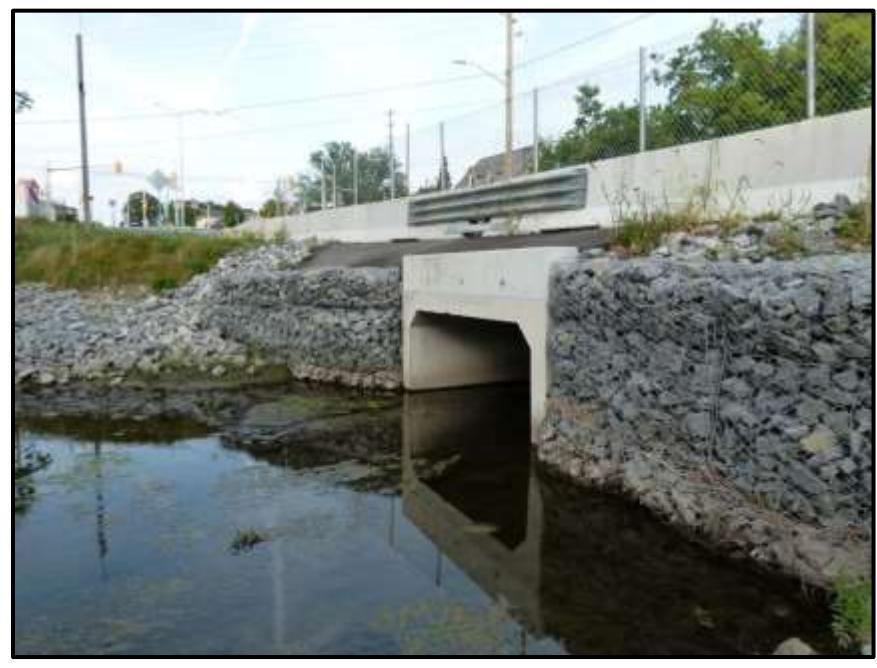
Photograph 8: The northern box culvert along Shirley's Brook at Klondike Road (August 29th, 2017).

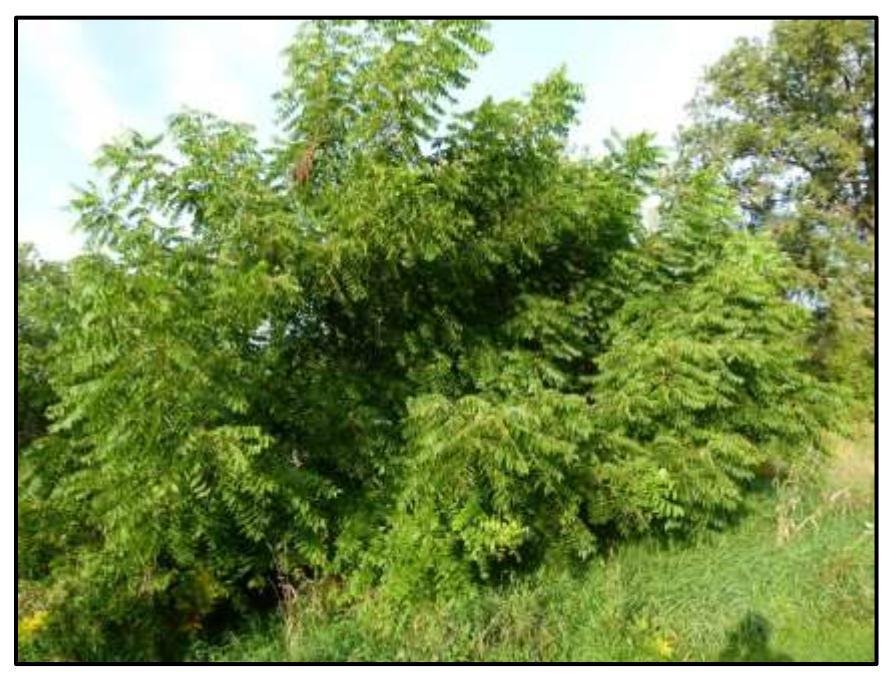
Photograph 9: Example of a Black Walnut found in the riparian corridor east of Shirley's Brook (August 29th, 2017).

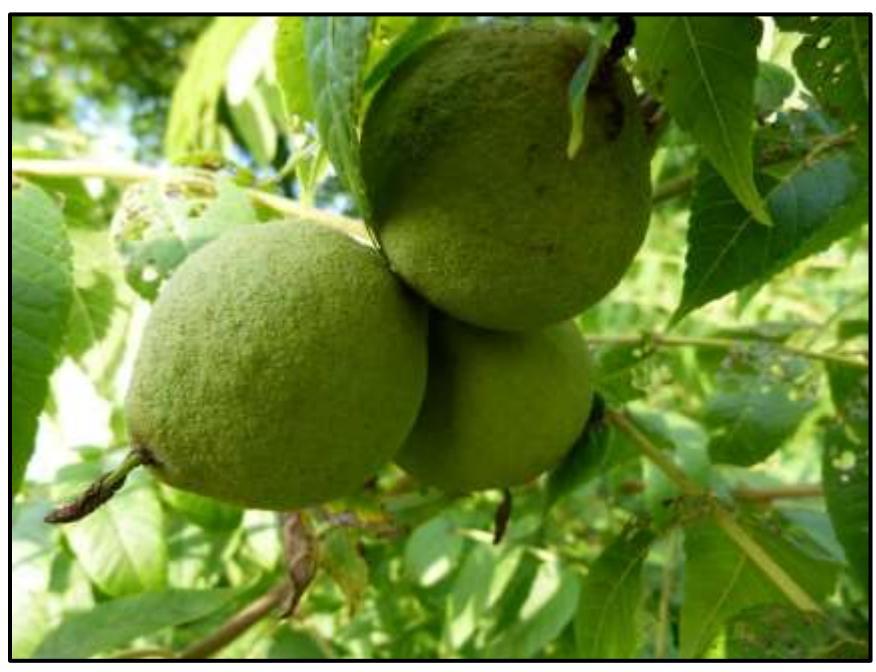
Photograph 10: Example of the Black Walnut fruit, photographed at the Site. The round shape and hairless fruit distinguishes Black Walnut from Butternut (August 29th, 2017).
