February 13, 2018

# RE: 20 and 30 Frank Nighbor Place Environmental Impact Satement

I have completed an Environmental Impact Statement (EIS) for two concurrent Site Plan applications; one for a proposed commercial development at 20 Frank Nighbor Place in Kanata, and a second for a private street over a portion of the site to the south of the parking for the commercial development. The private street will provide a secondary access to 20 Frank Nighbor Place and access to future developments on 30 and 40 Frank Nighbor Place through subsequent Site Plan applications and associated EIS assessments. As shown in Novatech (2018) in late 2017, 30 and 40 Frank Nighbor Place were severed from 20 Frank Nighbor Place.

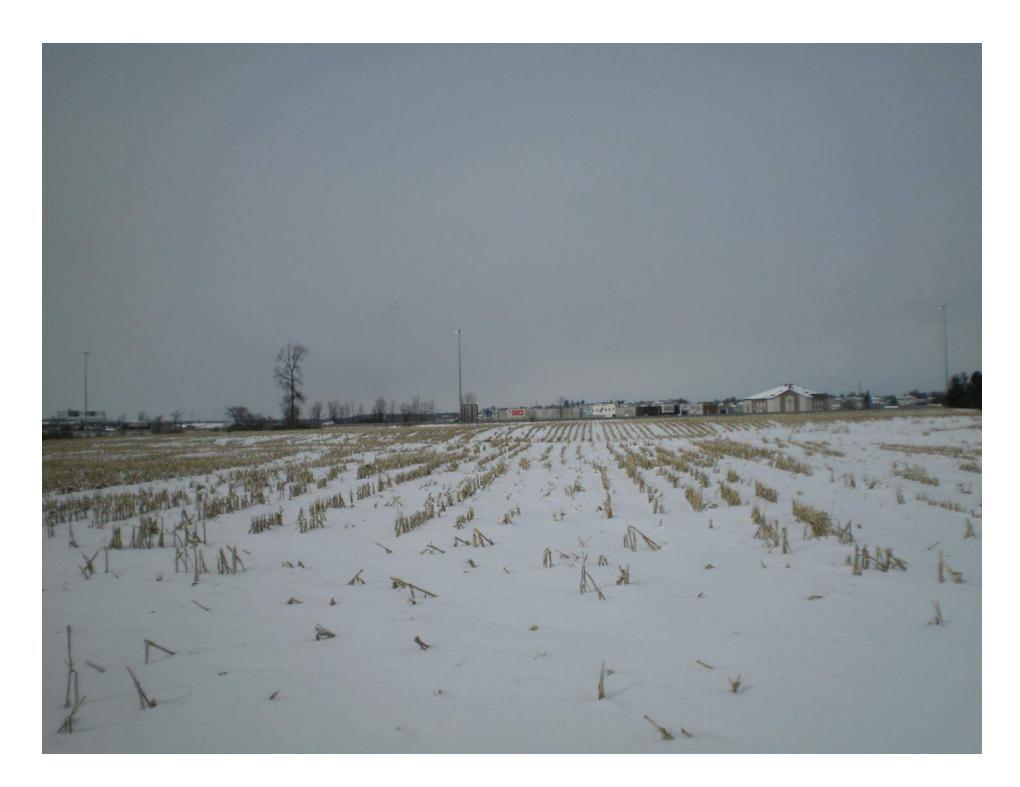
The site has been heavily disturbed over an extended time, with no tree cover of note since at least 1976. Except for the west edge, the site has been in cultivation since 2011, with corn stalks dominating the current site conditions (Photo 1). The Carp River corridor is the only significant natural heritage feature in the area. At its closest point the Carp River itself is approximately 70 metres west of the southwest potion of the site. The west edge of the site corresponds to the east edge of Mississippi Valley Conservation's regulatory limit east of the Carp River. The floodplain of the Carp River is to the west of the site, with the closest portion of the floodplain about 30 metres to the west of the southeast corner of the site (Figure 1).

*Photo 1 – Site, with view looking north from the south-central edge of the site*

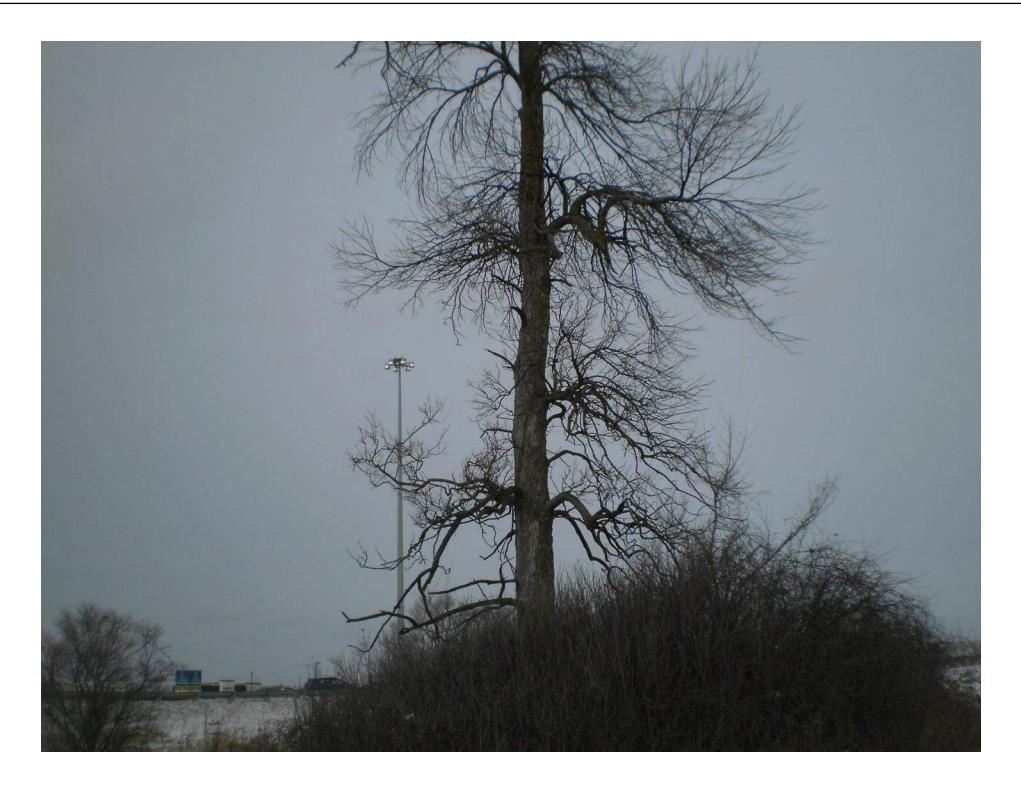
A 70cm diameter at breast height (dbh) white ash was in the meadow habitat in the northwest corner of the site (Photo 2). Evidence of emerald ash borer was on the trunk of the ash tree. Other woody vegetation in the cultural meadow habitat included red raspberry and tartarian honeysuckle shrubs, along with regenerating ash, white spruce, and elm stems. Red raspberry and staghorn sumac were dominant in the cultural thicket habitat, with chokecherry, glossy buckthorn, blackberry, and red-osier dogwood also well represented.

*Photo 2 – Mature white ash in the northwest corner of the site.*

The only tree on the site is a mature white ash affected by the emerald ash borer. It is recommended that this tree be removed. The critical root zone of the trees to the west of the site will not extend onto the site. The critical root zone of the trees to the south and east of the site may extend up to one and 2.5 metres, respectively onto the site. To protect these trees, no excavations, filling, grading or other site disturbances are to occur where the critical root zones of the adjacent trees encroached onto the site, unless a certified arborist determines no potential impact to the adjacent trees.

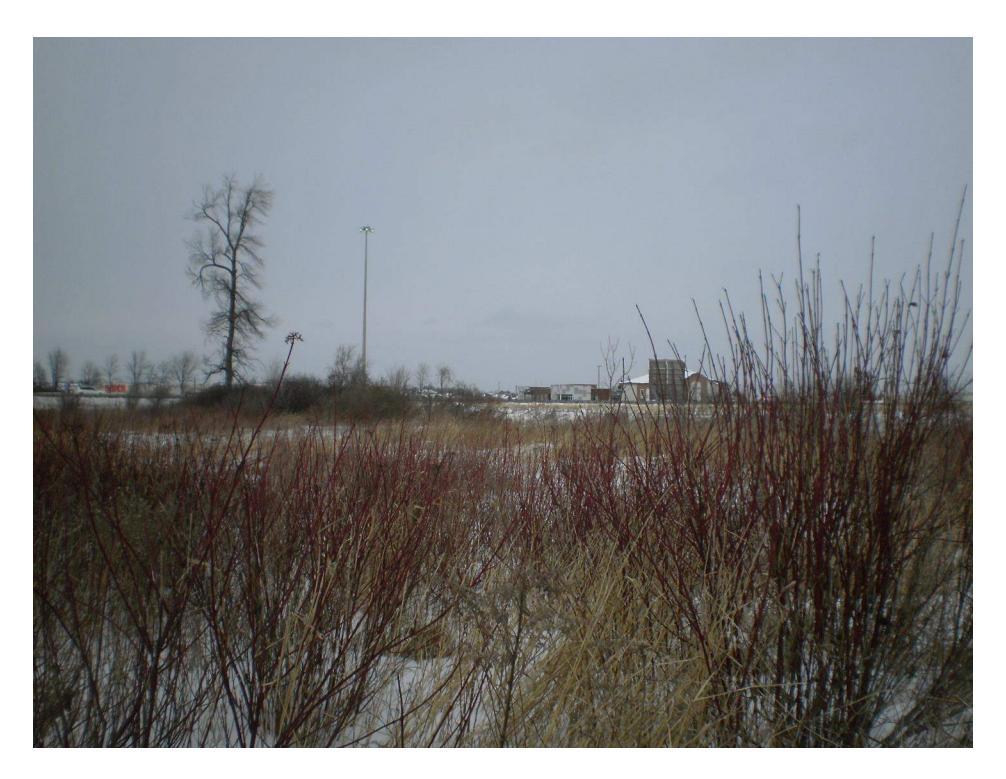
In addition to the cultivated fields, areas of cultural meadow and cultural thicket are along the west portion of the site and the north edge (Figure 1, Photo 3). Wild carrot, chicory, orchard grass, reed canary grass, wild parsnip, evening primrose, common milkweed, common teasel, common burdock, aster, goldenrod, purple loosestrife, wild cucumber, elecampane, and field sow-thistle were representative of the ground flora in the cultural habitats.

Photo 3 - Cultural thicket in the west-central edge of the site. View looking north

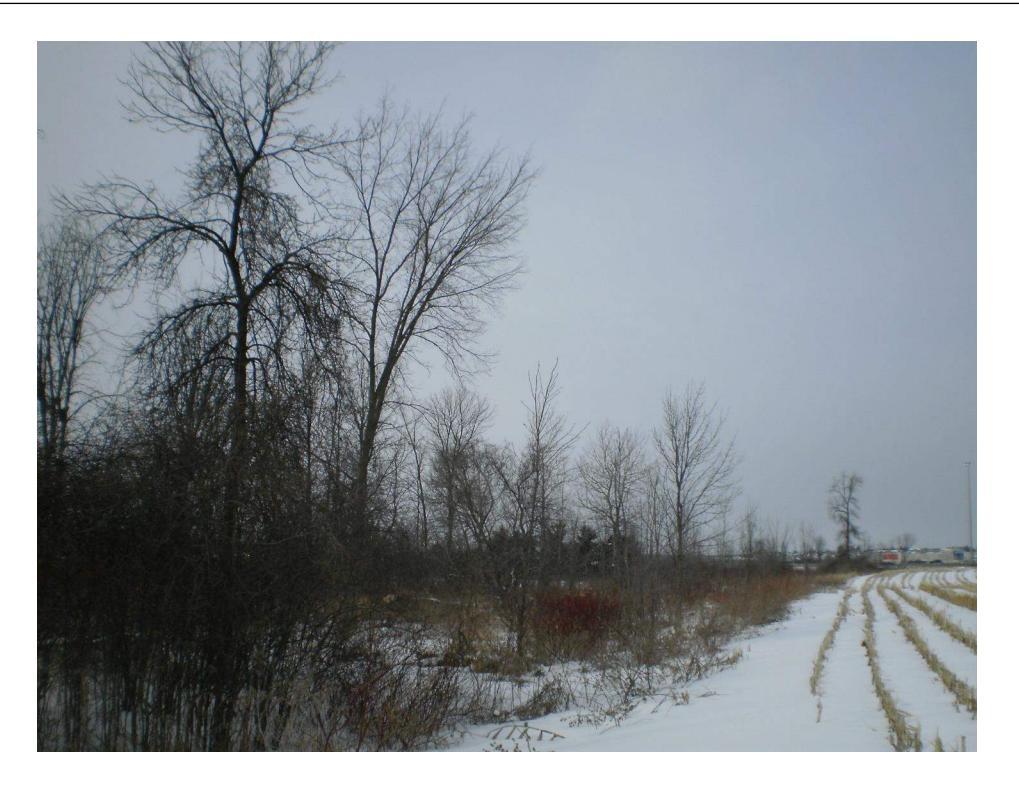
Woody vegetation was limited in the Carp River corridor to the west of the central and north portions of the site. A cluster of regenerating white spruce up to 22cm dbh was to the west of the west site edge, north of the access road (Photo 5). More trees are further to the west of the south portion of the site, including white ash and white elm up to 38cm dbh and smaller Manitoba maple (Photo 4). Recent beaver cuttings were common in this area.

*Photo 4 – Woody vegetation to the west of the south portion of the site. View looking northwest*

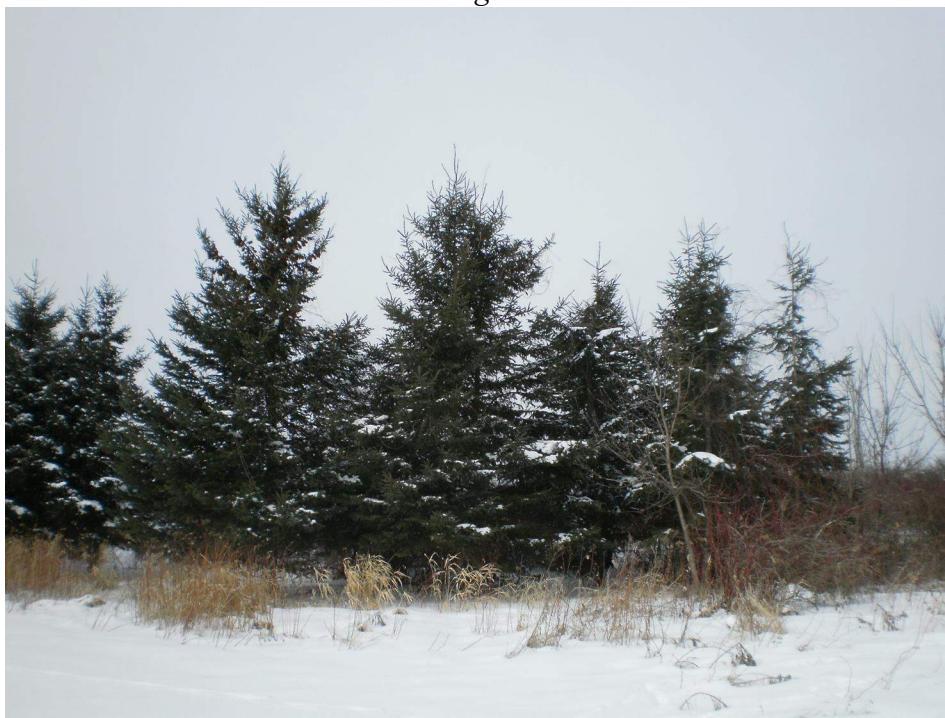
*Photo 5 – Regenerating white spruce to the west of the west-central edge of the site.*

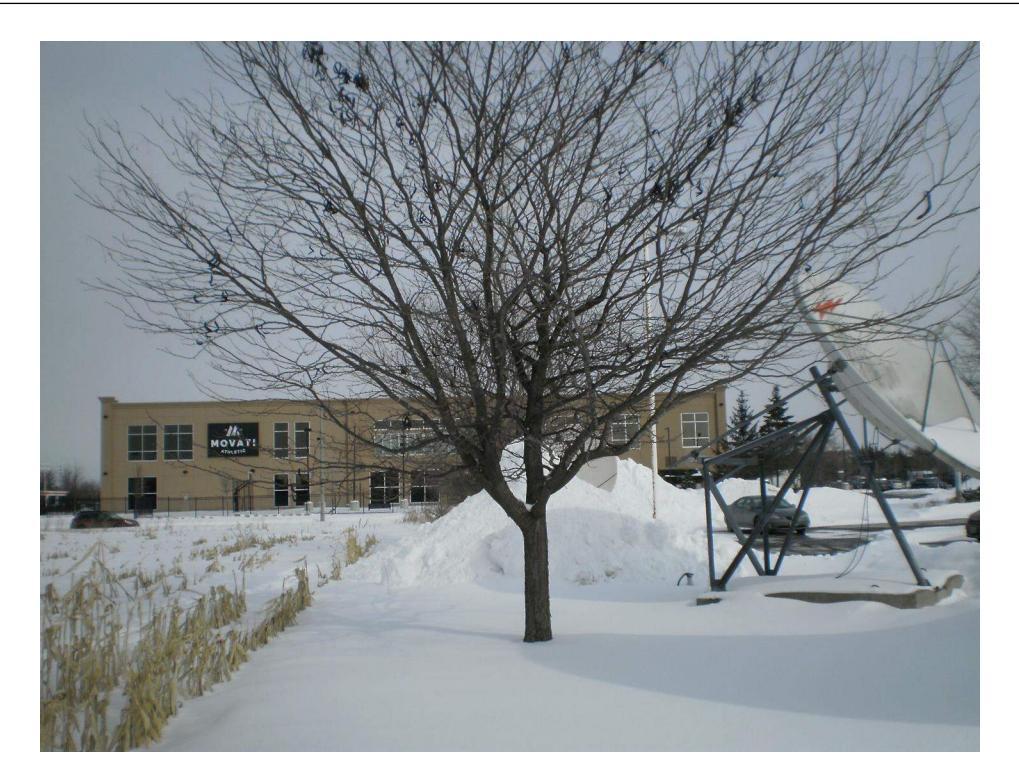
Four planted lindens, between 25cm and 28cm dbh are between two and four metres to the south of the site (Photo 6). Planted conifers along the east edge of the site, west of the Home Depot, included white spruce and Austrian pine between 25cm and 30cm dbh (Photo 7). Two 25m dbh planted hackberry were to the south of the conifers. These trees appear to be between 0.5 and one metre east of the property line. The adjacent planted trees appeared to be in generally good condition.

Photo 6 – Planted lindens to the south of the site. View looking east, with the south edge of the site on the left

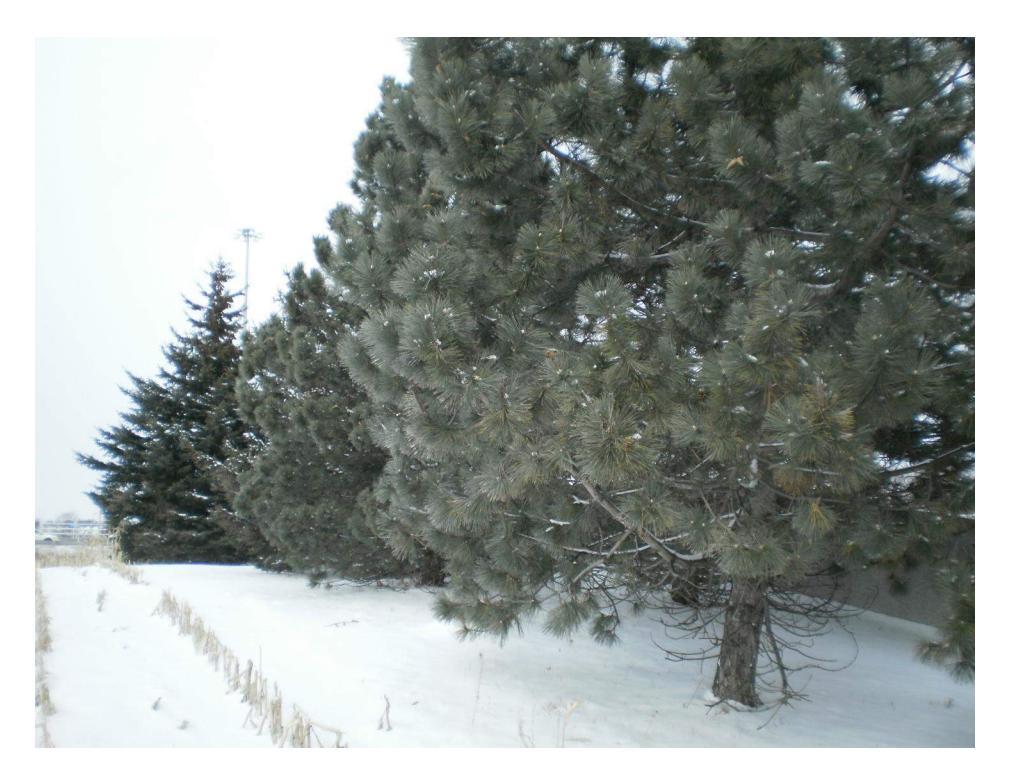
*Photo* 7 – *Planted conifers along the east edge of the site. View looking north*

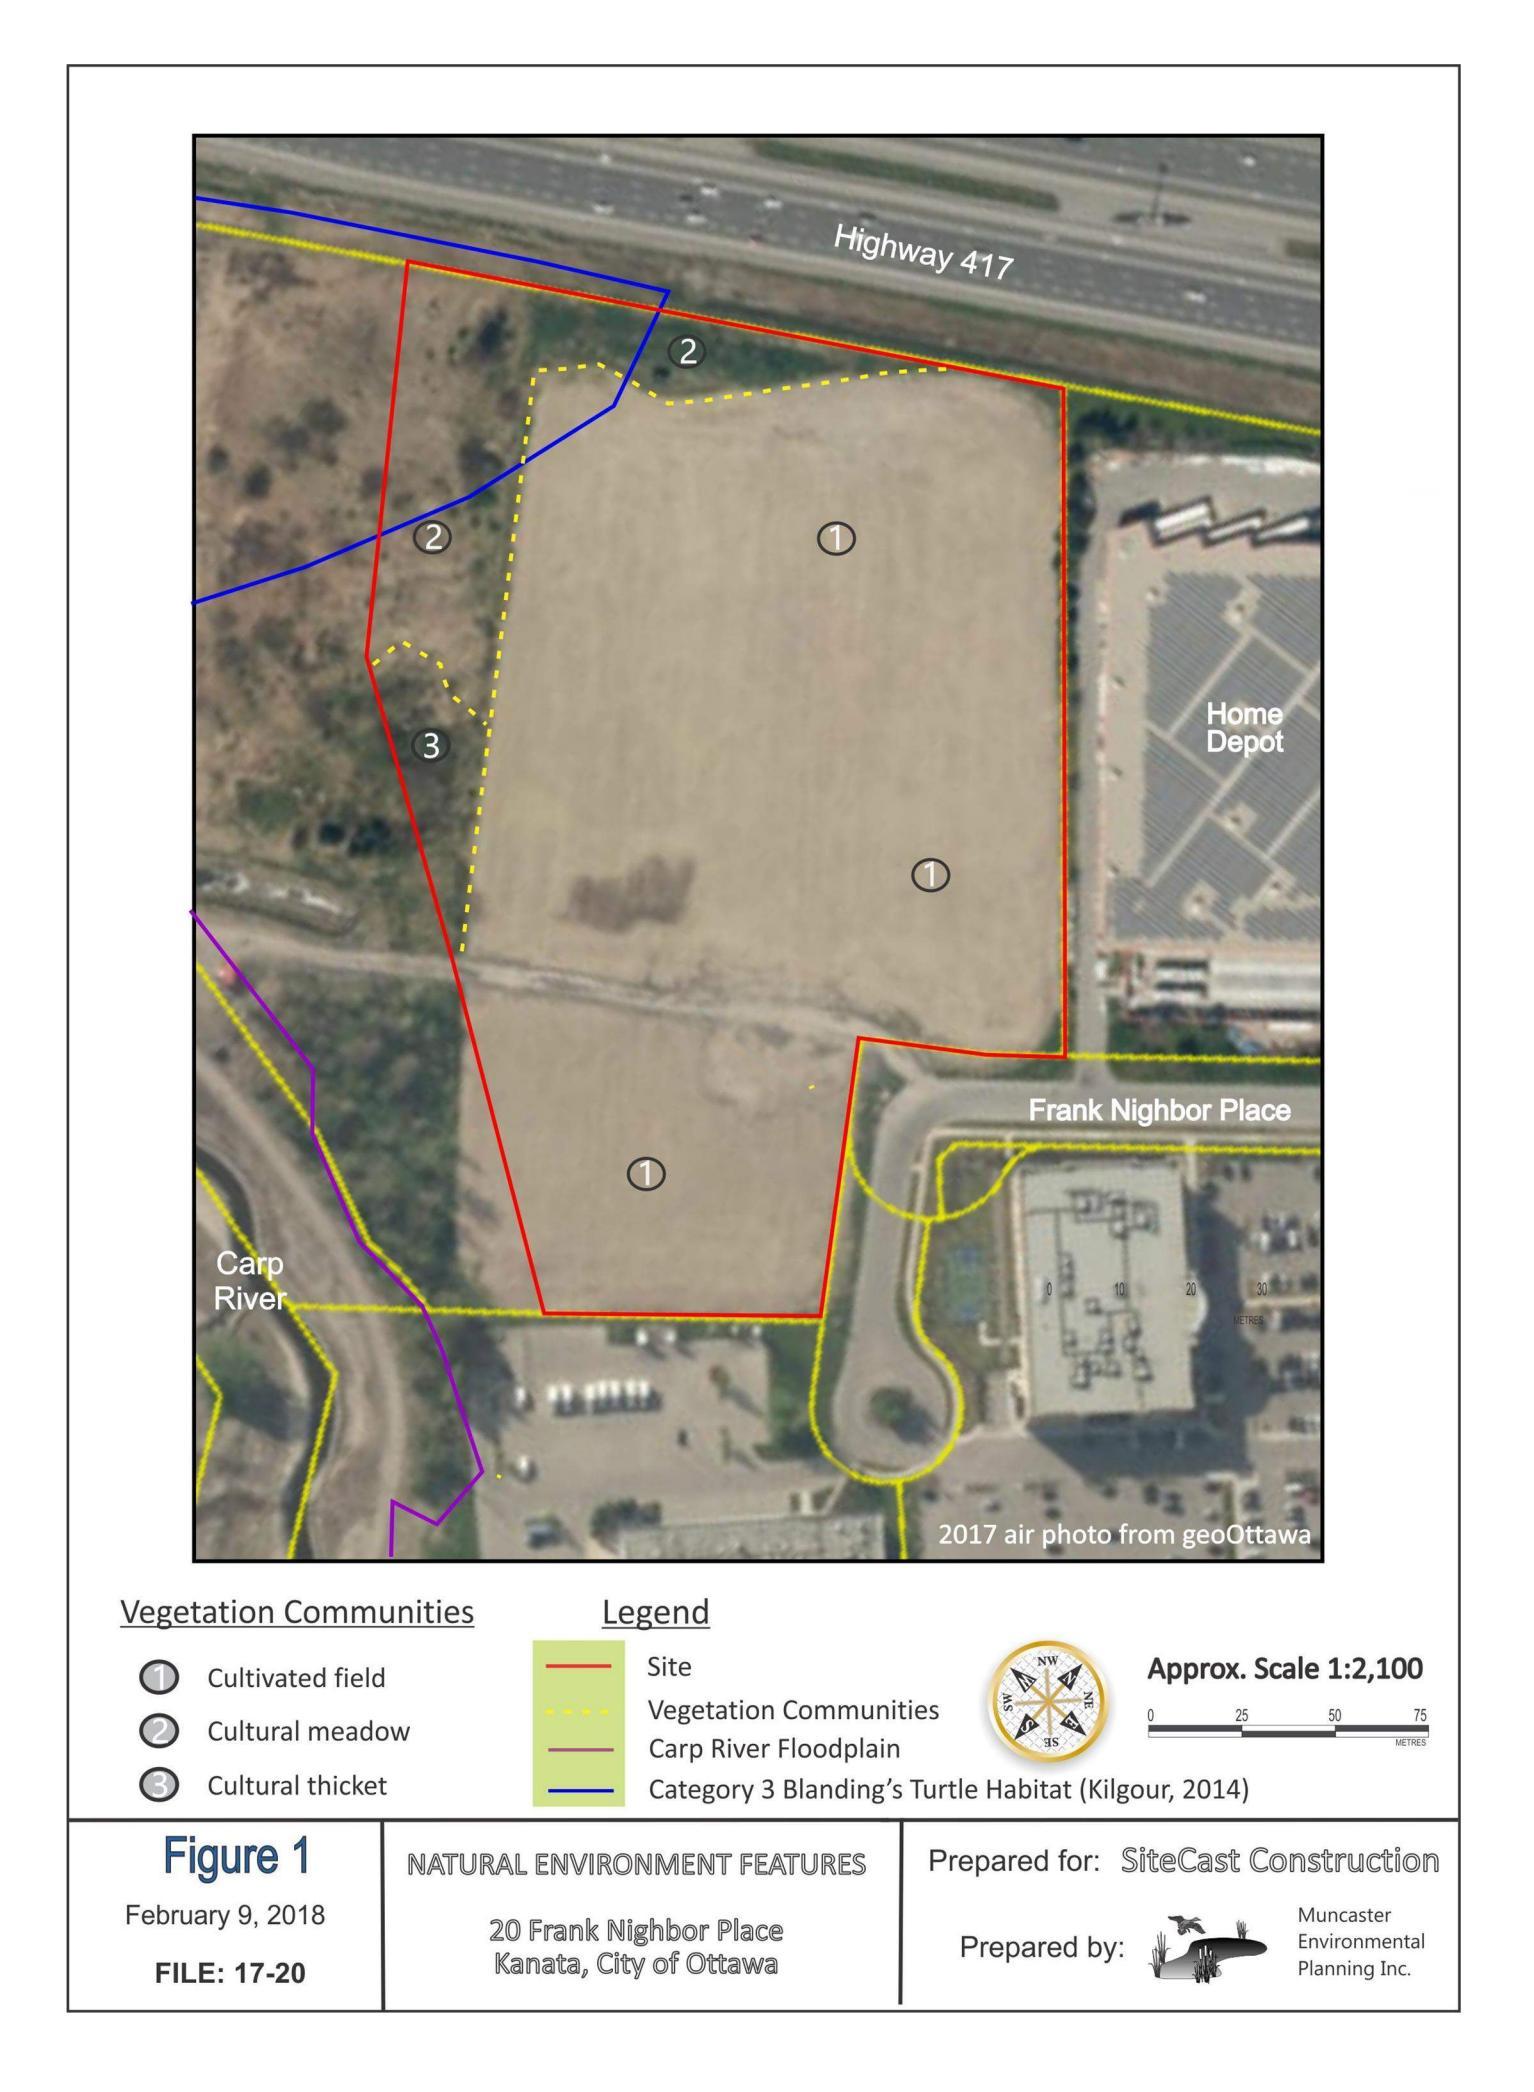
20 Frank Nighbor

The soils in the general area are mapped a poorly drained clay and sandy loams (Schut and Wilson, 1987), which is consistent with the observations of TSH (2005). An east-west access road off Frank Nighbor Place splits the south part of the site from the central and north portions (Figure 1). This road was used for the Carp River restoration work and provides access to a City easement which includes a sanitary pipe, a stormwater pipe, and a watermain.
