TREE CONSERVATION REPORT

OFFICE BUILDING DEVELOPMENT

3026 SOLANDT ROAD

CITY OF OTTAWA

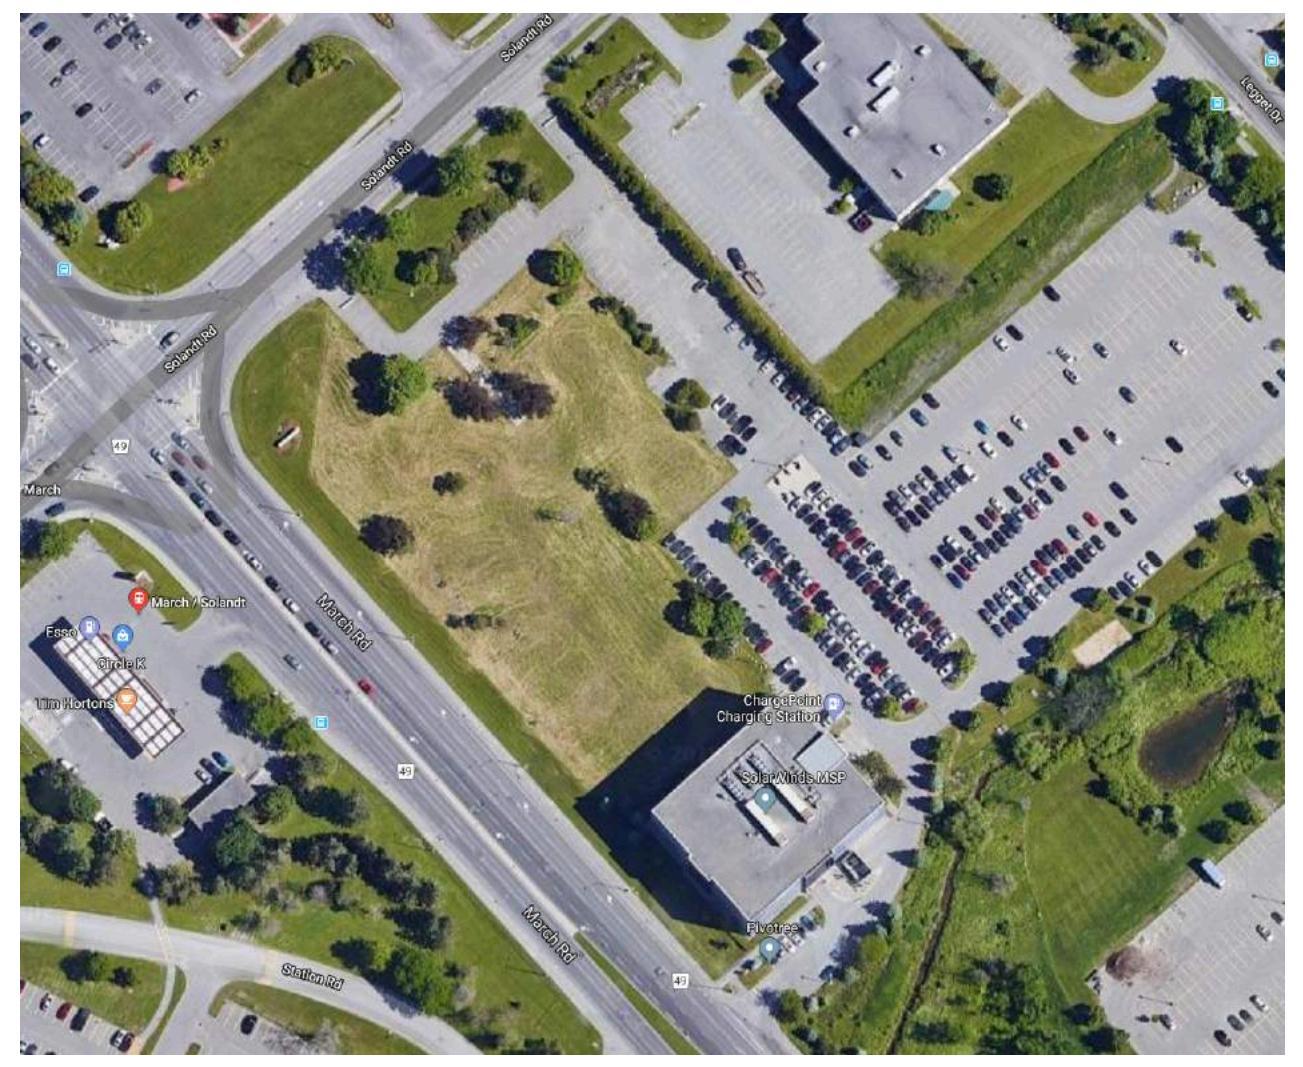
2019 AERIAL

Refer to 2019 aerial showing existing vegetation (tree in central portion along March Road has since been removed), Map #1 – Current Vegetation, MAP #1D – Existing Vegetation Chart, Map #2 – Proposed Development and Conserved Vegetation, MAP #2D - Tree Preservation Notes and Details, and Map # 3 – Existing trees overlain on Gradin Plan.

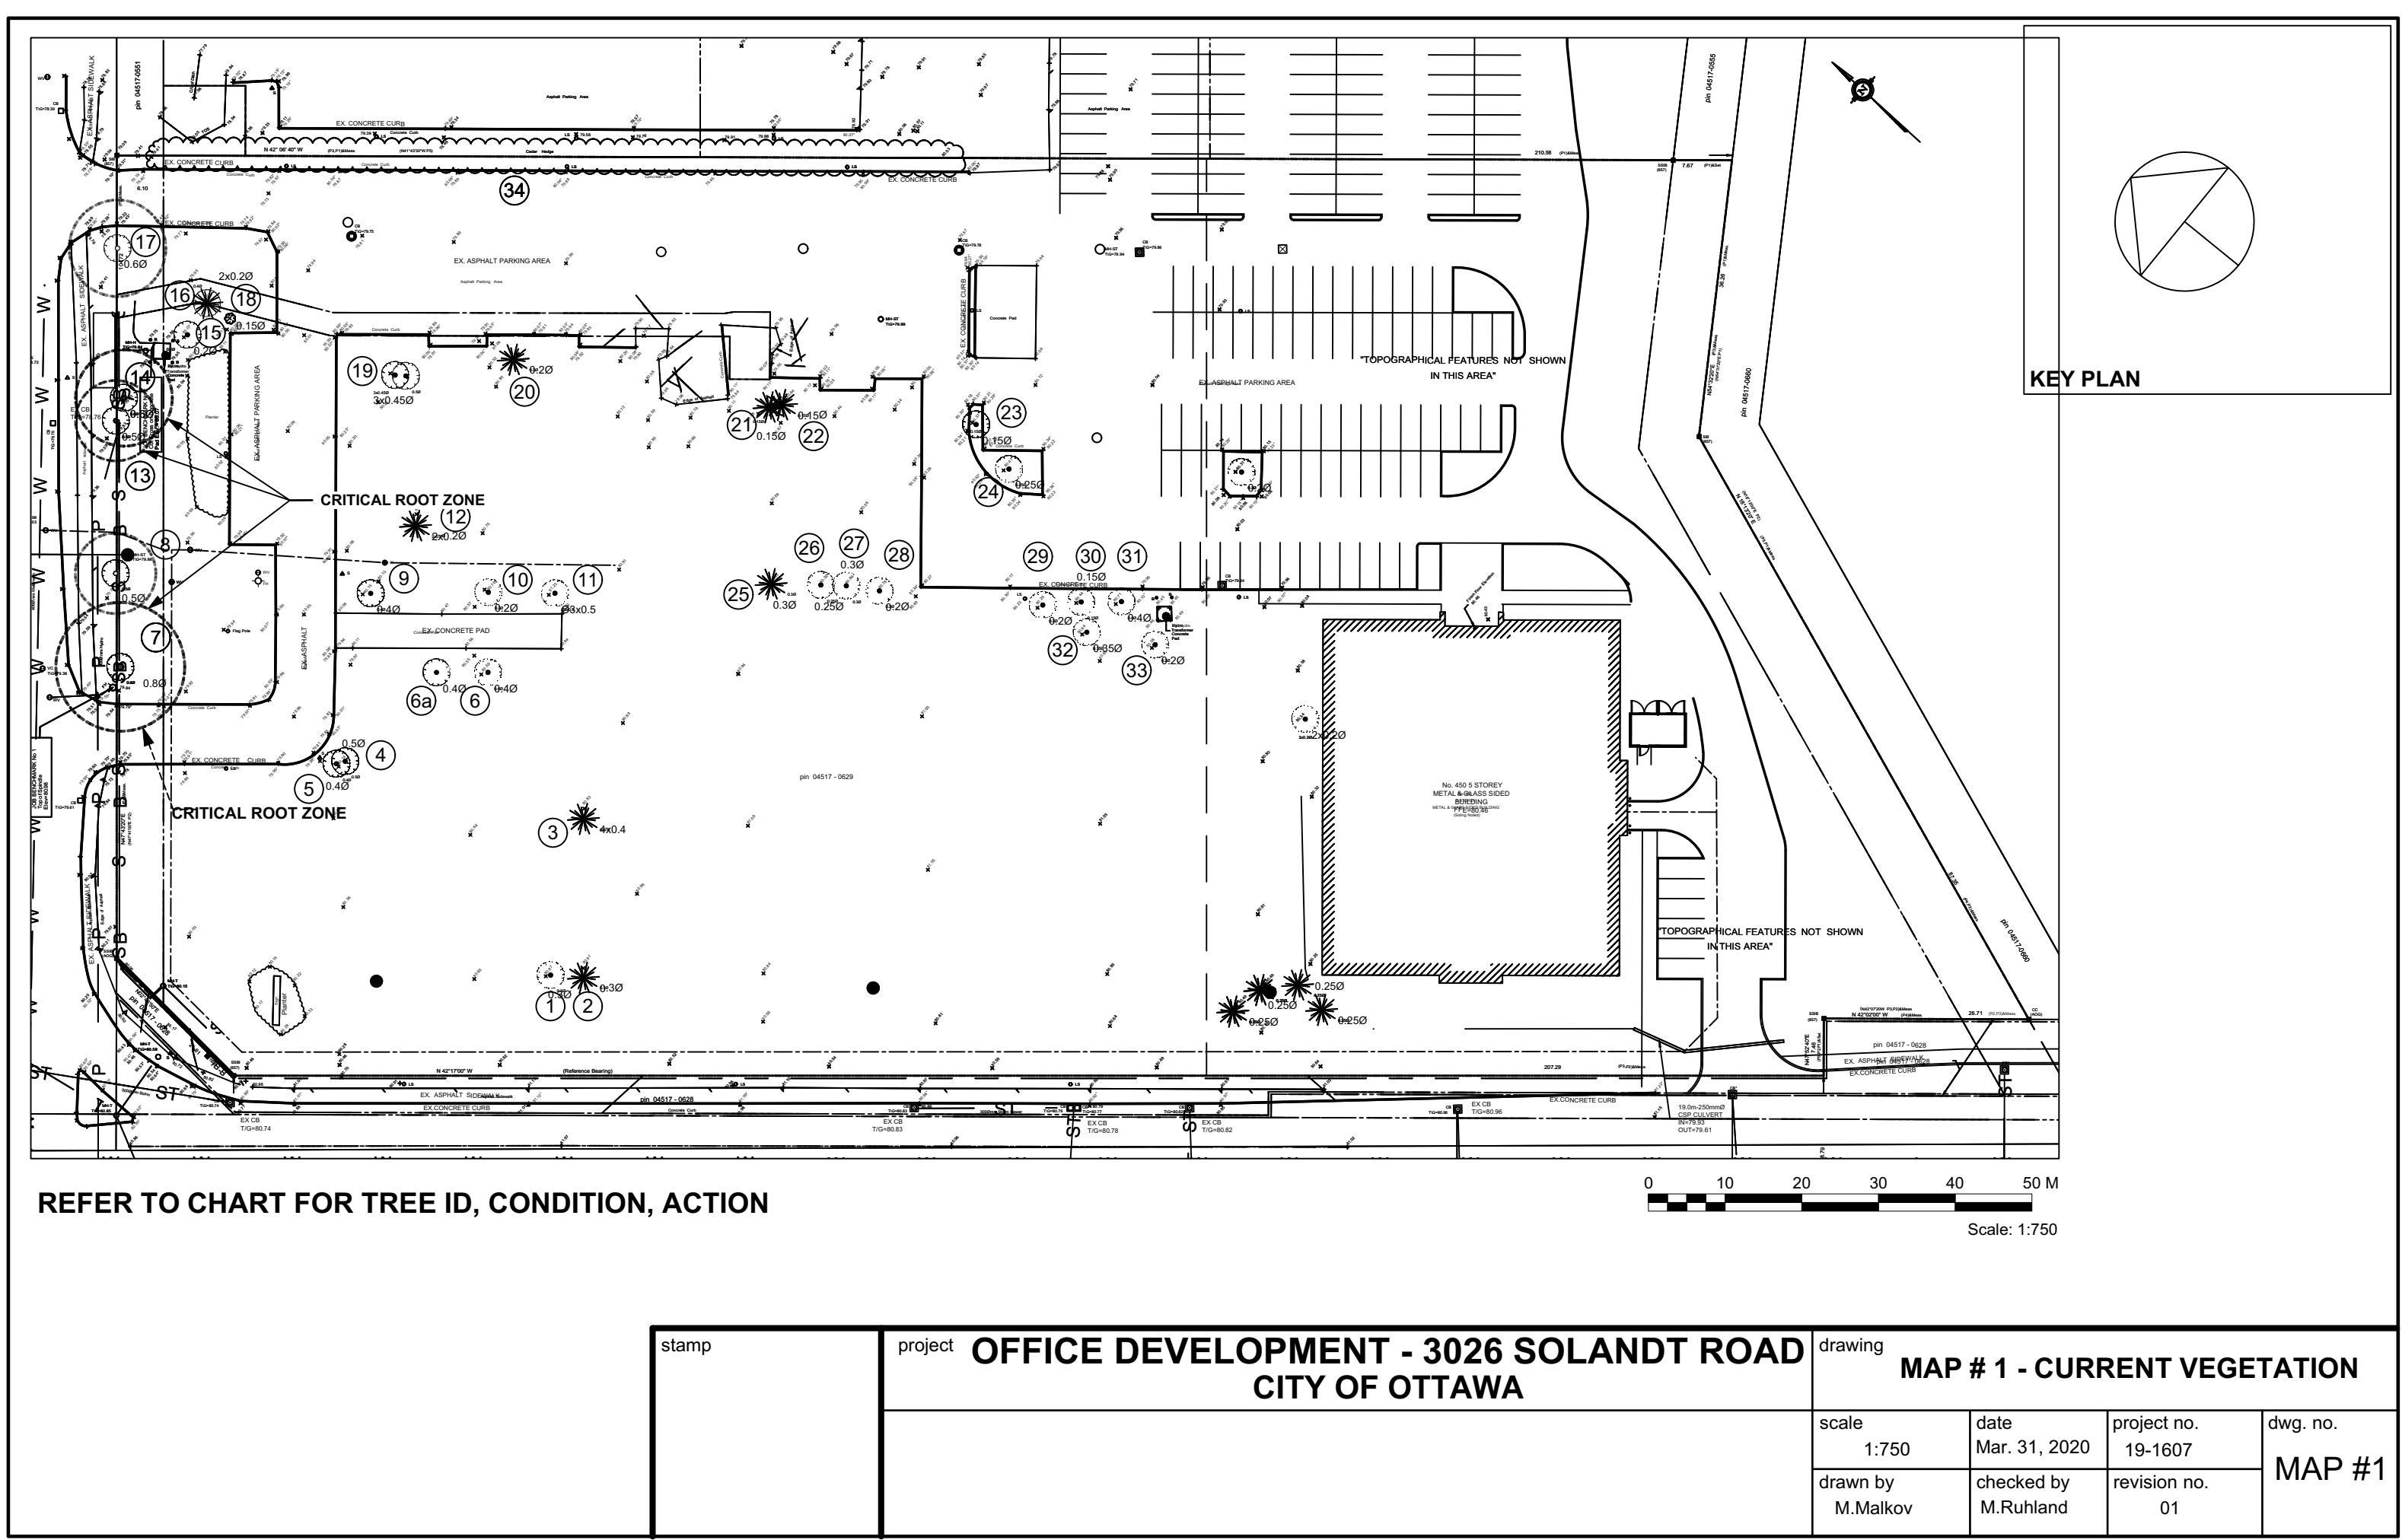
Seven (7) distinctive trees were found on site, refer to Map #1 – Current Vegetation, MAP #1D – Existing Vegetation Chart.

MARCH ROAD FRONTAGE (#1-2):

No trees are located within the city road allowance. Trees #1-2 are located adjacent to the street.

SOLANDT ROAD FRONTAGE (#7-8, 13-18):

Trees #8 and 13 are located within the city road allowance as show on the existing survey information, and tree # 17 is straddling the property line. The remainder are located adjacent to the street.

<u>Condition</u>: fairly good to good condition. Tree #17 is in poor condition with a large portion of the crown dead.

INTERNAL AREA (#1-6A, 9-12, 19-33):

<u>Condition:</u> tree conditions range from poor to good. Trees in poor condition include the 50cm DBH Sugar Maple - #4 (rot at trunk base and dead central leader), 40cm DBH Crab Apple - #6a (major branch dead cracked and removed) and Mugho Pine - #3. Trees in fair condition include the remainder of the Mugho Pine (all are overgrown with bad habit) and some of the crab apples which are crowded out. Trees in fairly good condition include about half of the Crab Apples, and Scot's Pine. The remainder of the trees are in good condition.

Although retention for Trees #7 (80cm DBH Bur Oak) and #13 (50cm DBH Sugar Maple) are considered very low, these are to be considered for retention.

Although retention for Tree # 14 (58cm DBH Bur Oak) are considered low, this tree is planned for retention.

The remainder of the trees along Solandt Road are to be removed. Tree #8, (51 cm DBH Bur Oak in good condition, is located in the middle of the entrance road

and Tree # 17 (49 DBH Bur Oak in poor condition) is slated for removal due to tree condition.

The remainder of the existing vegetation located on the subject lands are to be removed. The remainder of the trees are located within the proposed development area.

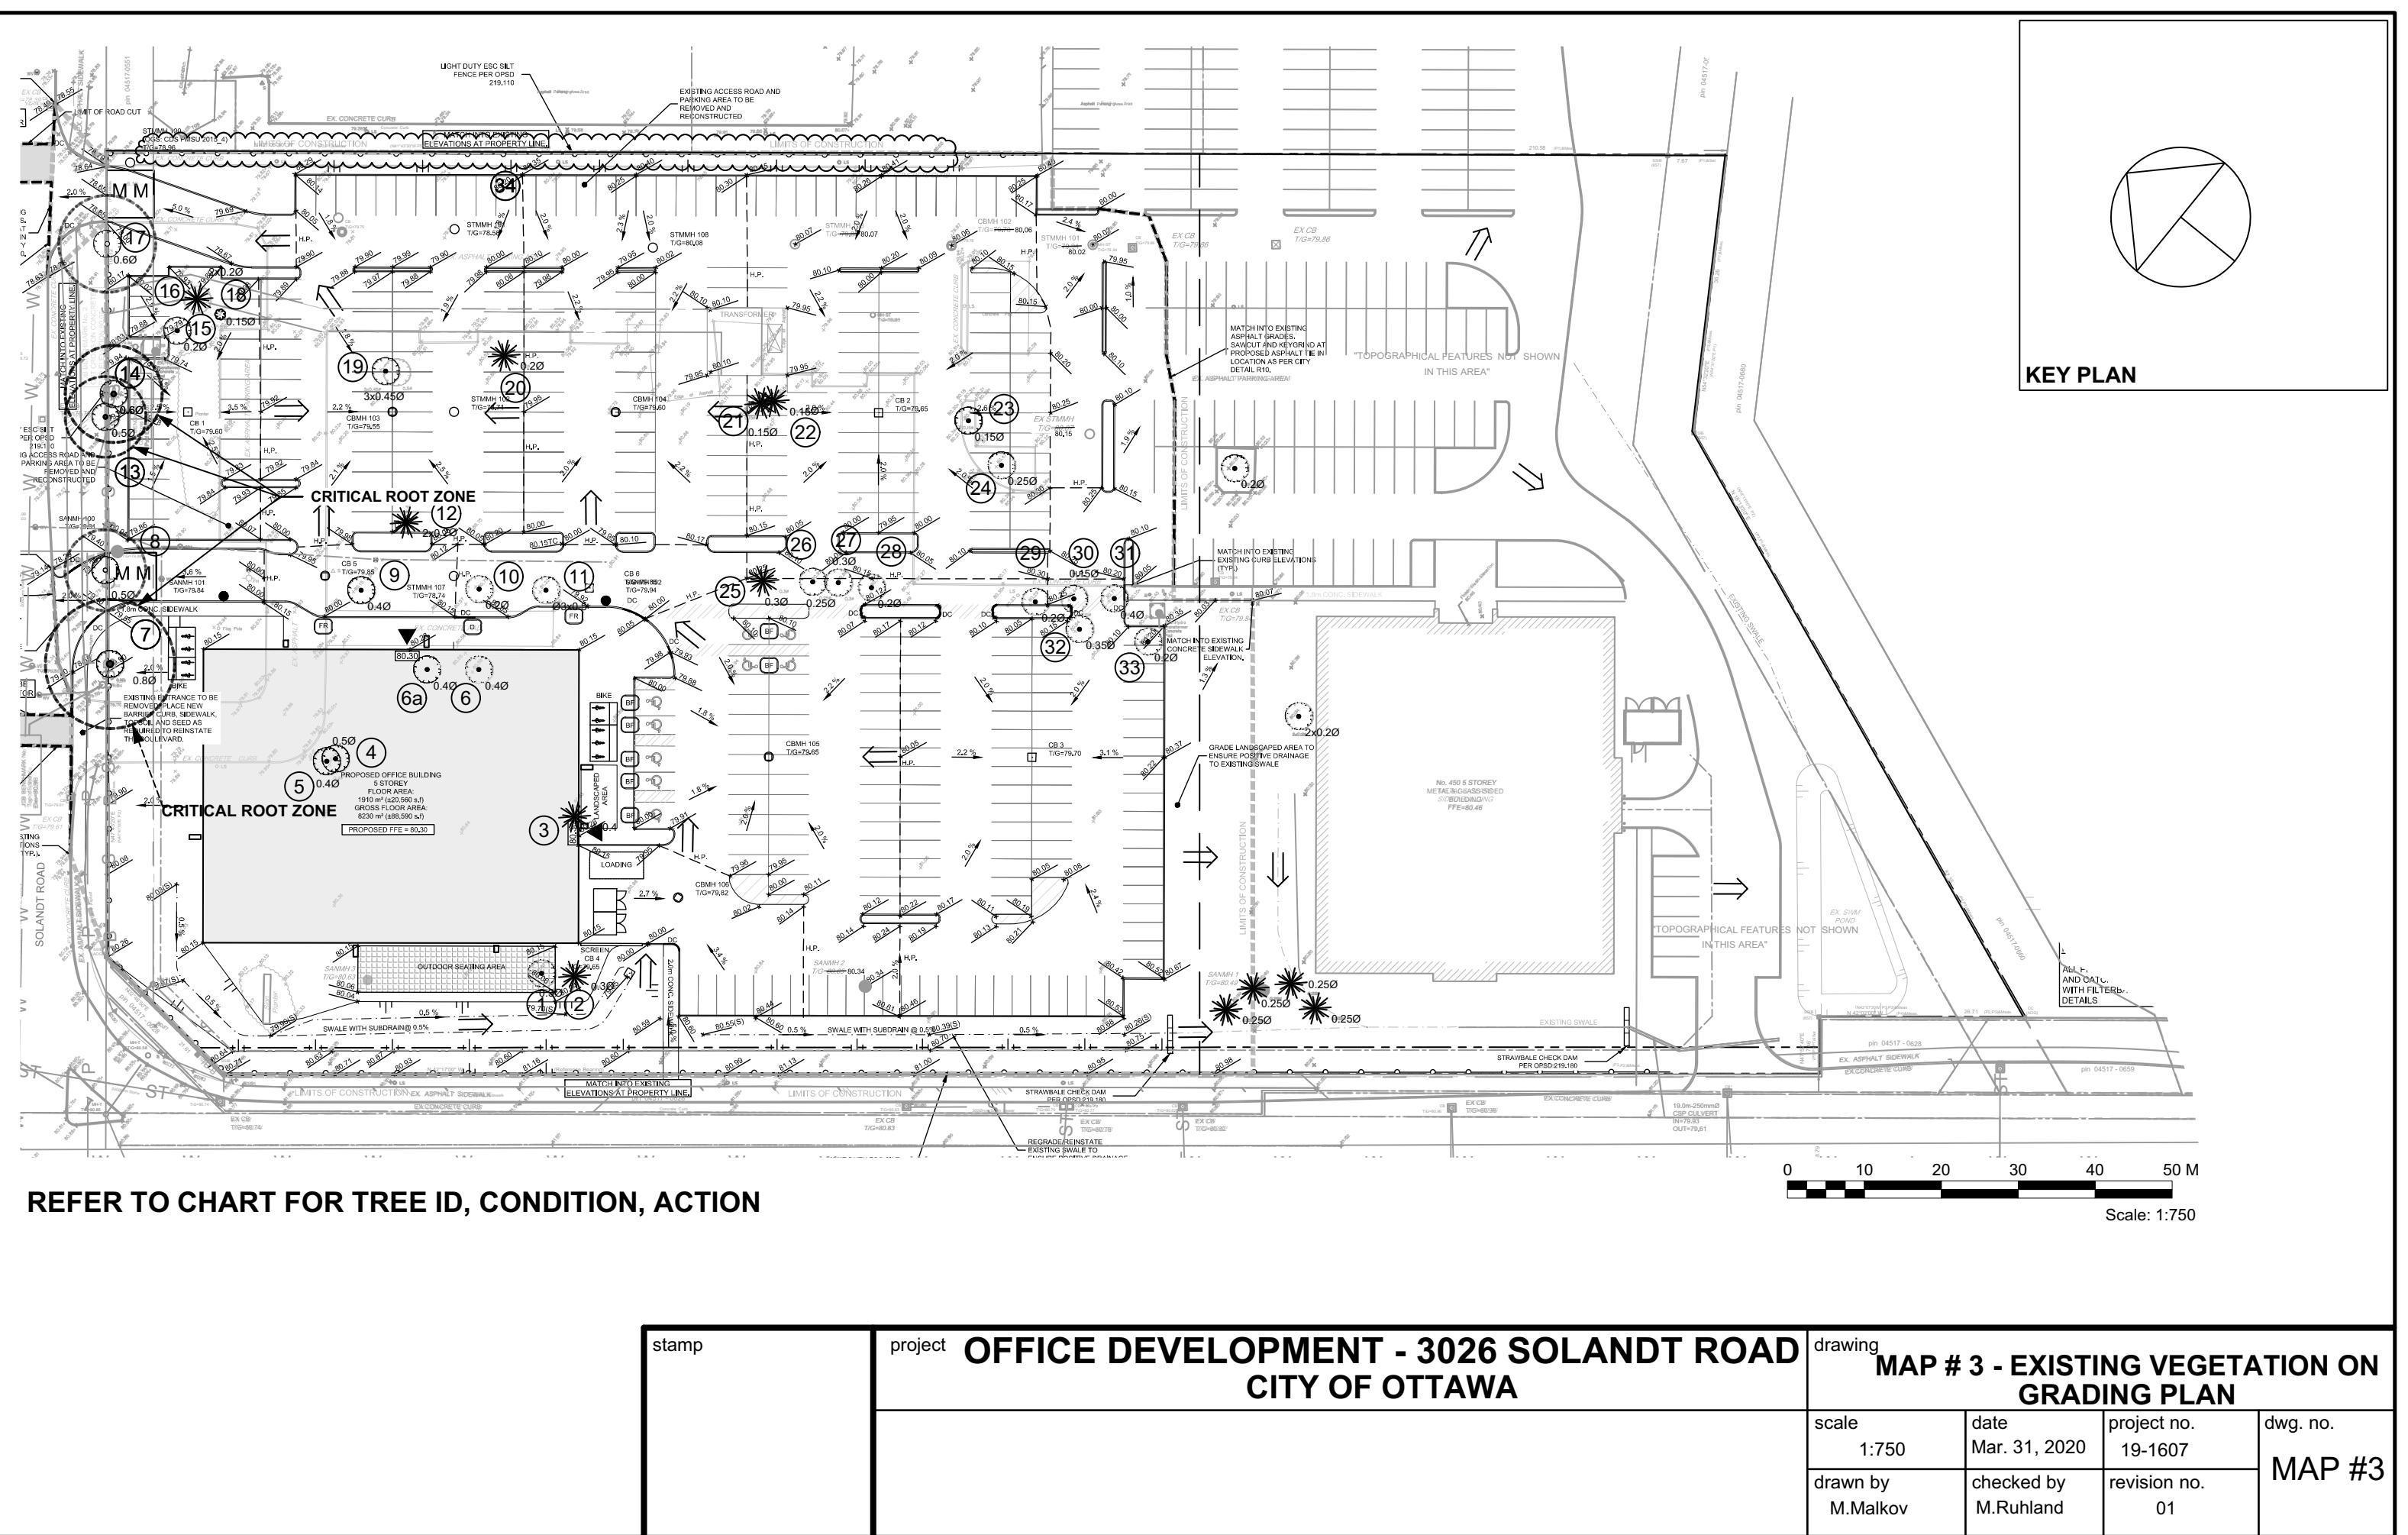
Feasibility of retaining Trees #7 and #13 to be reviewed by a qualified arborist prior to construction start up. It is noted that excavation for the development of the building, parking lot, roadways and/or sidewalks will be within the CRZ of these trees, therefore the health and long term sustainability of the trees will be affected.

- Limit of excavation relating to the CRZ of the tree
- Overall health of tree and long term sustainability
- Pruning requirements for health of tree and safety of users
- Any additional mitigation measures required beyond those listed in the TCR.

Based on the above, feasibility of preserving these two trees will be made in consultation with the City of Ottawa Forestry Department. If it is determined that one or both of these trees cannot be preserved, they will be replaced with 2, 80-90mm caliper deciduous trees per tree removed. Replacement trees will be of a large deciduous species conducive to the developed environment such as Bur Oak, Red Oak, Red Maple, Hackberry, American Linden street varieties, Elm varieties resistant to Dutch Elm Disease.

Preliminary root cutting at the edge of proposed excavation areas prior to any on site excavation would protect the integrity of the existing root system of trees in proximity of the proposed development, refer to Map #2 and MAP #2D - Tree Preservation Notes and Details.

In accordance with the Municipal Trees and Natural Areas Protection By-law No. 2006 – 279, a protection fence is to be erected at vegetation that is to be preserved and set up along the property lines on the north and east sides of the site, as indicated on Map #2. The protection fence shall be erected as per T MAP #2D - Tree Preservation Notes and Details. The protection fence shall be maintained throughout all phases of the development. No work is to be done within the tree protection fence.

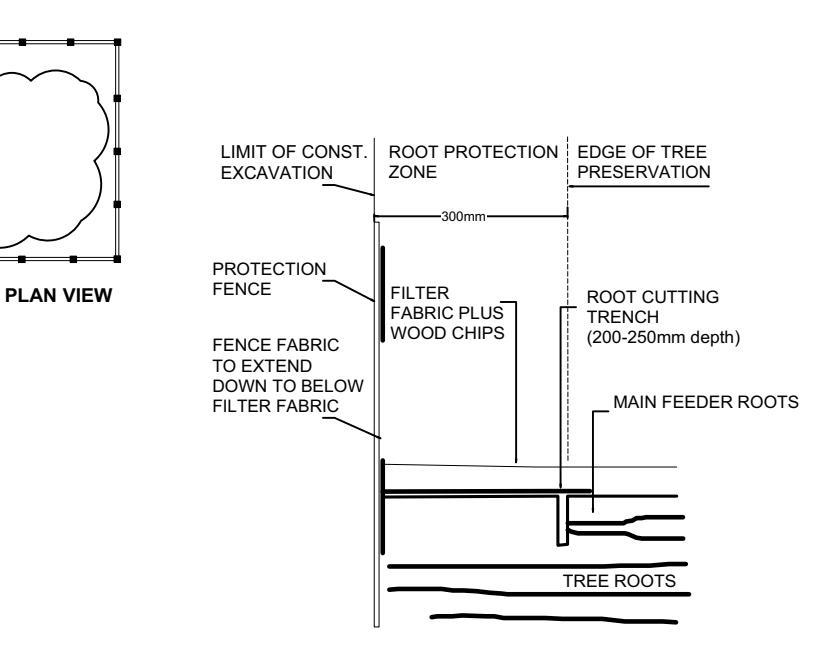
TREE PROTECTION AND ROOT CUTTING DETAIL

38x38x2400 mm STEEL POST 1200 mm PLASTIC SNOW FENCE EXISTING TREES EXISTING TREE 38x38x2400mm 'T' RAIL 3000 O.C. MAX 1200 MM PLASTIC SNOW FENCE (ORANGE) PLACED ±300MM ABOVE GRADE. ELEVATION

D (DIAMETER OF TRUNK IN CENTIMETERS) X 10CM = CRITICAL ROOT ZONE. THE CRITICAL ROOT ZONE IS ESTABLISHED AS BEING 10 CENTIMETRES FROM THE TRUNK OF A TREE FOR EVERY CENTIMETRE OF TRUNK DIAMETER, THE TRUNK DIAMETER IS MEASURED AT A HEIGHT OF 1.2 METRES FOR TREES OF 15 CENTIMETRES DIAMETER AND GREATER AND AT A HEIGHT OF 0.3 METRES FOR TREES OF LESS THAN 15 CENTIMETRES DIAMETER. THE CONTRACTOR MUST OBTAIN ALL PERMITS AND APPROVALS PRIOR TO THE START OF CONSTRUCTION. THE CONTRACTOR MUST CALL A CITY TREE INSPECTOR WHEN WORK IS REQUIRED NEAR A CITY TREE

PLACE FENCE AT EDGE OF TREE PRESERVATION ZONE (CRZ)

ROOT CUTTING PRIOR TO EXCAVATION
