MEMO

DATE:	March 29, 2020
SUBJECT:	5 Orchard Drive = Tree Conservation Report Memo
FROM:	Byron Lester, Senior Landscape Designer, WSP Landscape Architecture & Urban Design
TO:	Mr. Brent Payne, AECOM Canada Inc. C/O Shell Canada

This memo includes: an inventory of individual trees anticipated to be impacted by the proposed development activities on site; tree mitigation measures; and tree compensation recommendations. The information herein is to accompany the anticipated forthcoming site plan application for the NTI site located at 5 Orchard Drive (project site) in Ottawa, Ontario.

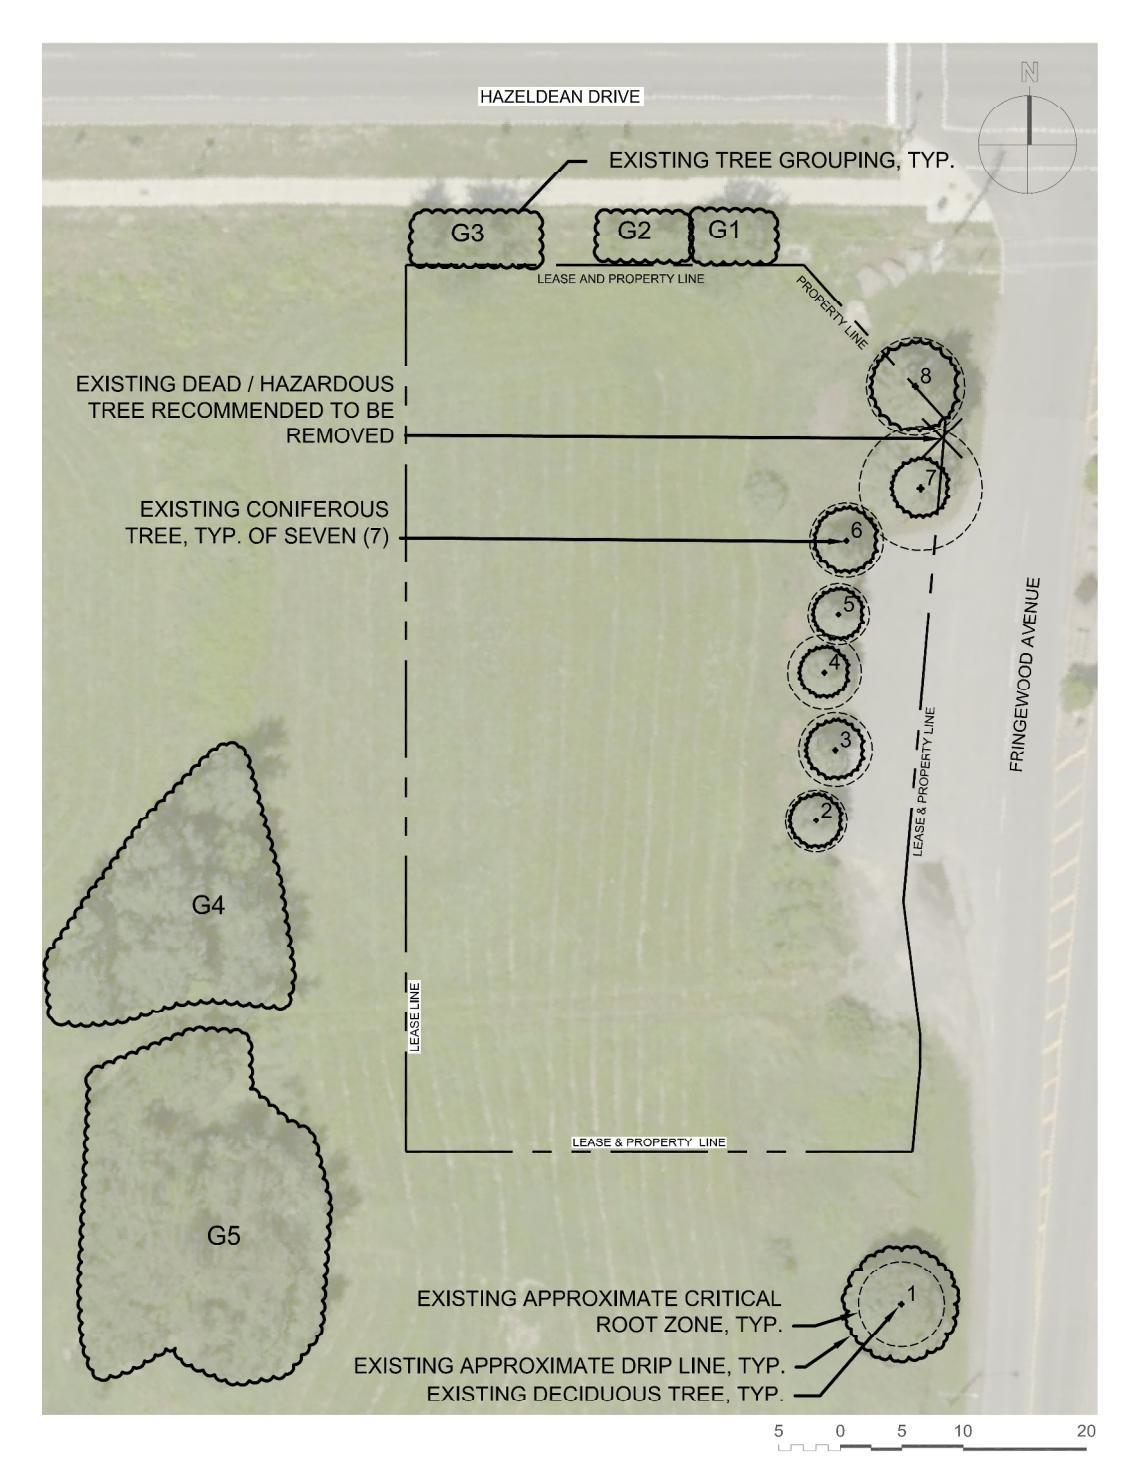
Existing Conditions Plan

Species inventoried consist of a variety of native and non-native deciduous and coniferous trees including: Norway Maple (*Acer platanoides*), Manitoba Maple (*Acer negundo*), Ash Species (*Fraxinus sp.*), Elm Species (*Ulmus sp.*), Norway Spruce (*Picea abies*), Eastern Cottonwood (*Populus deltoides*), Trembling Aspen (*Populus tremuloides*). Refer to inventory table and existing conditions sketch below for tree location condition, recommendation, and quantity:

or insect infestation may also be recommended for removal. It is anticipated that seven (7) individual trees (ID# 2-8) and one tree grouping (G1) will require removal. Refer to existing conditions map and tree inventory table above.

To facilitate the proposed construction works, tree removals are necessary. A recommendation to remove trees is determined by the anticipated degree of excavation / disturbance within the critical root zone, considering: tree species, size, condition and the number of critical roots that would be impacted that are vital to sustaining the trees overall health and stability. Trees that are dead, in poor condition or trees that could pose future safety concerns and trees dying because of a disease

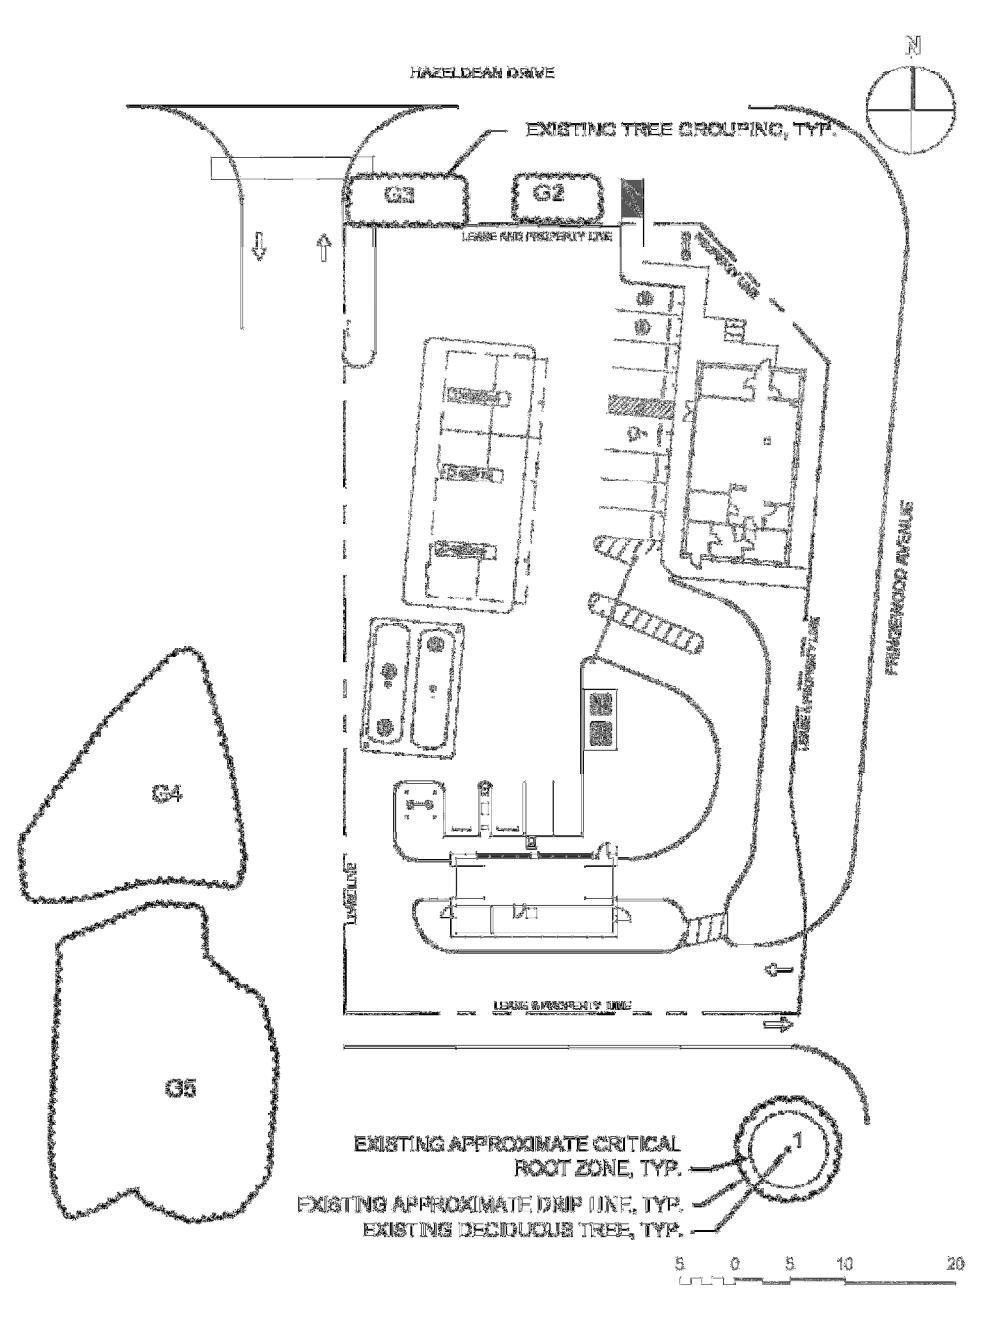
Proposed development and Conserved Vegetation Plan*

*Note: proposed plan as shown is draft only – refer to latest site plan. All trees within project site are anticipated to require removal.

Trees shall be replaced at a 2:1 ratio minimum. Replacement plant material shall be as per City of Ottawa specifications and standards. Monoculture planting of single tree species is not permitted. All replacement tree species shall be selected to be low maintenance, tolerant of urban conditions including winter maintenance practices and native species where possible / feasible. All plant material shall meet the requirements of the Canadian Standards for Nursery Stock. Refer to sketch below for proposed limits of tree protection fencing.
