Geotechnical Investigation

Proposed Multi-Storey Building 36 Robinson Avenue Ottawa, Ontario

Robinson Village LPIV Limited Partnership c/o TC United Development

Report PG5231-1- Revision 1

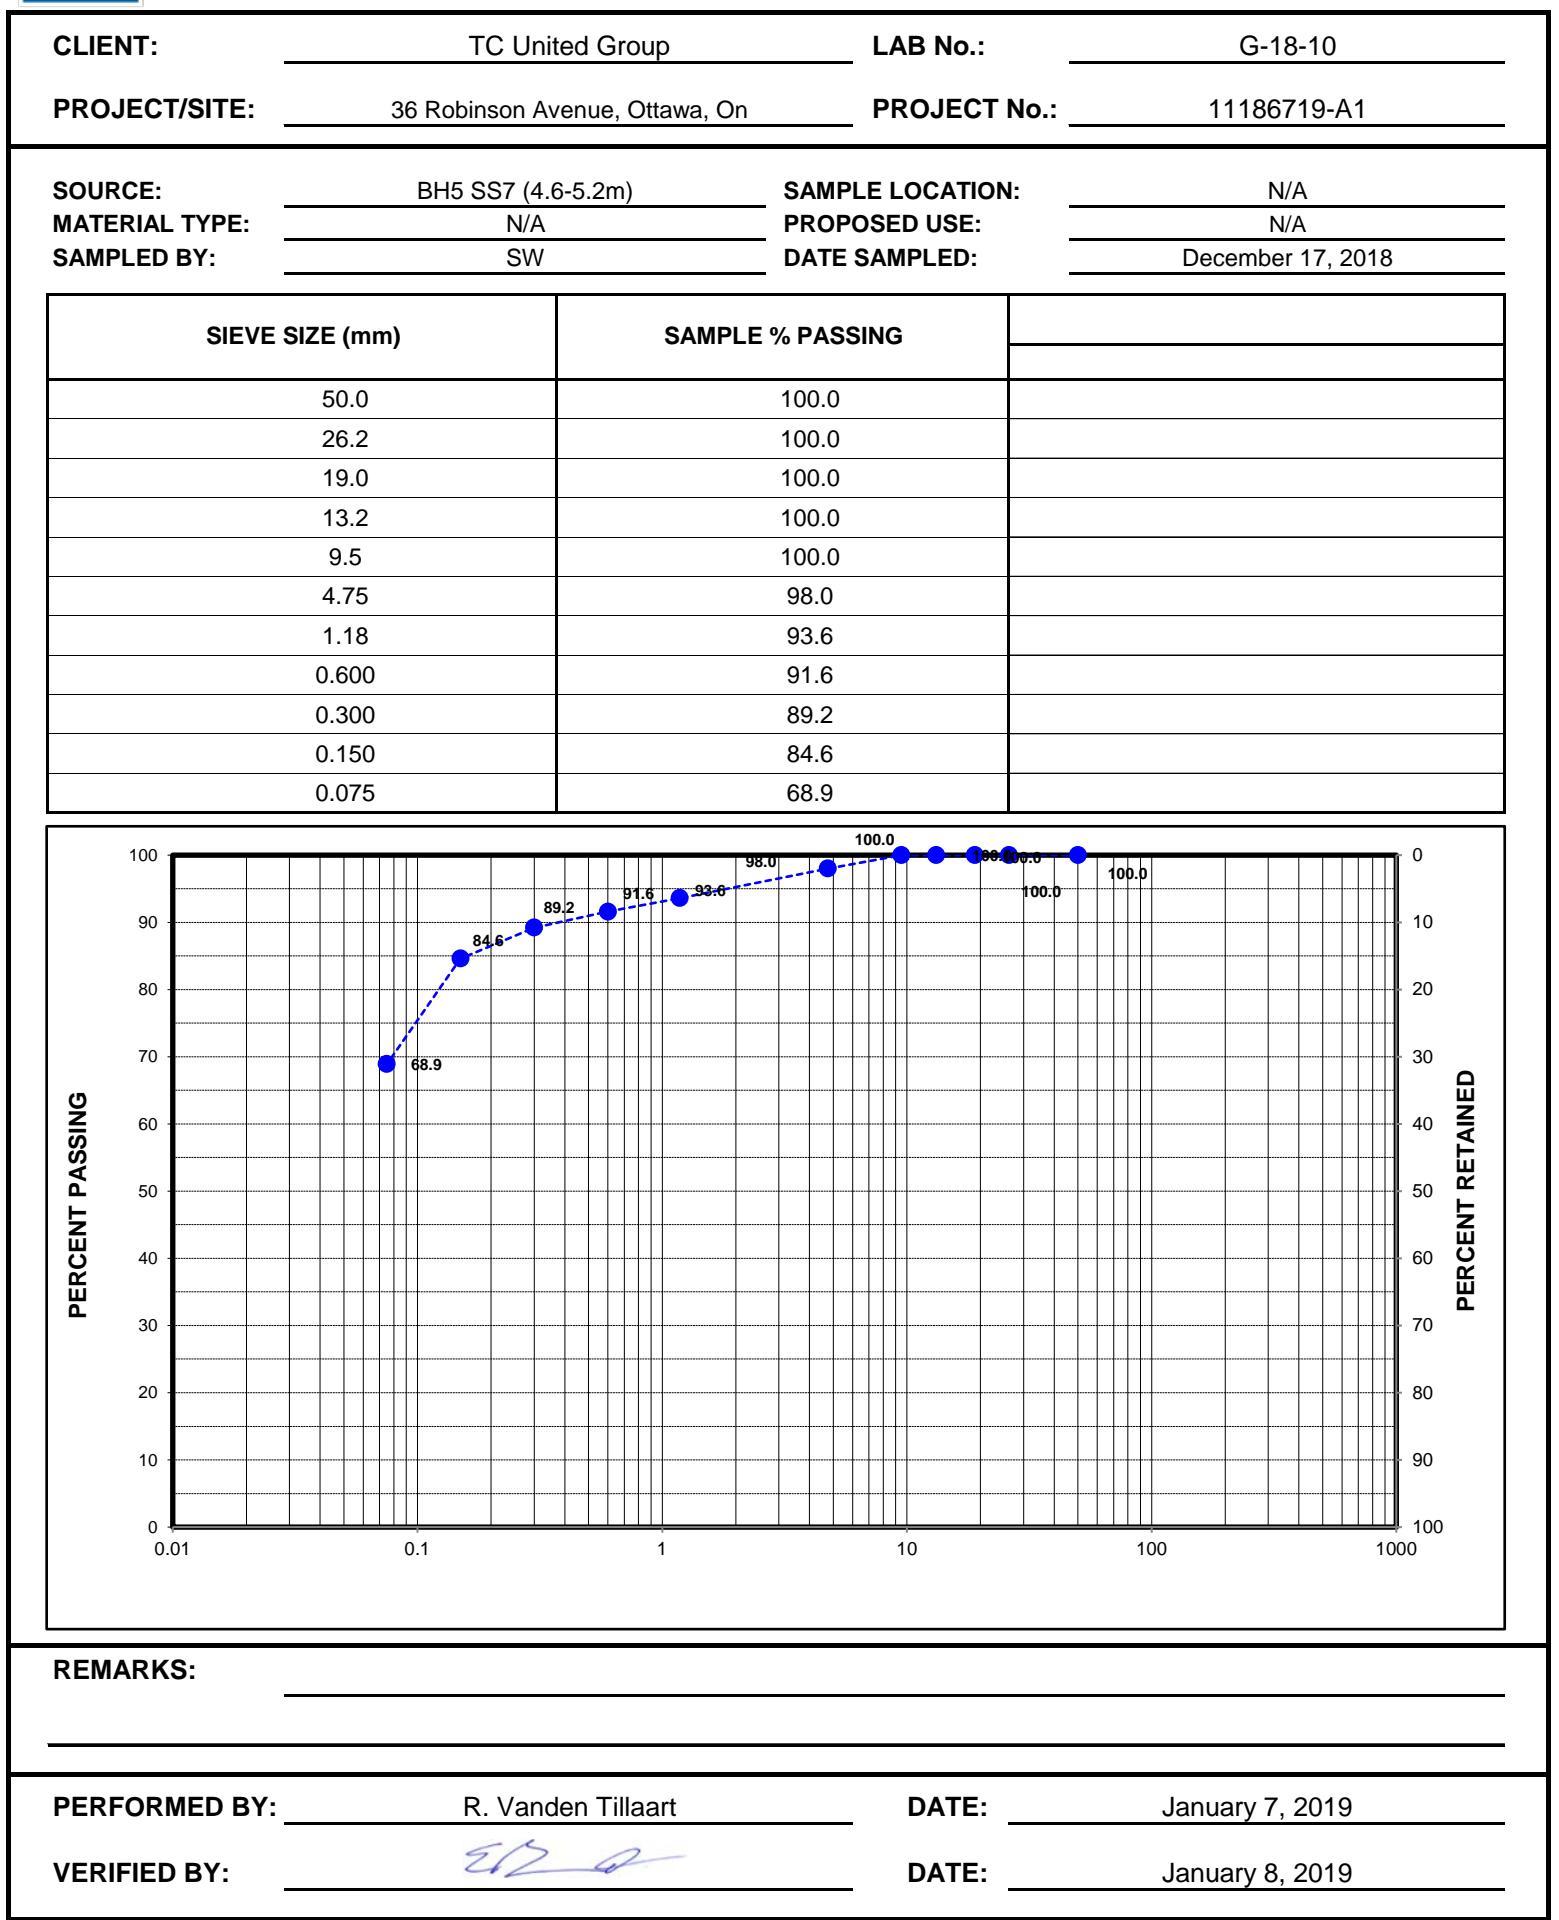
SIEVE ANALYSIS

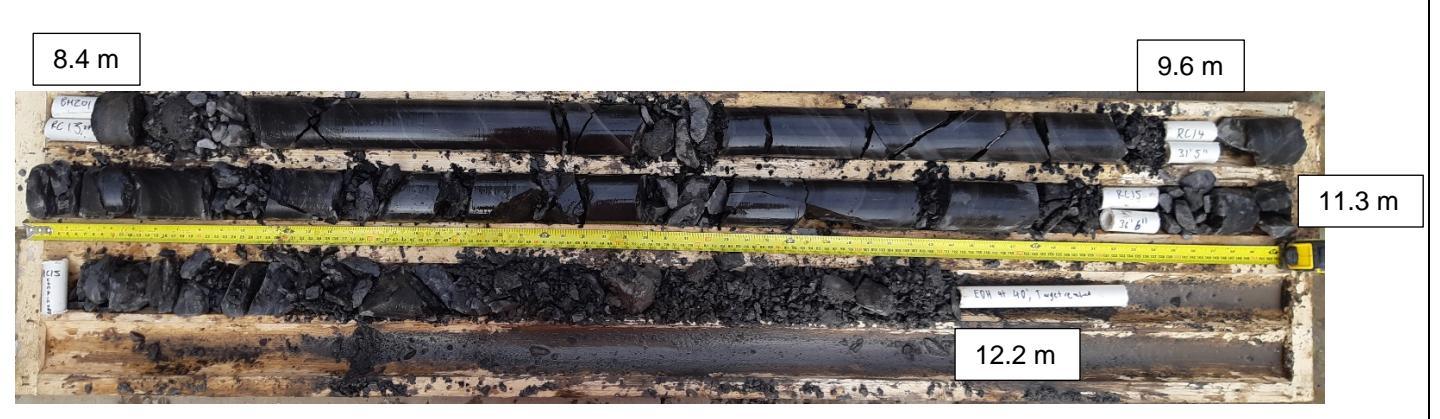
BH7-RC13/RC14/RC15

BH7-RC13, RC14, RC15 November 18, 2019						
Core Run - Depth below ground	Reco	overy	Remarks			
surface (mbgs)	m	%				
BH7 – RC13 – 8.4 to 9.6 mbgs	1.2	100	37% RQD			
BH7 – RC14 – 9.6 to 11.1 mbgs	1.3	84	21% RQD			
BH7 – RC15 – 11.1 to 12.2 mbgs	1.1	100	0% RQD

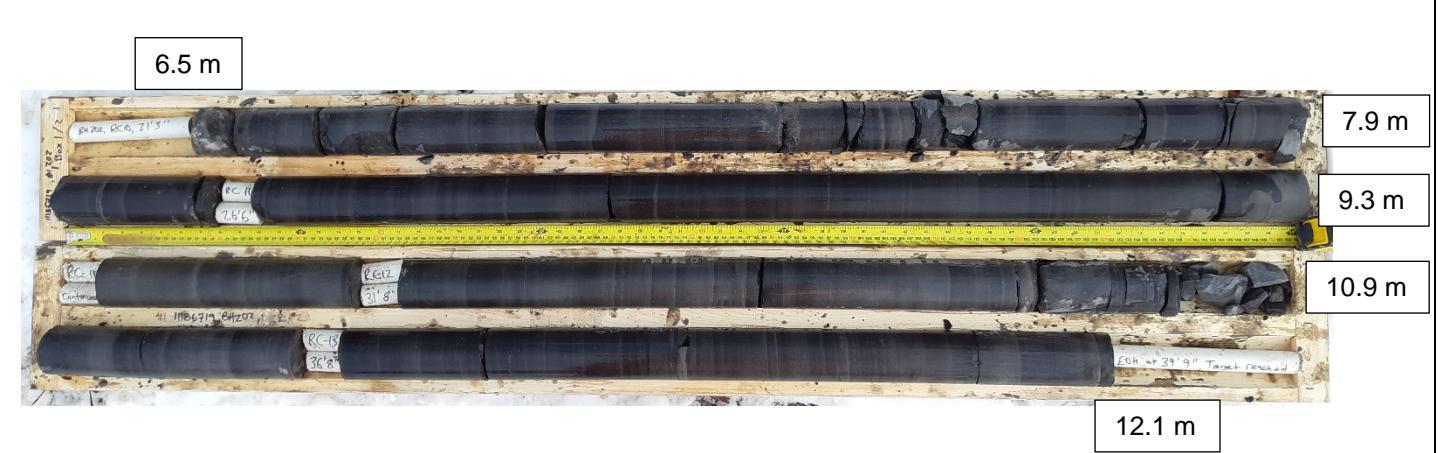
BH8-RC10/RC11/RC12/RC13

BH8-RC10, RC11, RC12, RC13 November 18, 2019						
Core Run - Depth below ground		overy	Remarks			
surface (mbgs)	М	%				
BH8 – RC10 – 6.5 to 8.1 mbgs	1.6	100	57% RQD			
BH8 – RC11 – 8.1 to 9.7 mbgs	1.6	100	100% RQD			
BH8 – RC12 – 9.7 to 11.2 mbgs	1.4	92	70% RQD			
BH8 – RC13 – 11.2 to 12.1 mbgs	0.9	100	100% RQD

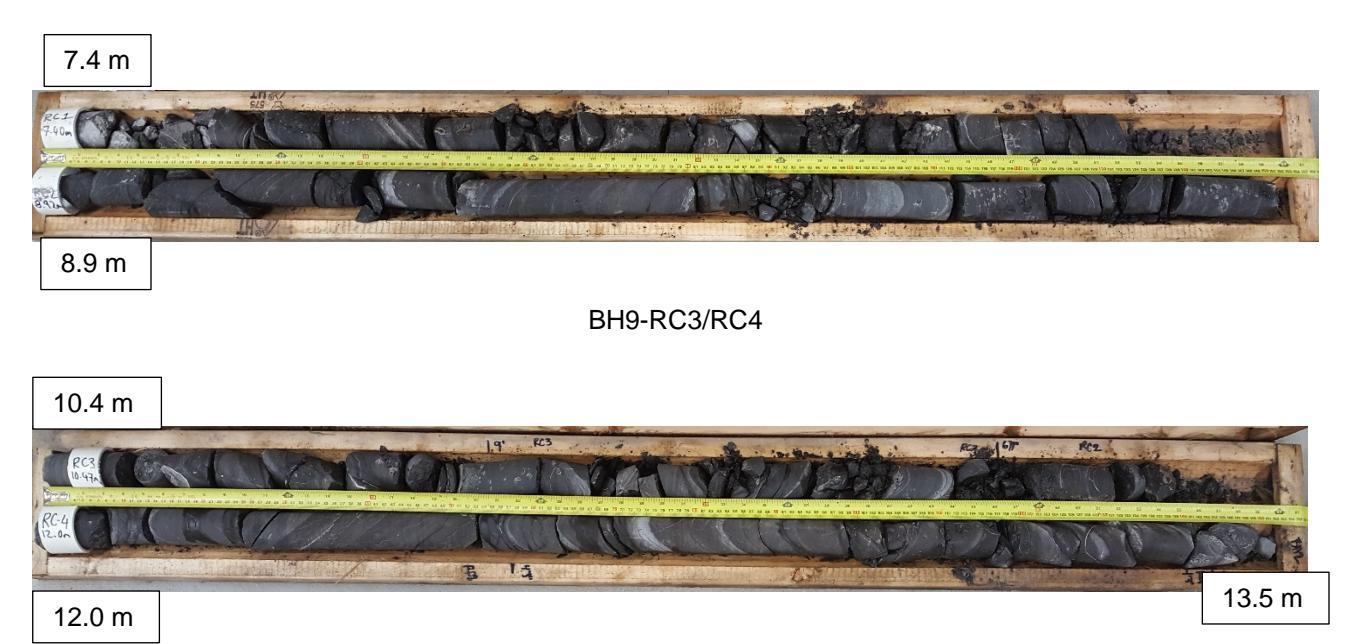
BH9-RC1/RC2

BH9-RC1, RC2, RC3, RC4 December 9, 2019					
Core Run - Depth below ground	Recovery		Remarks		
surface (mbgs)	m	%			
BH9 – RC1 – 7.4 to 8.9 mbgs	1.3	87	9% RQD		
BH9 – RC2 – 8.9 to 10.4 mbgs	1.5	100	50% RQD		
BH9 – RC3 – 10.4 to 12.0 mbgs	1.5	92	14% RQD		
BH9 – RC4 – 12.0 to 13.5 mbgs	1.5	100	44% RQD
