# **ENVIRONMENTAL IMPACT STATEMENT**

6776 Rothbourne Road, Ottawa, ON

Project No.: 0CP-17-0381

## ENVIRONMENTAL IMPACT STATEMENT 6776 ROTHBOURNE ROAD, OTTAWA, ON

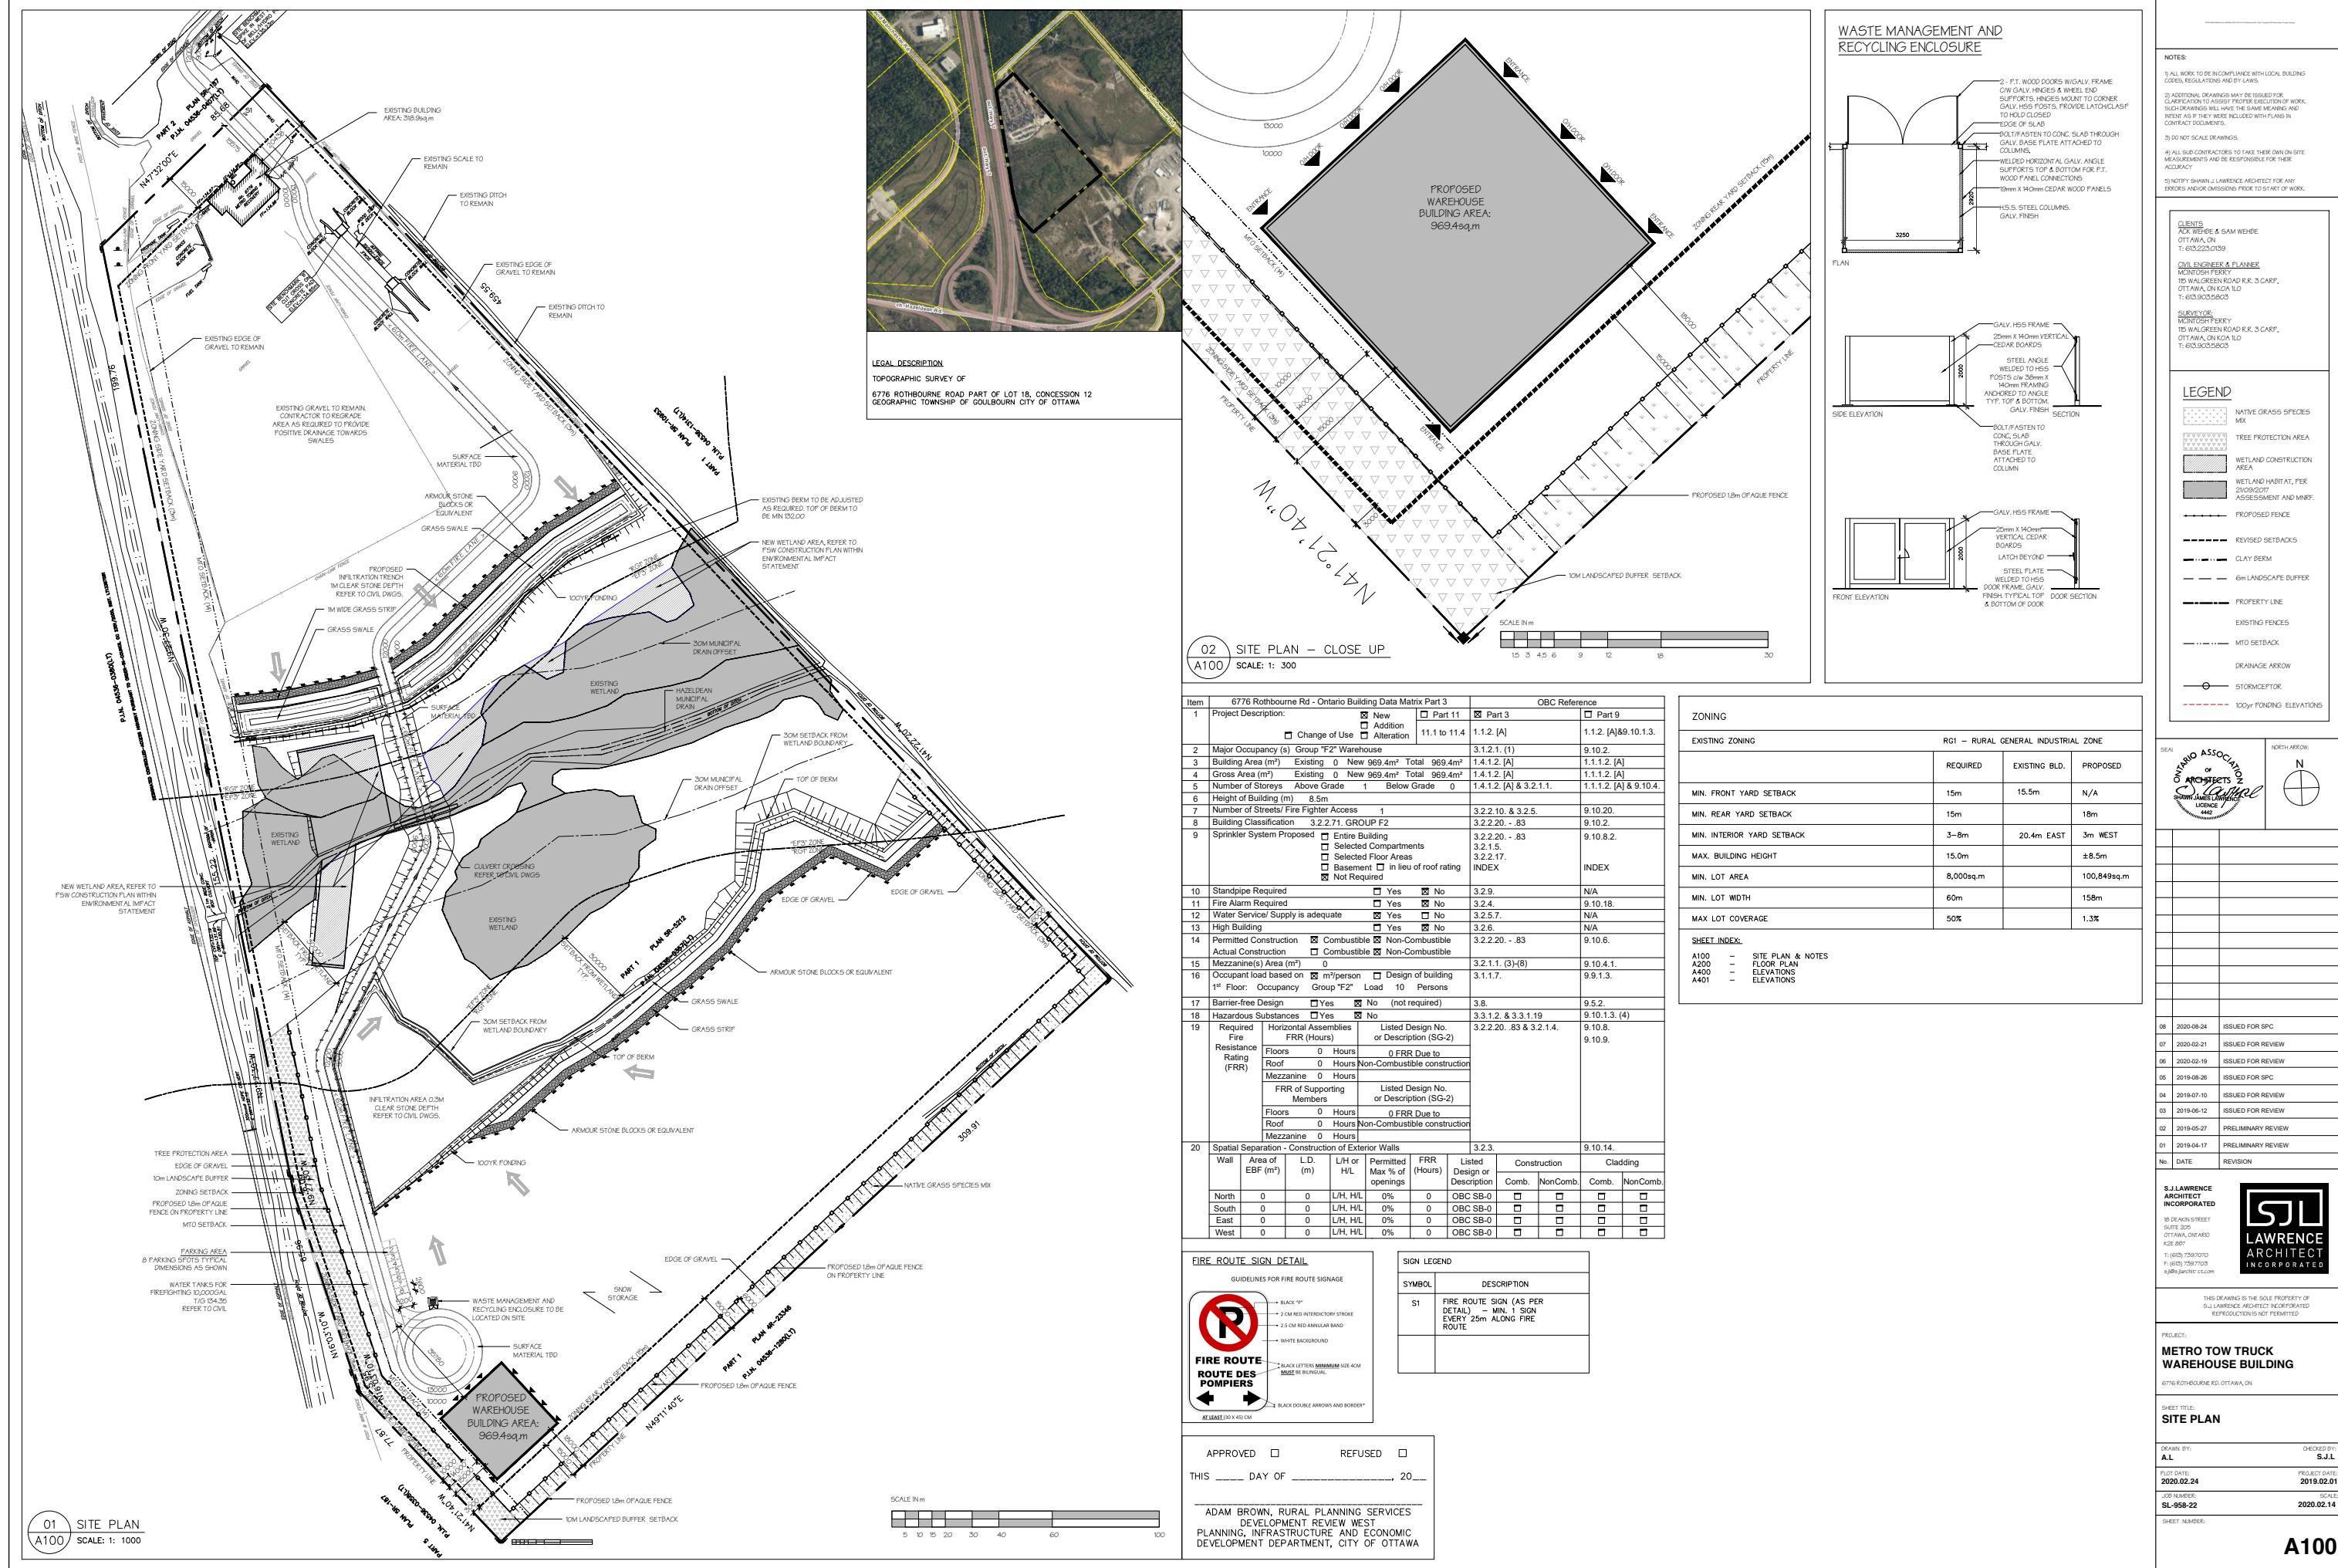
A100

- Zoning side yard setback of 3 m on the west side and 15 m on the south side;
- A landscape buffer setback of 10 m on the west side, and
- Ministry of Transportation of Ontario (MTO) setback of 14 m from the Highway 7 ROW on the west side and south side.

In addition to the setbacks, an opaque 1.8 m fence will be installed along the entire property line including the existing tow yard property north of the study area.

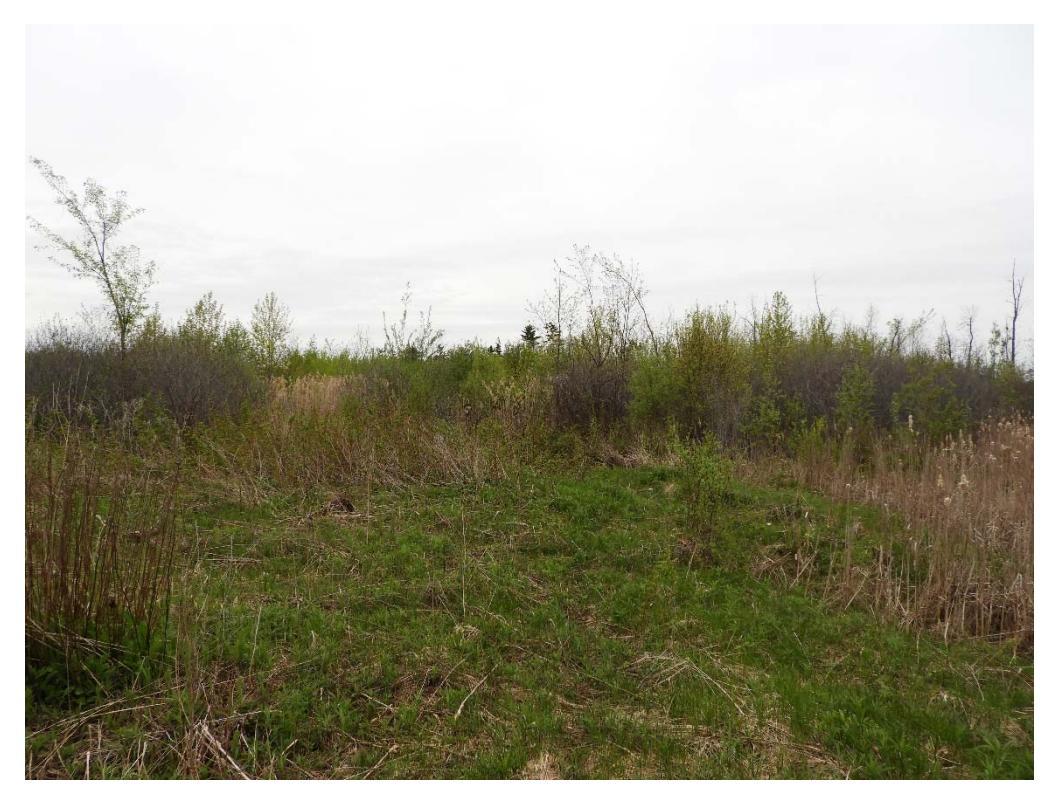
*Photo 3: North end of proposed fire route access road through the Mineral Meadow Marsh in the north end of the 20 m setback from the PSW. 23 May 2019.*

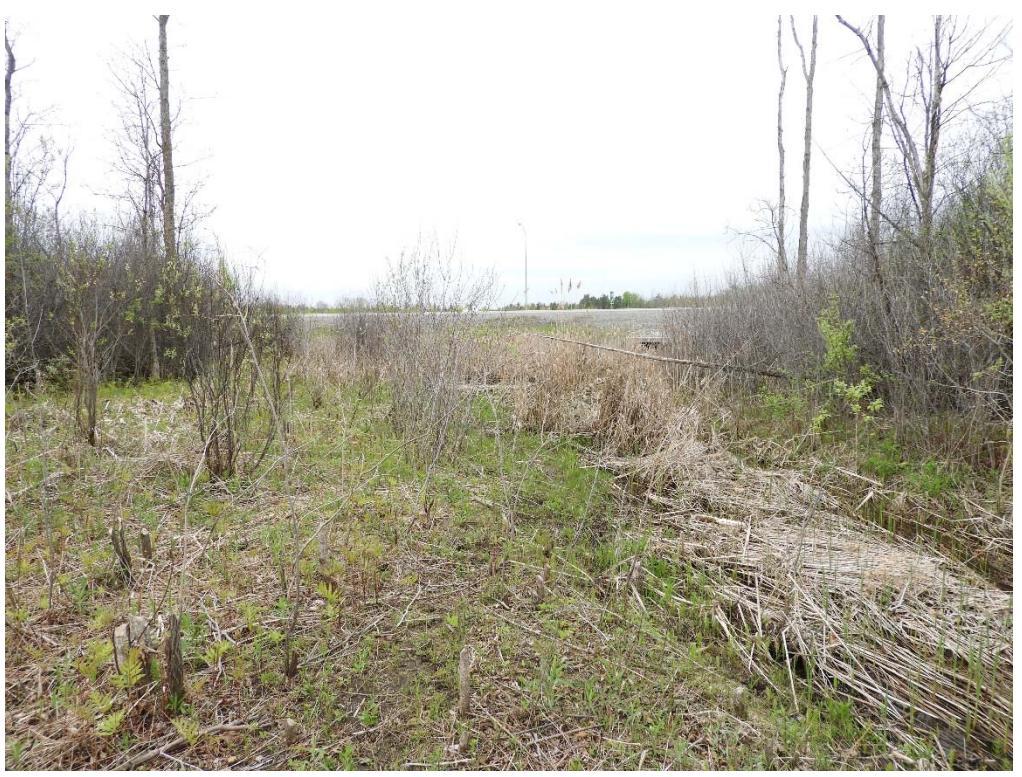
Photo 8: Upstream view of tributary of Poole Creek entering study area from Highway 7 culvert (background) and entering PSW within study area. 23 May 2019.

During the field investigations, the soils were observed to have moderately poor drainage as was evident with the wet soils and wetlands present in the study area. Standing water was present in many areas adjacent to the tributary (**Photos 2 - 14**). The tributary was flowing during the May 23, 2019 field investigation; however, the rate was low. Potential groundwater was observed within the tributary due to oil-like films on the water surface within the portions of the watercourse within the cattail wetland; however, this may have been caused by runoff from Highway 7. The depth of the water varied from approximately 0.3 to 0.8 m deep. The substrate consisted of silt, clay, muck, and organic debris. The banks of the watercourse had very shallow slopes and contained tall shrub swamp conditions. Robust emergents, narrow-leaved emergents, and ground cover types of vegetation were also present within and adjacent to the watercourse. No fish were observed within the watercourse during the May 23, 2019 field investigation.

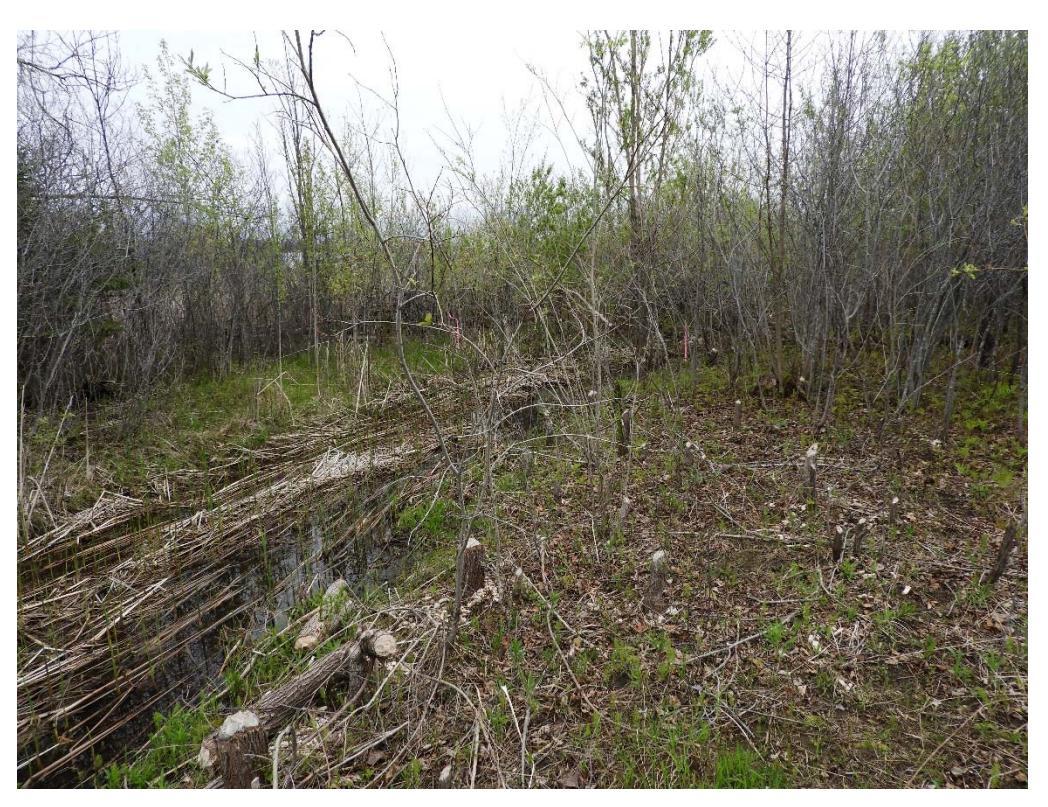
Photo 9: Downstream view of tributary of Poole Creek within Willow Mineral Thicket Swamp (SWT2-2) of the PSW. 23 May 2019.

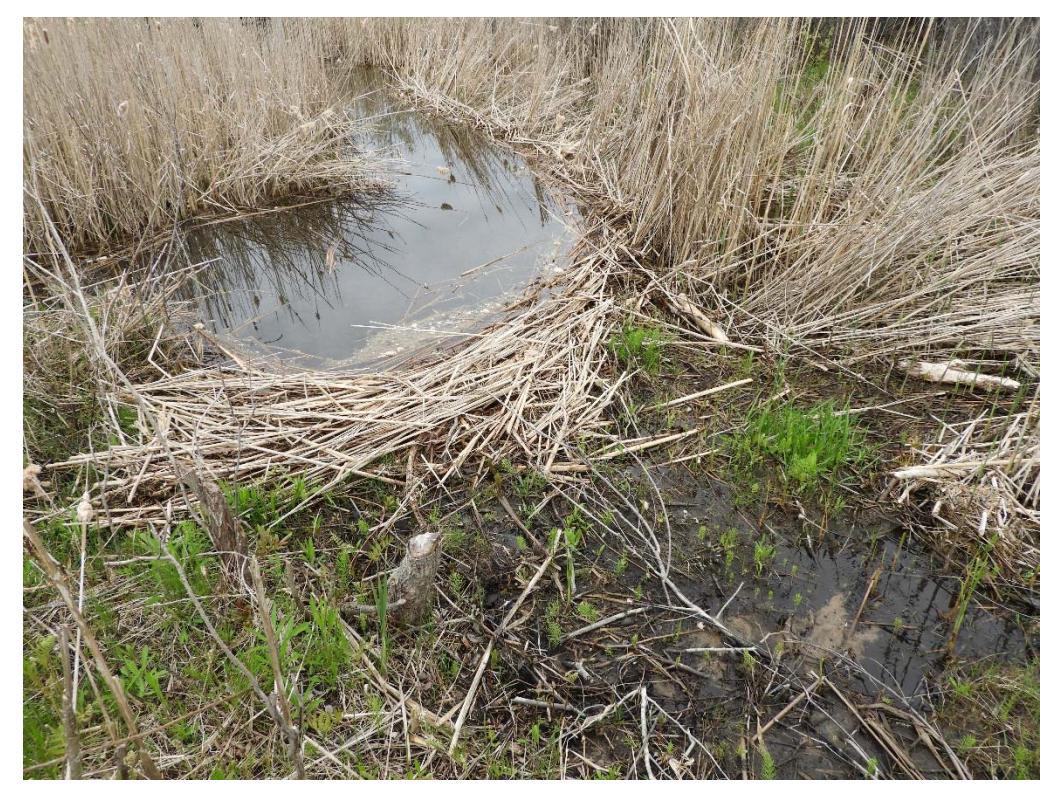
Photo 10: Small beaver dam constructed in the tributary of Poole Creek within the PSW. 23 May 2019.

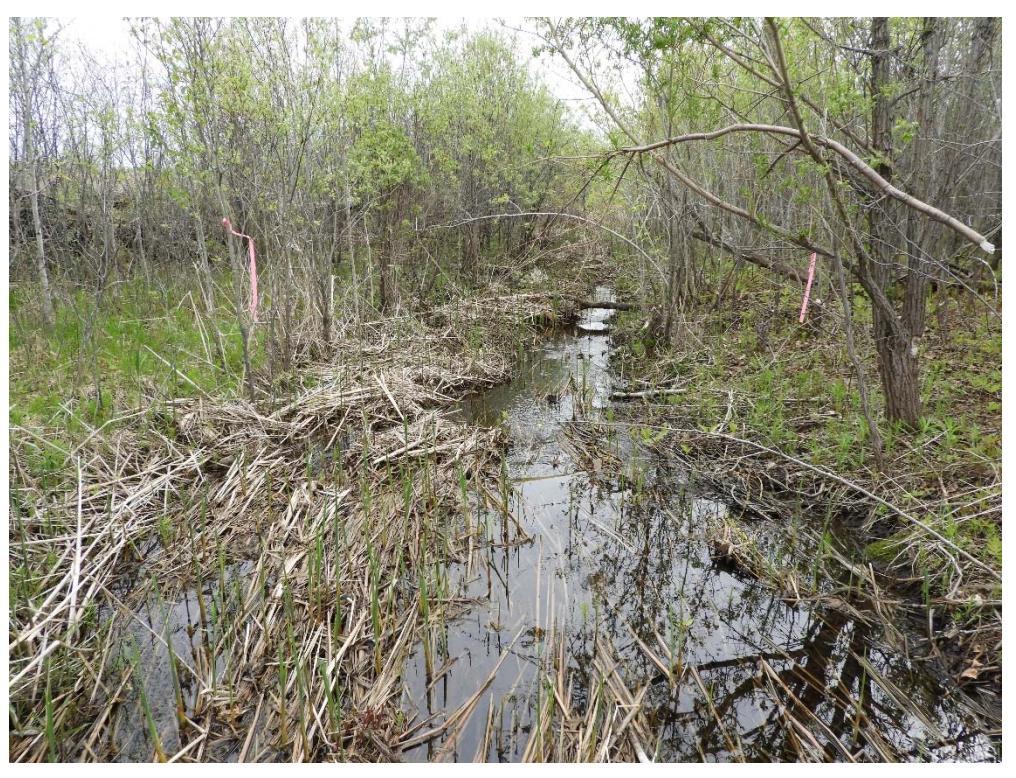
Photo 12: Downstream view of tributary of Poole Creek within the PSW. 23 May 2019.

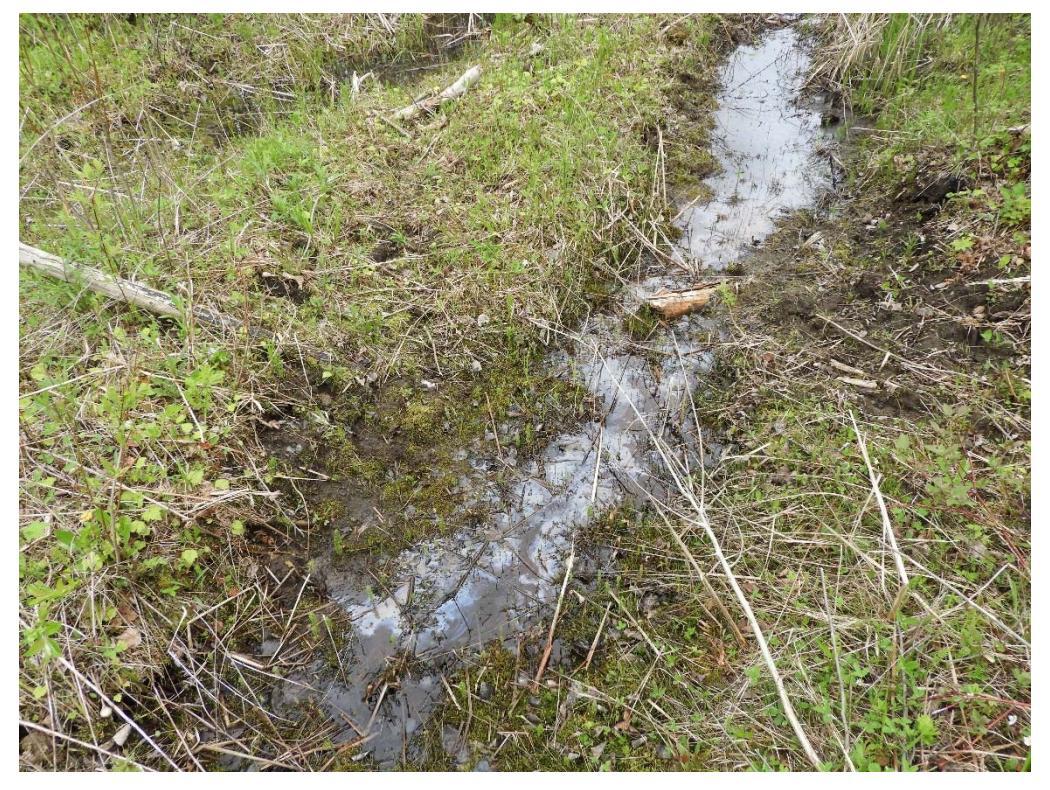
Photo 14: Film on standing water which may indicate groundwater upwelling within the PSW. 23 May 2019.

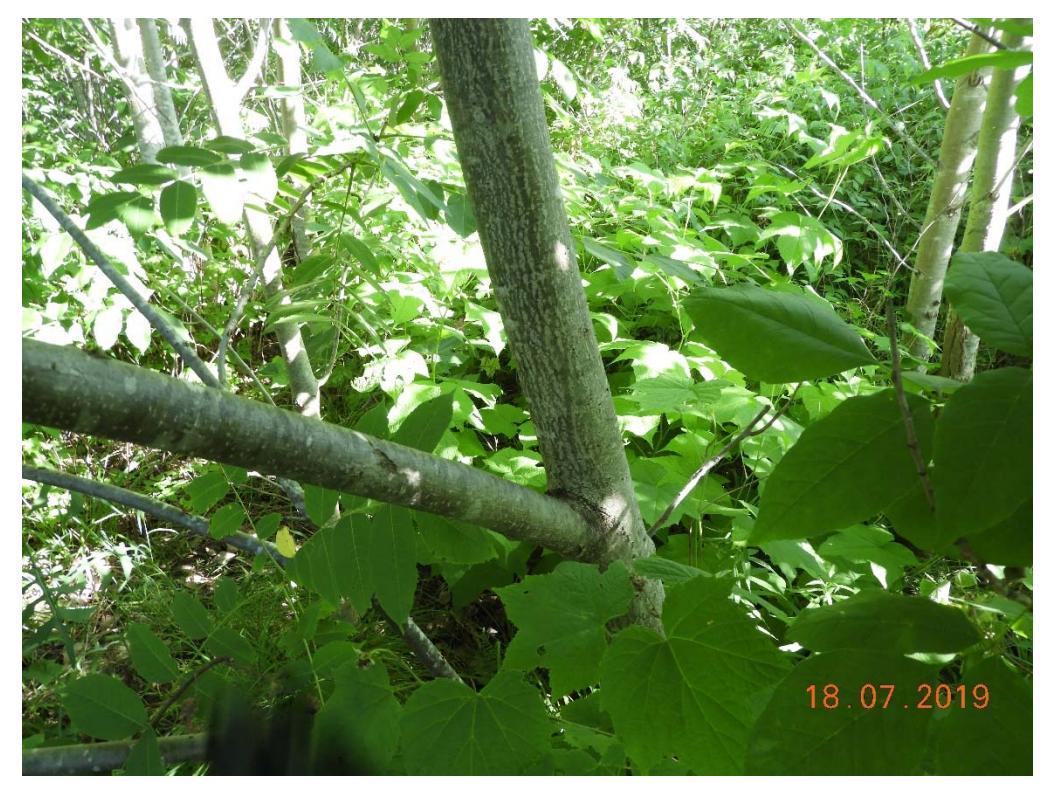
Photo 20: Bark of mature Butternut (Juglans cinerea) with low rate of damage from Butternut canker. 18 July 2019.

A Butternut Health Assessment was conducted in the study area on August 13, 2019 and a report was prepared on September 5, 2019 (**Appendix C**). A total of 17 Butternuts were identified within the study area. Four (4) of the individuals were ranked as Category 2 and 13 of the individuals were ranked as Category 2. The Report noted that a large portion of the lands that were surveyed had recently been cleared. No other at-risk vegetation was observed within this area. Impact to adjacent vegetation as a result of the proposed removal is not anticipated. The entirety of the development is proposed to occur within the study area.

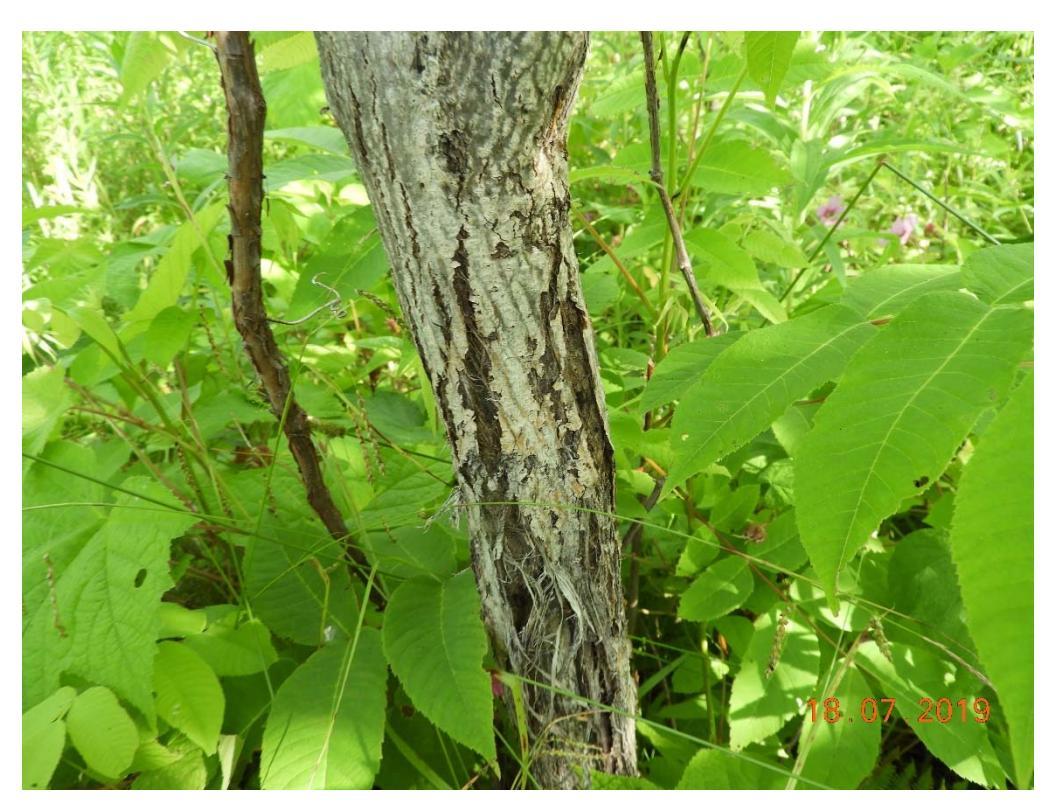
*Photo 21: Bark of mature Butternut (Juglans cinerea) with moderate rate of damage from Butternut canker. 18 July 2019.*

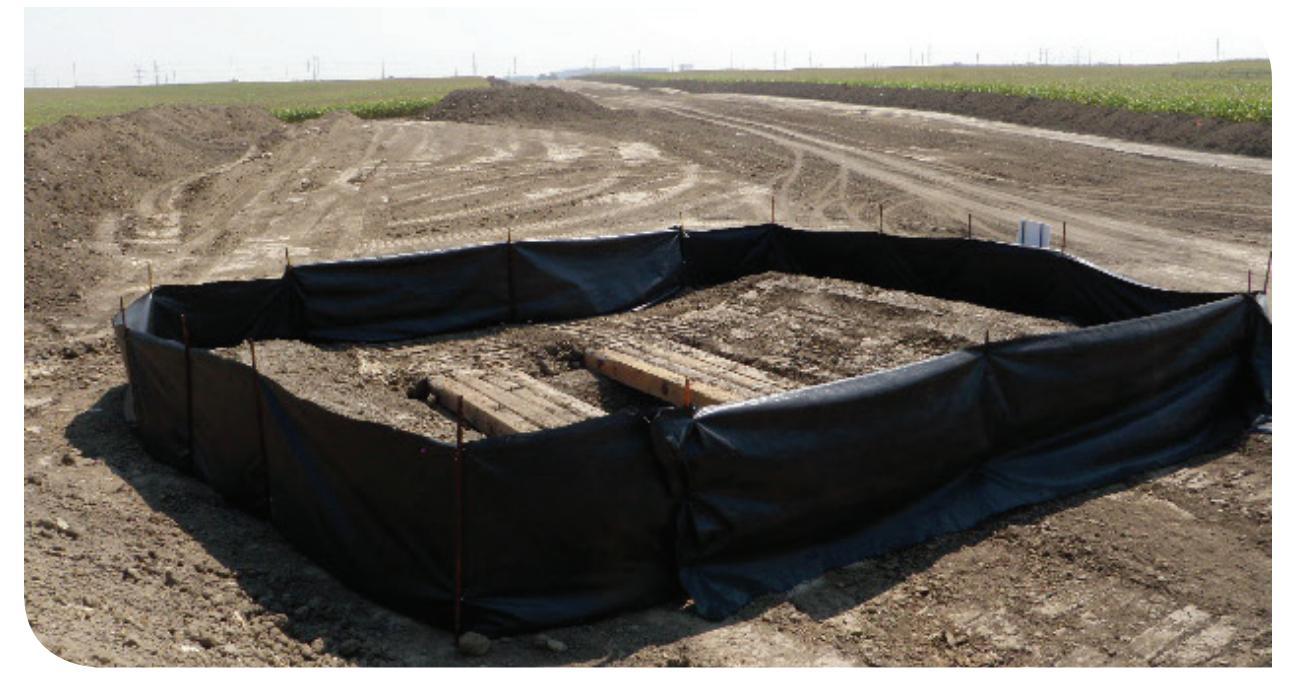
Cleaning station at construction site. Photo by: Mark Heaton, OMNR

- A pump and high pressure hose OR High pressure water unit
- Minimum water pressure for vehicle cleaning should be at least 90 pounds per square inch. Water can be supplied as high volume/low pressure or low volume/high pressure (NOAA Fisheries Service).
- Air compressor and blower OR Vacuum
- Shovel
- Pry bar
- Stiff brush or broom

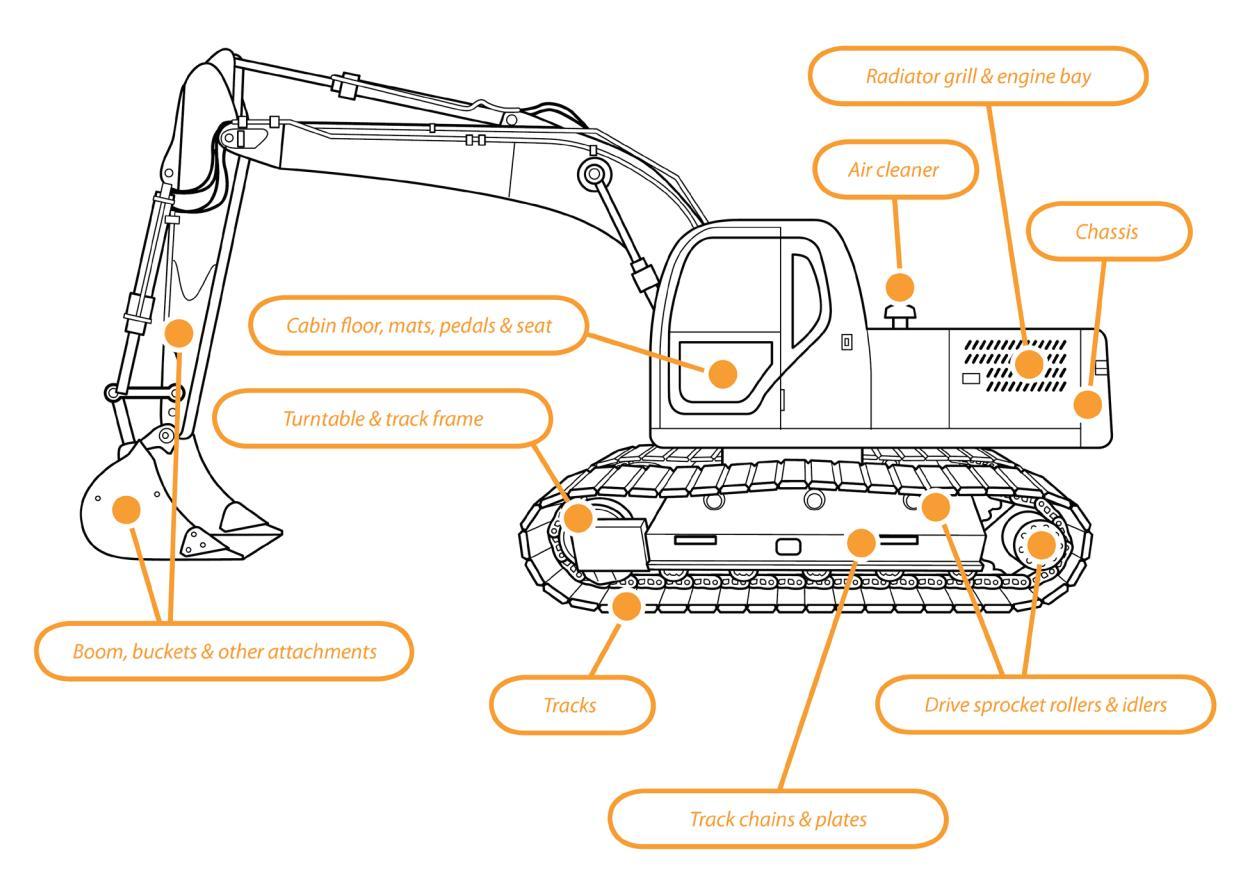
### EXCAVATOR WITH KEY SPOTS TO CHECK AND CLEAN

$\checkmark$
Cabin	Floor, mats, pedals, seats	
Engine	Radiators, engine bay, grill, air cleaner	
Tracks	Tracks, track frame, drive sprocket rollers, idlers	
Body Plates	Plates of cabin	
Body	Ledges, channels	
Bucket		
Booms		
Turret Pivot

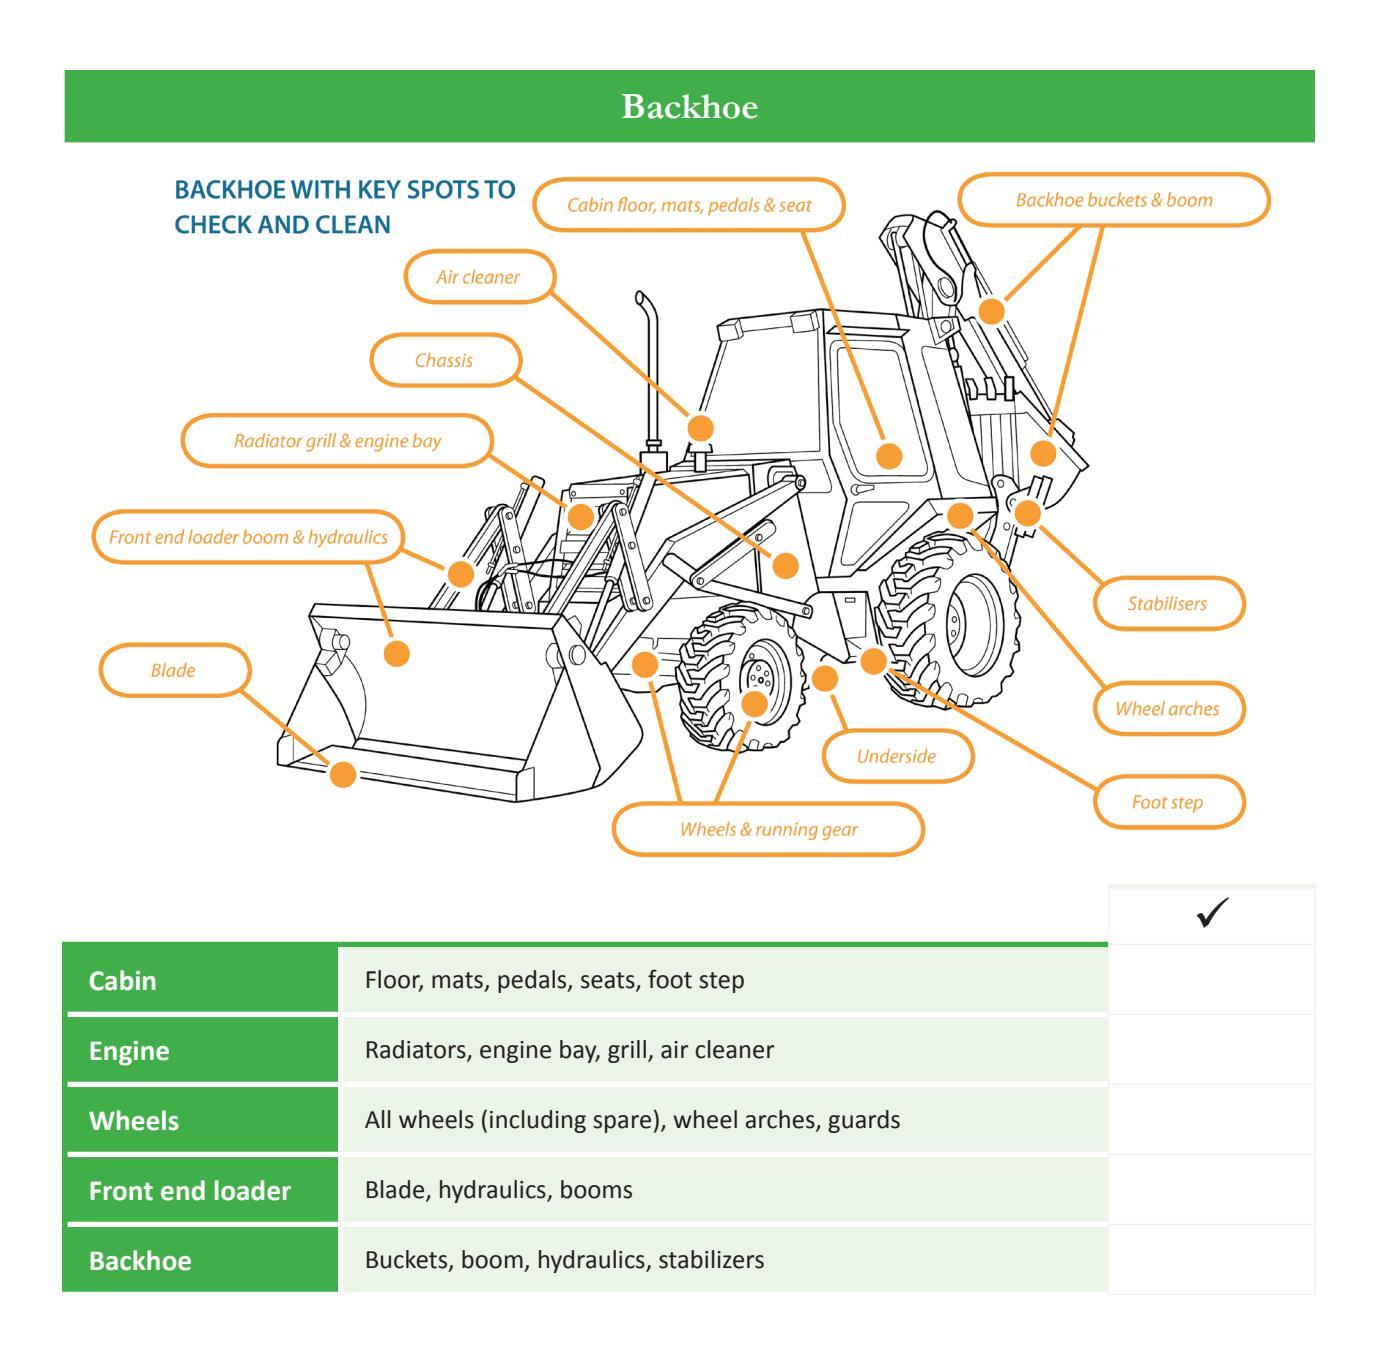
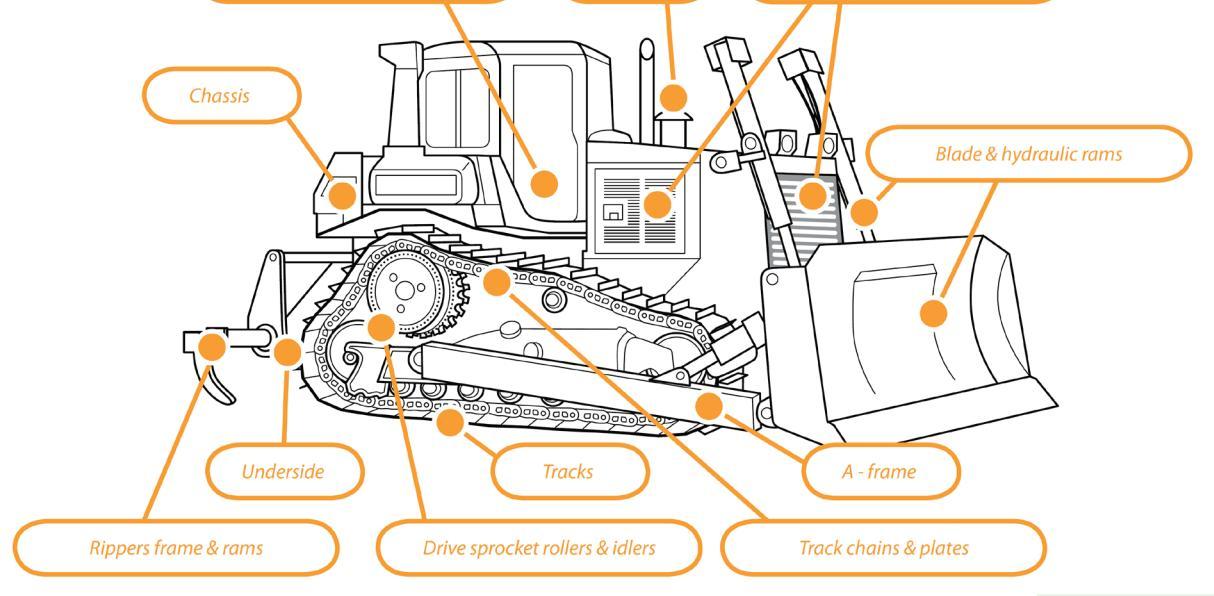
# Bulldozer BULLDOZER WITH KEY SPOTS TO CHECK AND CLEAN Cabin floor, mats, pedals & seat Air cleaner Radiator grill & engine bay

Cabin	Floor, mats, pedals, seats	
Engine	Radiators, engine bay, grill, air cleaner	
Tracks	Tracks, track frame, drive sprocket rollers, idlers	
Body Plates	Belly plates and rear plates	
Body	Ledges, channels	
Blade	Pivot points, hydraulic rams, a-frame	
Ripper	Ripper frame, ripper points
