# PHASE ONE ENVIRONMENTAL SITE ASSESSMENT

# 2020 BANTREE STREET, OTTAWA, ONTARIO

Client: 7137796 Canada Inc. Date: November 30, 2021 Project #: 11556- DRAFT

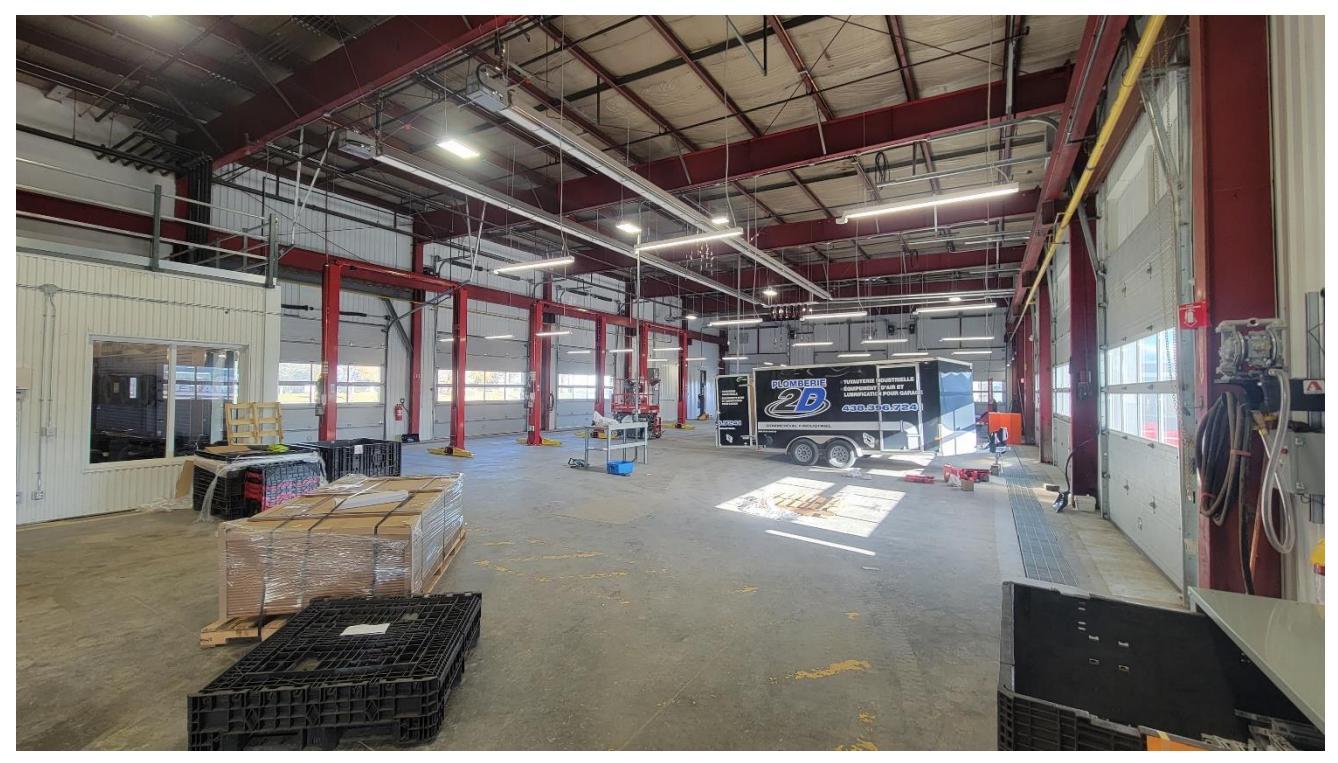
Photo 1: Facing Northeast, northeast corner of the Site, this section of the Site had been renewly renovated. Four aboveground Hydraulic Hoists can be seen in the background.

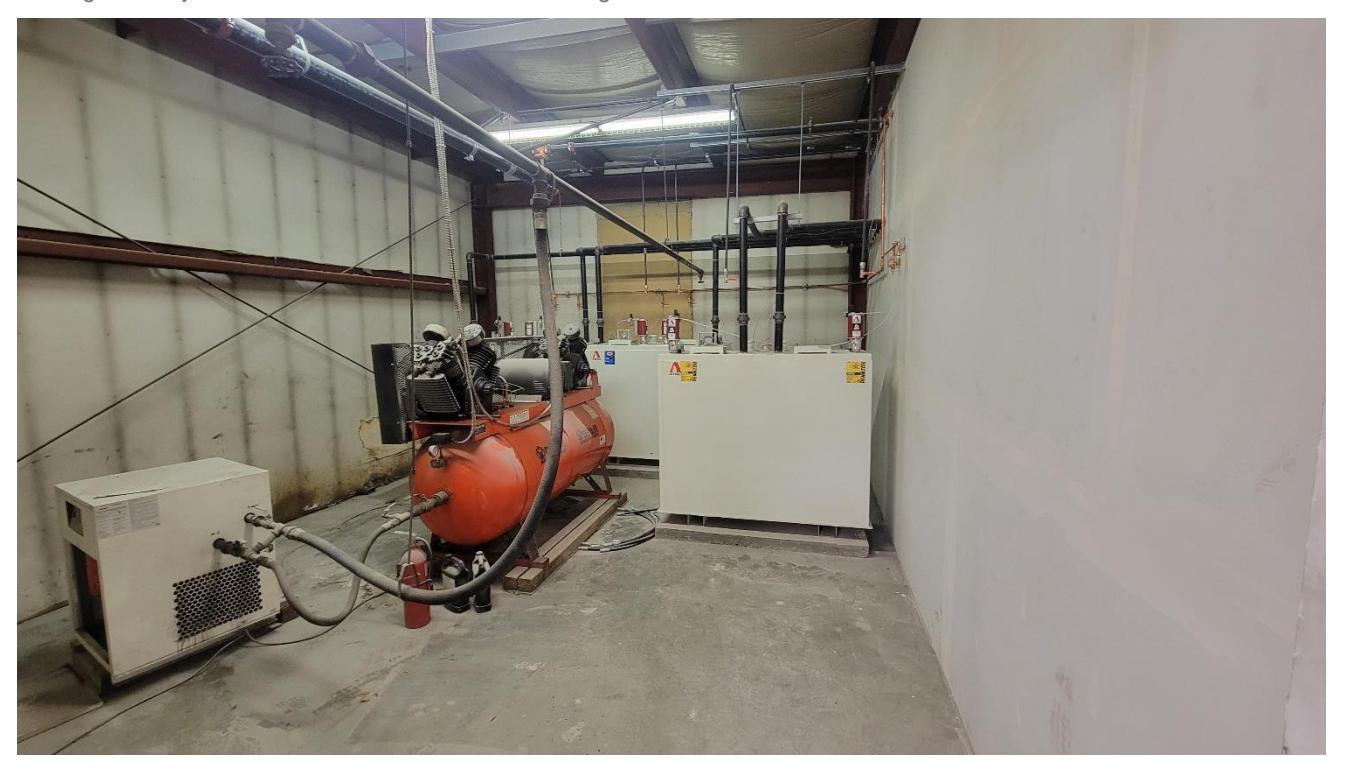
Photo 2: Facing Northeast, second floor northeast corner of the Site building. Three 2200L Active ASTs containg engine oil along with a compressor present.

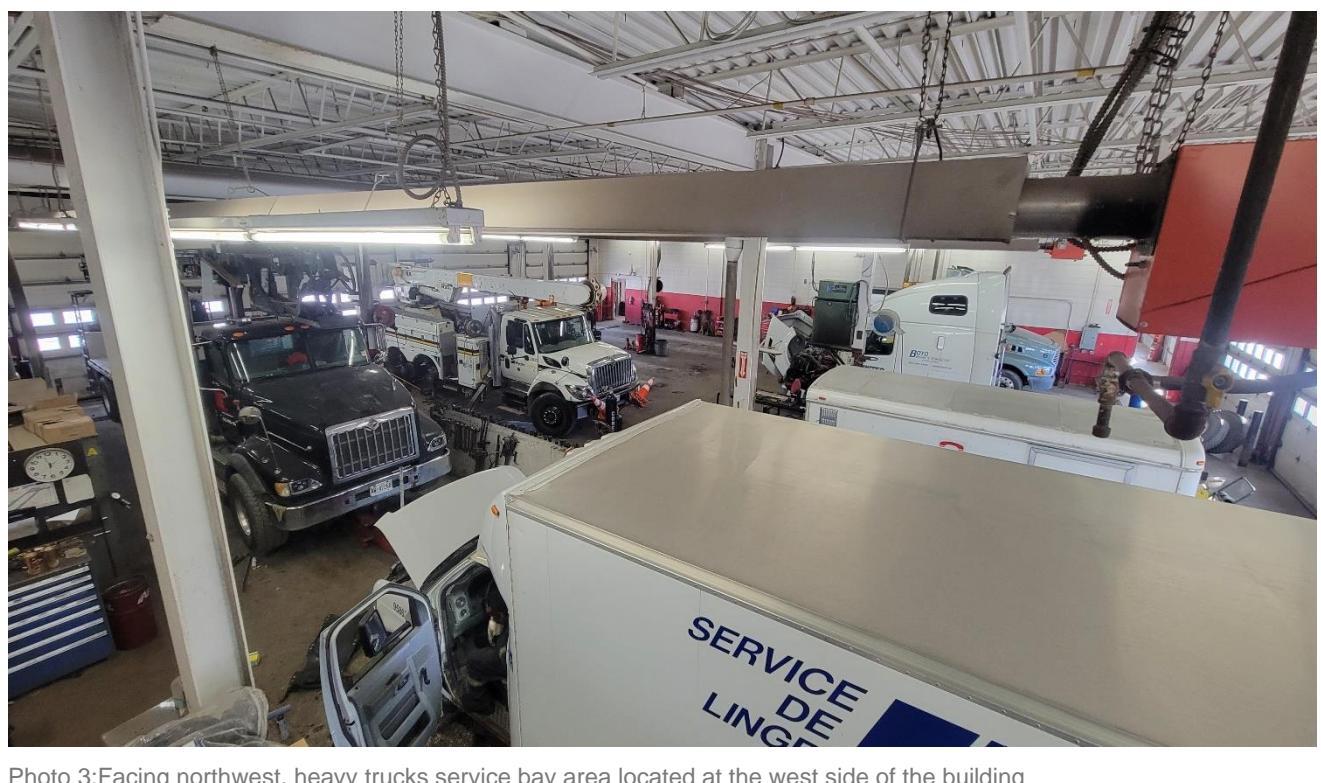
Photo 3: Facing northwest, heavy trucks service bay area located at the west side of the building

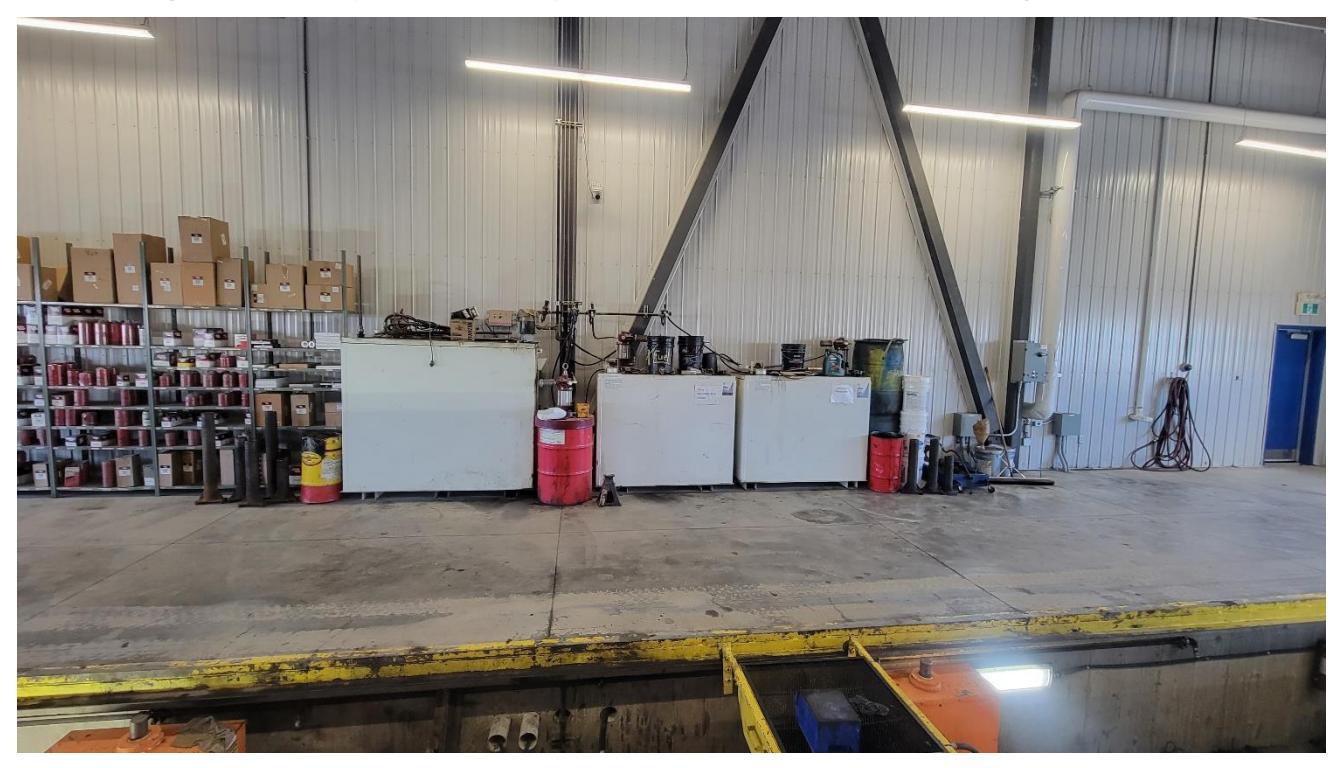
Photo 4: Facing south, three active ASTs containing engine oils present at the southwest corner of the building.

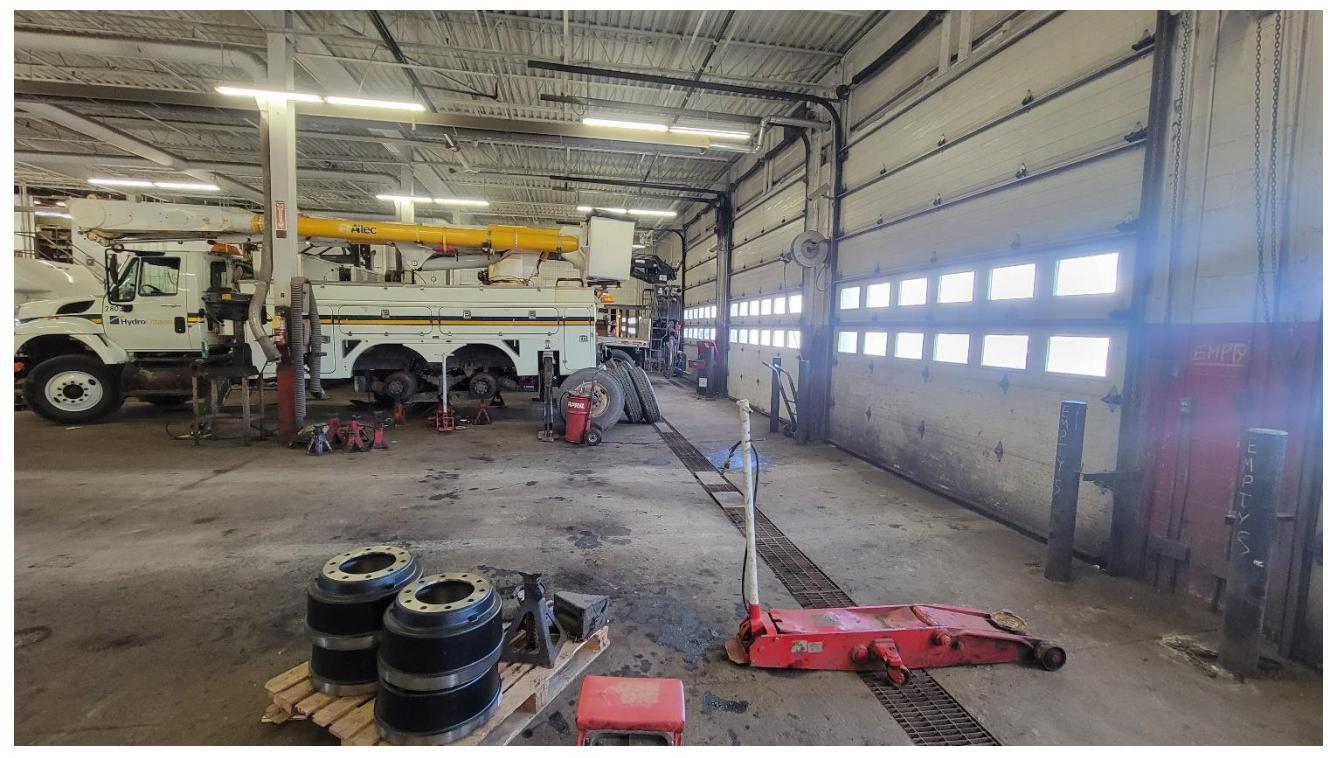
Photo 5: Facing south, moderate levels of oil stains observed on the concrete floor, floor drains leading to an Oil Water Separator present along the western portion of the building.

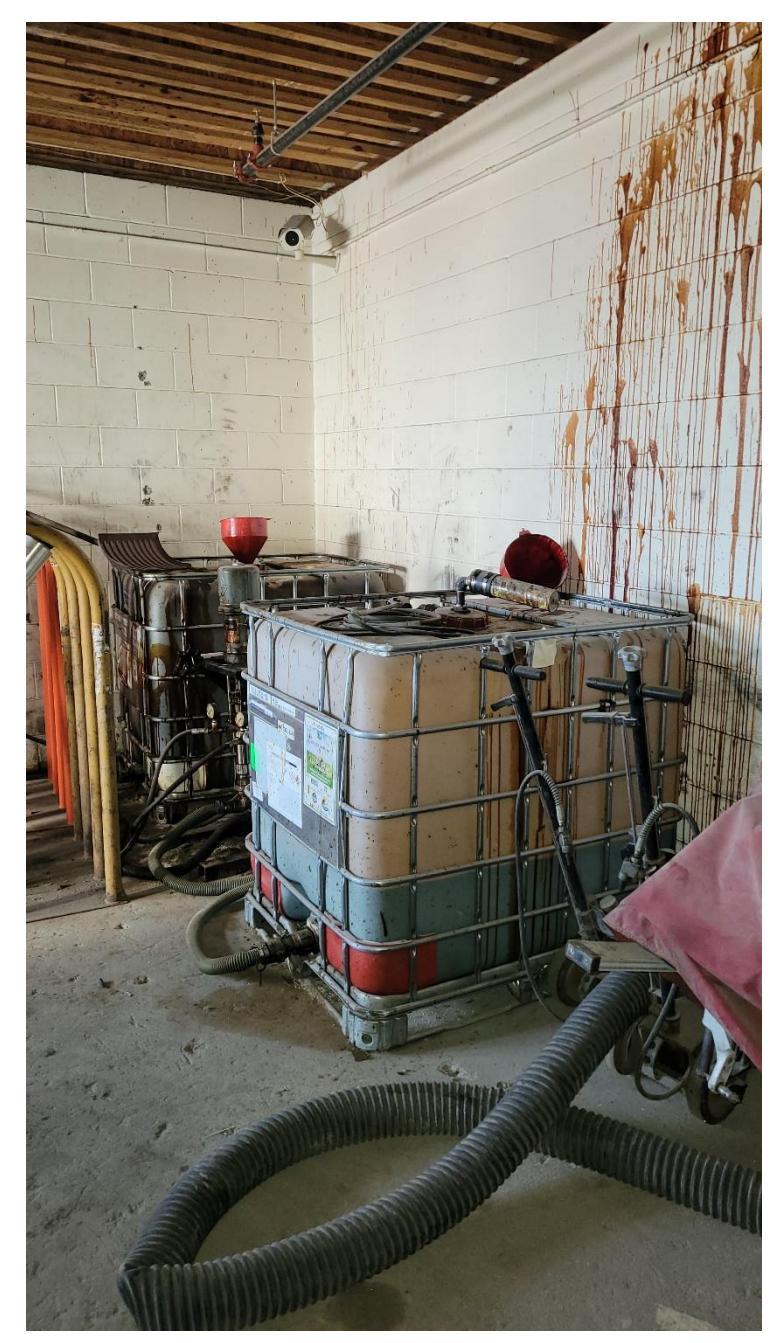
Photo 6: Facing northwest, two 275 Gal totes containg Hydraulic Fluid present, staining present on the totes and the neighbouring wall.

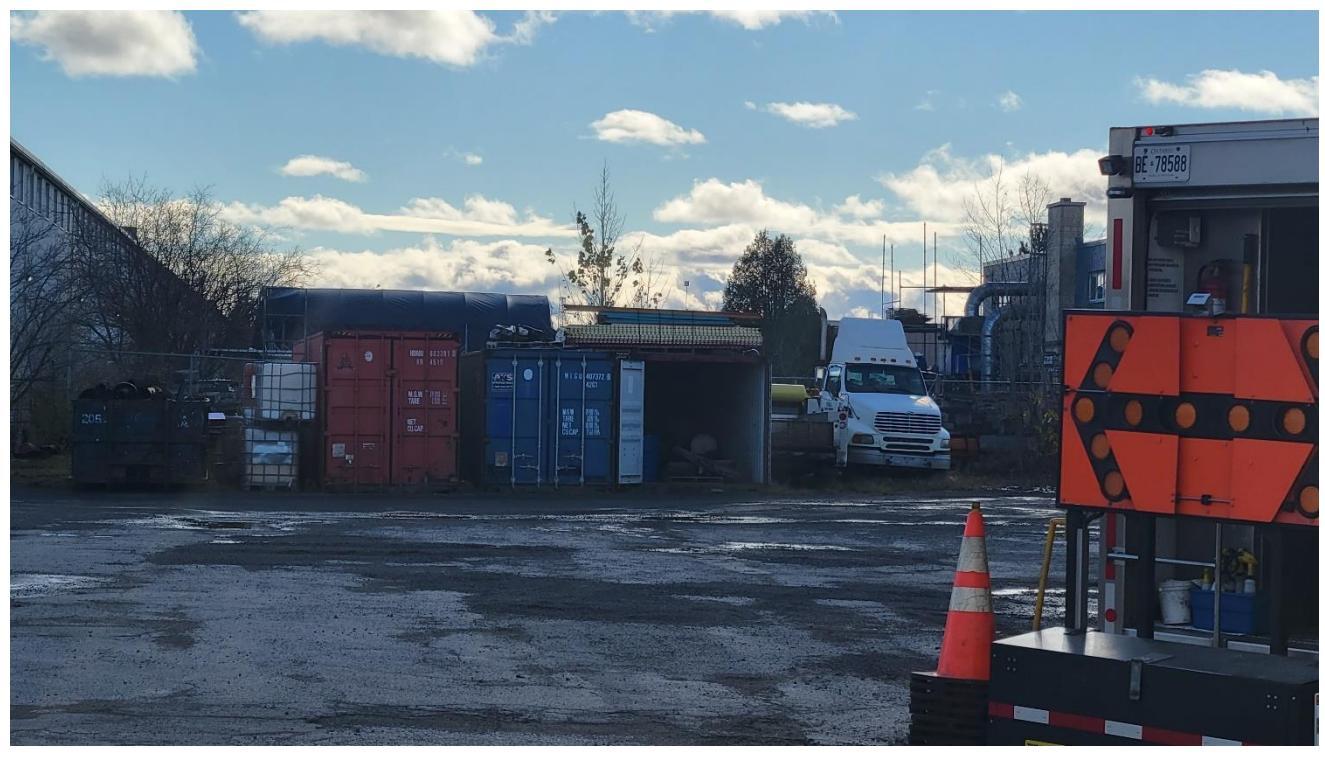
Photo 7: Facing south, southern perimeter of the Site used for storage and parking.
