Phase One Environmental Site Assessment

214-224 Somerset Street East Ottawa, Ontario

Prepared for: Ottawa Community Housing Corporation

June 21, 2023 LOP23-025B

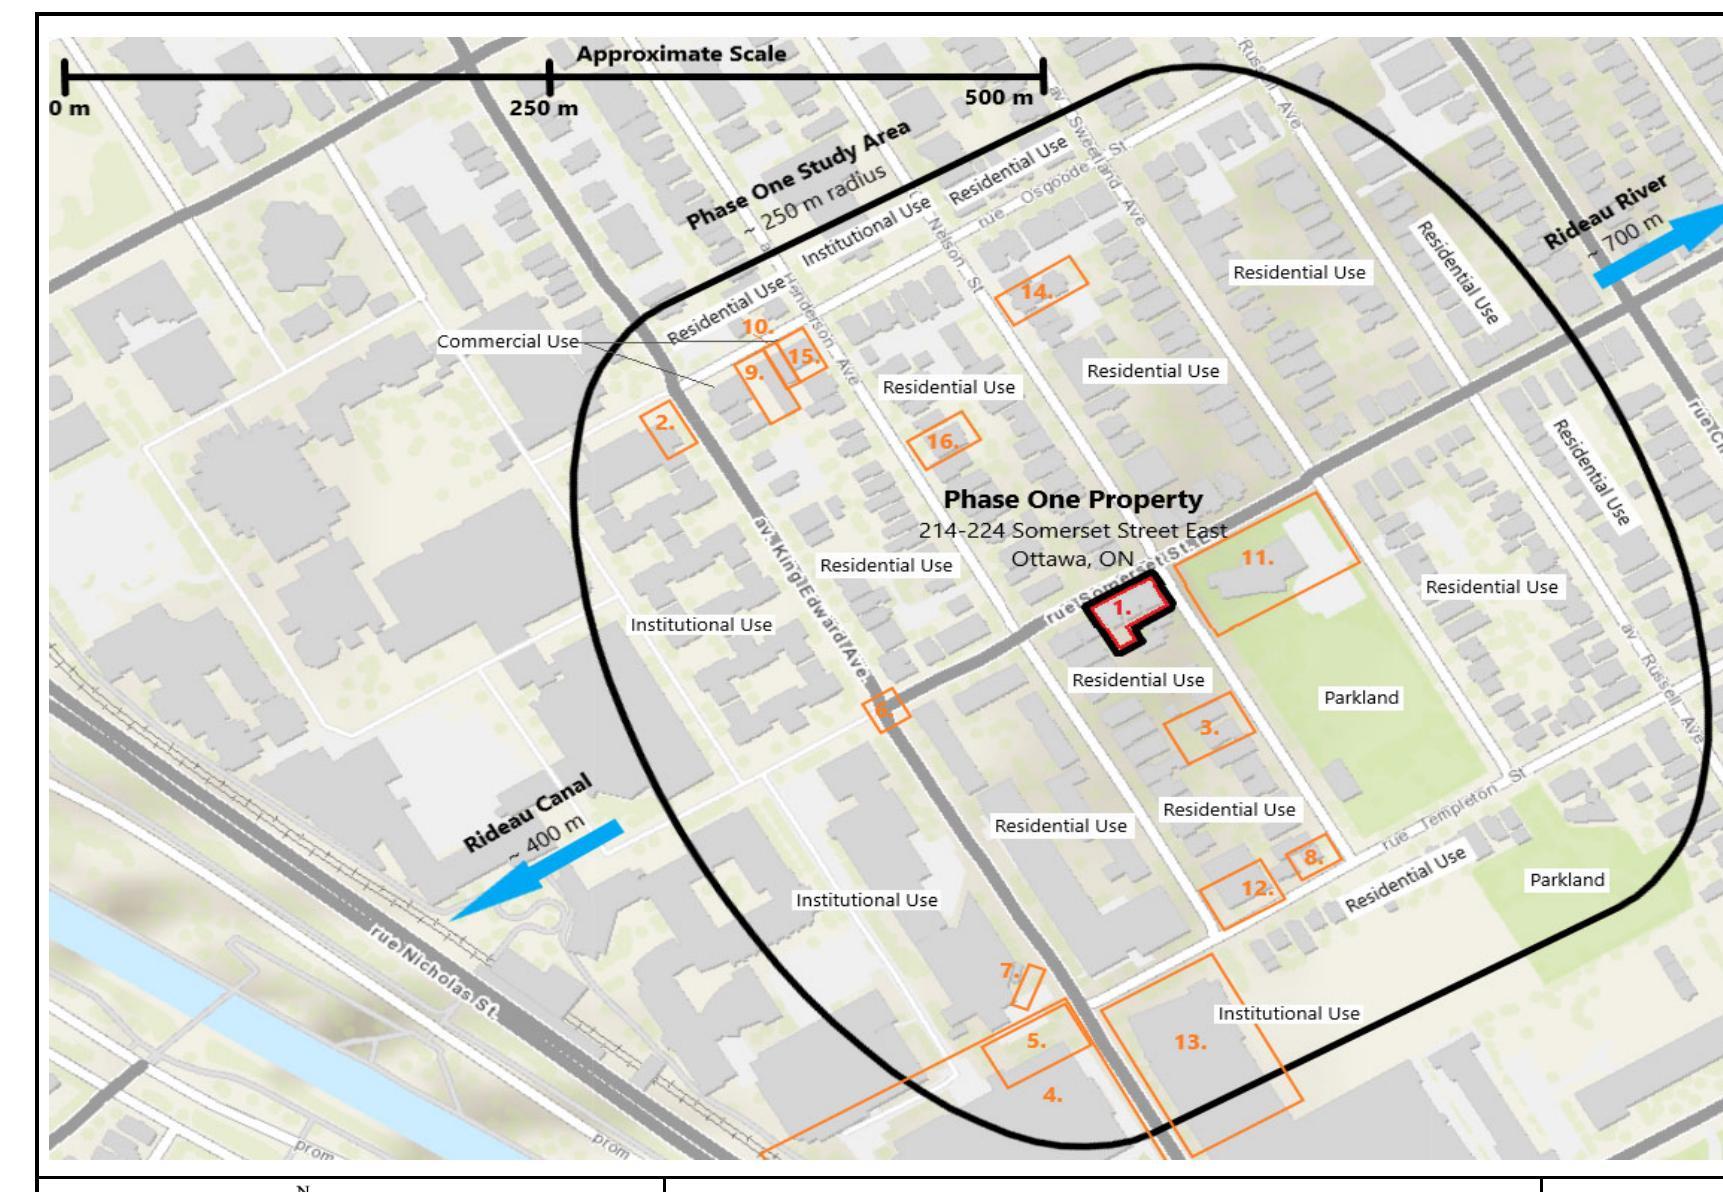
Project Reference No: LOP23-025B Drawing No.: LOP23-025B-3 Date: April 16, 2023 Author: L. Lopers Source: geoOttawa

Neighbouring land uses are shown on Figure 3: Surrounding Land Use. Two PCAs were observed during the review of land use in the Phase One Study Area.

- A hydro substation was observed at 113 Henderson Avenue, approximately 110 m northnorthwest of the Phase One Property. The hydro substation represents PCA #16, however, this operation is located a significant distance from the Phase One Property, so is not considered to represent an APEC for the Property.
- An AST was observed at the University of Ottawa Campus, approximately 190 m southwest of the Phase One Property, respectively. The AST represents PCA #7, however, this PCA is located a significant distance from the Phase One Property and is cross-gradient to the Property, so it not considered to represent an APEC for the Property.

The uses of neighbouring properties in the Phase One Study Area, as well as any observed and/or historically identified PCAs, are presented on Figure 3: Surrounding Land Use.

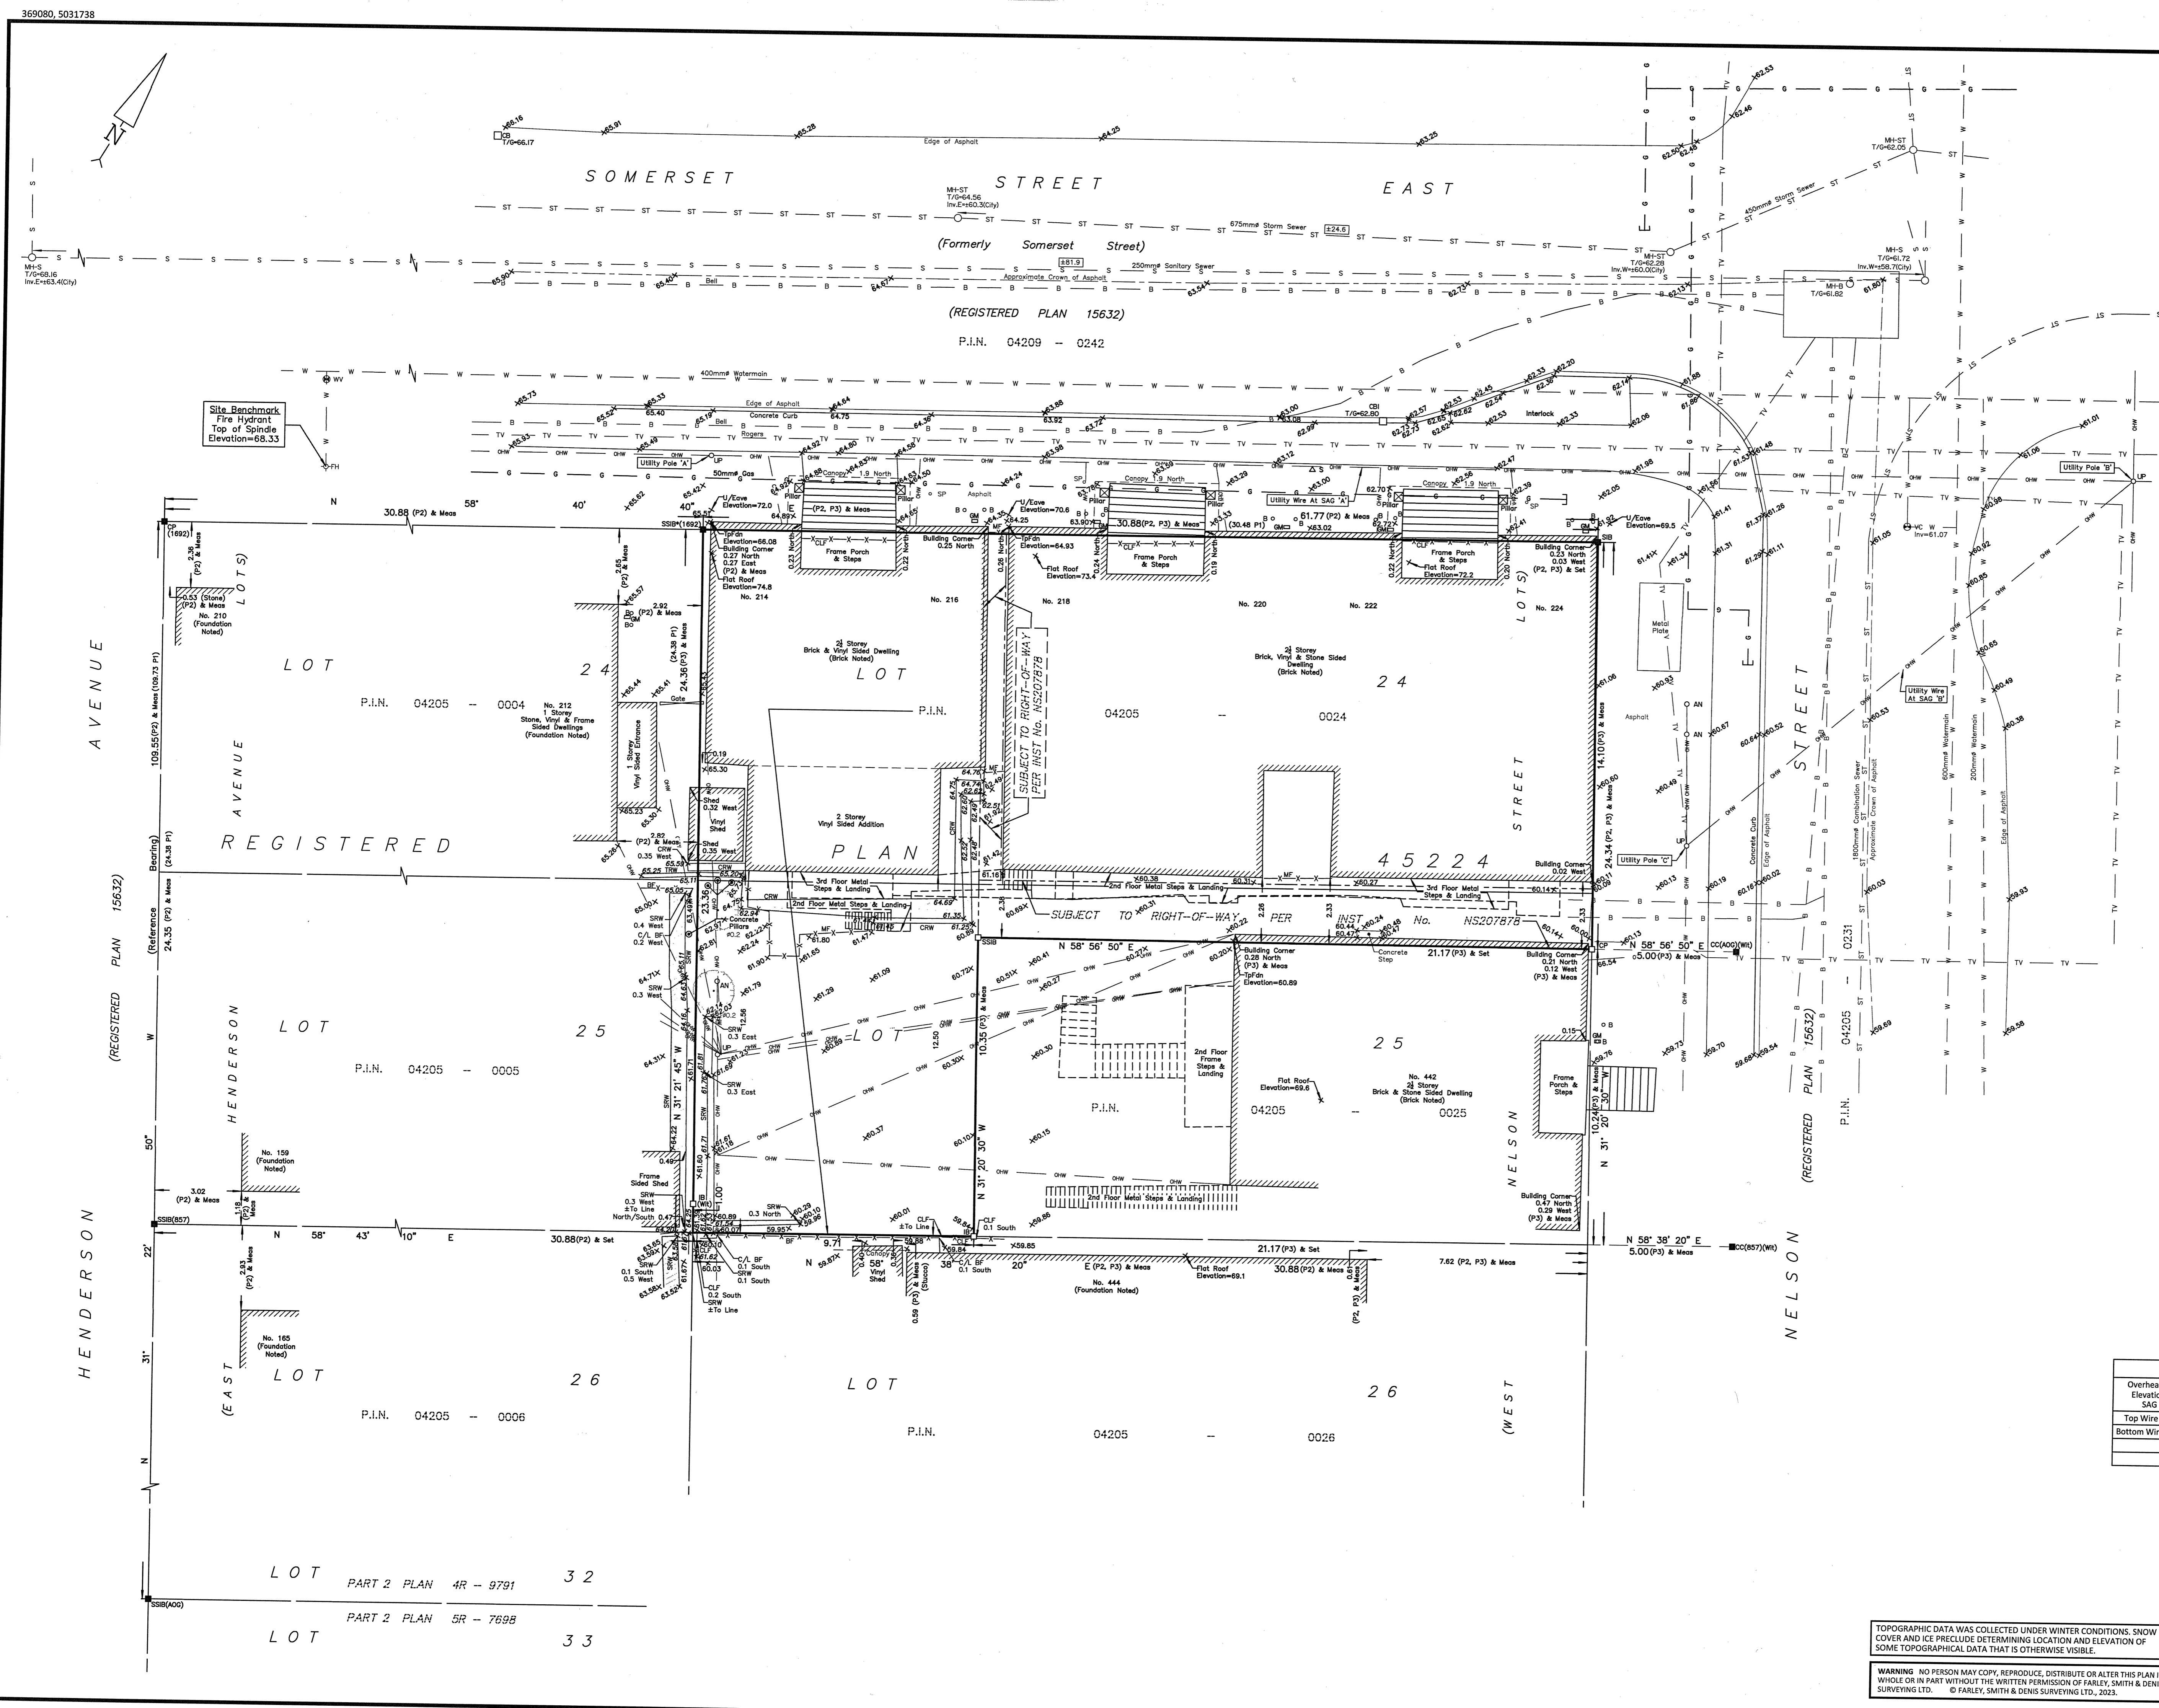
TOPOGRAPHIC PLAN OF SURVEY OF

LOT 24 AND PART OF LOT 25 (WEST NELSON STREET) **REGISTERED PLAN 45224 CITY OF OTTAWA**

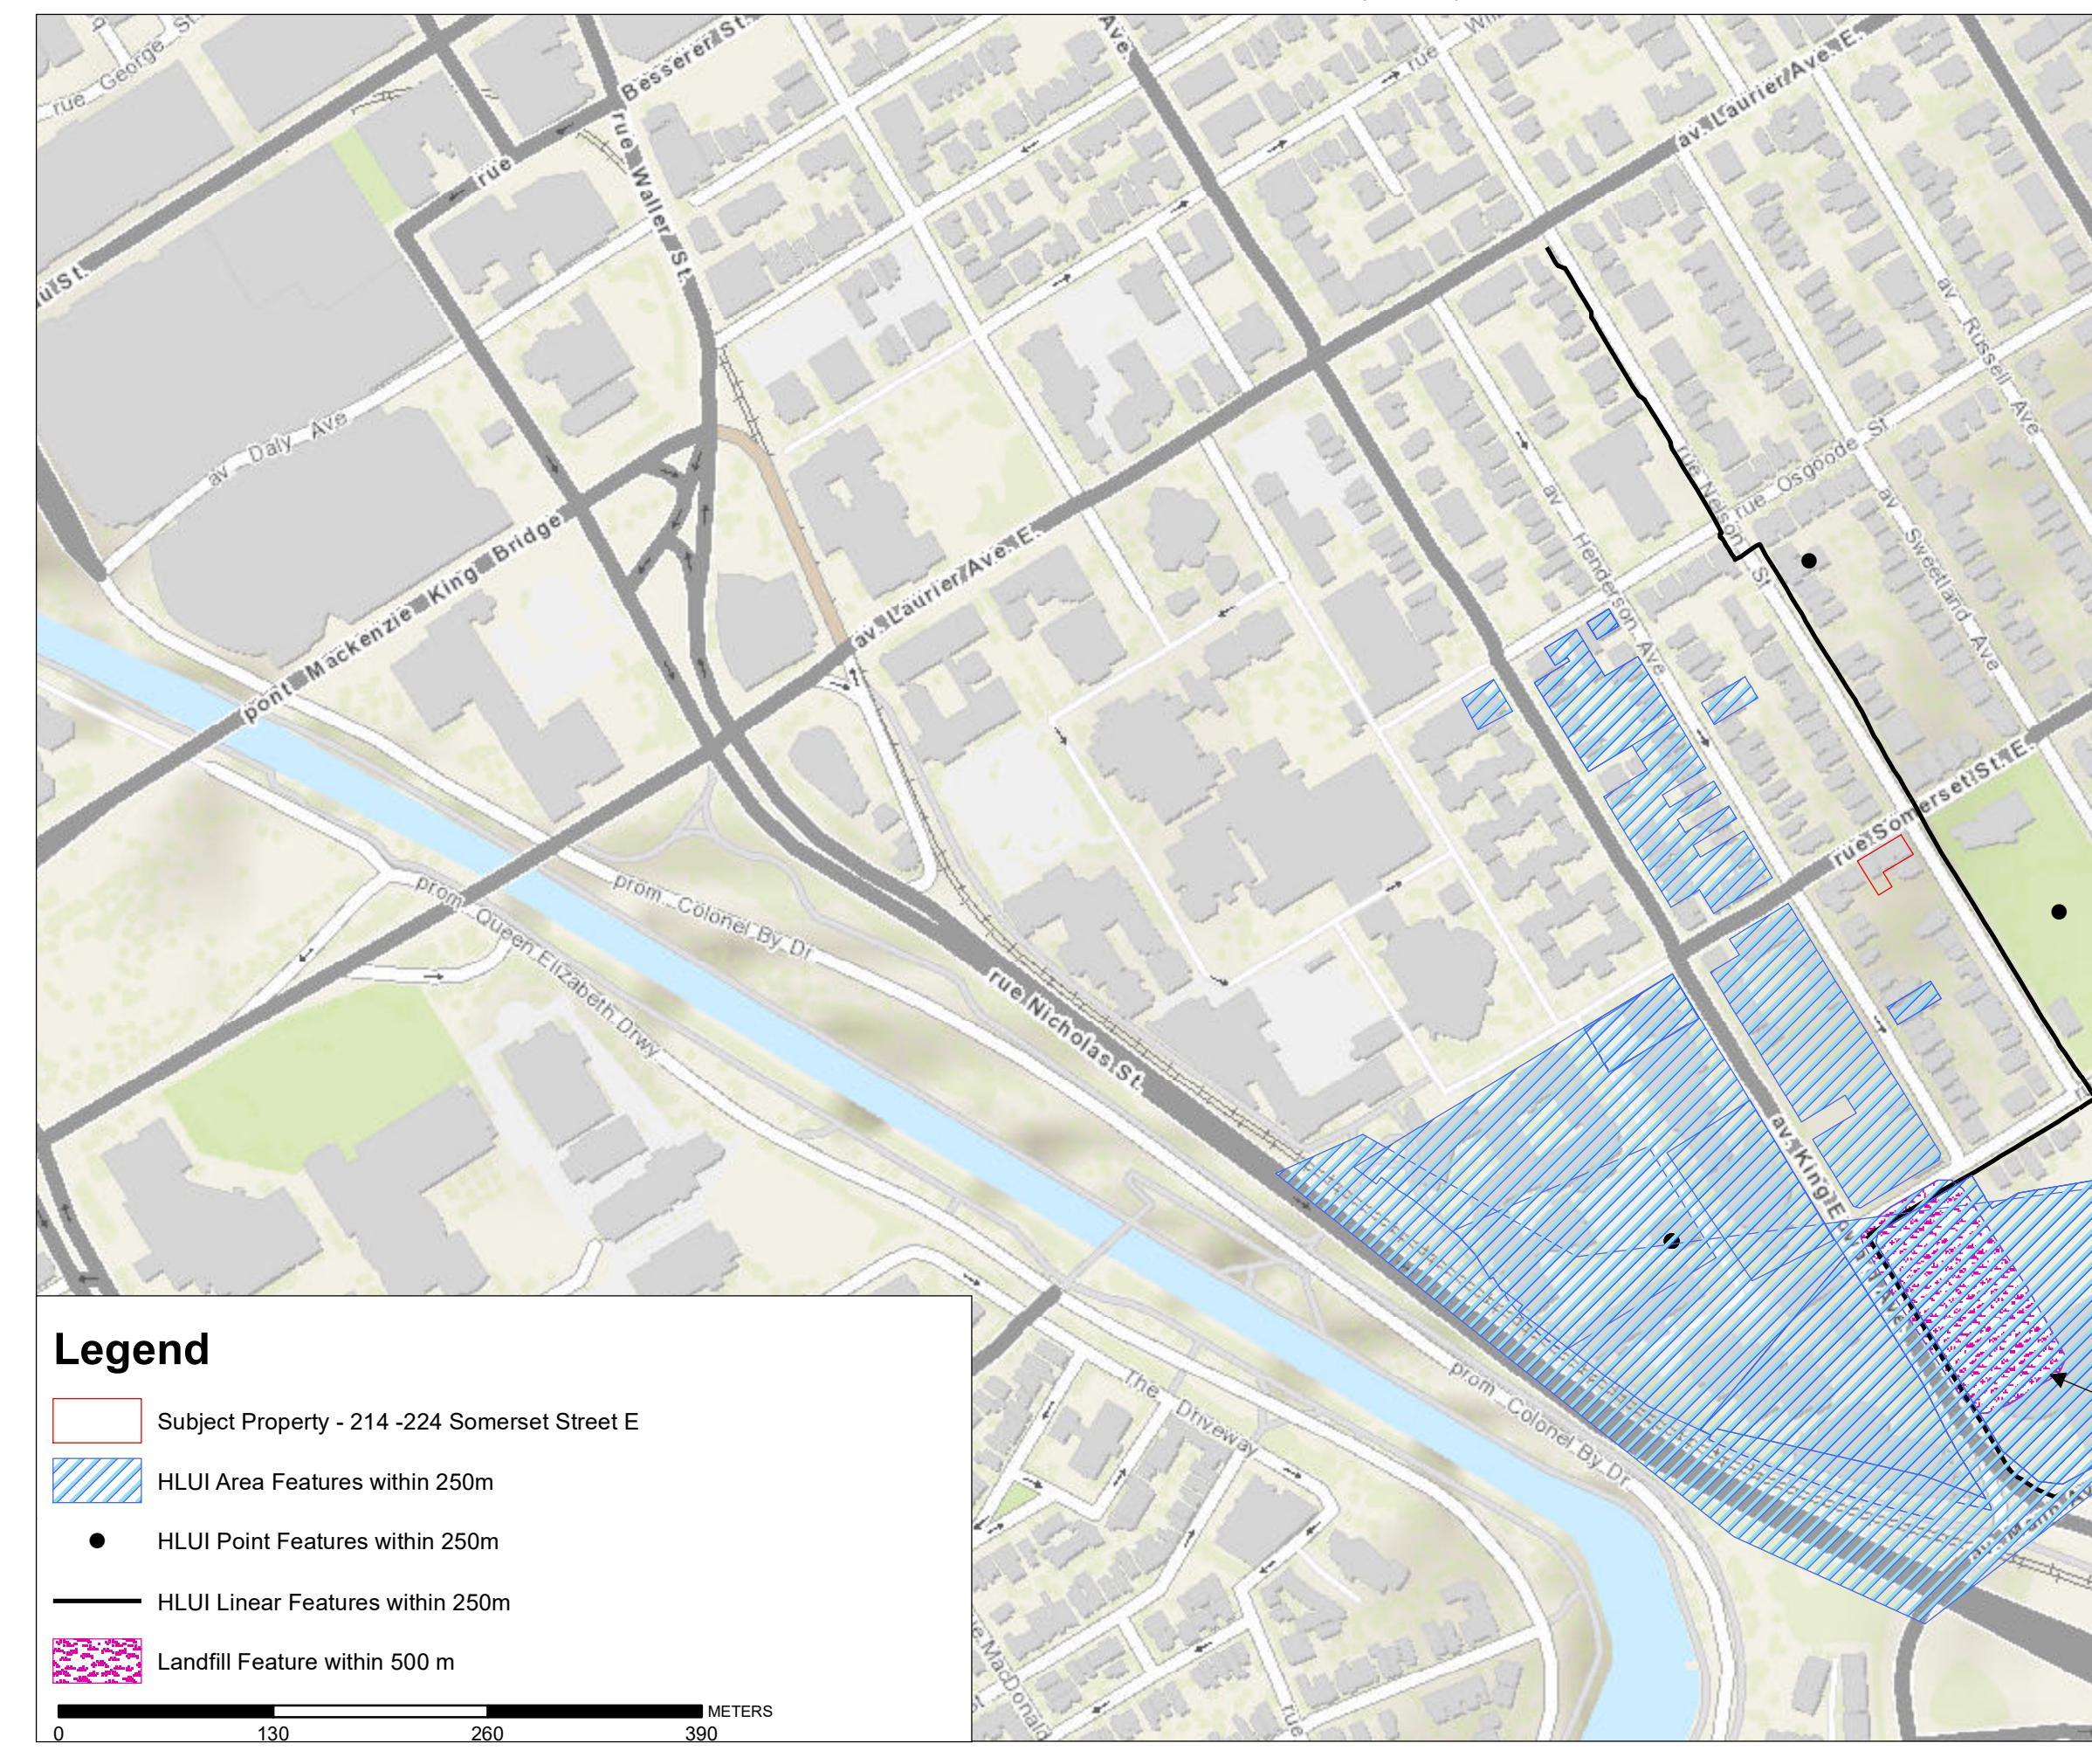
HISTORIC LAND USE INVENTORY (HLUI) - REPORT REFERENCE MAP

Historic Landfill Feature: Ur-40

l isted as a former landfill, the years of operation and closure are unknown
SITE NAME	Lietou de a former lanami, ale yeare el operador ana elecare ale amatemi.
SIZE HA	approx 0.8 ha
SOIL COVER	assumed to be covered based on land use, however thickness of cover unknown
TOPOGRAPHY	general area has a slight slope southeast towards the Rideau River
UTM NAD27 EASTING	446950
UTM NAD27 NORTHING	5029600
WASTEDEPTH	unknown
	unknown; building rubble, concrete slabs, bricks, pieces of coal and some cinder
WASTETYPE	encountered in probe holes
WATER_SUPPLY	municipally supplied water

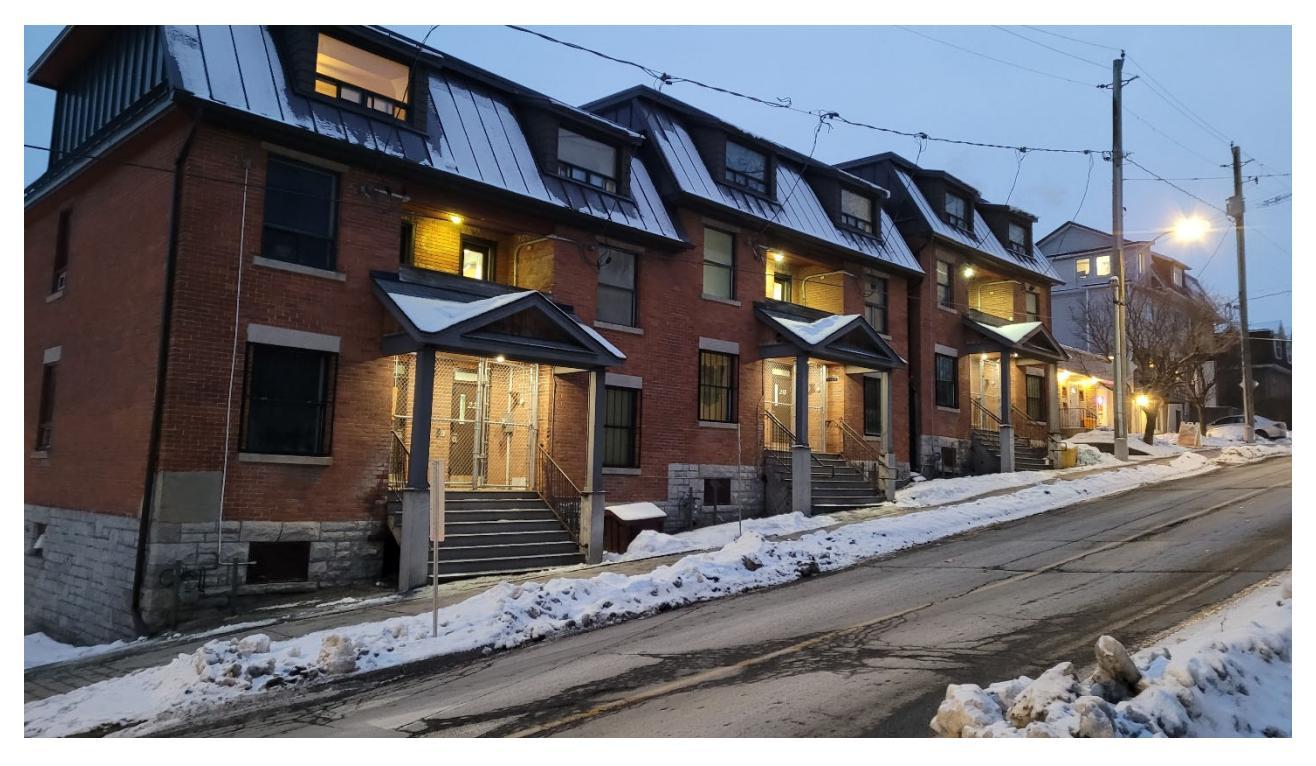
Photograph 1: View of the front of the Phase One Property, looking south from the north side of Somerset Street East; view shows the 3 present-day residential buildings at the Site.

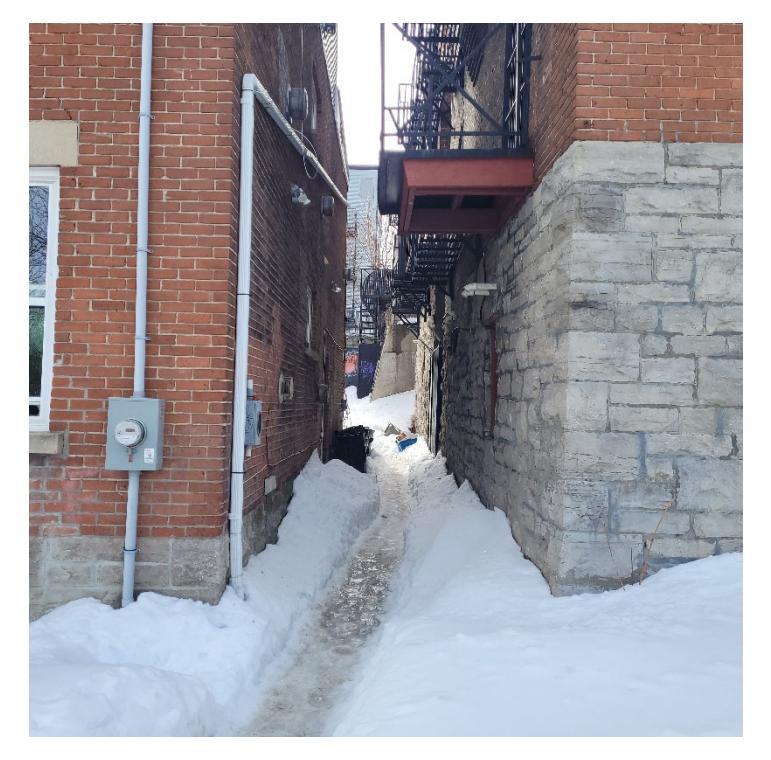
Photograph 2: View of the south portion of the Phase One Property looking west; view shows the (snow covered) asphalt pedestrian pathway shared between the Property and adjacent property to the south.

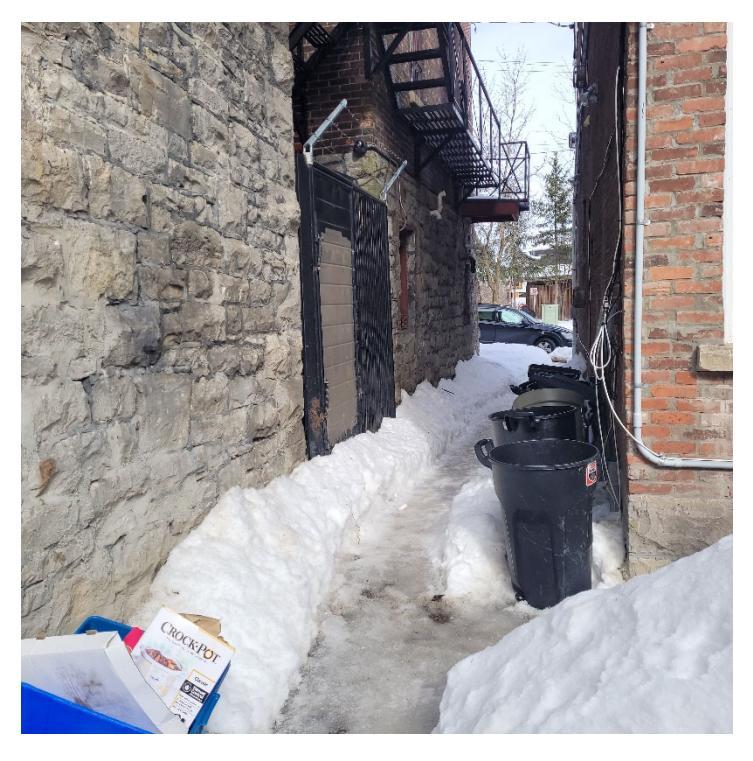
Photograph 3: View of the south portion of the Phase One Property looking east; view shows the (snow covered) asphalt pedestrian pathway shared between the Property and adjacent property to the south.

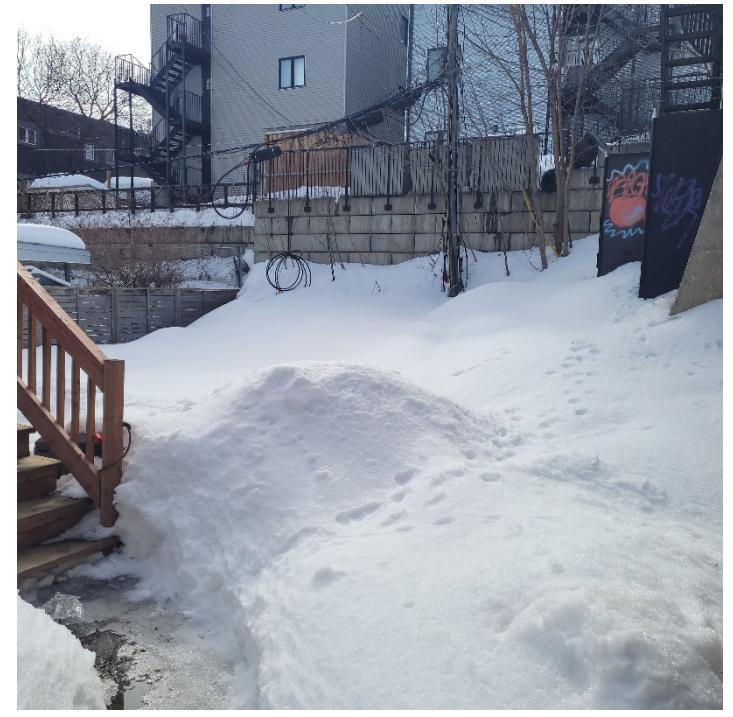
Photograph 4: View of the southwest (snow-covered) portion of the Phase One Property looking southwest. View shows retaining walls constructed on adjacent properties.

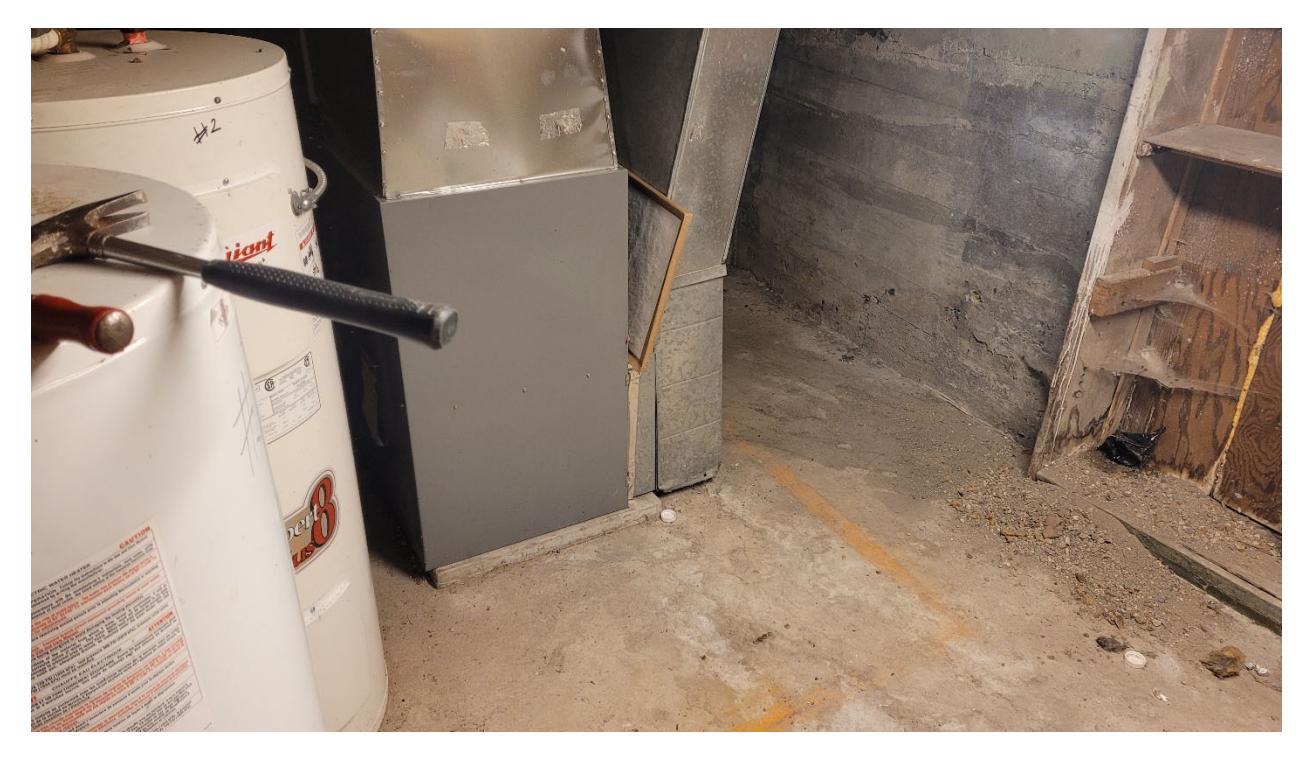
The residential units throughout the buildings are heated by (6) natural gas fired furnaces, present in each of the mechanical rooms (2 per building); there were supplemental baseboard heaters observed in some of the units and mechanical spaces. There were no details regarding former heating and cooling systems, including historical fuel sources for buildings at the Phase One Property.

Photograph 5: View of the natural gas fired equipment, flooring and foundations in one of the buildings' mechanical rooms.

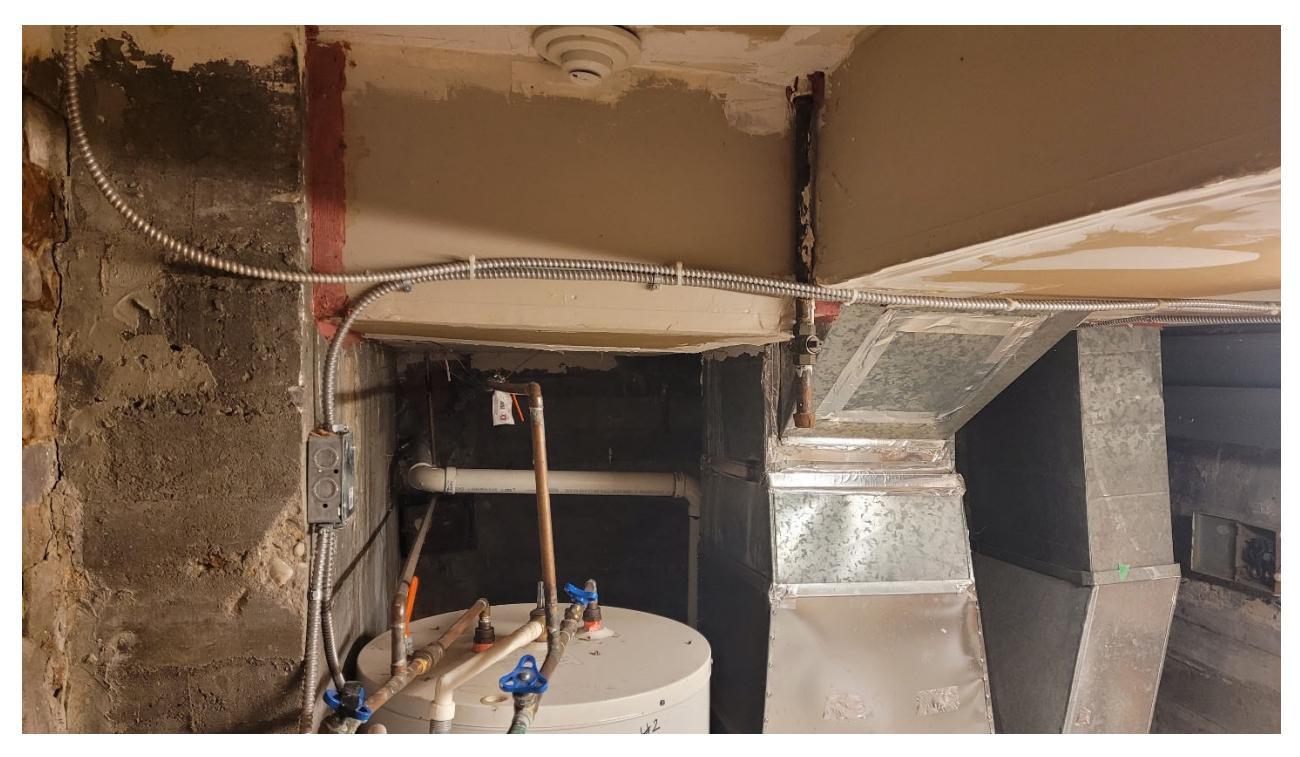
Photograph 6: View of the natural gas fired equipment, ceilings and foundation walls in one of the buildings' mechanical rooms. Note that recent drywalling around the mechanical room ceilings prevented observation of potential former heating oil supply lines.
