Geotechnical Investigation

Project Name Proposed Addition to New Horizon Jeunesse School 349 Olmstead Street, Ottawa, Ontario

Project Number OTT-00231875-A0

Date Submitted May 18, 2016

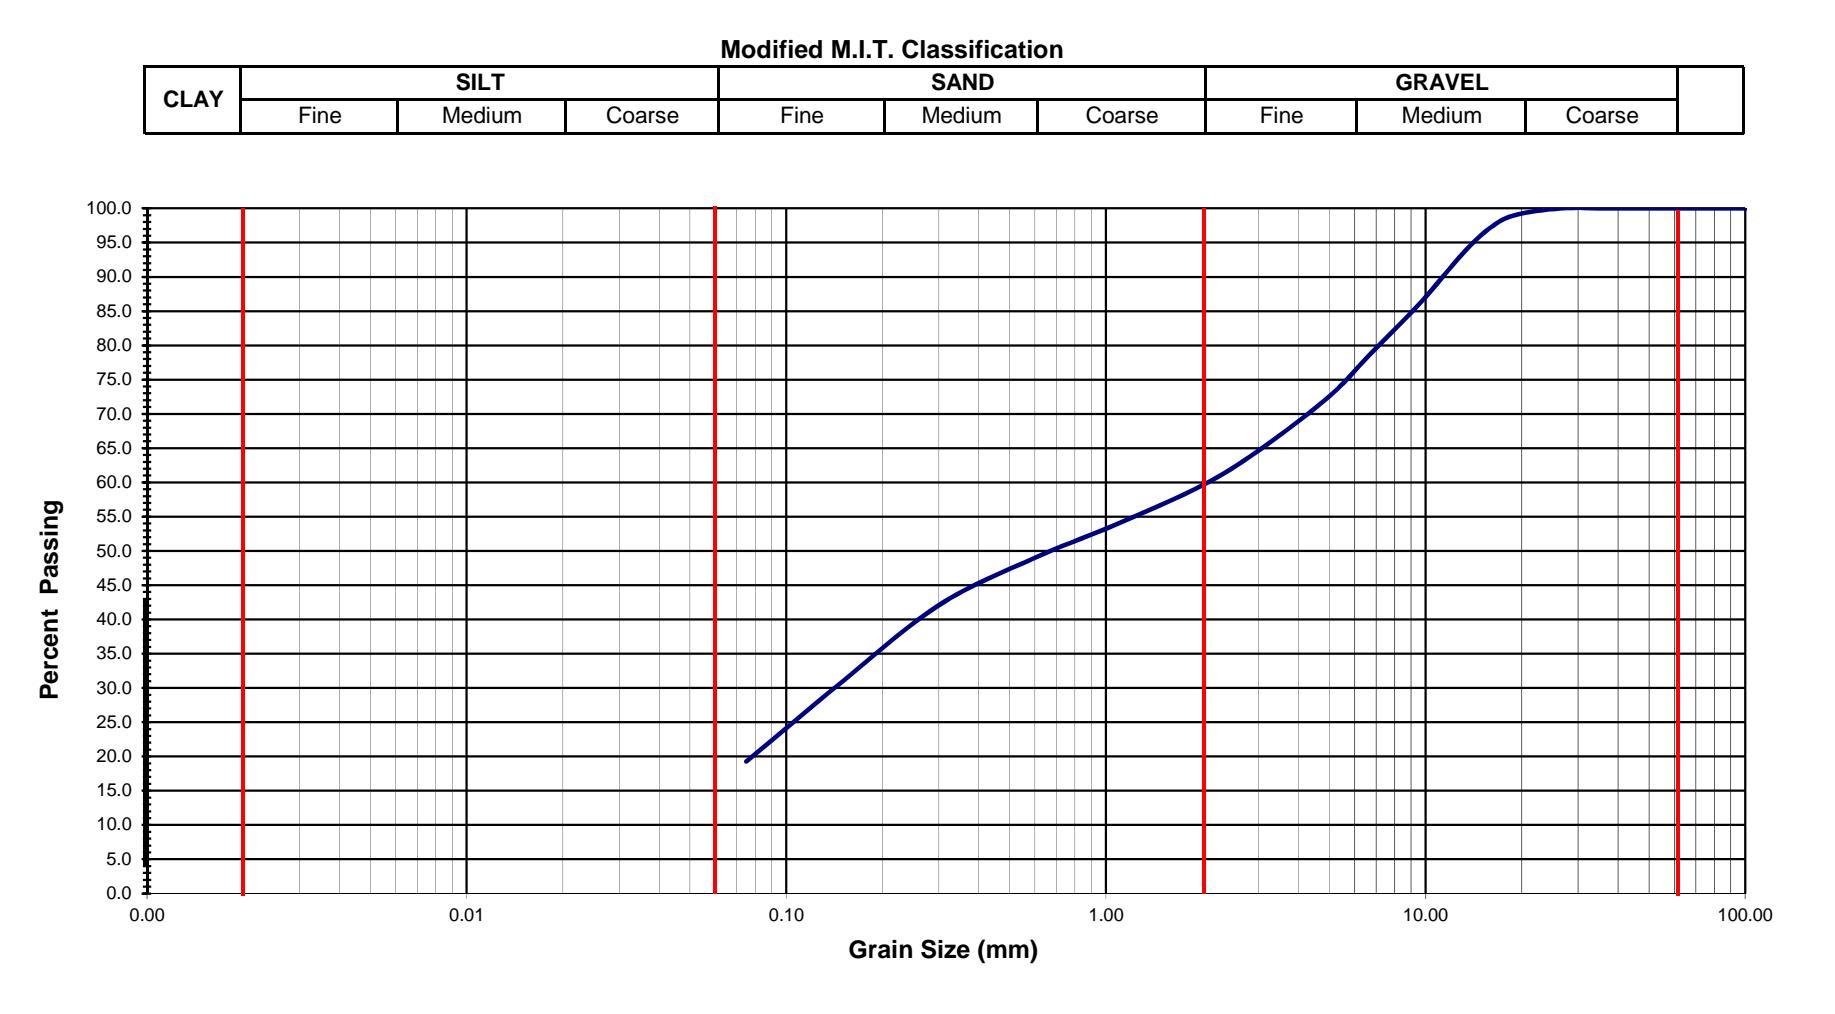
Method of Test for Sieve Analysis of Aggregate ASTM C-136 (LS-602)

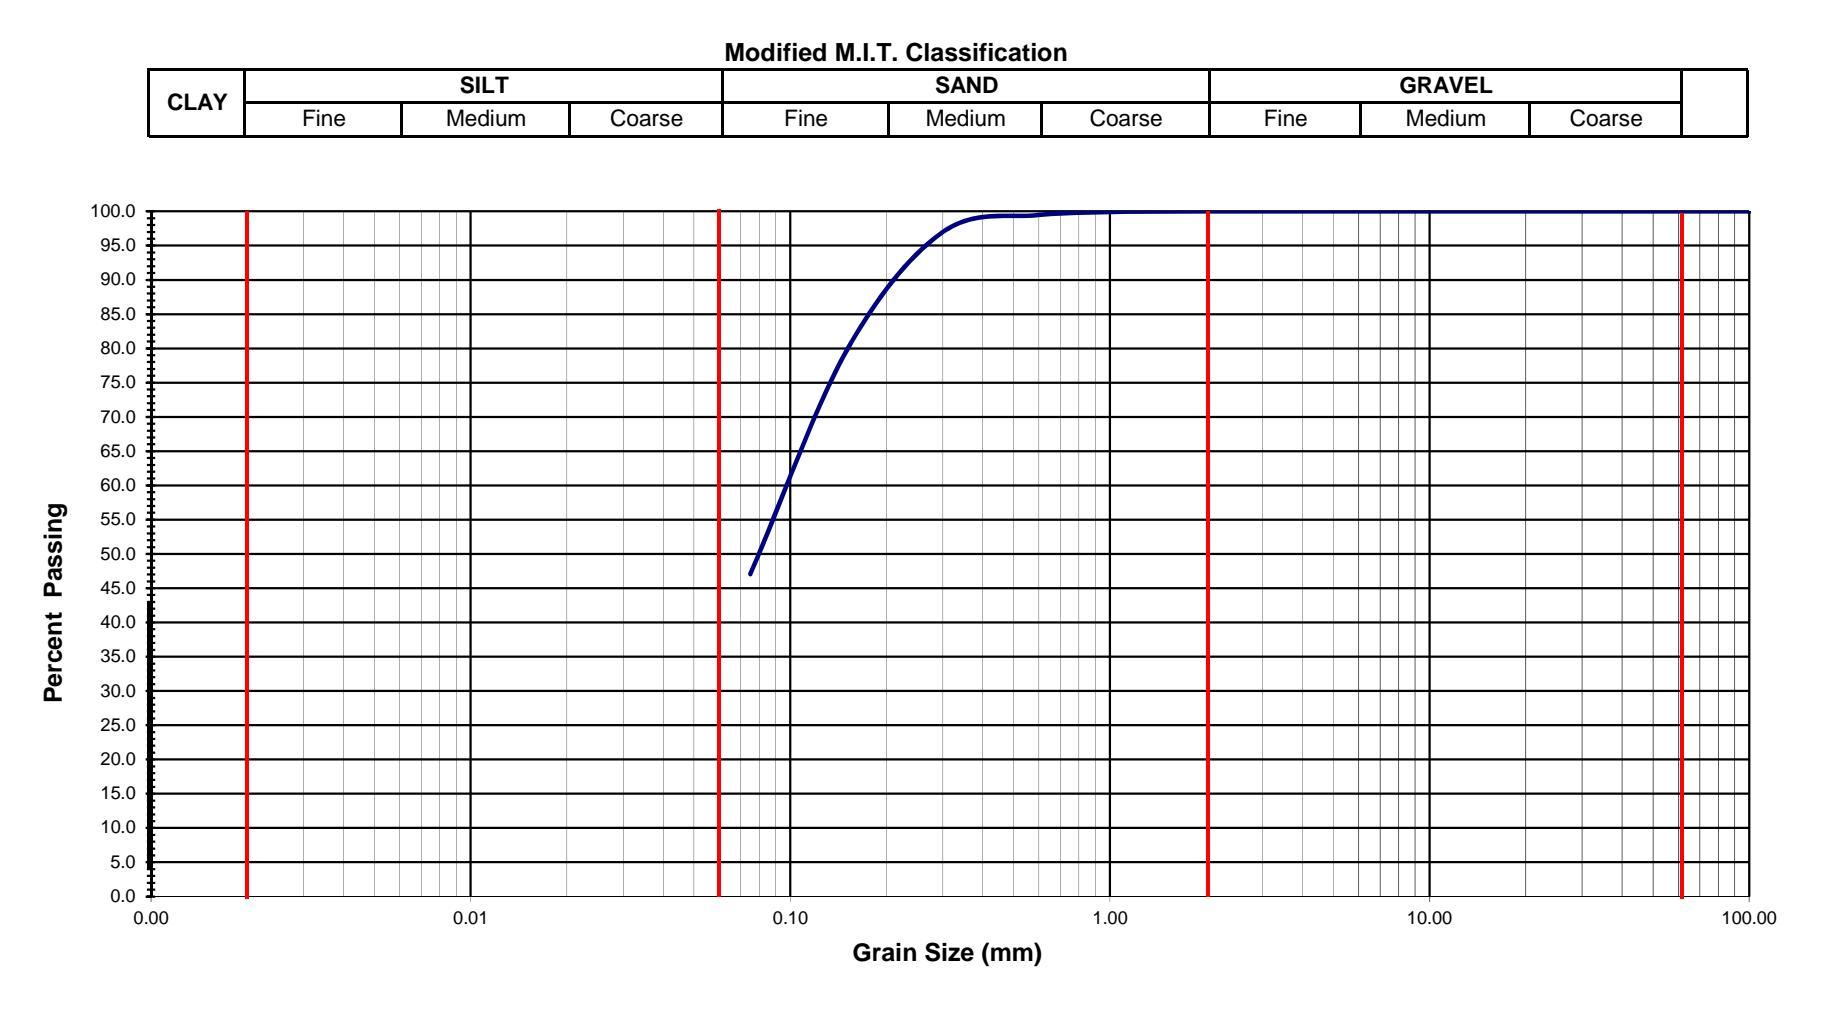
Method of Test for Sieve Analysis of Aggregate ASTM C-136 (LS-602)

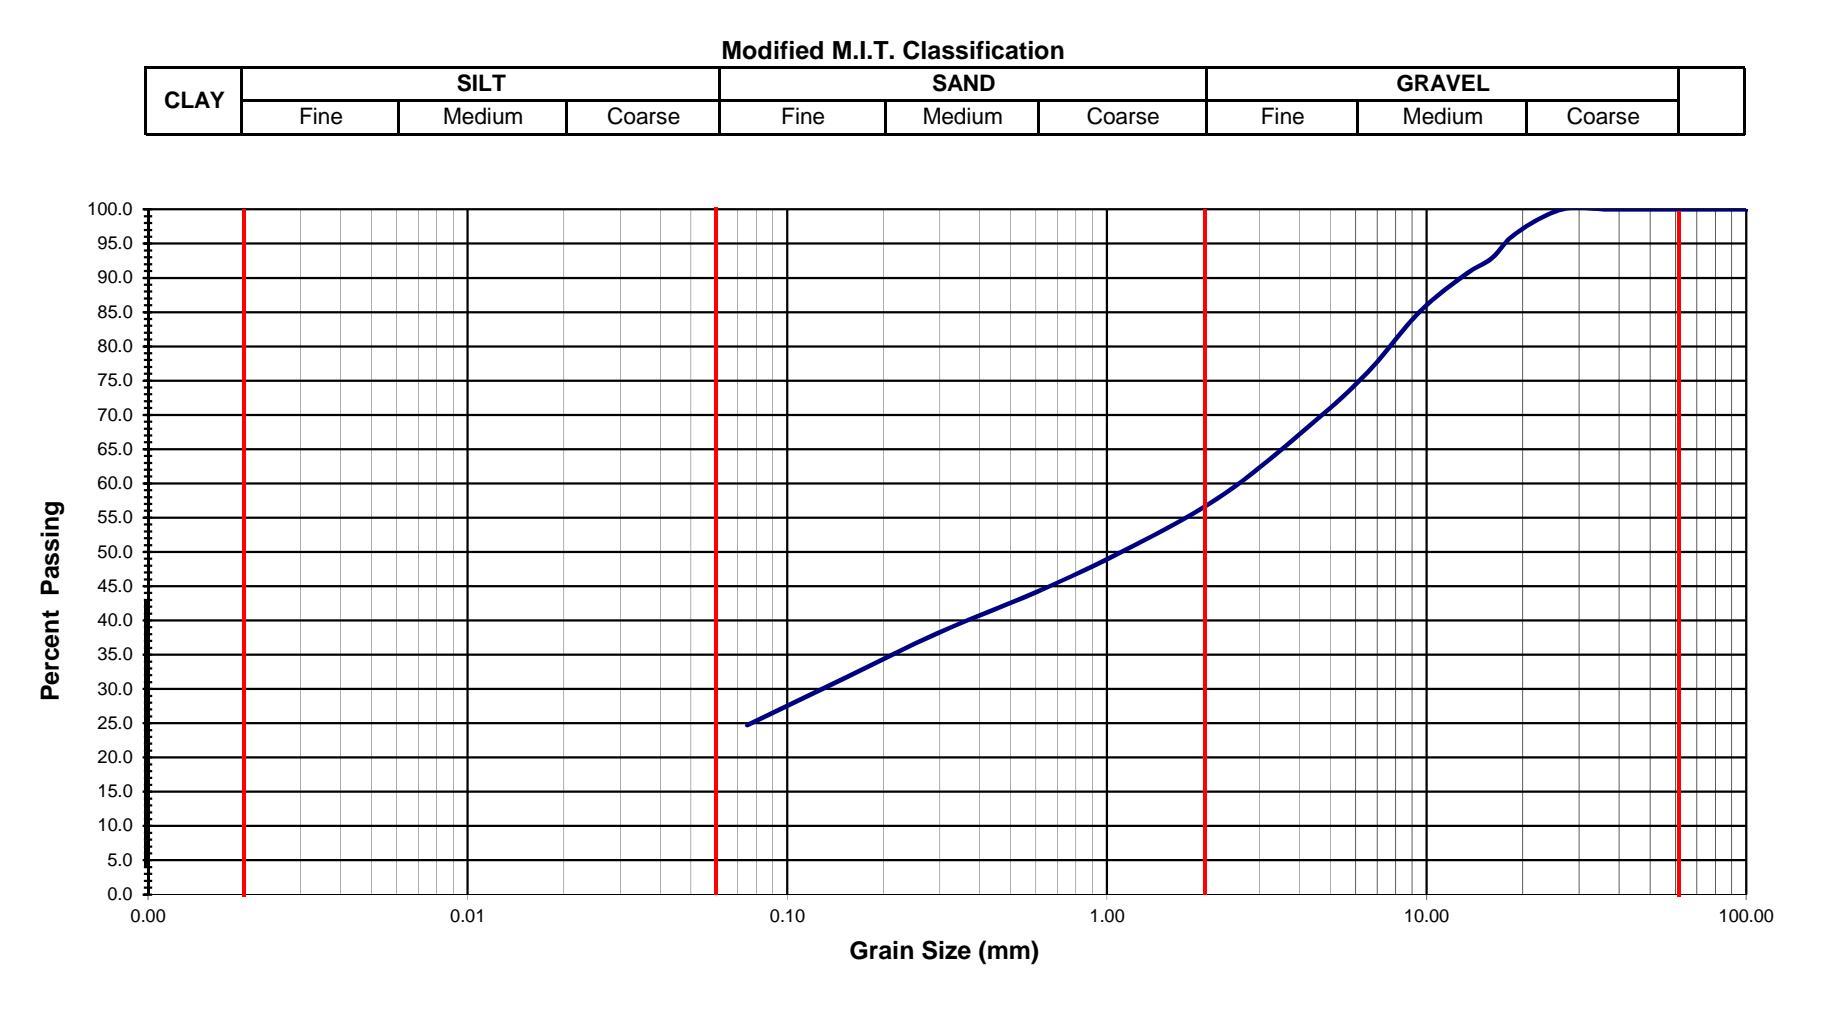
Method of Test for Sieve Analysis of Aggregate ASTM C-136 (LS-602)

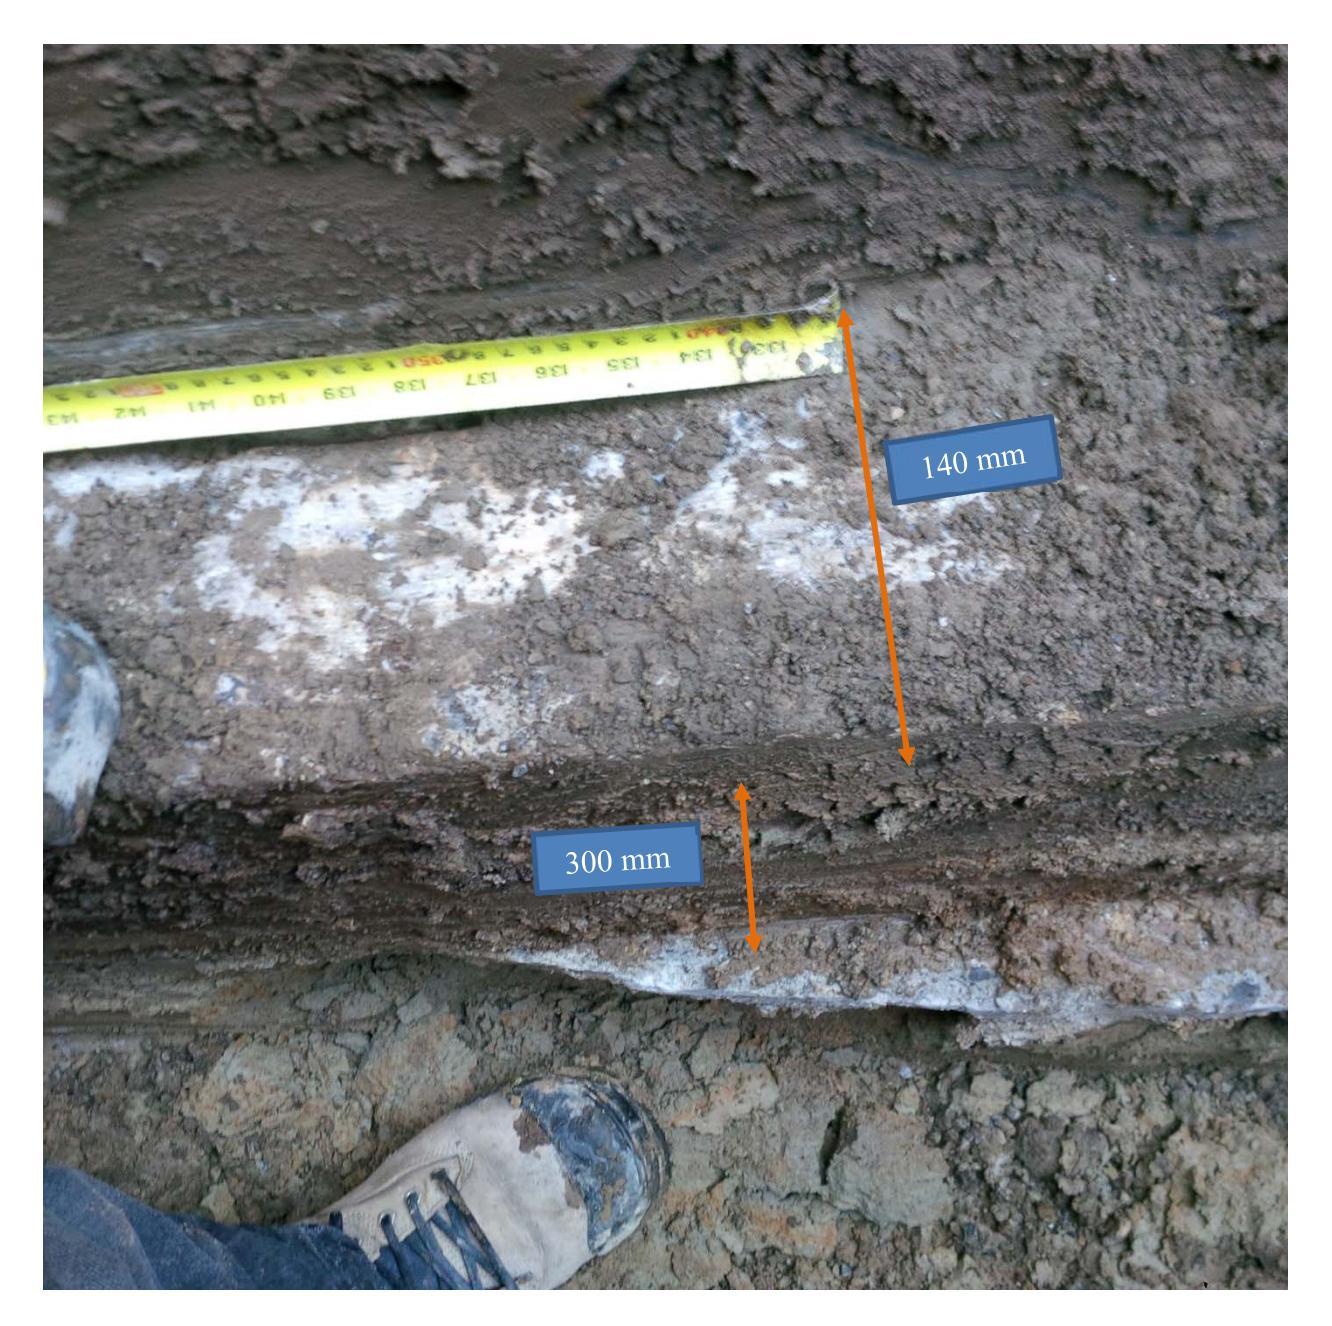
Photo B1: Strip Footing at Test Pit 1 – USF at 1.2 m below Grade – Elevation: **Founding Material: Silty Sand**

| Table 1: Summary of Findings in Test Pits along Building Line | | | | | | |
|---|---|--|--|--|---|--|
| TP-1 | 64.58 | Building is founded on strip footing at a depth of 1.2 m below the existing ground surface Existing footing is founded on compact Silty Sand | 140 | 300 | 63.38 | |

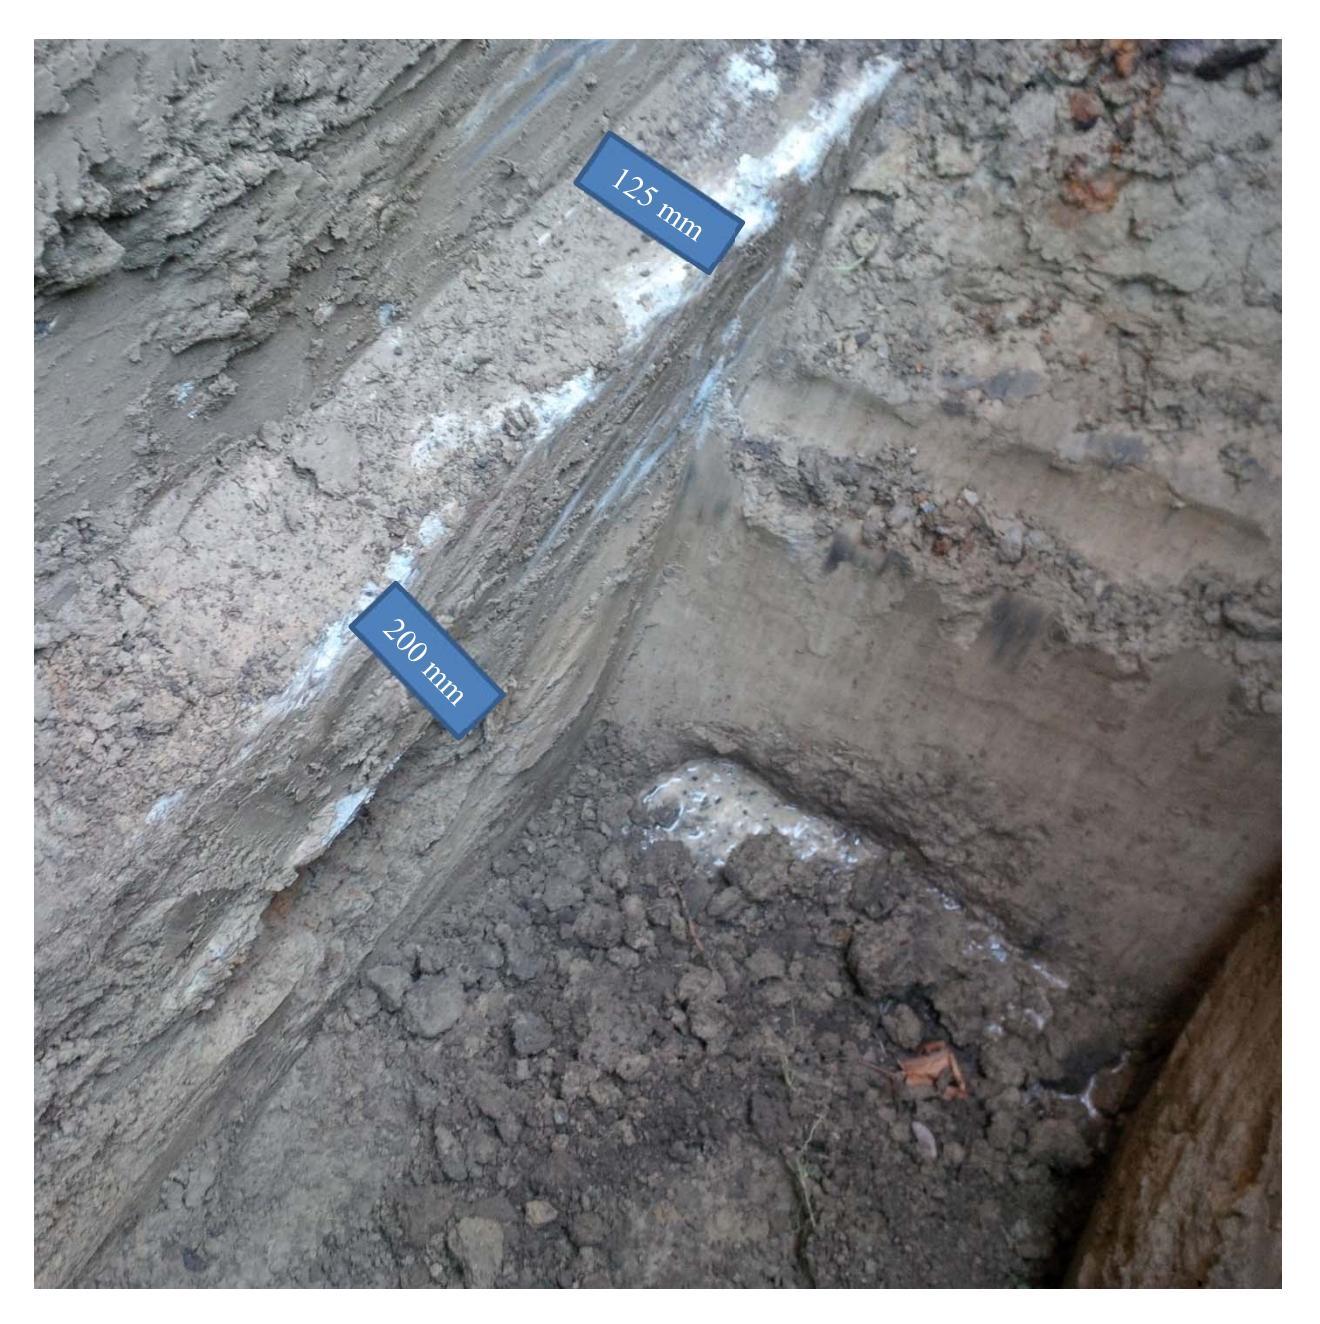
Photo B2: Strip Footing at Test Pit 2 – USF at 1.5 m below Grade – Elevation: **Founding Material: Silty Sand**

| Table 1: Summary of Findings in Test Pits along Building Line | | | | | | |
|---|---|--|--|--|---|--|
| TP-2 | 64.82 | Building is founded on spread footing at a depth of 1.50 m below the ground surface. Existing footing is founded on compact Silty Sand. | 125 | 200 | 63.32 | |

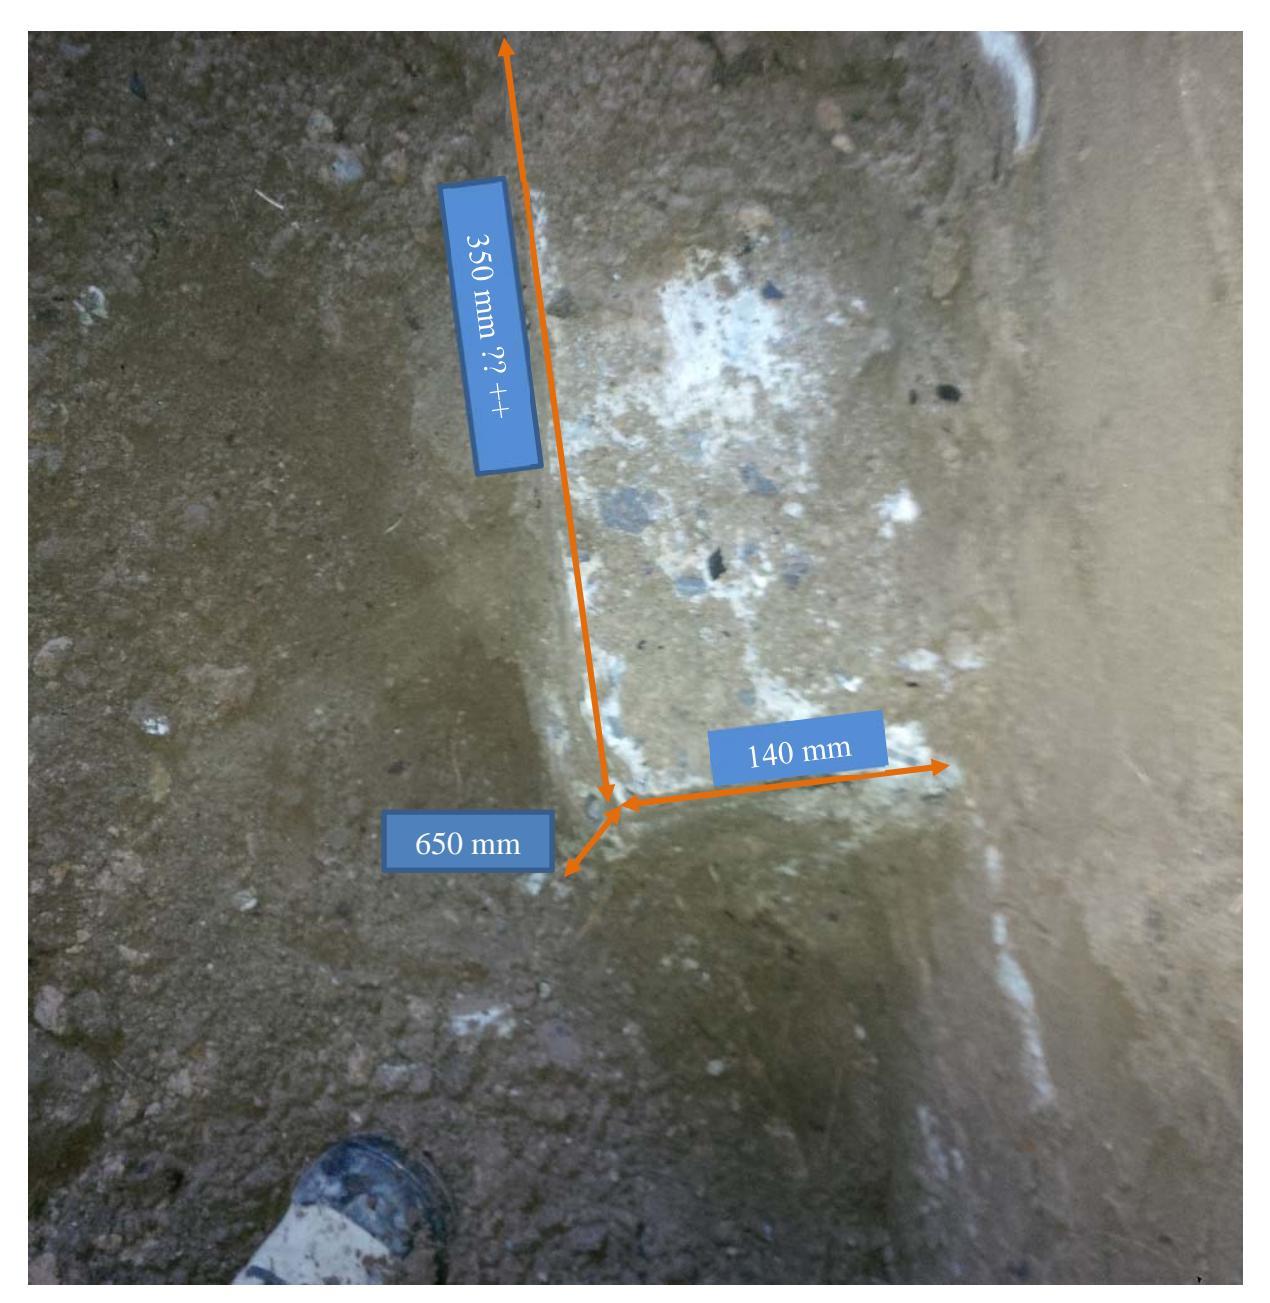
Photo No. B3: Test Pit No. 3- Spread Footing at a depth 2.2 m, i.e. Elevation: xx m (Partial length of Footing was exposed as shown)- **Founding Material: Glacial Till**

| Table 1: Summary of Findings in Test Pits along Building Line | | | | | | |
|---|---|--|--|--|---|--|
| TP-3 | 64.73 | Building is founded on strip footing (this portion with basement) at a depth of 2.20 m below the existing ground surface Existing footing is founded on compact Silty Sand glacial till | 140 | 650 | 62.53 | |

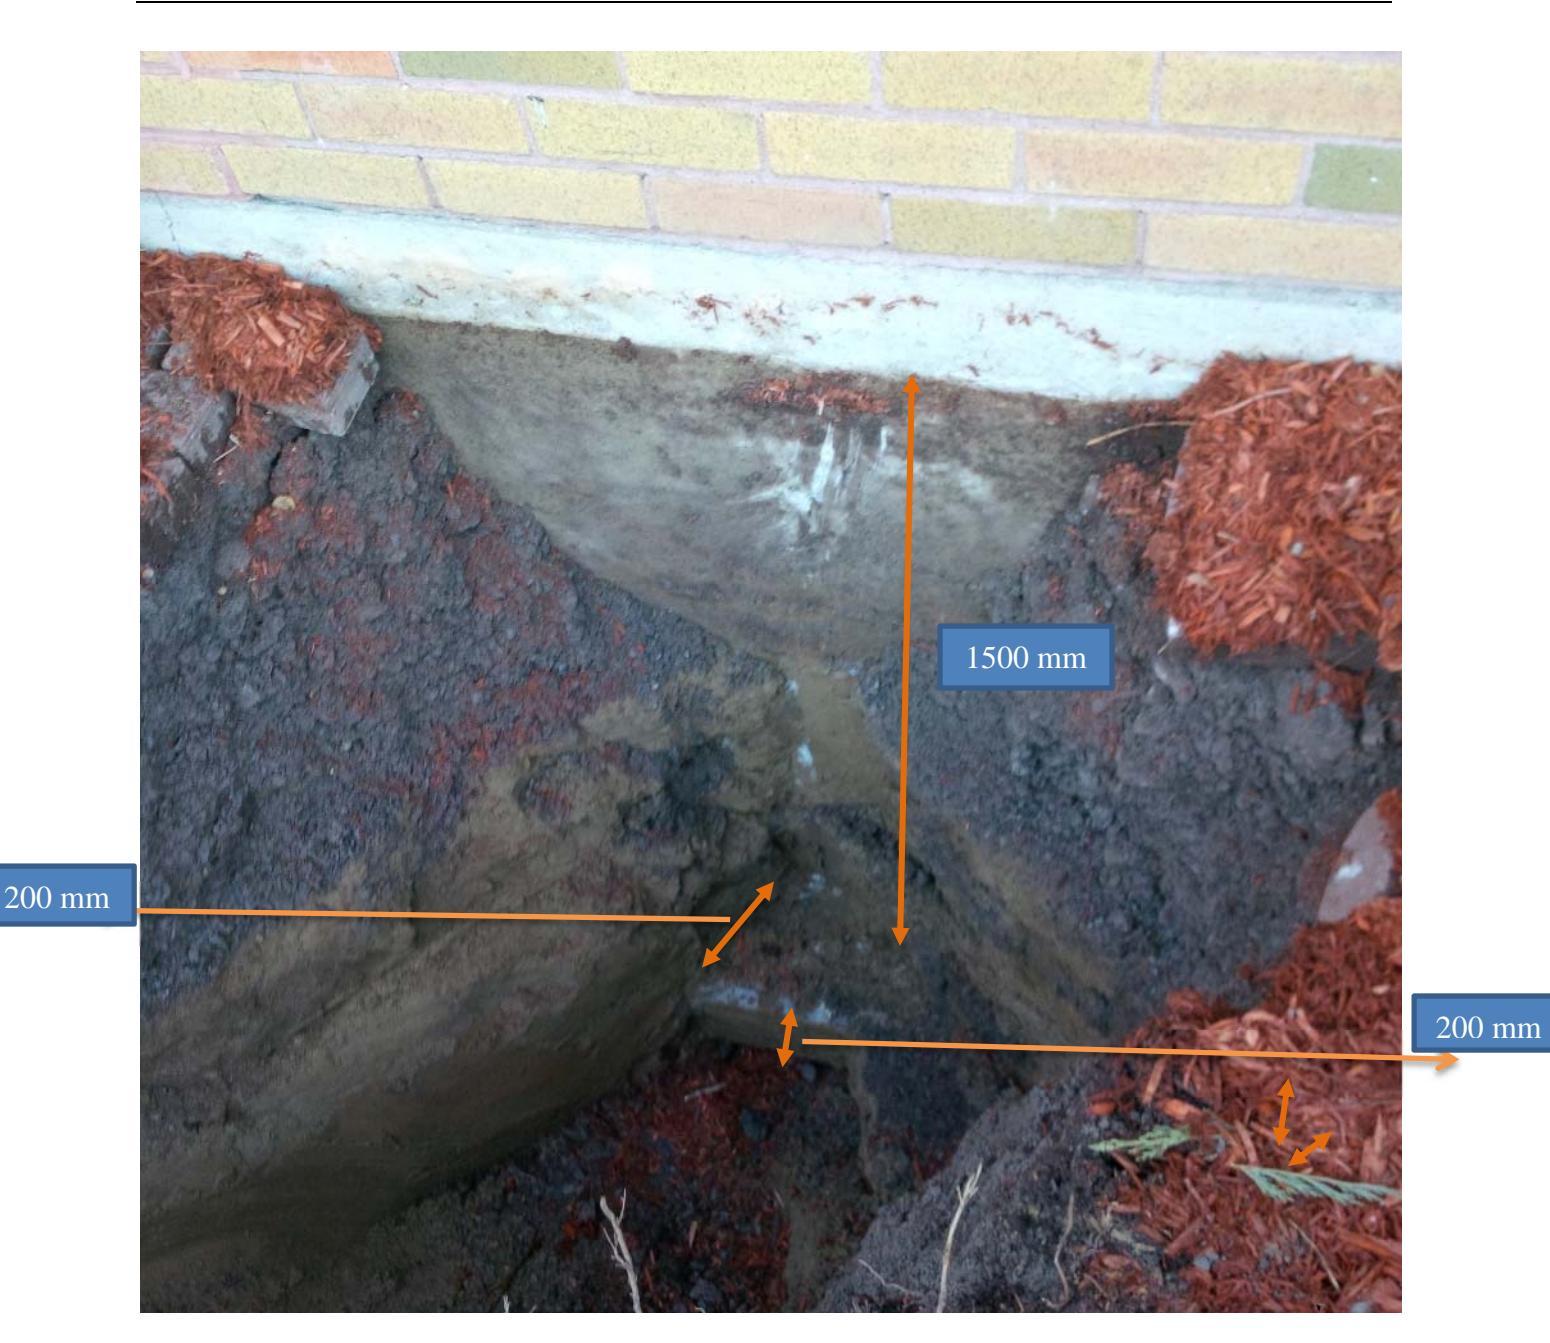
Photo No. B4: Test Pit No. 4- Strip Footing at a depth 1.5 m, Elevation: Founding Material: Silty Sand

| Table 1: Summary of Findings in Test Pits along Building Line | | | | | | |
|---|---|--|--|--|---|--|
| TP4 64.70 Building is founded on strip footing at a depth of 1.45 m below the existing ground surface Existing footing is founded on compact Silty Sand. | | 200 | 200 | 63.25 | | |

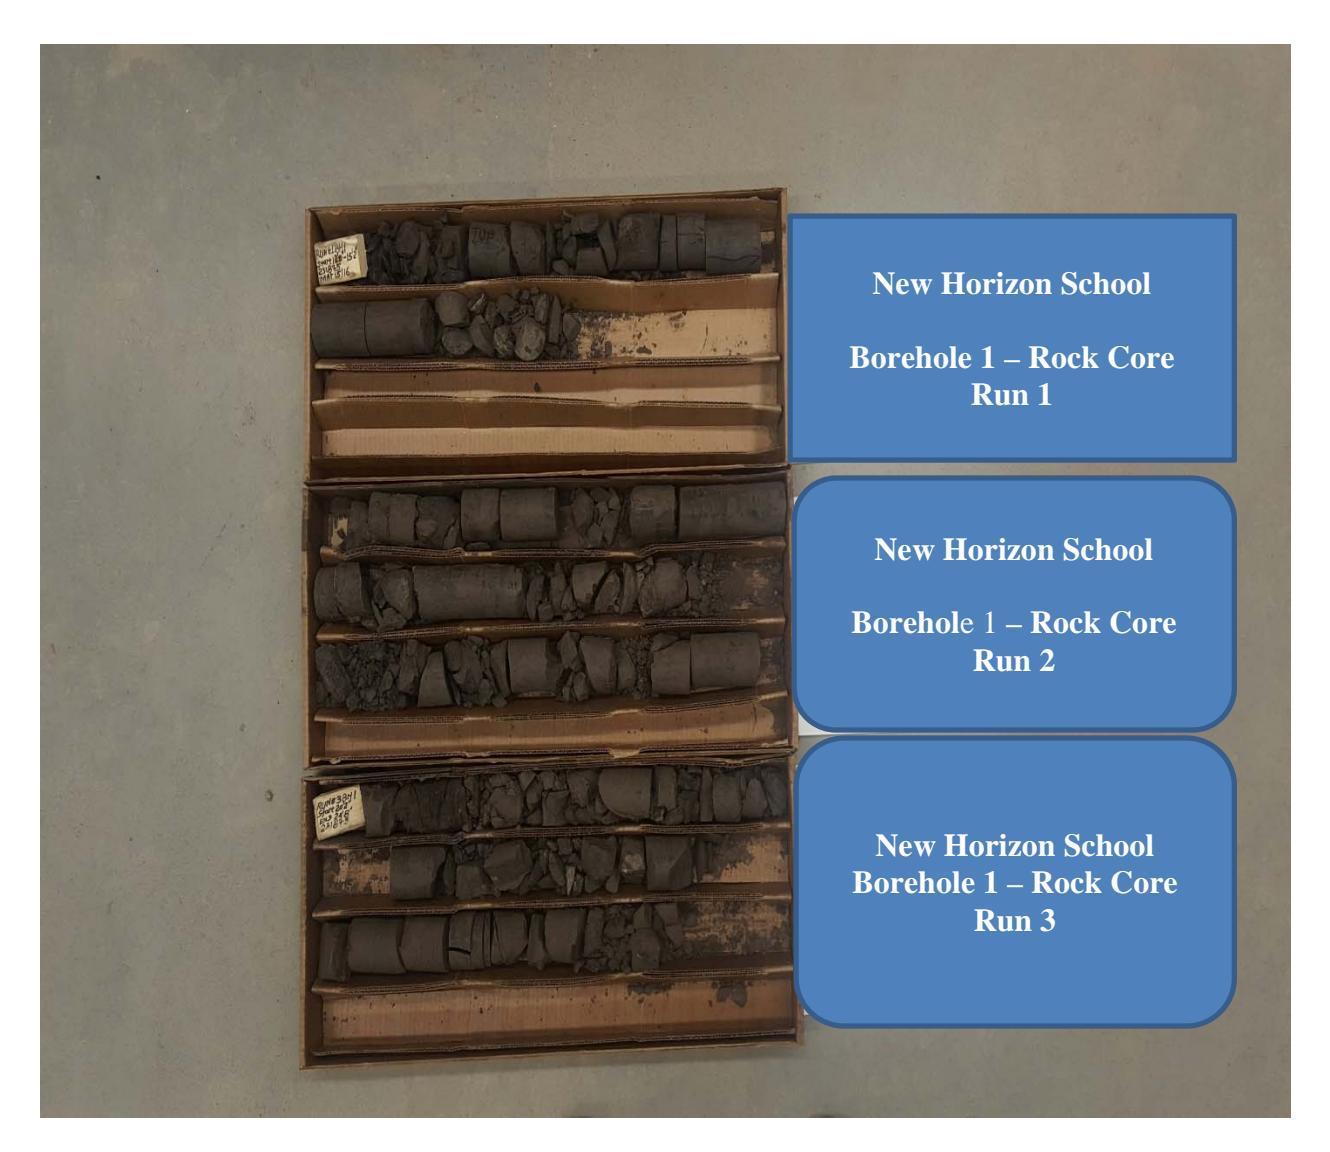
Photo No. B5: Bedrock Cores from Borehole No. 1 –Run 1, Run 2 and Run 3

The bedrock underlying the site is described as highly fractured Shale bedrock of the Billings Formation, horizontally stratified, fissile to very thinly bedded and contains some near vertical joints. The Billings Shale is known to contain disseminated iron sulphide, which can be oxidized by autotrophic bacteria to produce secondary hydrous sulphates of greater volume. This type of oxidation is favoured by warm, drained, humid environment. The shale bedrock also weathers readily when exposed to the environment by parting along weakly bonded fissile bedding planes and disintegrates into debris.

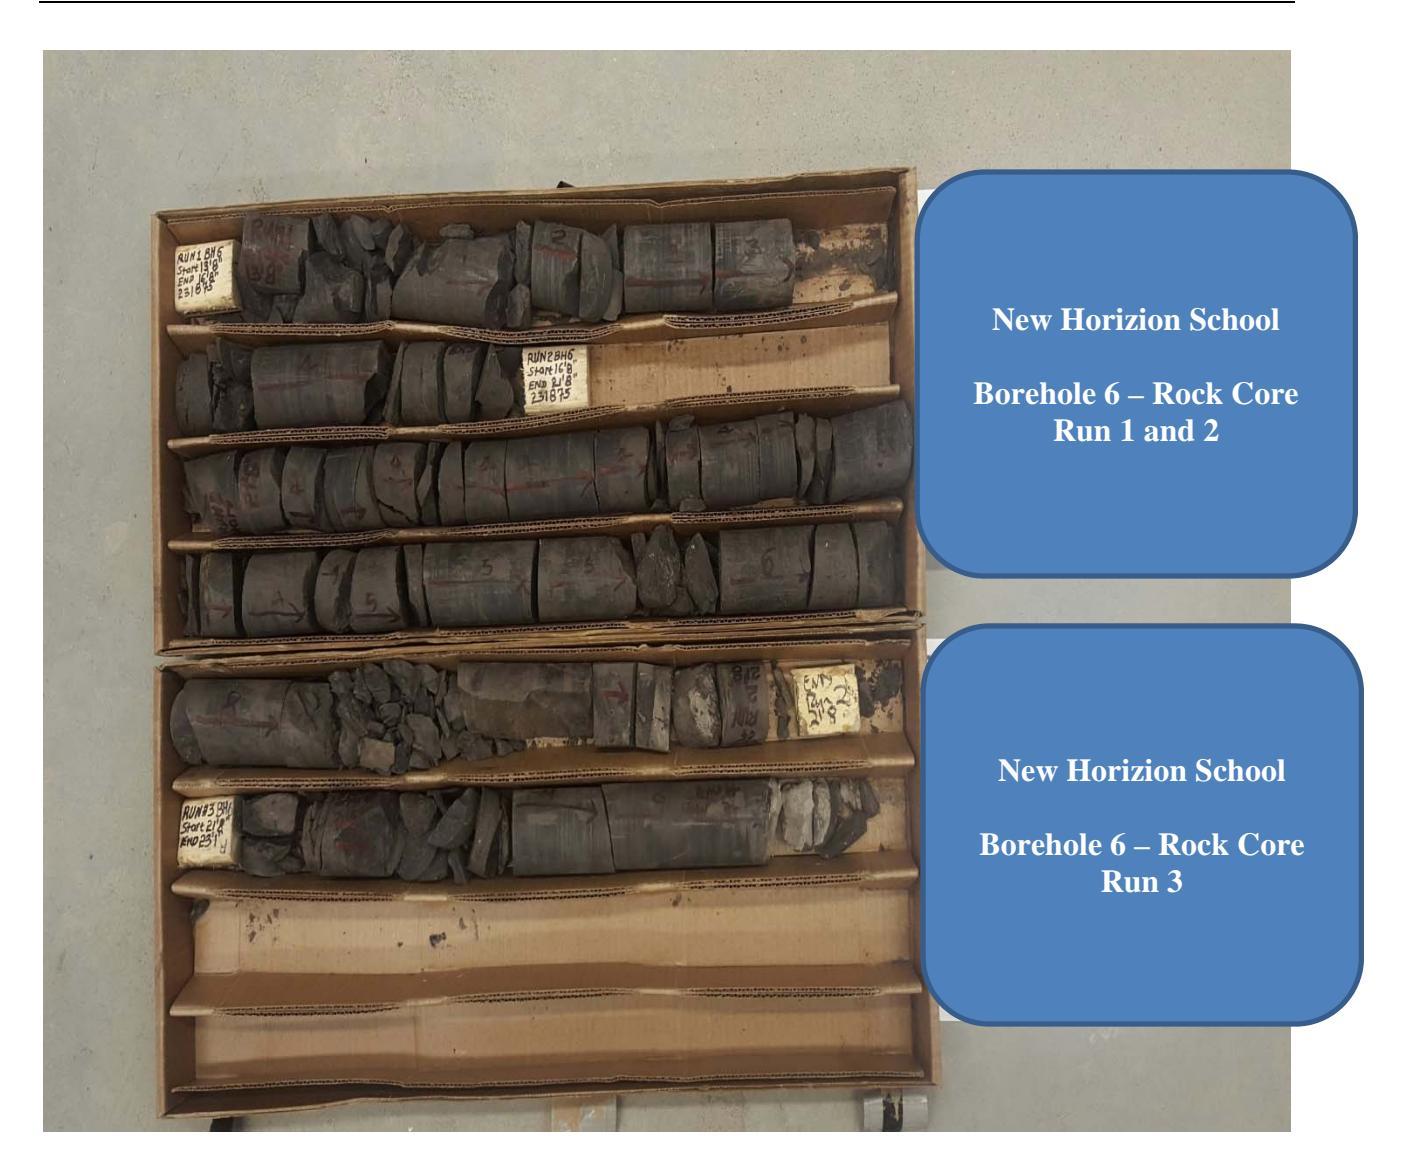
Photo No. B6: Bedrock Cores from Borehole No. 6 - Run 1 to 3
