Tree Conservation Report Half Moon Bay South

February 6, 2019

KILGOUR & ASSOCIATES LTD. www.kilgourassociates.com Project Number: MATT671.4

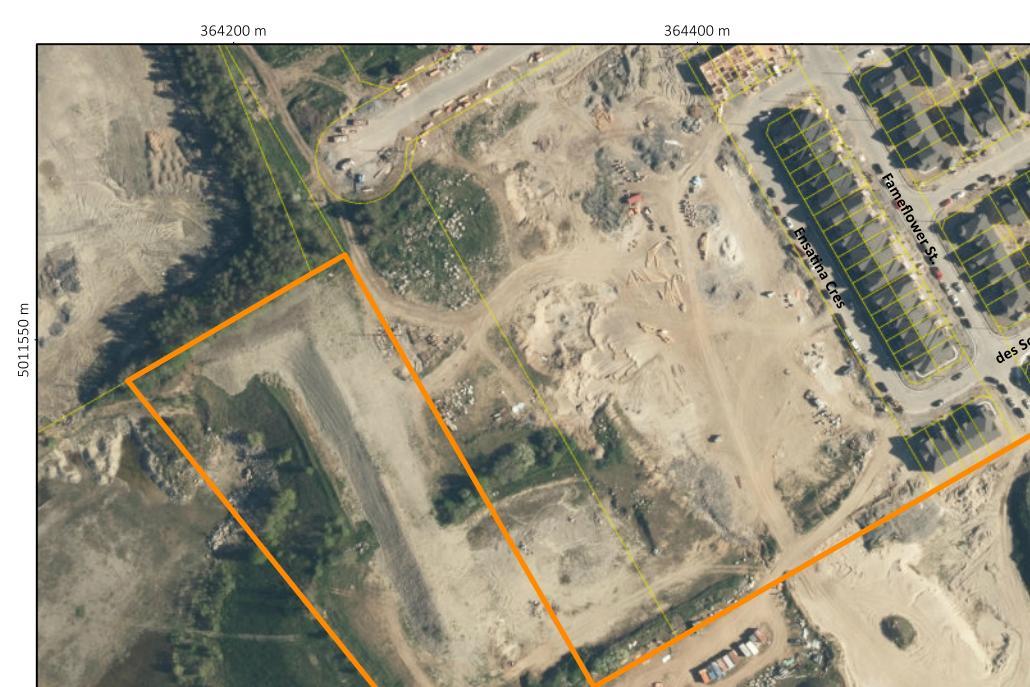
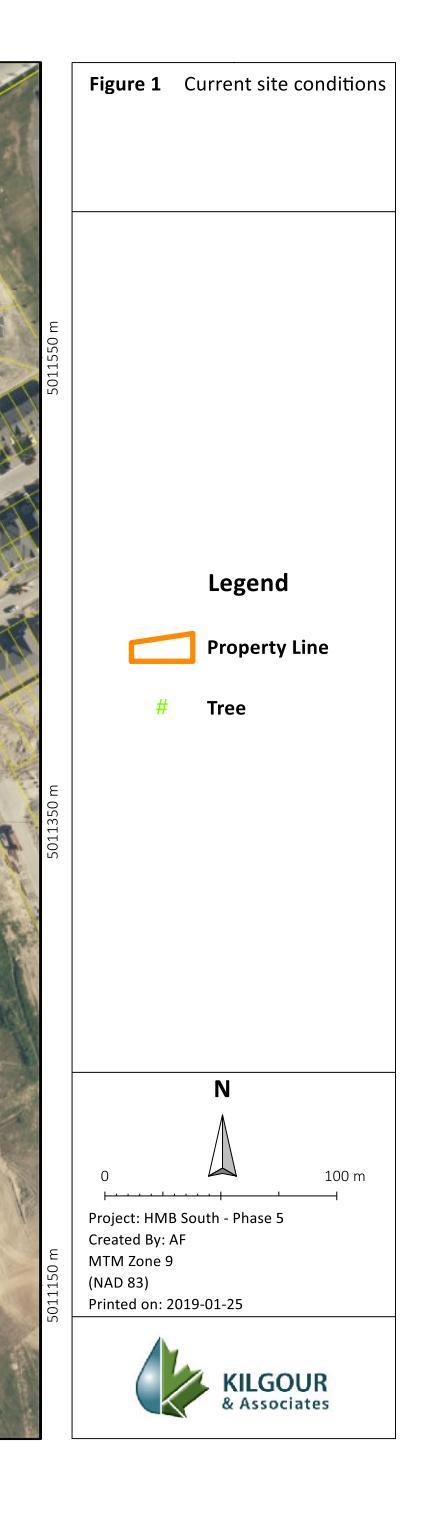
No trees of special significance were found within 50 m of the proposed development area. Trees here are located almost entirely with a narrow hedgerow along the south property line. The hedgerow terminates at the east end at a new residential development and, as such, would not serve as a wildlife corridor connecting natural areas. Trees here may provide some limited food and nesting opportunity for small, urban-tolerant species, as well contributing to the overall canopy cover to the area.

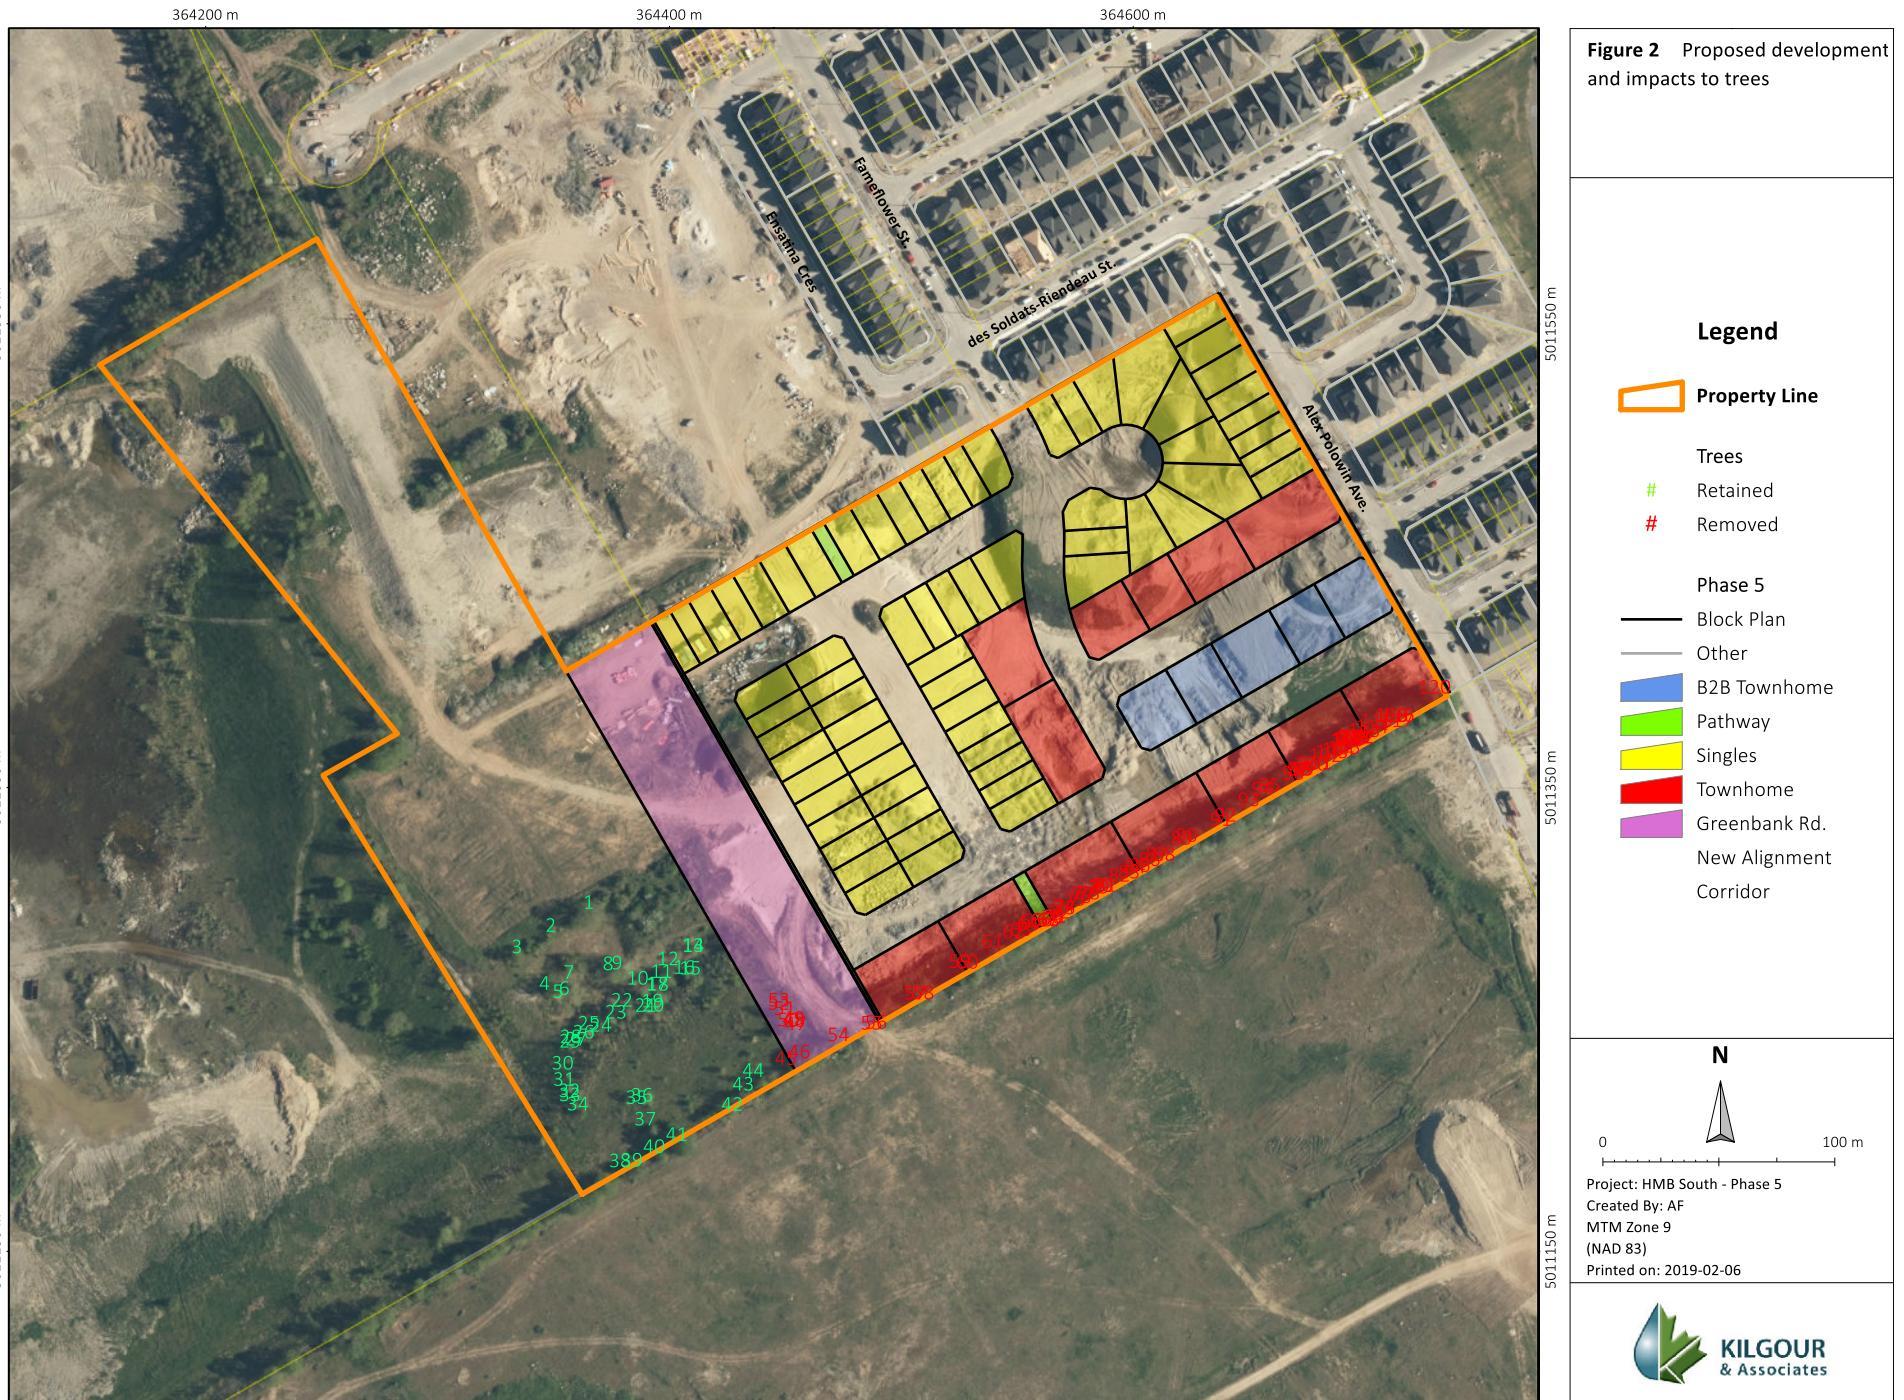
Table Note: Trees indicated in green (i.e. #1-44) are outside the area proposed for development within this current phase, and will be retained. Trees indicated in red (i.e. #45-120) will be removed to allow for site grading and construction. Retained trees may be removed in future phases of development beyond the scope of this report.

The proposed development (Figure 2) will consist of a mix of singe homes and townhomes. The new Greenbank Road alignment is will be located at the western edge of the development area, in the central portion of the lot. Most of the site has already been cleared; remaining site trees on the eastern half of the site, located primarily in a single row along the south boundary, will be removed to accommodate site grading in the winter of 2019. Housing construction will begin in the spring of 2019 and be completed by 2020. The Greenbank Road corridor will also be cleared in prepared for road construction. Areas to the west of the Greenbank Road corridor will be left as-is for the time being. Trees there will be cleared under future phases of development with their removal addressed in Tree Conservation Reports associated with those development phases.

As no natural areas currently occur on or adjacent to the development area, no natural heritage features will be impacted by site development or will require specific mitigation measures for their protection or preservation. All trees on site will be removed. The limited canopy cover and function provided by these trees can be replace within the new community through trees to be planted as part of a site landscape plan.
