Re: Review of Meander Belt Width Delineated for the Jock River Subwatershed Study Jock River, Barrhaven Conservancy GEO Morphix Project No. PN17071

Appendix A Meander Belt Widths

Appendix B Photographic Record

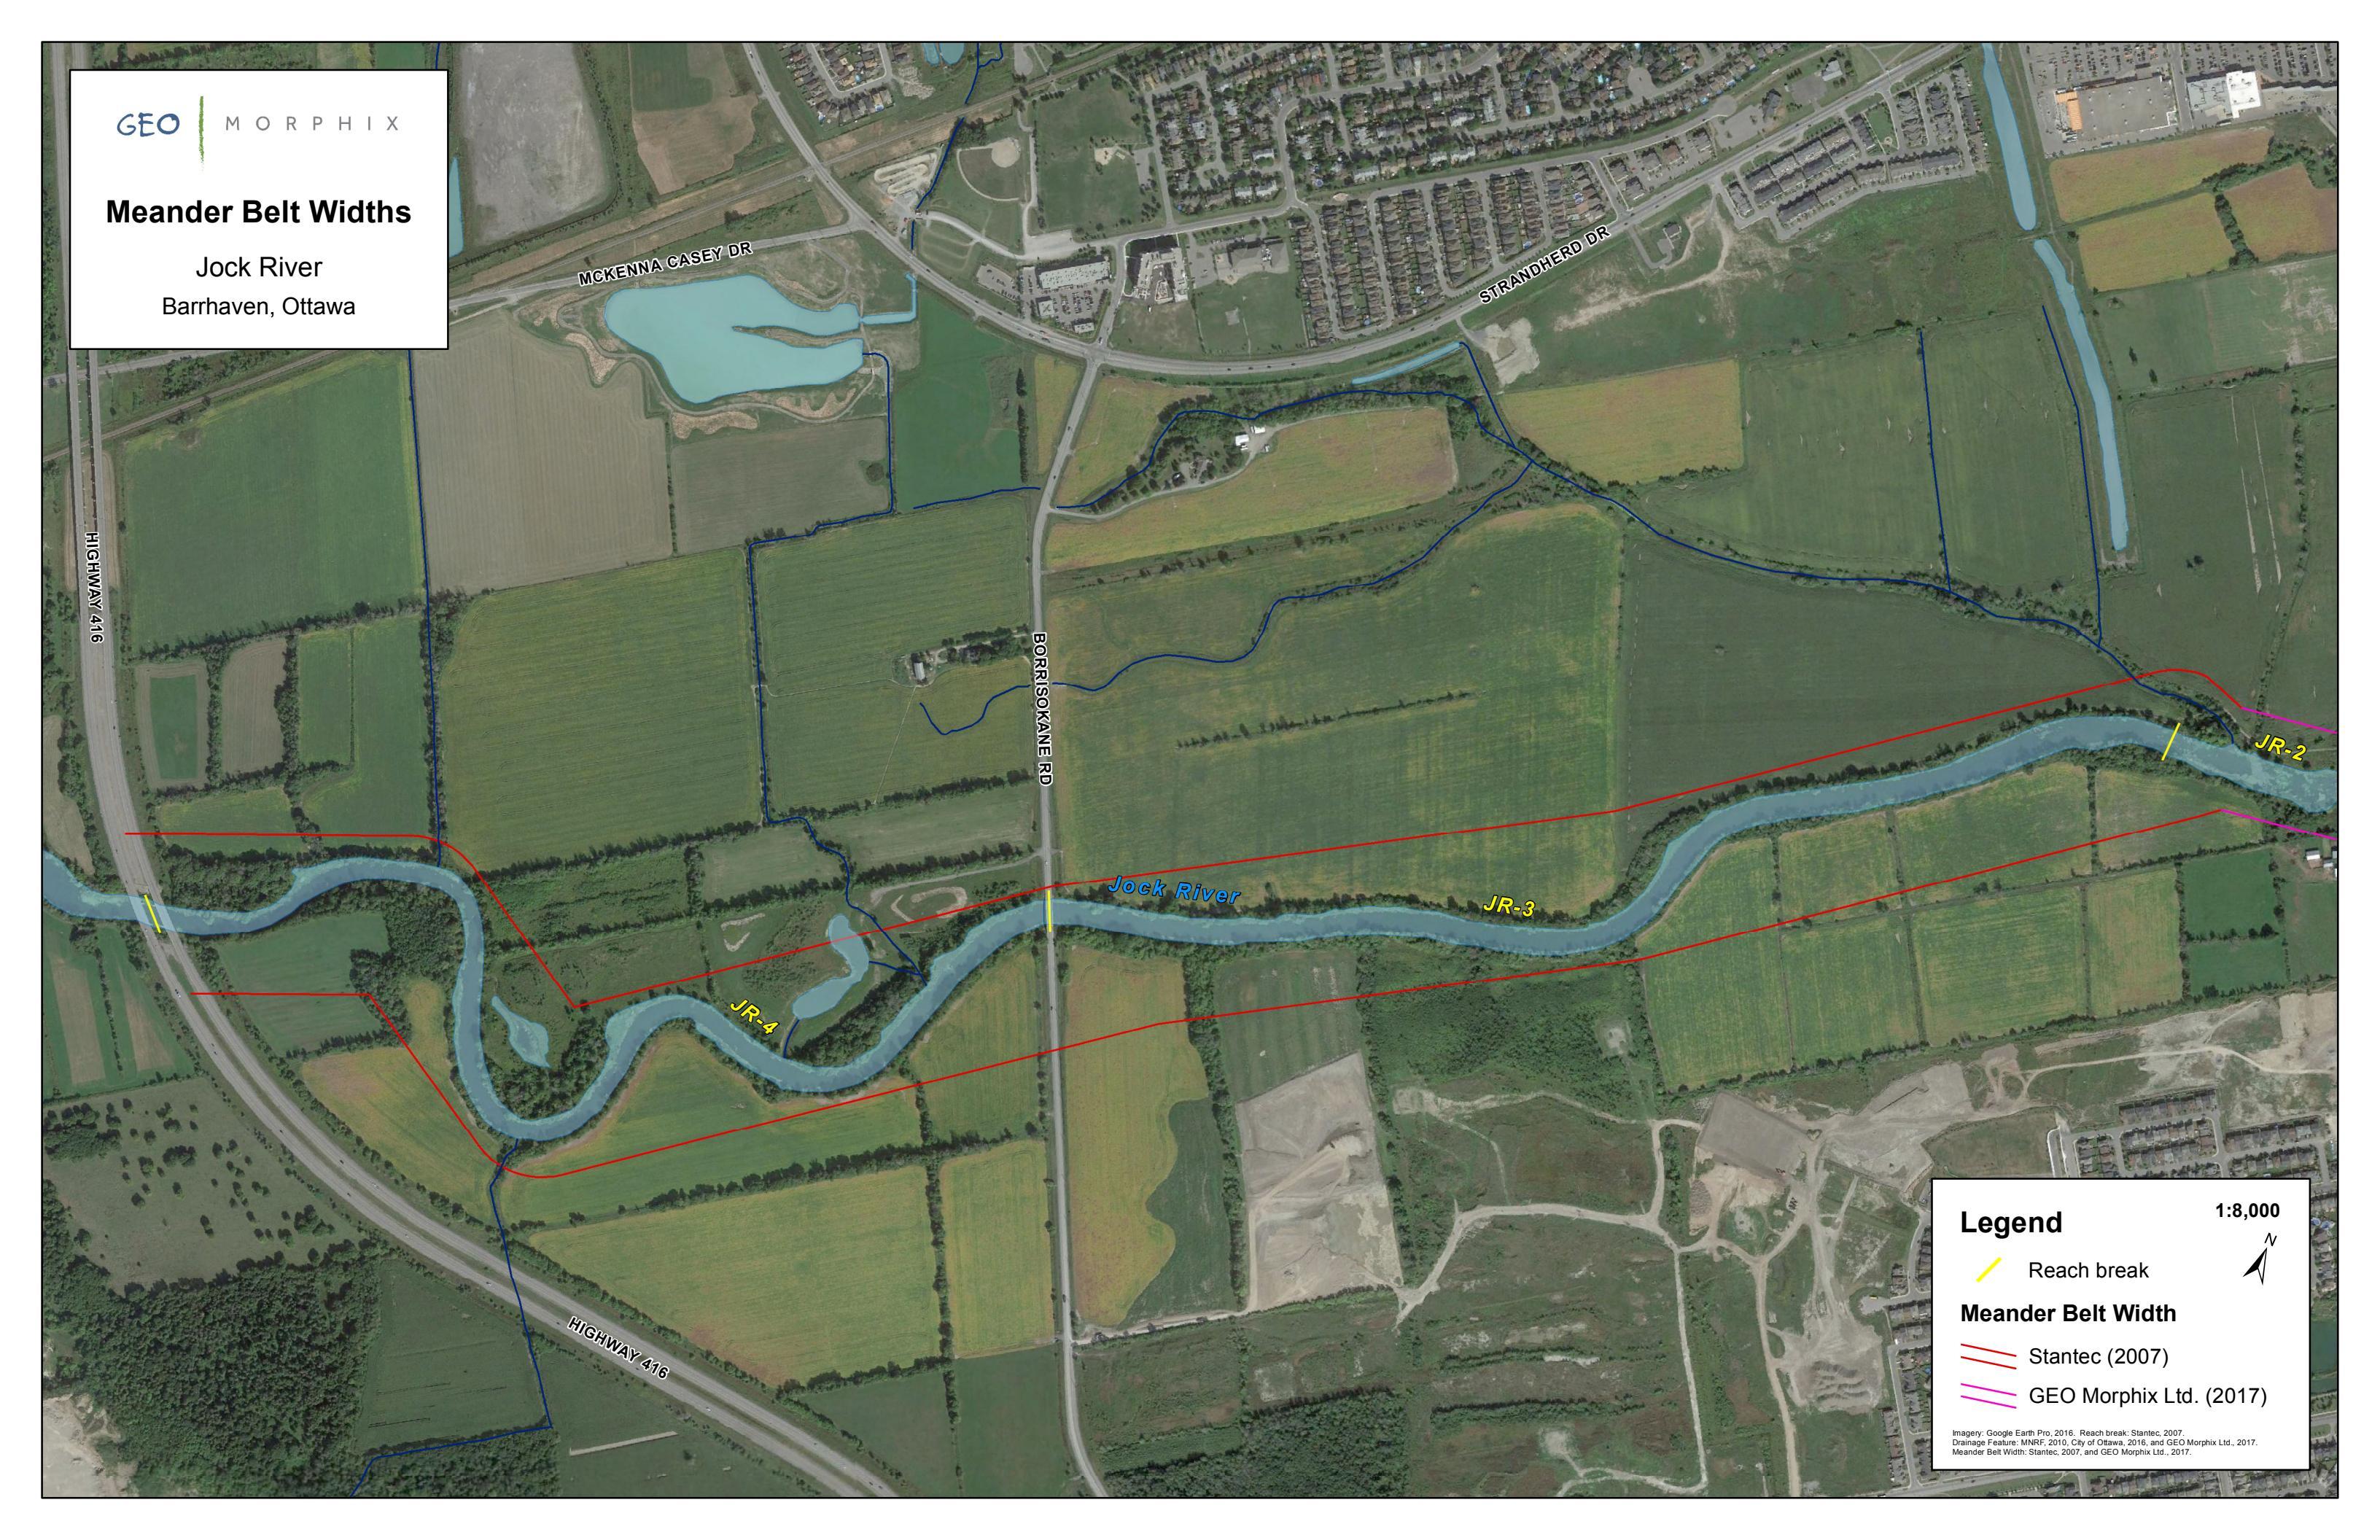
The Jock River meander belt widths within the Subwatershed Study (Stantec, 2007) were reviewed to assess suitability. The meander belt widths provided by the Subwatershed Study for reaches JR-3 and JR-4 are 218 and 231 m, respectively (Stantec, 2007). These meander belt widths include a 10% buffer. We are generally in agreement with the scale of the meander belt widths. The central tendency of the watercourse generally follows the overall trend of the channel passing through riffles or runs. Although there may be an opportunity for minor adjustments to the central tendencies for reaches JR-3 and JR-4. This does not fundamentally adjust the meander belt width from the location illustrated in the subwatershed study. Our finalized meander belt widths and central tendencies are provided in **Appendix A**.

We have a minor refinement for the downstream reach, JR-2. The geologic feature at Half Moon bay is not technically a meander. Half Moon bay was formed by reworking the underlying glaciomarine deposits (OGS, 2010). Therefore, the meander belt width for reach JR-2 is 130 m plus a 10% buffer plus a 7 m setback. The proposed meander belt width for reach JR-2 is 150 m. This is smaller than that proposed in the subwatershed study.

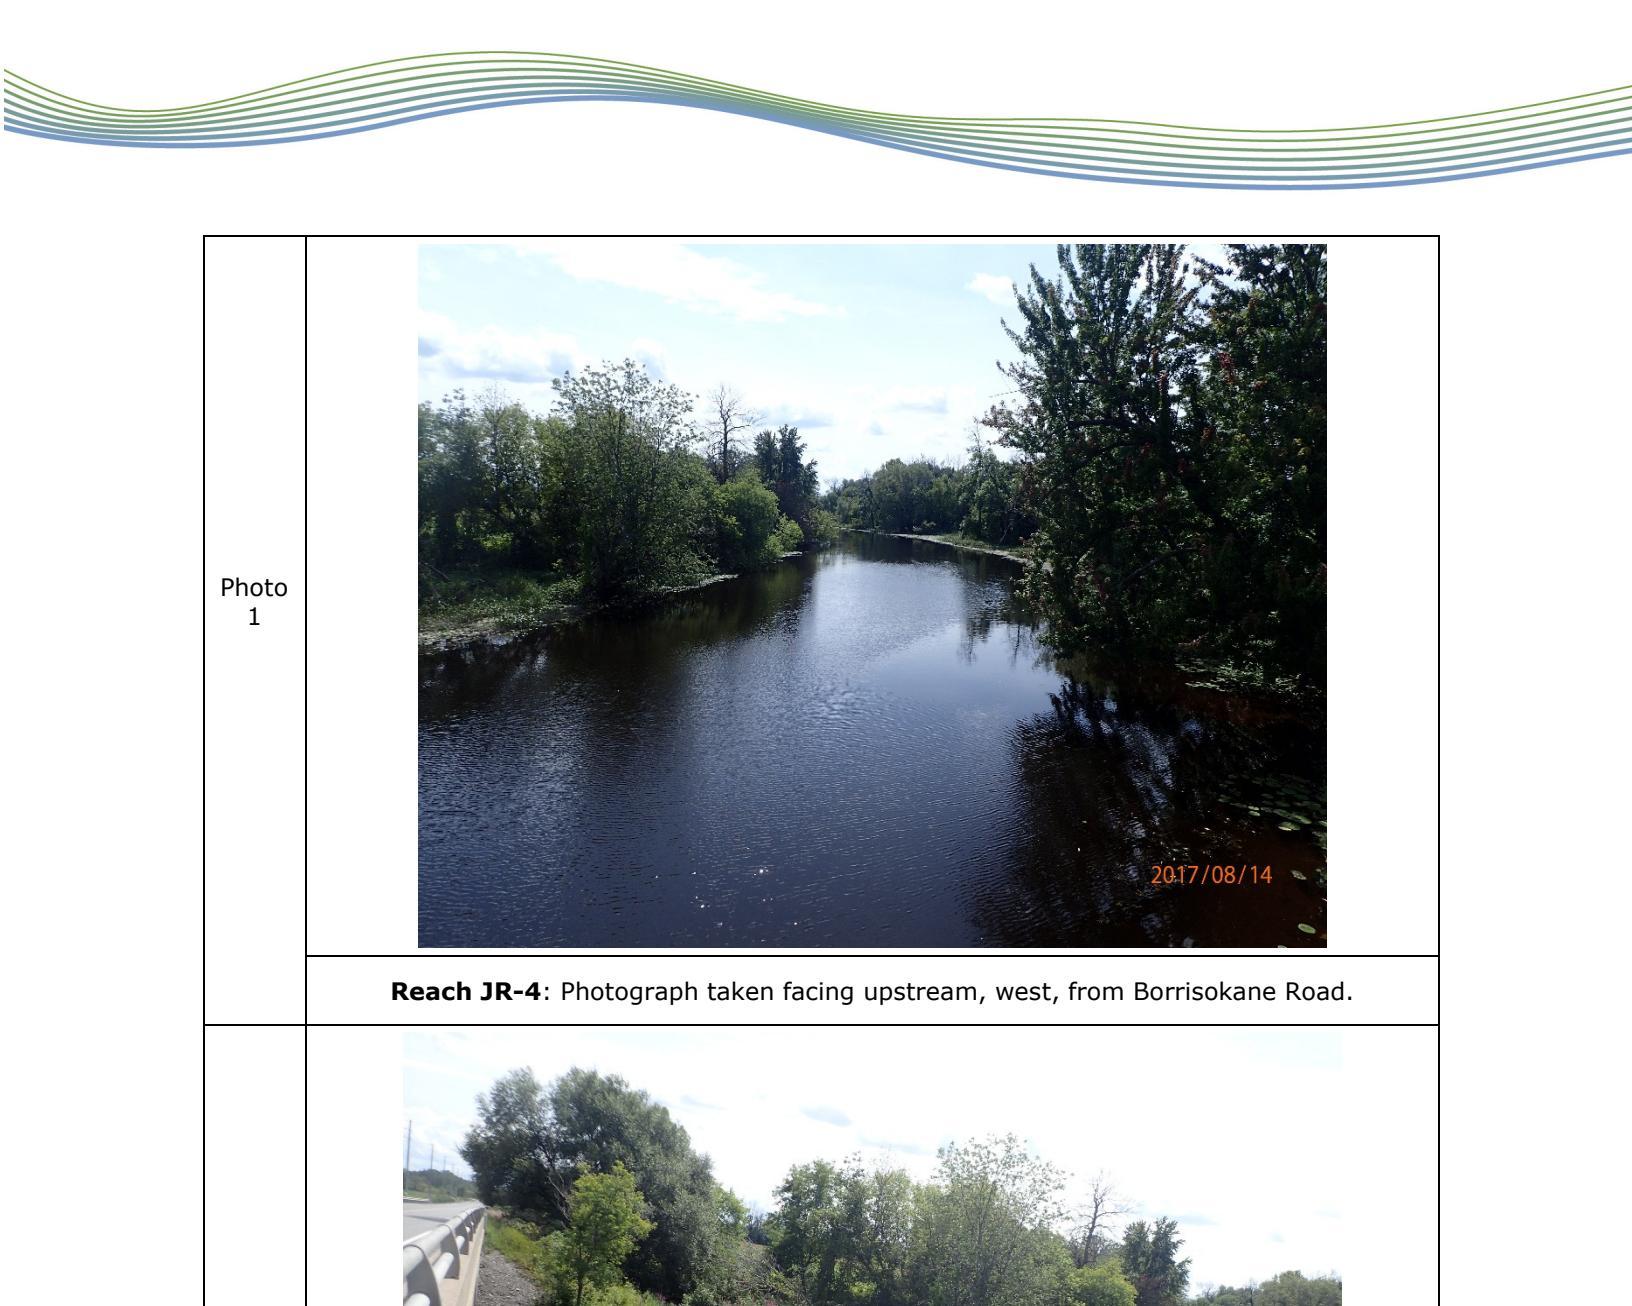
Photo 2

Reach JR-4: Photograph taken facing right bank, south, from Borrisokane Road. The reach was unconfined.
