Erosion Hazard Assessment: Van Gaal Drain, Richmond, ON

Submitted to:	David Schaeffer Engineering Limited
Prepared by:	M.H. Davies, Ph.D., P.Eng.
	Coldwater Consulting Ltd. 5510 Canotek Road, Suite 203 Ottawa, ON, K1J 9J4 (613) 747-2544
Version:	1.2
Date:	15 October 2013

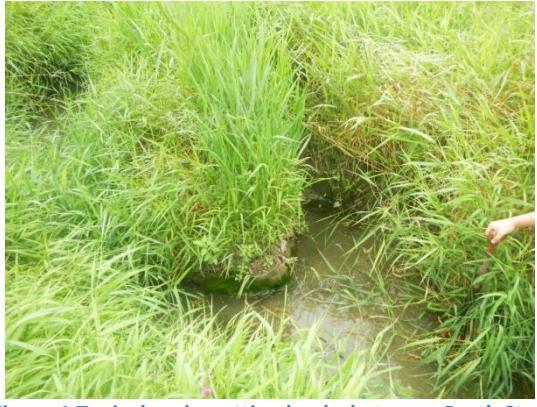
Figure 1 Typical undercutting banks between Perth St. and Fortune St.

The field investigation found several sites with significant erosion on the Van Gaal Drain. This agrees with previous studies. For most of the reach between Perth St. and Jock River, the channel is too narrow for the current hydrologic conditions. The existing drain will continue to erode and widen until it reaches equilibrium - even without the proposed storm management plan. Figure 1 through Figure 4 show examples of erosion in the Van Gaal Drain. Figure 5 shows the location of each photo.

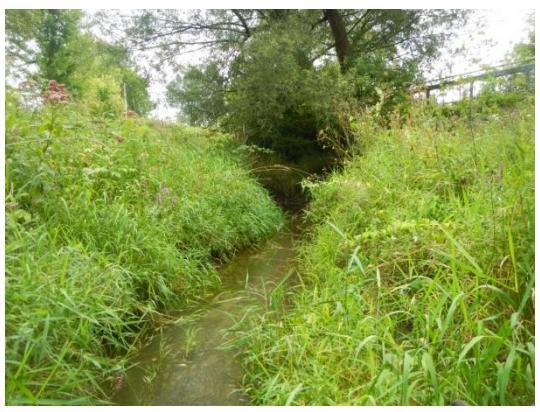
Figure 2 Eroding bank downstream of Fortune St.

The existing meander immediately downstream of Fortune St. is creating an erosional hotspot. Here, a channel re-alignment is recommended (Item C in the Figure 17) that will shift the channel away from the eroding bank. Cross-vanes will be used to develop riffle-pool structures that will stabilize the channel in its new location while also providing natural in-stream features.

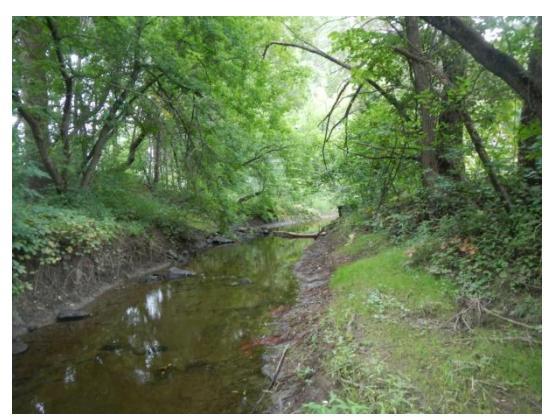
Figure 3 Bank widening upstream of Fowler St.

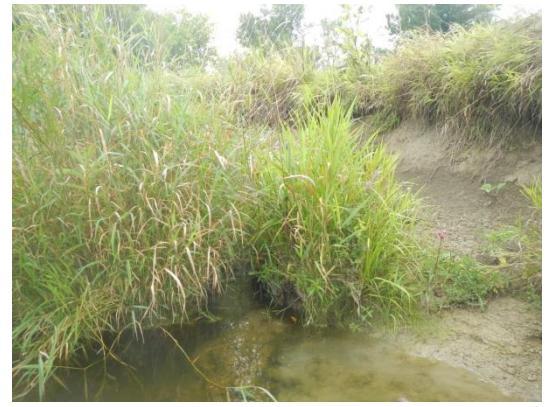
Figure 4 Eroding banks downstream of Fowler St.

Downstream of Fowler St., bank re-grading and revetment is required to protect the adjacent property on the west side of the stream. A small timber weir exists beneath the pedestrian bridge just upstream of this site and the remnants of a somewhat larger timber weir exist further downstream. It is quite possible that the loss of this downstream weir has significantly increased erosion upstream. We are proposing several cross-vane weir structures composed of quarrystone to replace and improve the function of these weirs. These structures will reduce channel slope in the area and help to stabilize the banks.

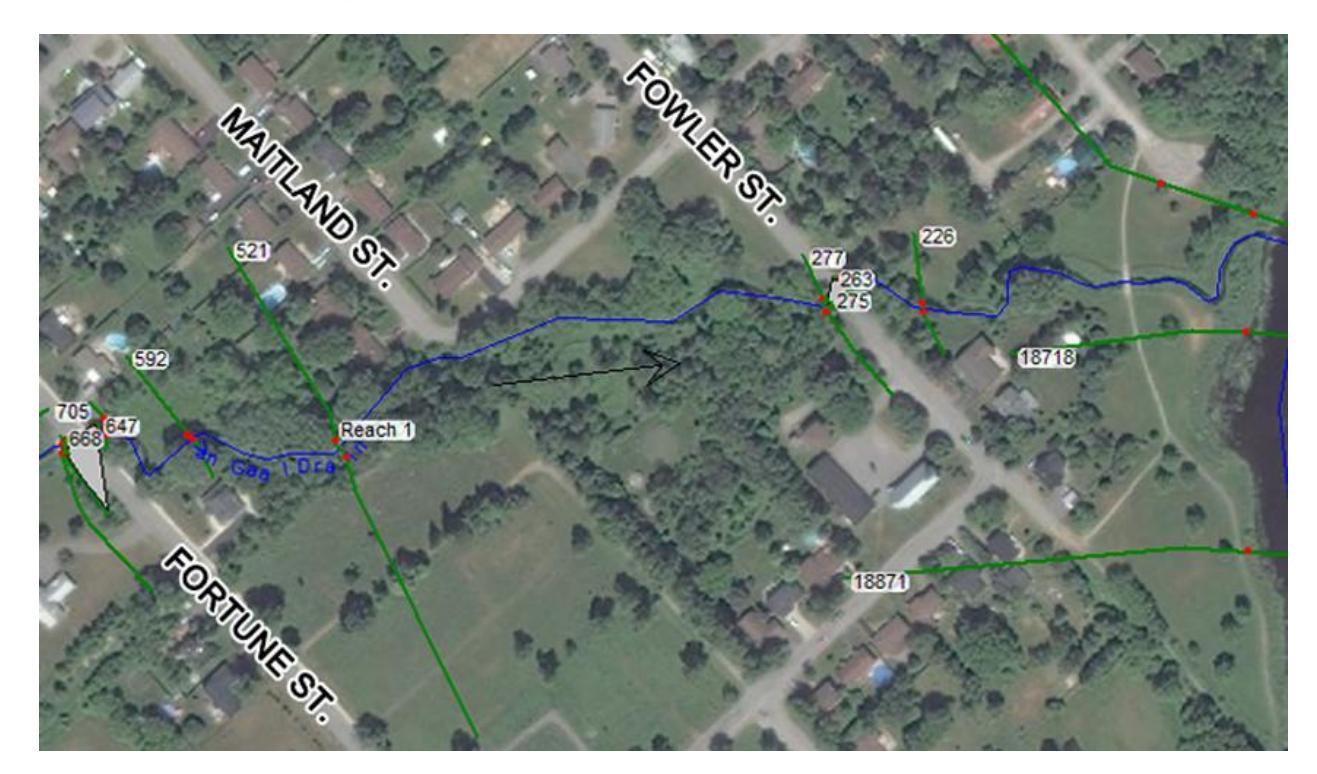
The original HEC-RAS model (JFSA, 2009) covers a very large domain and was found not to have sufficient resolution in the reach downstream of Fortune St. New cross-sectional survey data was provided by DSEL and were incorporated into the HEC-RAS model by Coldwater. Figure 6 shows the original model (with only one cross-section below Fowler St.) and Figure 7 shows the refined model (with 7 cross-sections below Fowler St.).

Figure 6 Original HEC-RAS model provided by JFSA with limited number of cross-sections d/s of Fortune St.

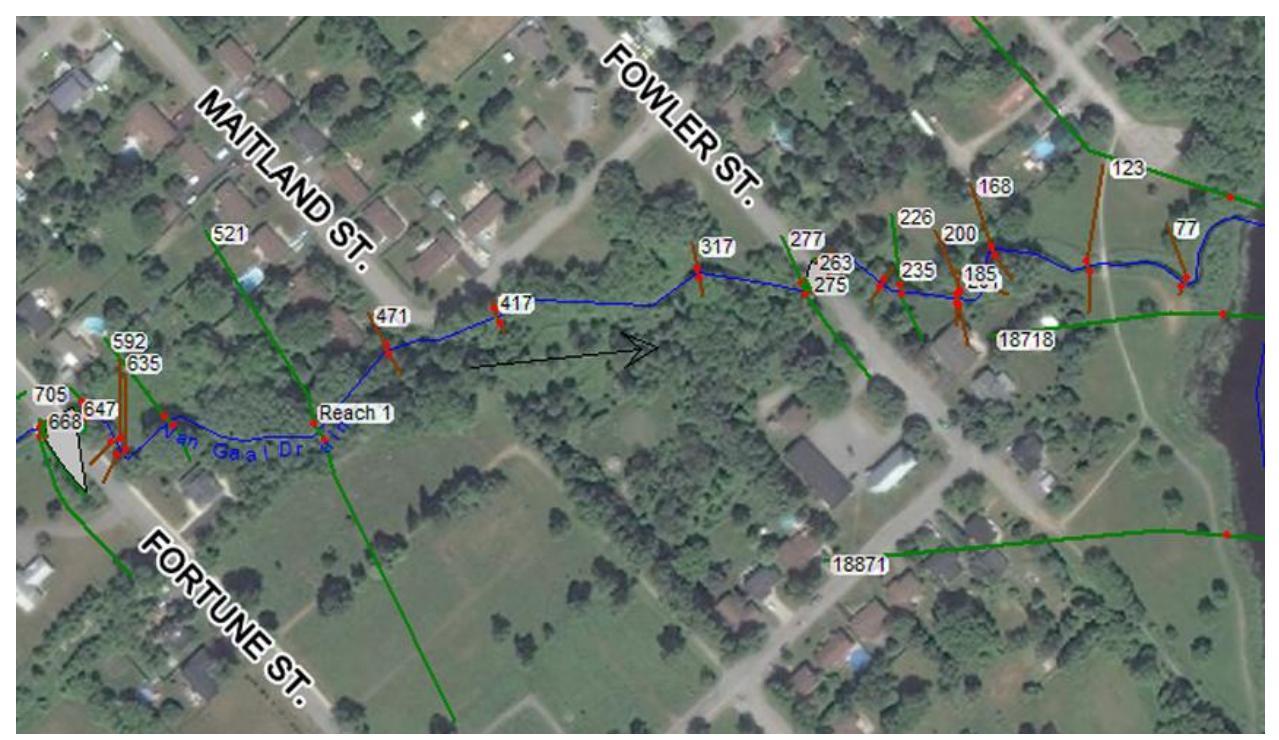
Figure 7 HEC-RAS model provided by JFSA with supplemental cross-sections added.

The erosion model requires two types of input; the predicted discharge for the scenario being studied and station-specific values for shear stress, velocity and wetted perimeter as a function of discharge. These station-specific values were calculated using the refined HEC-RAS model. At each station, 22 discharges scenarios ranging between 0 m^3 /s and 16.42 m^3 /s were modelled to obtain these relationships (16.42m^3 /s being the 1:100 year flow level). In total 726 (= 22 scenarios x 33 stations) sets of discharge, shear stress, velocity and wetted perimeter data were created to model the Van Gaal Drain between Perth St. and Jock River.

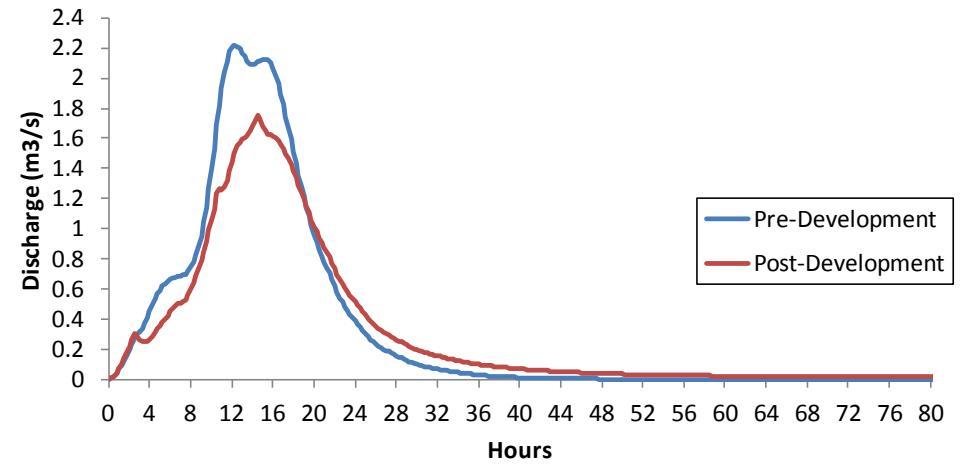
Figure 8 shows the hydrograph for the event. The peak discharge decreases by 0.5 m³/s from pre- to post-development. Pre-development discharge remains higher than post-development condition until it hits the 19.25 hour mark. The shear stress, shown in Figure 9, mimics the pattern. The shear stress is lower up until after the peak of the event. Shear stress is above critical until 31.75 hr for pre-development condition and until 40.5 hr for post-development case. Figure 10 shows the erosion index (EI) results; post-development EI remains lower than pre-development conditions until 19.25 hr. In total, there's 30.75 hours of erosion for the pre-development condition and 39.5 hours of erosion for the post-development condition. The cumulative erosion index for the event, a measure the impact of the event on the stream, is shown in Figure 11. Although the total duration of erosion for the pre-development case is 66.1 MJ and 50.8 MJ for the post-development case. This pattern was found to be repeated for the majority of the events at stations downstream of the retention pond (Stations 746 and lower). Stations upstream of this point showed lesser variation in the results of the two scenarios.

Figure 8 Continuous time series of discharge for pre- and post-development cases for the April 1980 event

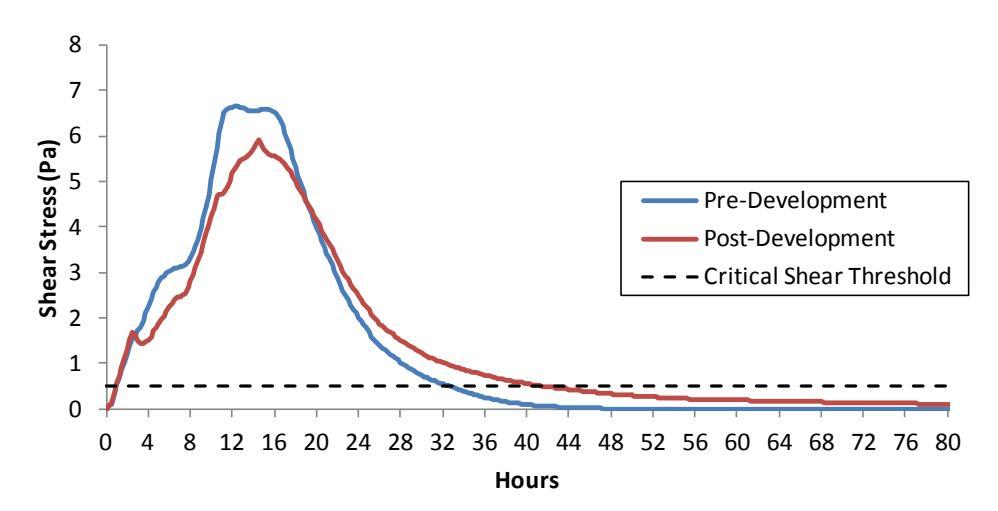
Figure 9 Continuous time series of shear stress for pre- and post-development cases for the April 1980 event

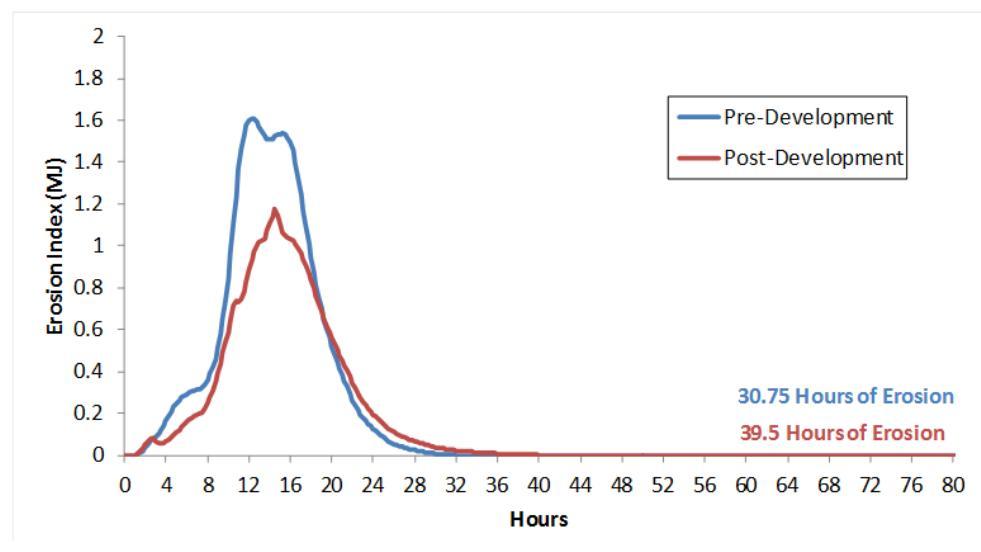
Figure 10 Continuous time series of erosion index for pre- and post-development cases for the April 1980 event

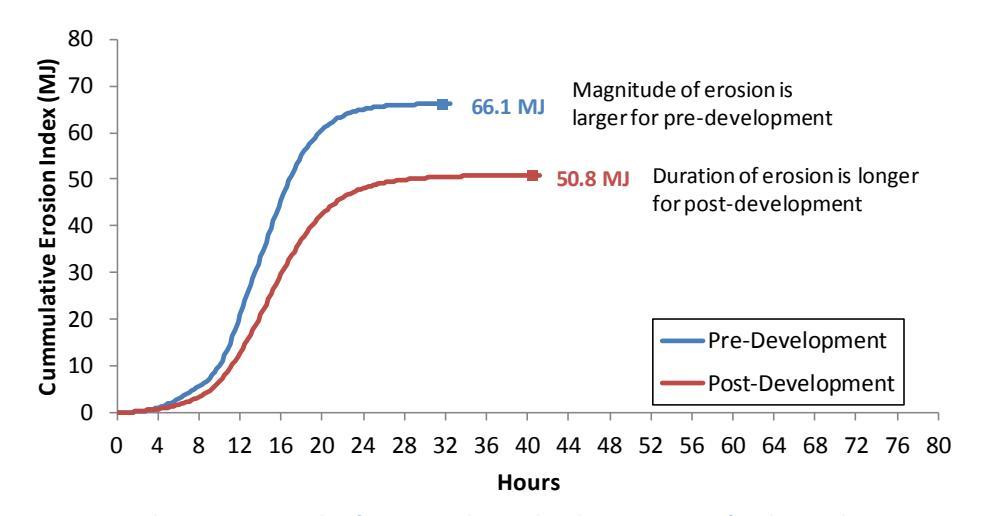
Figure 11 Cumulative erosion index for pre- and post-development cases for the April 1980 event

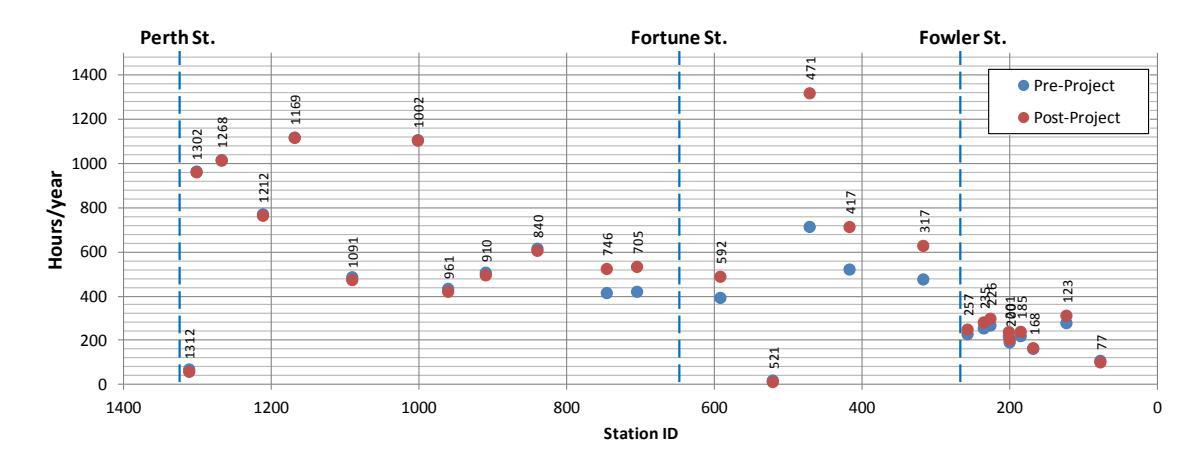
Figure 12 and Figure 13 show the average annual time above critical shear and the change in this measure computed as post-development minus pre-development. Upstream of Station 746 there is little change. Downstream of this point, the post-development case tends to spend more time in an erosional state. However, as was illustrated by the example in Section 5.1, this is not truly representative of the impact of the changes to the system on potential erosion of the stream. Figure 14 and Figure 15 show the annual average erosion index and change in this measure. These plots illustrate that the impact on the stream of the changes to the system lead to a reduction in erosion potential along the entire reach. This is illustrated in plan view in Figure 16.

Figure 12 Average annual time above critical shear for a 36-year simulation

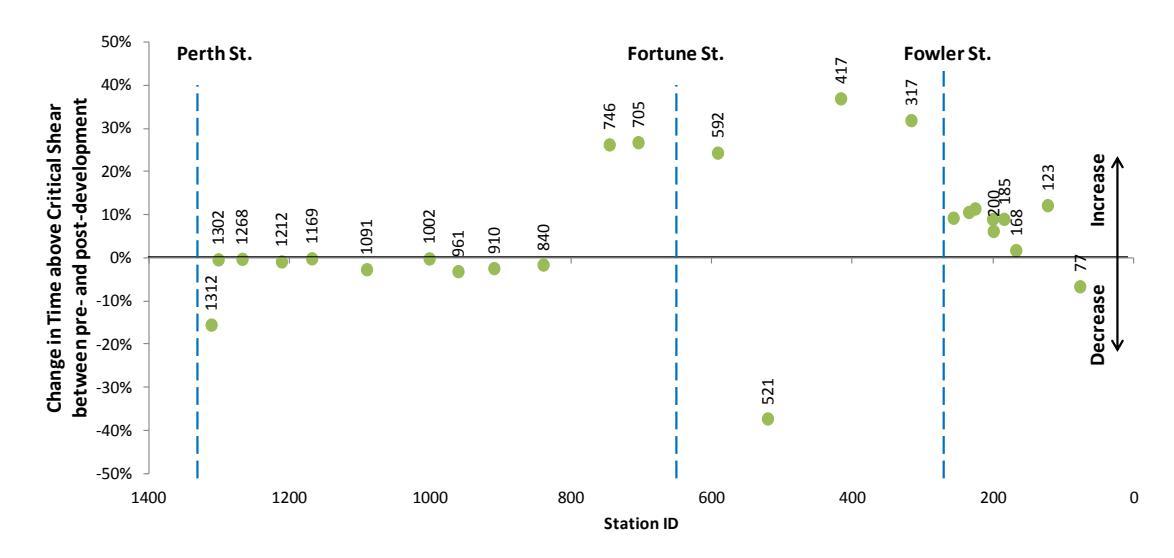
Figure 13 Change in annual time above critical shear for a 36-year simulation (post - pre)

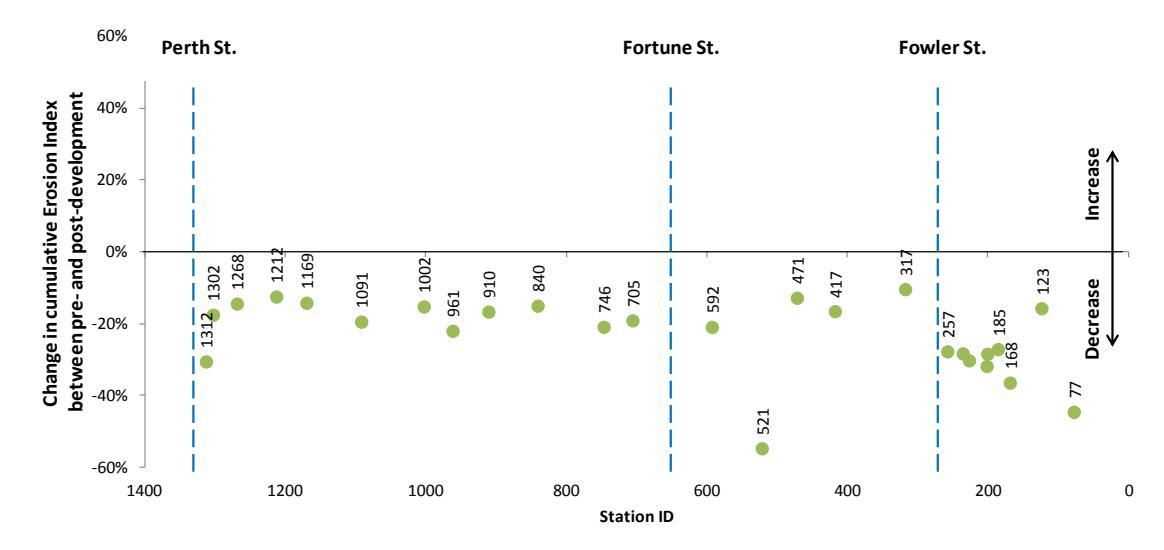
Figure 15 Change in erosion index for a 36-year simulation (post - pre)

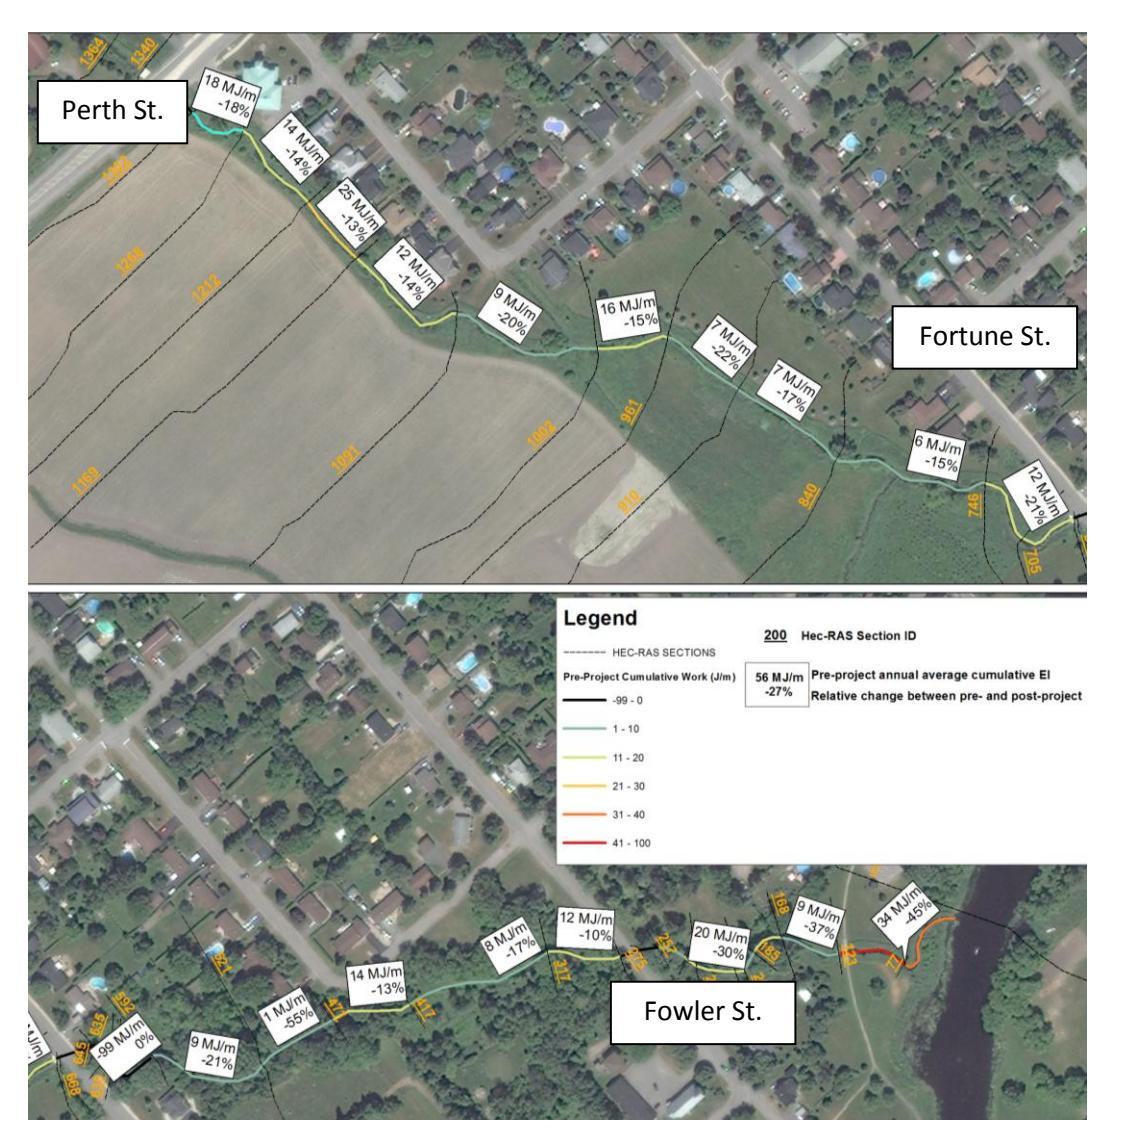
Figure 16 Annual average pre-development erosion index and change in erosion index over the 36-year simulation

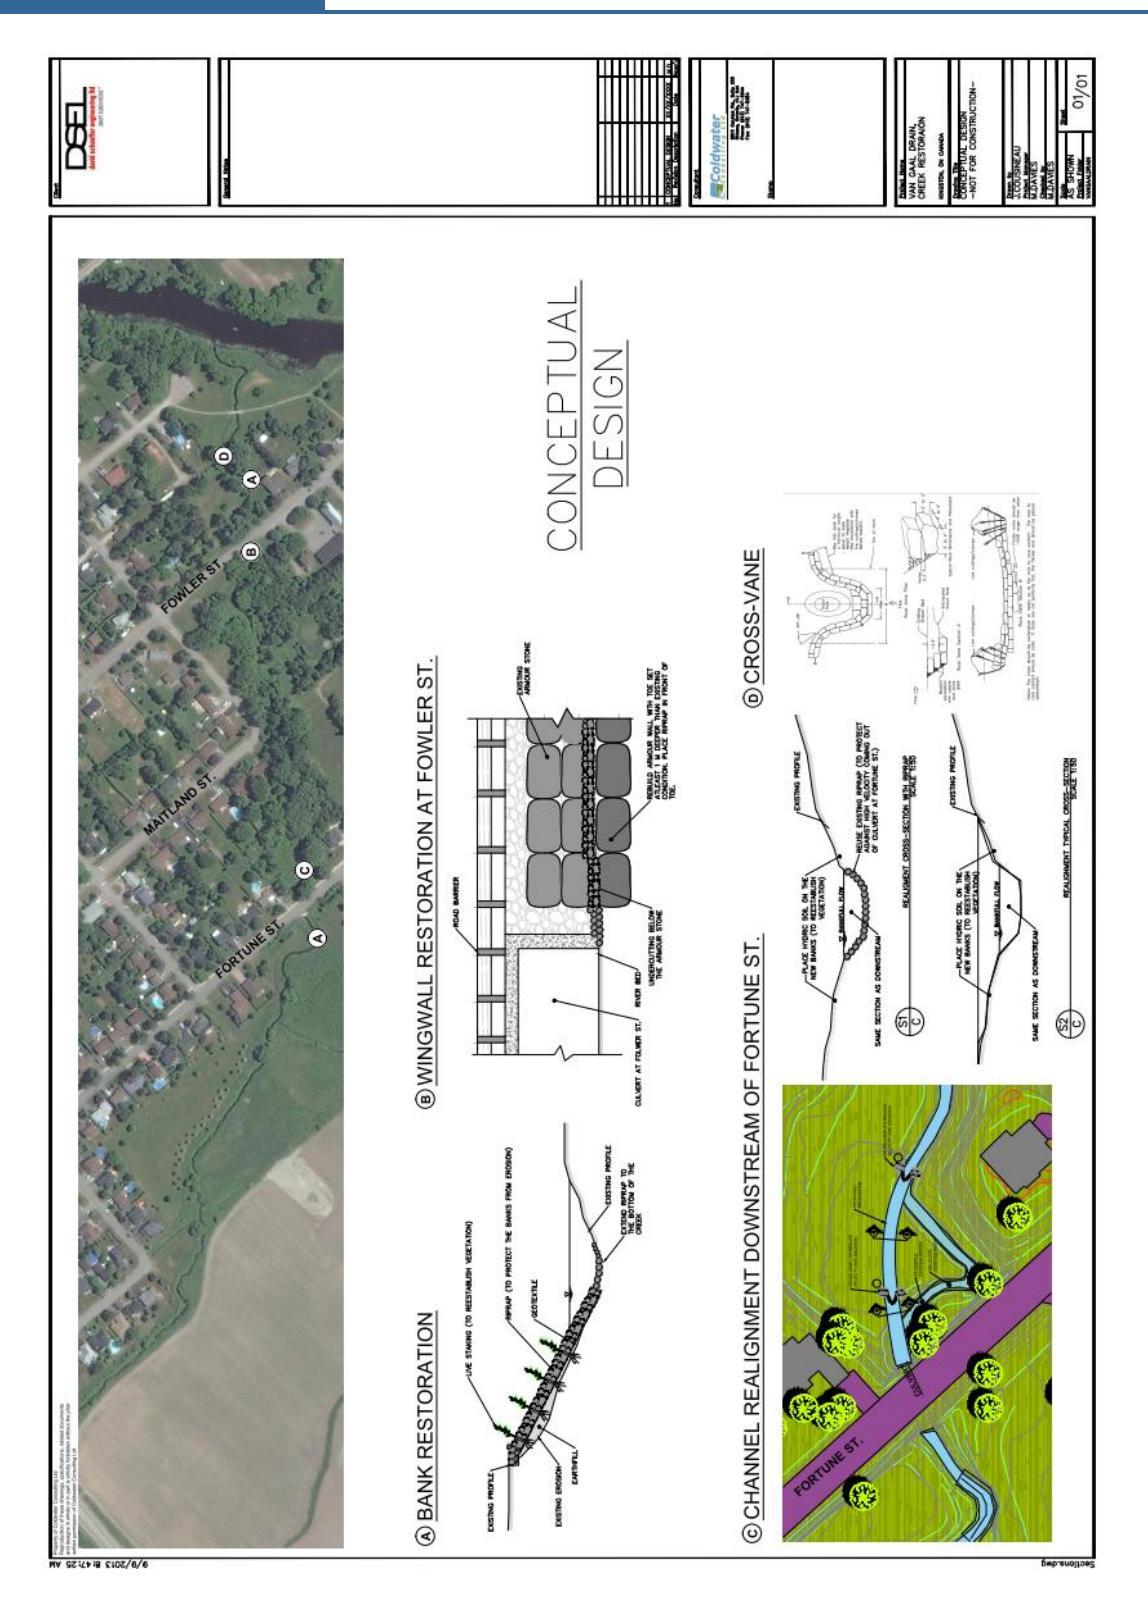
The upstream wingwall for the Fowler St. crossing is presently being undercut, as identified in Item B in Figure 17, wingwall restoration works are proposed to remedy this situation.

Figure 17 Restoration Conceptual Designs

As shown in Figure 17, conceptual restoration works have been developed for five specific sites. Bank restoration works are proposed both upstream of Fortune St. and downstream of Fowler St. This involves re-grading of the slopes, riprap bank protection and live stake plantings to re-establish vegetative cover.
