Tree Conservation Report Richmond West

Final Report - Revised

October 24, 2012

Frank Cairo Richmond Village (South) Limited

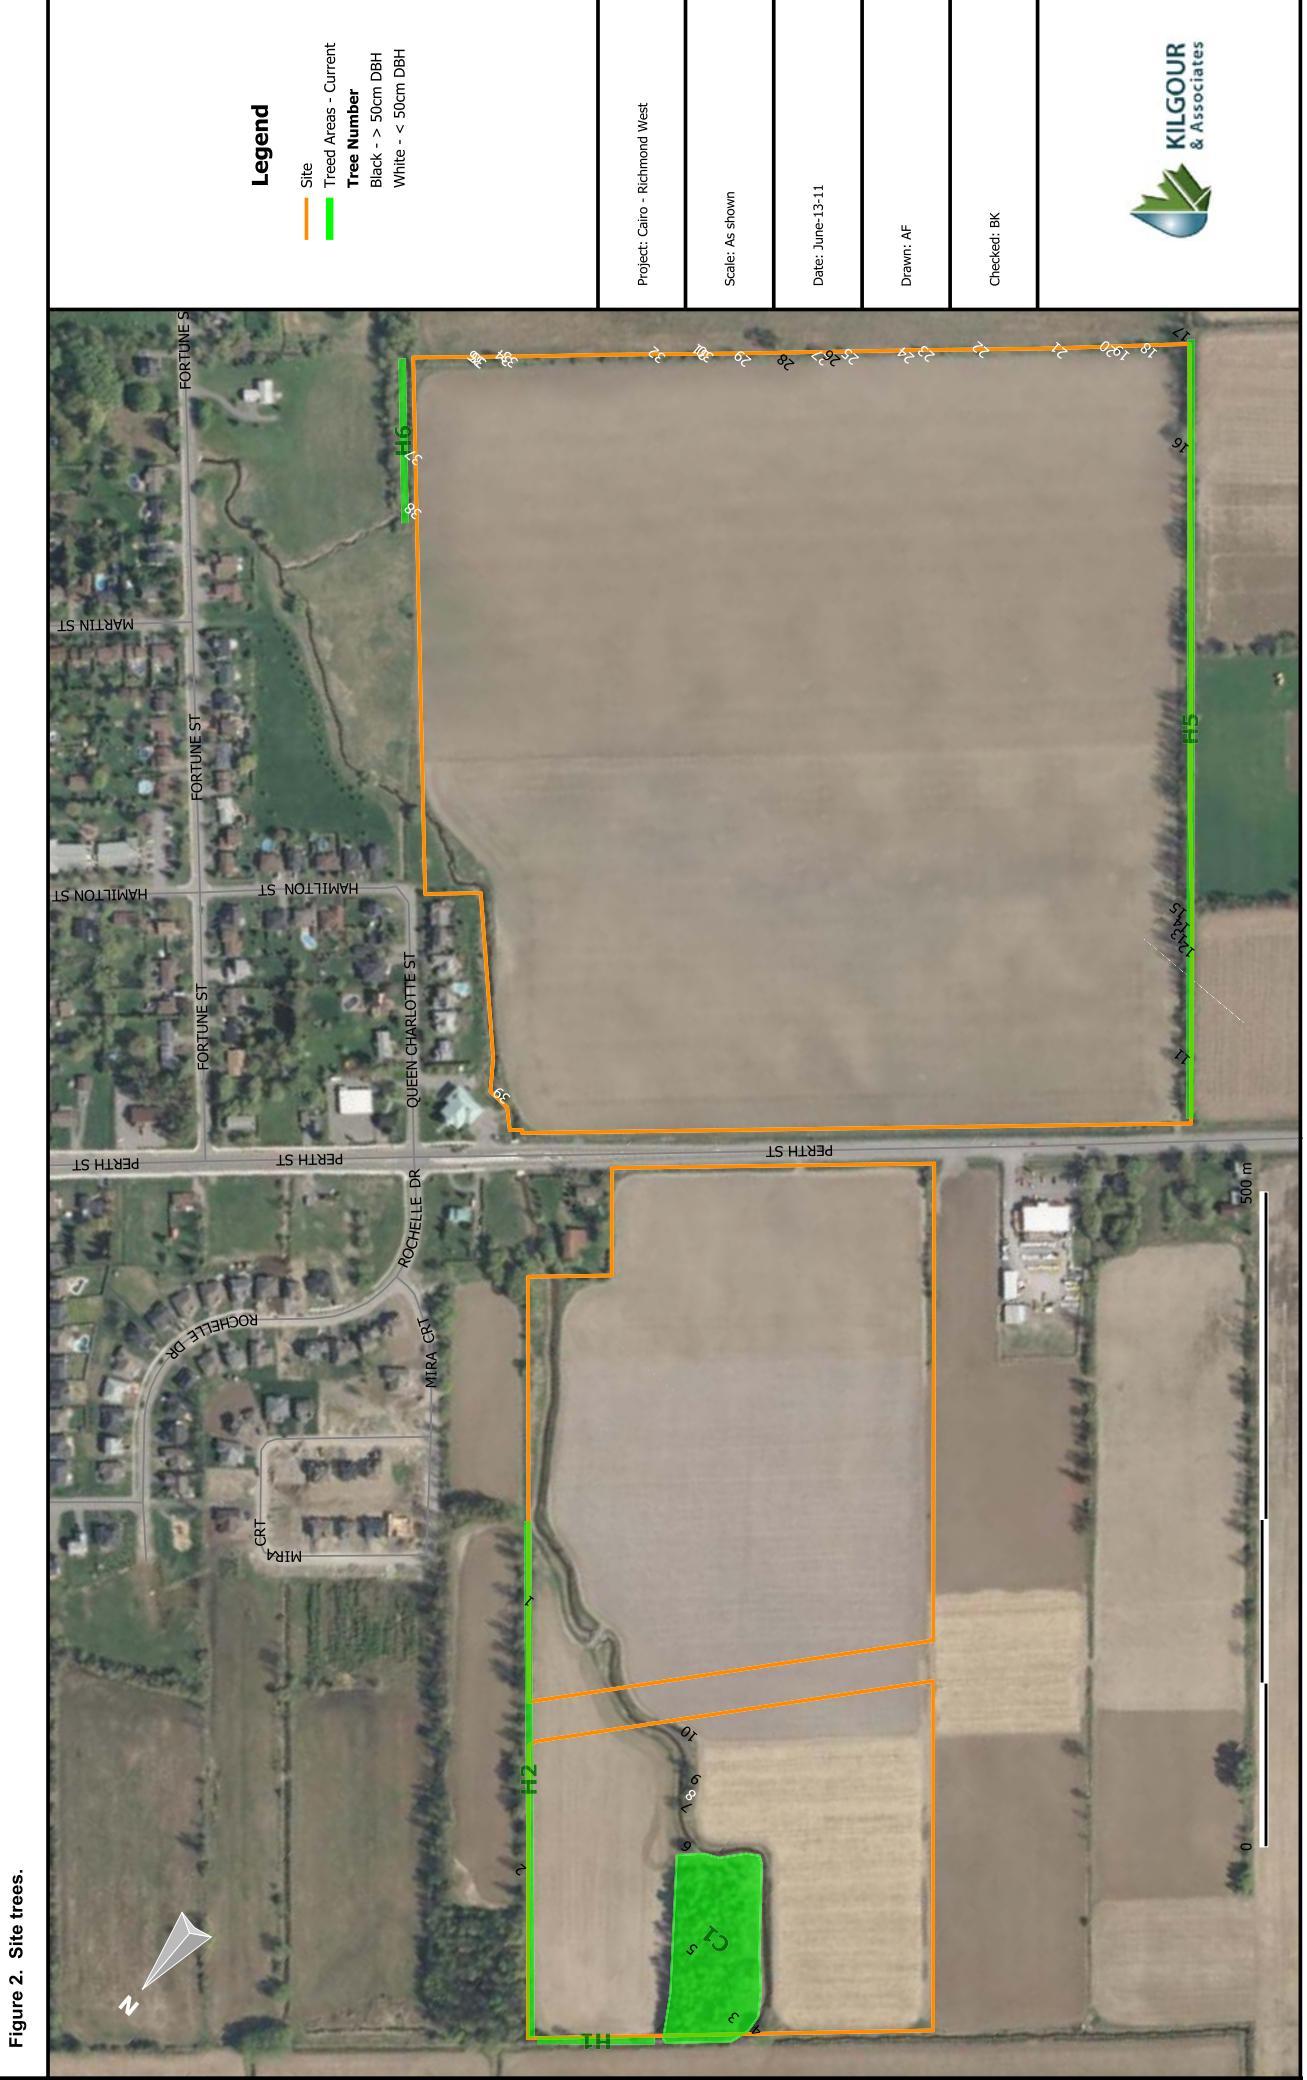
Apart from a few individual trees along the Van Gaal Drain and the southern edge of the site, all trees were located within the fairly dense hedge rows and Community 1 woodlot. All trees over 10 cm DBH standing in open areas were individually noted; however, the woodlot and hedgerows contain too many trees to practically list every individual over 10 cm DBH. For these areas, only significantly sized trees (i.e., >50 cm DBH) were individually identified. Tree records are detailed in Table 1. Trees on site were generally healthy unless specifically noted otherwise.

Table 1 Trees and small tree clusters on the site.

Tree sizes: s=10-34cm DBH, m=35-49cm DDBH, xl > 75 cm DBH but with multiple stems splitting near breast height and fencing complicating direct measure. * indicates a specimen tree (>50 cdm DBH, reasonably healthy, non-invasive).

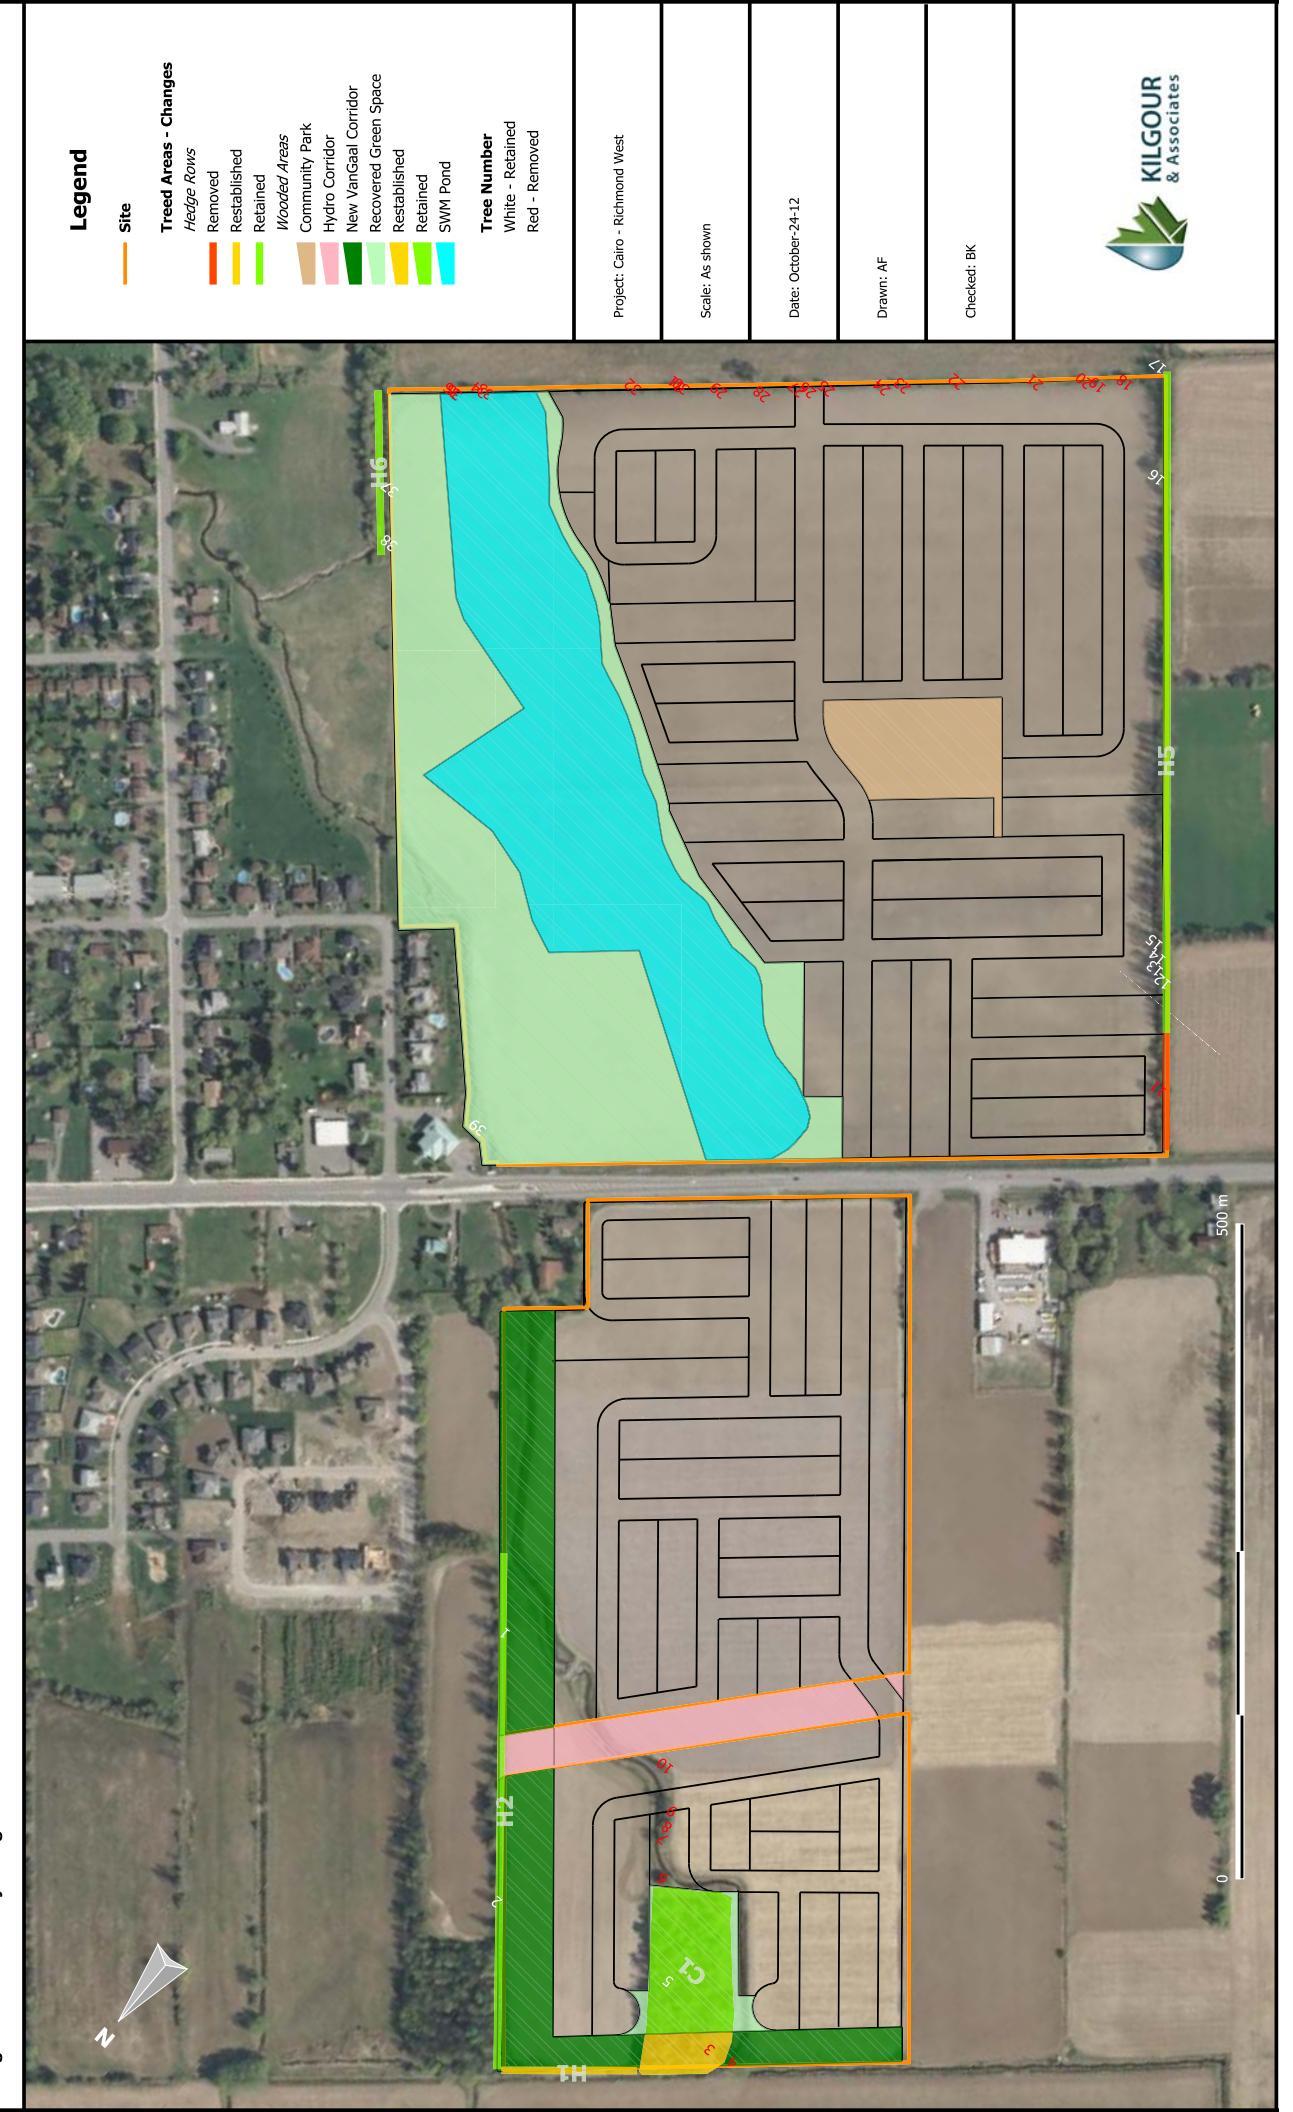
The current subdivision concept plan is shown in Figure 3.

Under the development plan (Figure 3), grading requirements and the realignment of and bridge construction over the Van Gaal Drain will require the removal of 26 individual trees along the southern property line and along the Van Gaal corridor. Approximately 77% of the current Community 1 woodlot area (0.7 ha) will be protected as part of a future park block. The northern portion of the woodlot subject tree removal may be replanted with trees after construction of the new channel according to a landscaping plan indicating appropriate local specimens to provide and improve the buffer functionality for the drain.

Hedgerow H1, located directly in line with new proposed Van Gaal realignment will be removed. Replacement trees will be incorporated into the landscape plan for the Van Gaal corridor. Hedgerow H6 is immediately adjacent to the site. Construction of the proposed area storm water management pond on the south eastern portion of the property will be graded to prevent any damage to these trees.

Hedgerows H2 and H5 straddle the property line. Most trees, including trees of significant size occurring immediately off site will remain and grading will be managed such that they are not negatively impacted. The Van Gaal Drain will be realigned adjacent to H2, but final grading during the detailed design will be managed to preserve trees. The north-most 90 m of H5, however, will be thinned significantly as an entrance road will be constructed parallel to this hedge section approximately 5 m from the property boundary. Grading will be managed to preserve trees on the neighbouring property, though trees present on site – Manitoba Maple and Green Ash, one of which is a specimen tree of 84 cm DBH – will be removed.
