Phase One Environmental Site Assessment 1568 Meadowbrook Road, Ottawa, Ontario

Type of Document: Final

Project Number: OTT-21019403-A0

Date Submitted: 2021-11-16

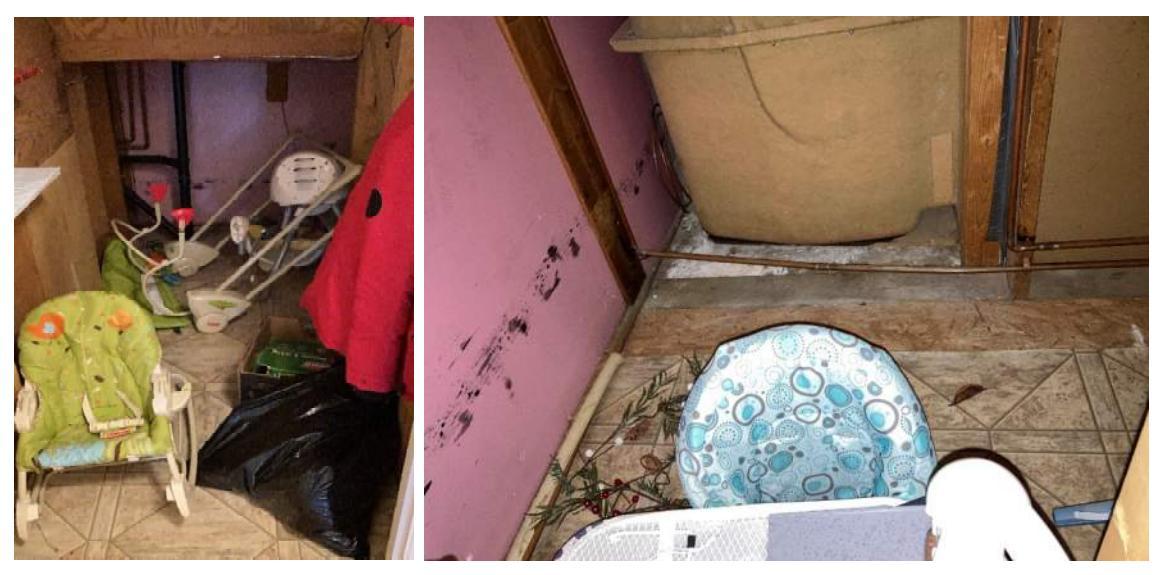
Photograph No. 2 View of potential former location of furnace oil AST underneath the stairwell.

Cut vent pipes were observed within the south side of the basement underneath the stairwell suggest that a furnace oil AST may have been formerly located there. At the time of the visit, the tank had been removed from the property and no visible sign of spills or contamination were present. As no visible signs of contamination were present in the basement, the potential former AST does not represent an APEC.

PCA#2 is not a concern since it was removed and there was no evidence of staining or contamination visible in the basement of the residence. No other PCAs that took place within the vicinity of the Phase One property (approximately 250 m radius) were identified.

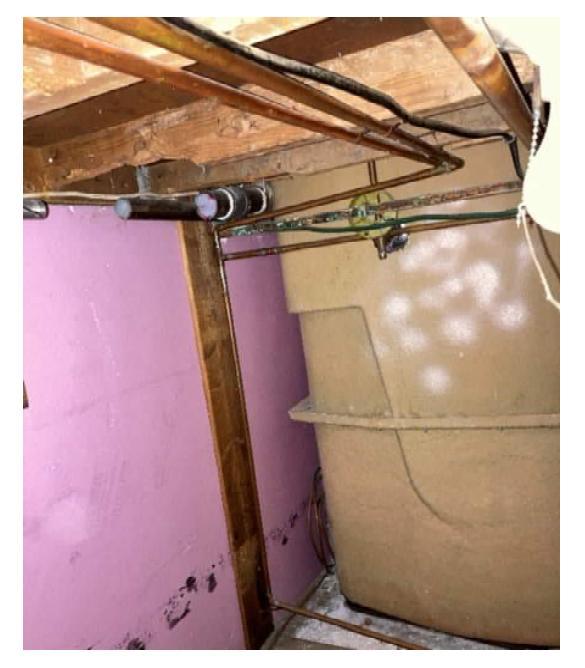
Photograph No. 3

View location of former vent/fill pipes. Vent/fill pipes have been cut and holes filled with silicone.

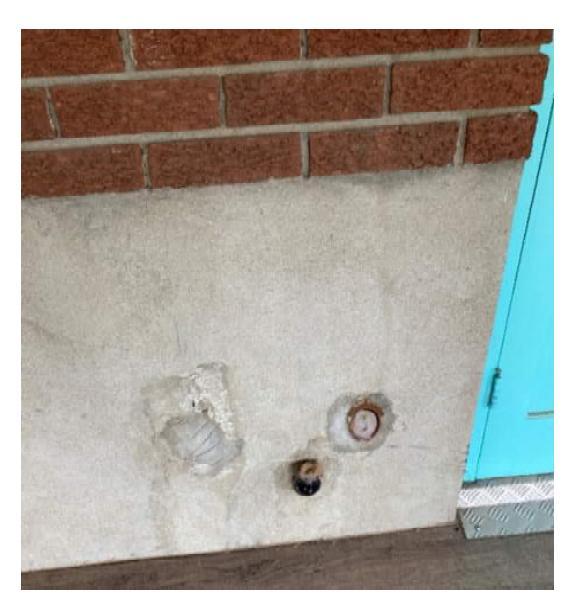
Photograph No. 4

View location of former vent/fill pipes. Vent/fill pipes holes have been filled. This area is within the solarium.
