August 7, 2018
File: PE4378-LET.01

Subject: **Phase II - Environmental Site Assessment**
1987 Robertson Road
Ottawa, Ontario

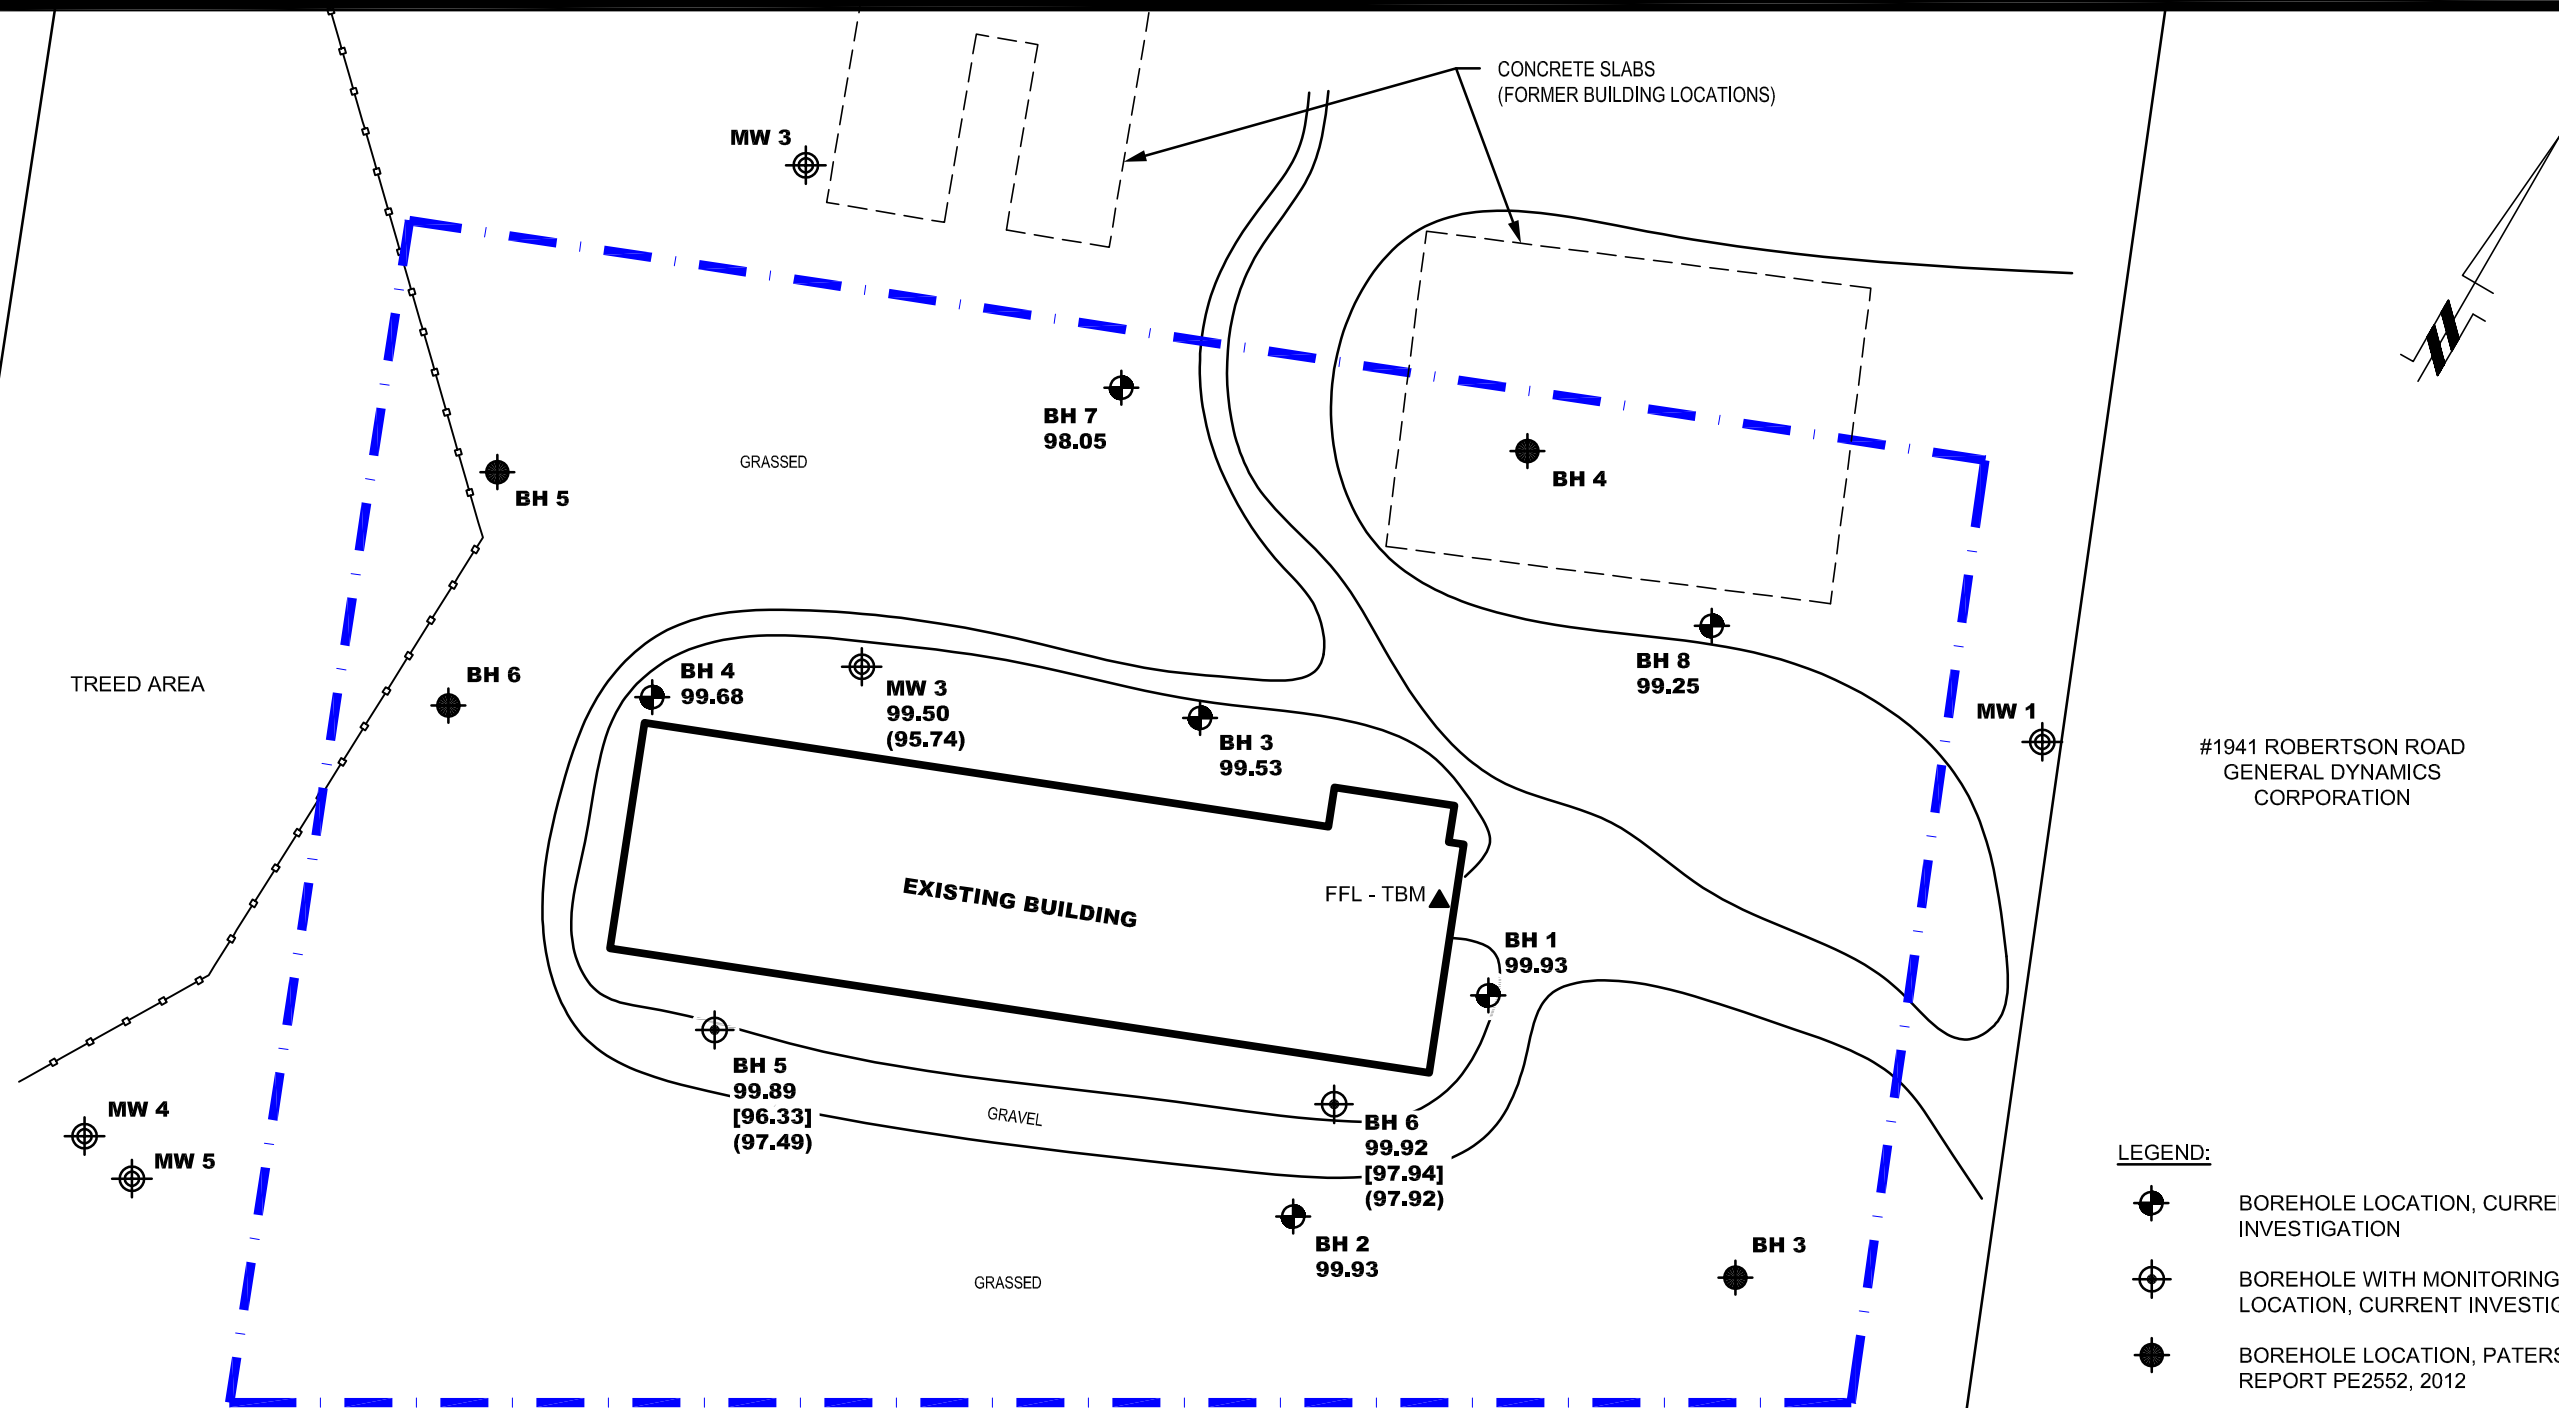
The Phase II ESA Property is designated as the southern part of the property, addressed 1987 Robertson Road, in the City of Ottawa, Ontario. The subject site is occupied by a large storage/warehouse style building, a gravelled laneway around the exterior of the building and is grass covered in the remaining area. The Phase II ESA Property is presented in Drawing PE4378-2 – Test Hole Location Plan, appended to this report.

Boreholes 1 through 3 (BH1-BH3 and BH8) were terminated on the inferred bedrock surface at depths ranging from 1.8 to 2.4 m below the existing grade. Boreholes BH5 and BH6 were subsequently advanced to depths of 7.2 m and 6.3 m below ground surface by means of coring the bedrock, in order to intercept the groundwater table. The locations of the boreholes are illustrated on the enclosed Test Hole Location Plan.

Groundwater monitoring wells were installed in BH5 and BH6, the location of which can be seen on the attached Test Hole Location Plan. Typical monitoring well construction details are described below:
