Phase II Environmental Site Assessment

424 Churchill Avenue North, Ottawa, Ontario

Muoi Lam Ho Final Report

November 2022 02103035.000

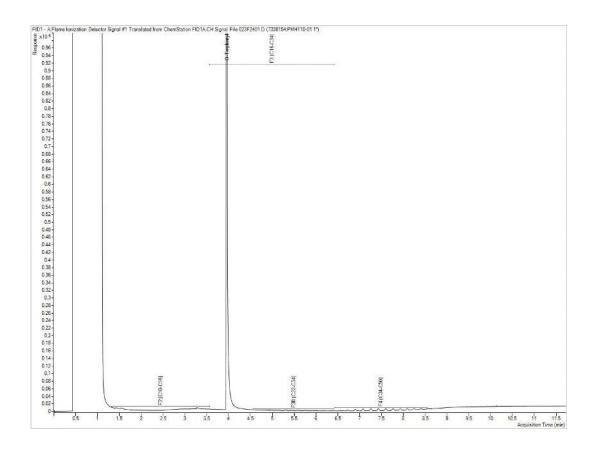
Petroleum Hydrocarbons F2-F4 in Water Chromatogram

BV Labs Job #: C1B9704 Report Date: 2021/05/07 BV Labs Sample: PMH110 DST Consulting Engineers Inc Client Project #: 2103035 Client ID: MW21-3
