Preliminary Geotechnical Investigation

Proposed Mixed Use Development

1987 Robertson Road
Ottawa, Ontario

Report PG5715-1 Revision 4 dated February 14, 2023

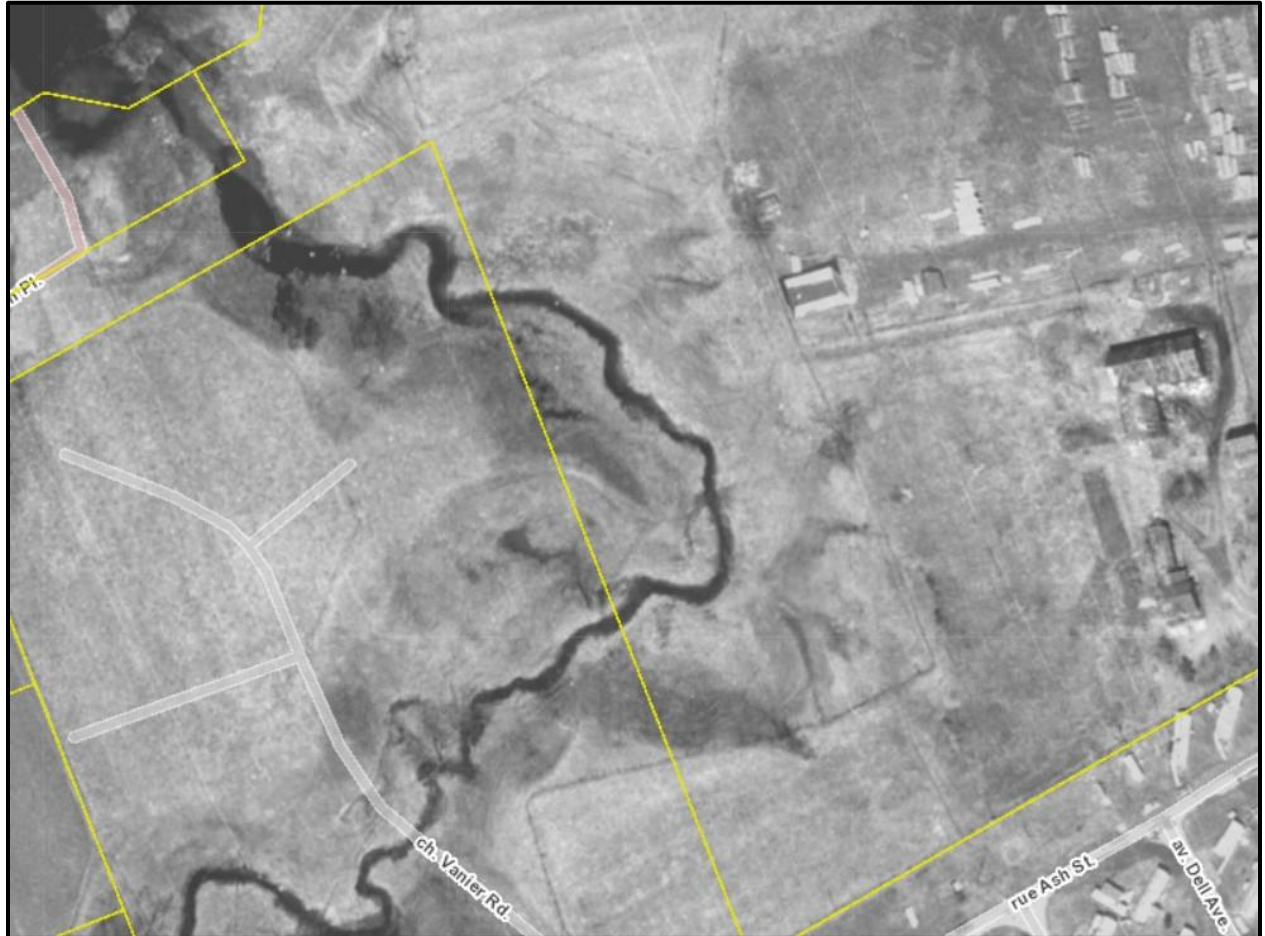
FIGURE 2

1958 AERIAL IMAGE

Based on historical aerial images of the slope face obtained from GeoOttawa, the natural course of the creek has been altered due to fill placement within the subject site. When aerial images of the creek from 1958 and 2011, shown in Figures 2 to 4 in Appendix 2, are compared the natural course of the creek was observed to have shifted to the west and the meander shapes were altered. In-filling at the site has forced the water course to re-establish further west. The original top of slope is set back further from the apparent existing top of slope as under existing conditions what appears to be the top of slope has been infilled and does not represent the natural top of slope.

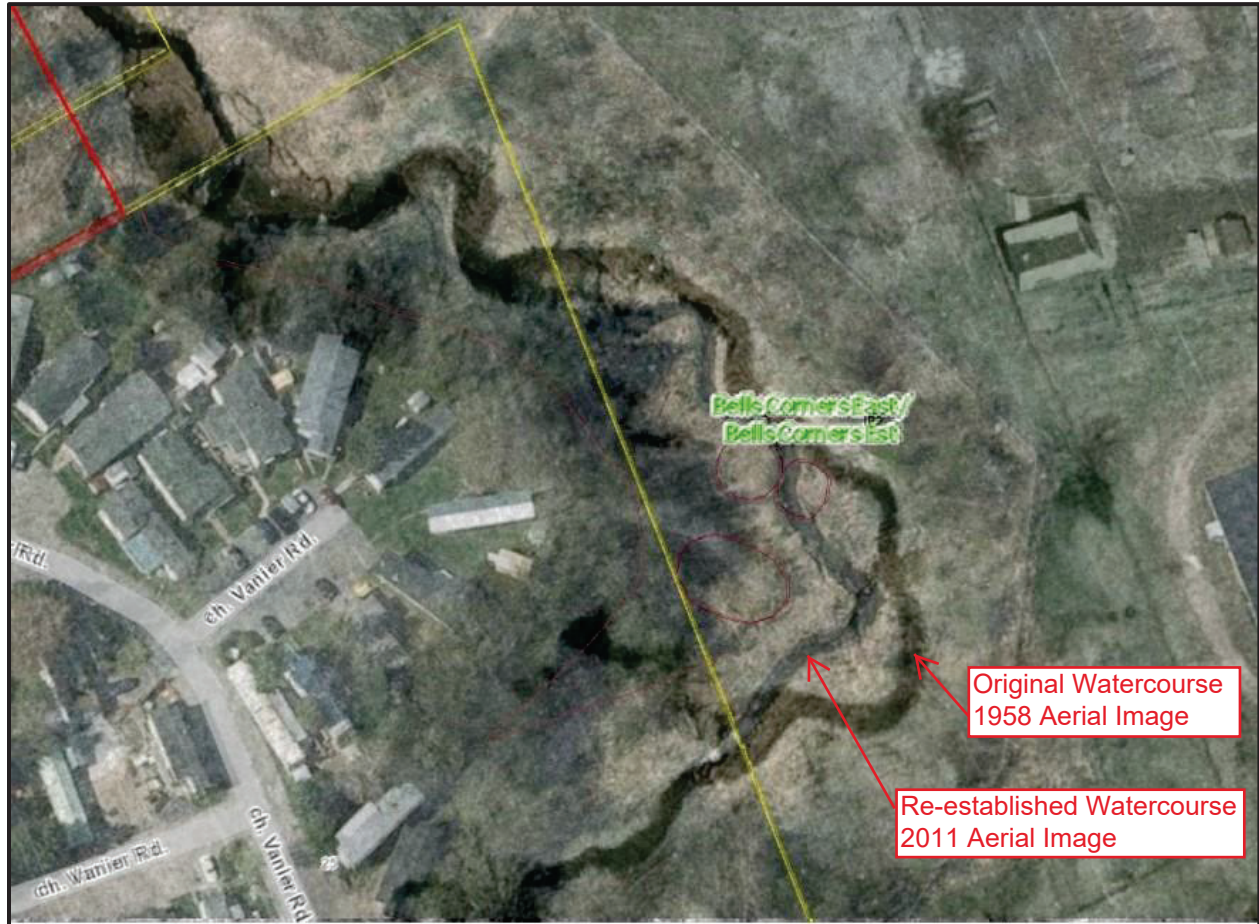
FIGURE 4

OVERLAY OF 1958 & 2011 AERIAL IMAGES

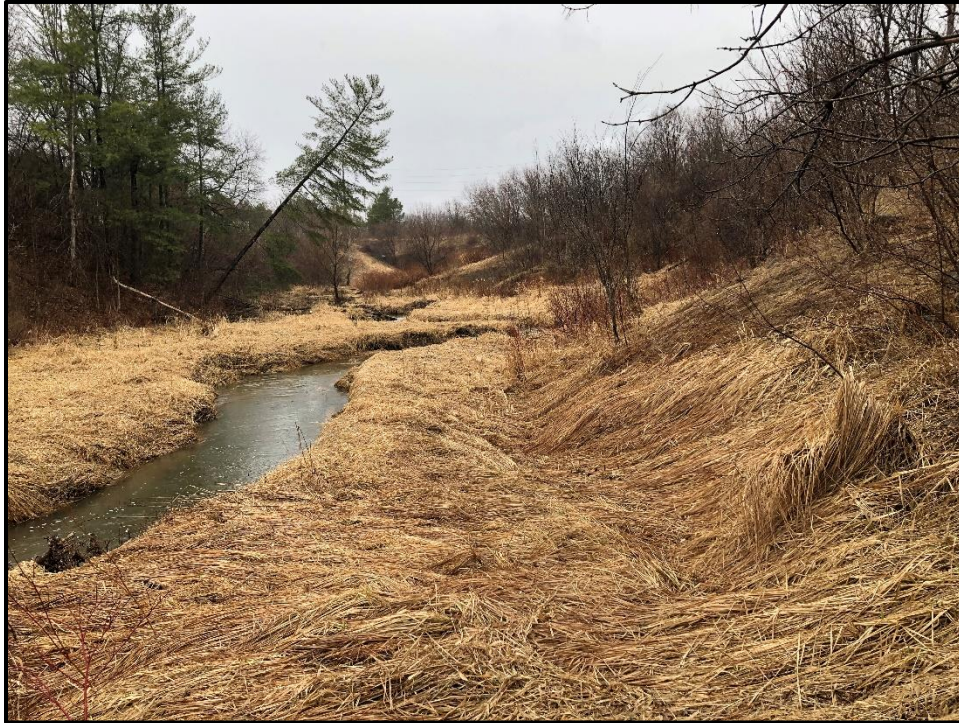
Photo 1: Photograph of Stillwater Creek and toe of slope taken at the west portion of the site towards the north illustrating grass covered side slopes, no toe erosion was observed.

Generally, the overall slope face was observed to be grass covered with some mature trees, minor toe erosion was observed along the edges of the meanders at some locations. Significant in-filling was observed at the top of the slope and down the slope face. Photographs taken during our site visit to assess the slope condition can be found in Appendix 2.

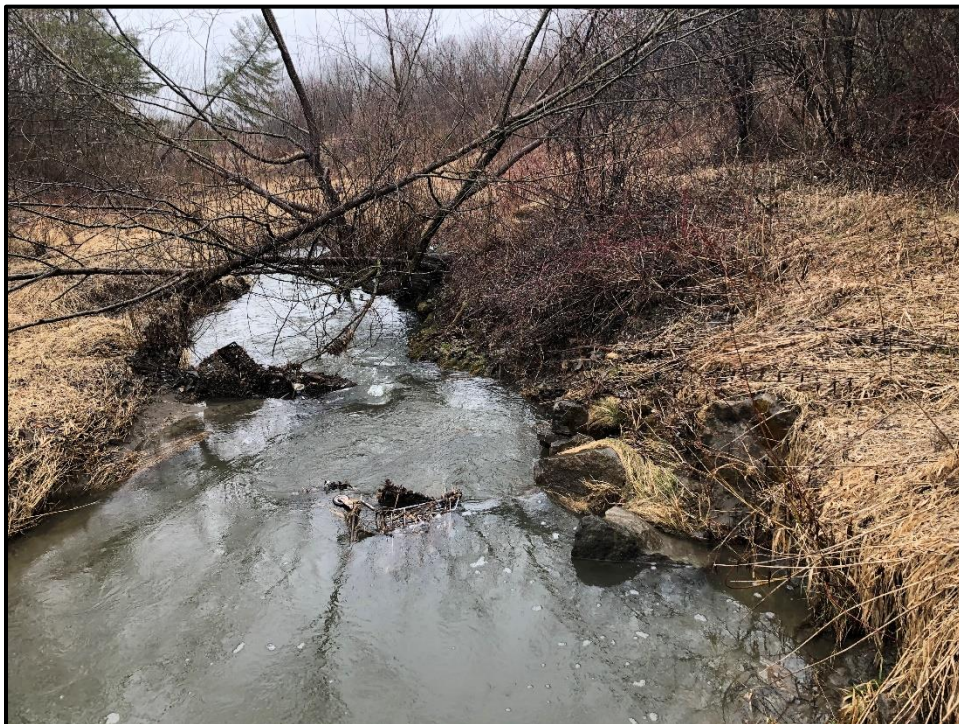
Photo 2: Photograph of Stillwater Creek and toe of slope taken at the west portion of the site towards the north illustrating grass covered side slopes, minor toe erosion was observed.

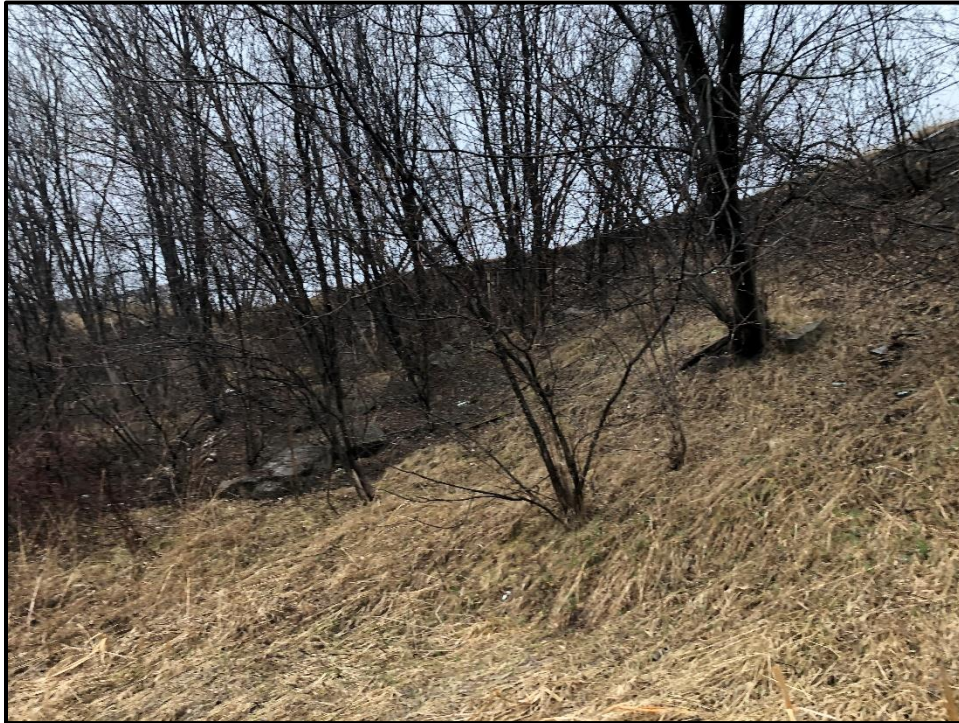
Photo 3: Photograph from the creek looking east towards the top of slope illustrating fill on the slope.

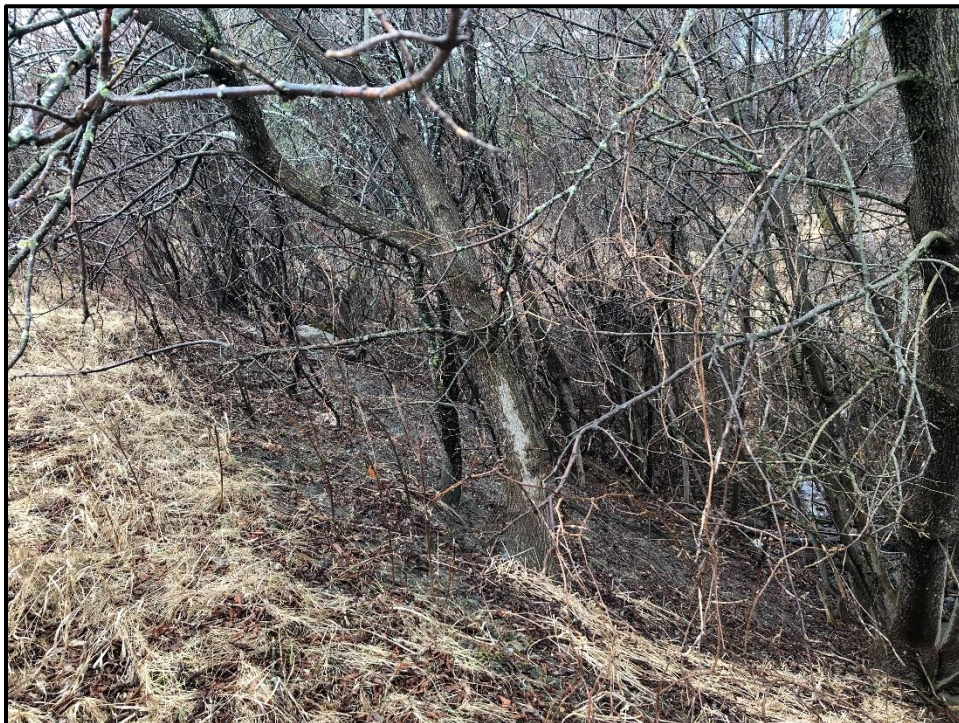
Photo 4: Photograph from the top of slope looking west towards the creek illustrating fill on the slope.
