**Functional Site Servicing and  
Stormwater Management Report  
Rev.03 – 1987 Robertson Road  
(Stillwater Station)**

Stantec Job #160401686  
City of Ottawa File Numbers:  
D01-01-21-0021  
D02-02-21-0120

Prepared for:  
The Properties Group Management Ltd.

Prepared by:  
Stantec Consulting Ltd.  
300 - 1331 Clyde Avenue  
Ottawa ON K2C 3G4

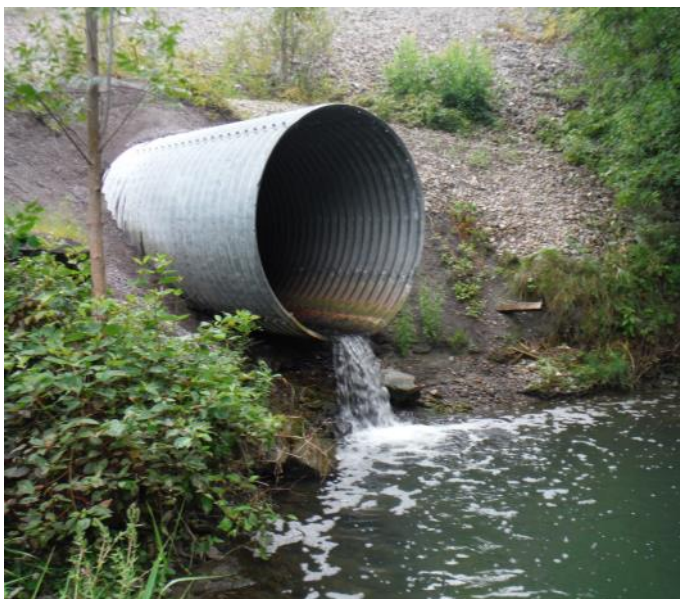
A perched culvert observed along a tributary of Stillwater Creek

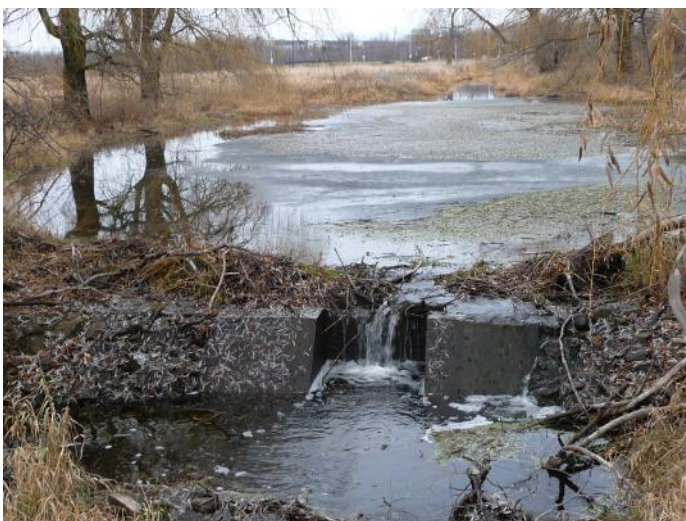
A weir constructed along Stillwater Creek downstream of Moodie Drive that was observed in 2009 and 2015

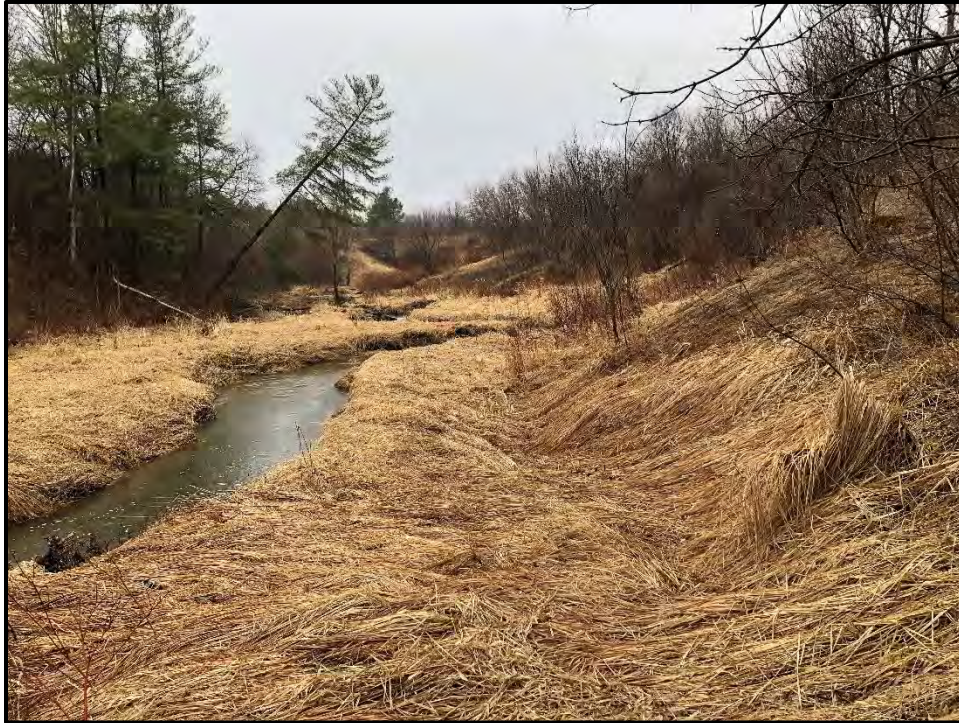
Photo 2: Photograph of Stillwater Creek and toe of slope taken at the west portion of the site towards the north illustrating grass covered side slopes, minor toe erosion was observed.
