Geotechnical Investigation Proposed Multi-Storey Building

St. Joseph Boulevard and Duford Drive Ottawa, Ontario

Prepared for Vuze Construction

Report: PG6609-1 Page ii

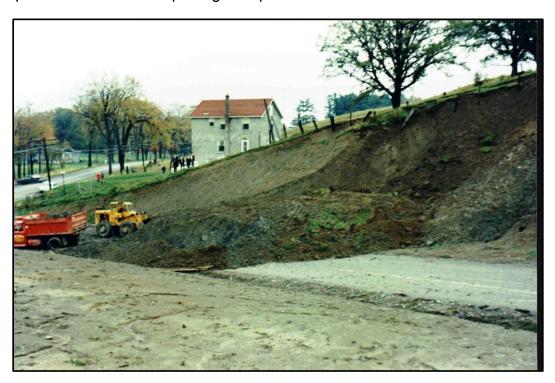
Photo 1: Localized slope failure occurring in the mid 1960s adjacent to Duford Drive. Subject site is located within the foreground of the photograph. St. Joseph Boulevard is in the background. Ground surface adjacent to Duford Drive is noted to be free of vegetation, which is indicative that construction of the subject roadway section and cutting of the subject slope was recently completed. It is suspected that the exposed slope was re-shaped to an unstable slope angle as part of the construction work at that time.

Section C was located within a former slope failure area. It is understood that a slope failure occurred along the east side of Duford Drive in the 1960s. Photographs of the slope failure were provided to Paterson for this response. Photographs 1 and 2 presented in Appendix 2 show a shallow slope failure across a limited section of overall slope face. Based on slope features noted in the photographs, such as lack of vegetation across the slope face and the soil surface in the area of Duford Drive, it appears that the slope failure occurred across a section of the slope, which had been recently re-shaped as part of the construction of Duford Drive.

The natural grade of the slope face was drastically changed during the construction of Duford Drive. It is expected that the slope failure can be directly contributed to the steepness of excavated slope face along with exposure to precipitation events before a vegetative layer could establish. It should be further noted that a vegetative layer across a slope face promotes surficial run-off during precipitation events and limits infiltration of rainwater into the slope soil. Infiltration of water from precipitation events into a slope reduces overall slope stability.

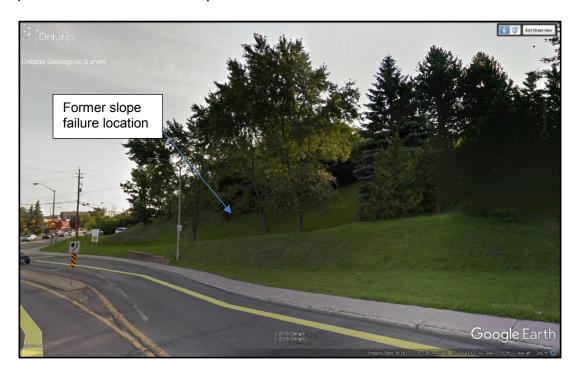
Photo 3: Street view image from Google Earth of former slope failure area (presented in Photos 1 and 2) adjacent to Duford Drive. Ground noted to be re-shaped with a terraced slope in front of reinstated slope.

The current slope face was noted to include a terraced area along the base of the slope face in the area of the former slope failure (see Photos 3, 4 and 5 in Appendix 2). It is suspected that the terraced area was introduced after the initial slope failure to stabilize the reinstated slope. Currently, the slope face was noted to be grass covered with mature trees. No signs of slope instability were noted.
