Project:
MERIVALE AND JAMIE AUTO GARAGE

1871 MERIVALE ROAD
OTTAWA, ONTARIO

Drawing:
TREE CONSERVATION REPORT

Scale: 1:300 Date: 09 SEP, 2014
Design By: SH Drawn By: SH
Project Number: 1887-02 Sheet Number: TCR 01

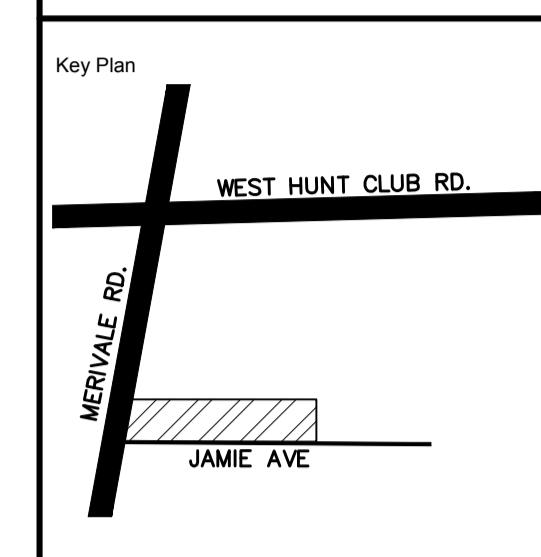
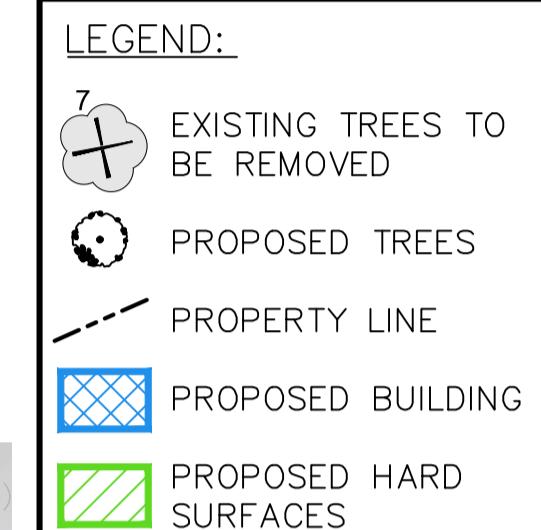
TREE INVENTORY PLAN – AERIAL PHOTOGRAPHY:

Tree No.	Botanical Name	Common Name	Caliper (cm)	Condition	High Quality Tree	High Quality Tree	Comments	To Be Preserved
1	Acer platanoides	Norway Maple	30	Dead	No	No	This tree is dead, many branches have died and fallen. This tree is a hazard.	No
2	Acer platanoides	Norway Maple	32.5	Dead	No	No	This tree is dead, many branches have died and fallen. This tree is a hazard.	No
3	Acer platanoides	Norway Maple	33	Poor	No	No	Central leader of tree is dead, there is approximately 40% die back in the canopy.	No
4	Acer platanoides	Norway Maple	32	Poor	No	No	Central leader of tree is dead, there is approximately 40% die back in the canopy.	No
5	Acer platanoides	Norway Maple	31	Moderate	No	No	Tree is in moderate condition.	No
6	Acer platanoides	Norway Maple	30	Moderate	No	No	Tree is showing approximately 20% die back in the canopy.	No
7	Acer platanoides	Norway Maple	31	Moderate	No	No	Tree is showing approximately 10% die back in the canopy, and some rot appearing at branch unions.	No

THERE IS A ROW OF SEVEN TREES ALONG THE NORTHERN PROPERTY LINE THAT WILL BE REMOVED TO ACCOMODATE THE PROPOSED BUILDING. A PORTION OF THE SOFT LANDSCAPE IS REQUIRED TO BE REMOVED. THIS IS NECESSITATED BY THE NATURE AND SCALE OF THE PROPOSED USE. THIS WILL HAVE IMPACT ON THE DRAINAGE OF THE SITE, PLEASE REFER TO THE CIVIL LOT GRADING AND DRAINAGE PLAN.
