**Geotechnical Investigation**

Proposed Residential Development  
2710 Draper Avenue  
Ottawa, Ontario

**September 20, 2018**

Report: PG1630-3 Revision 6

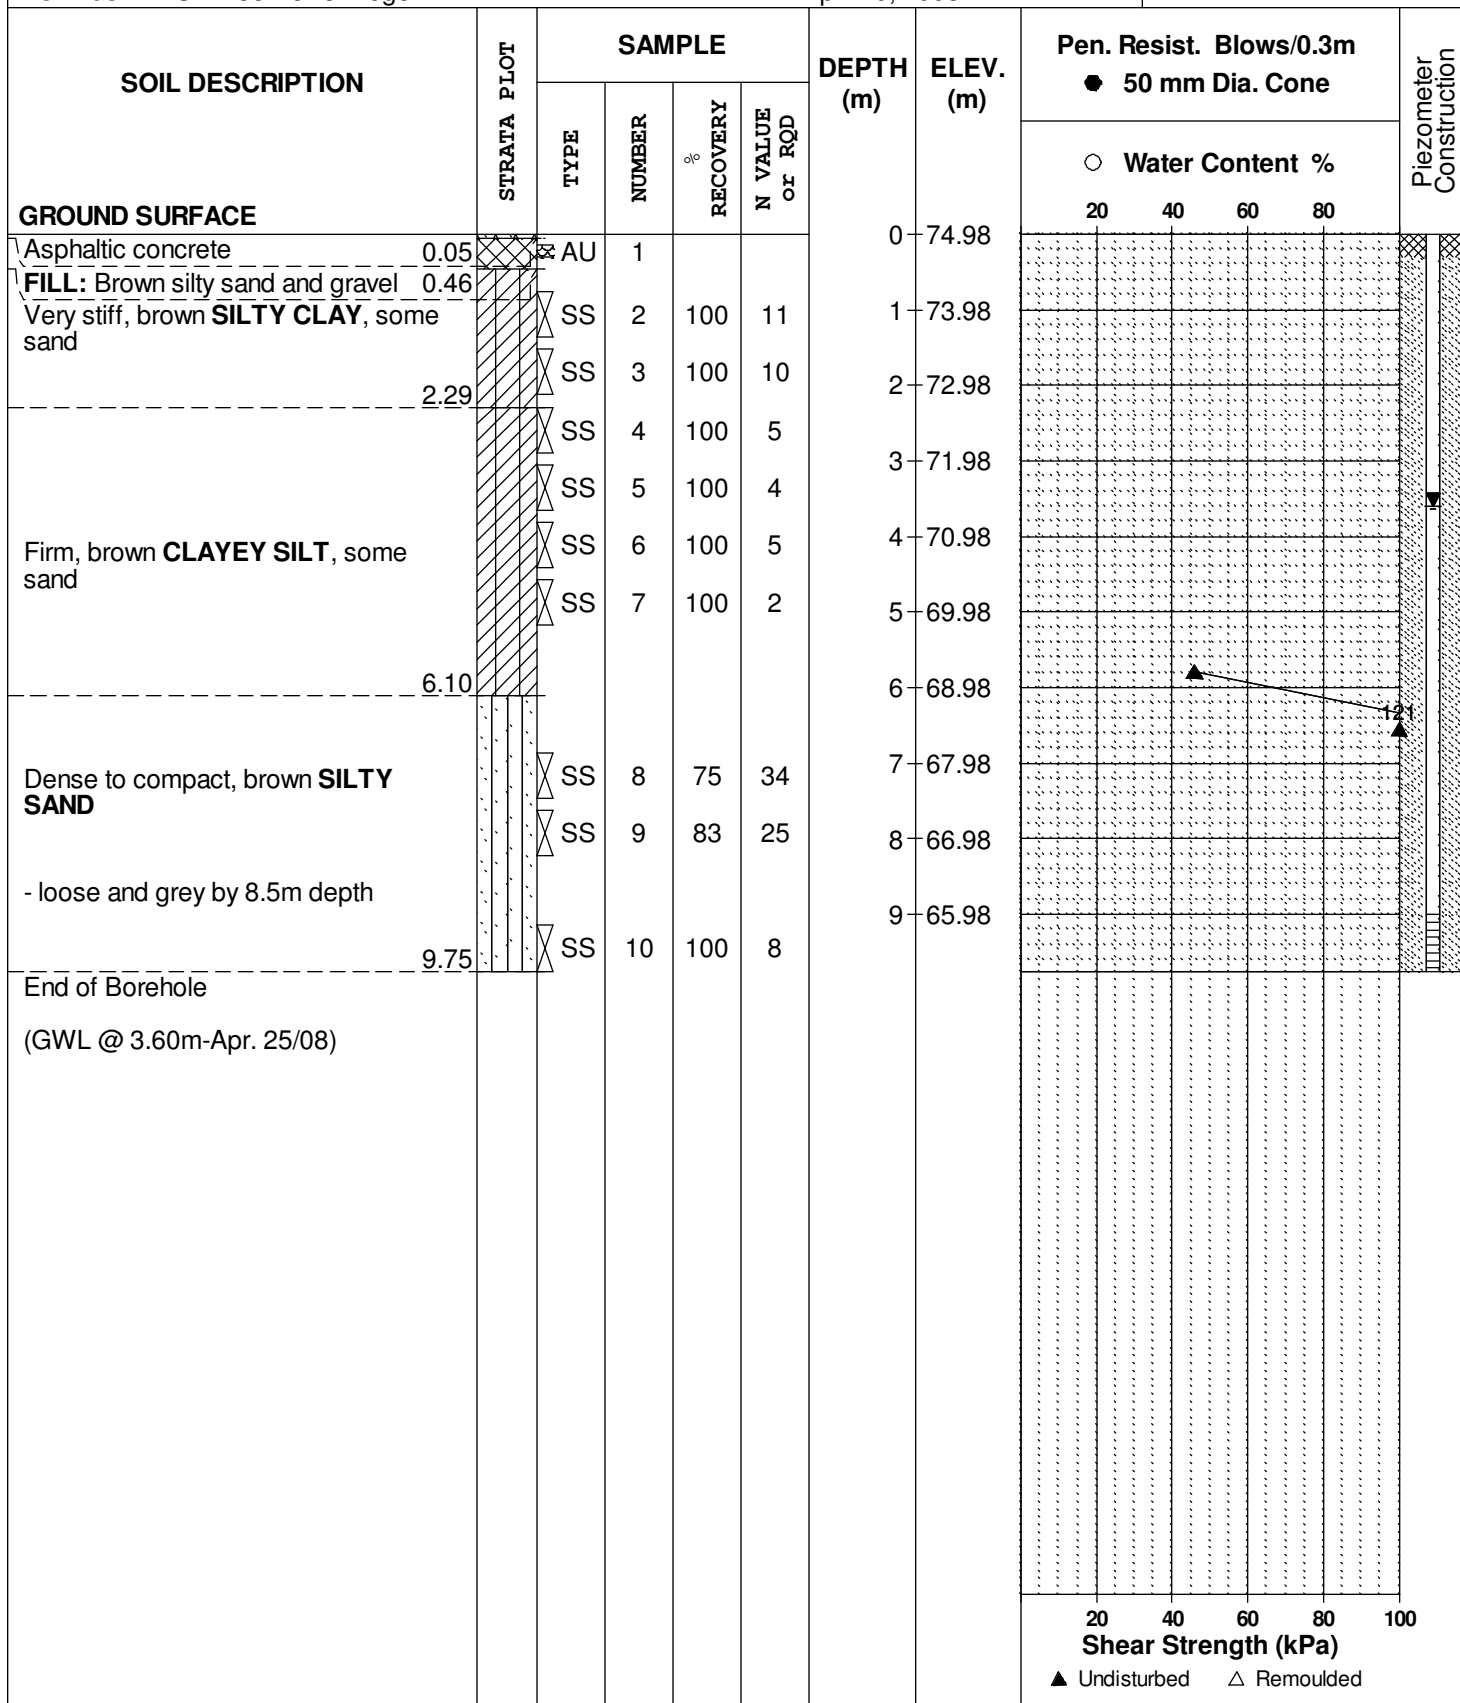
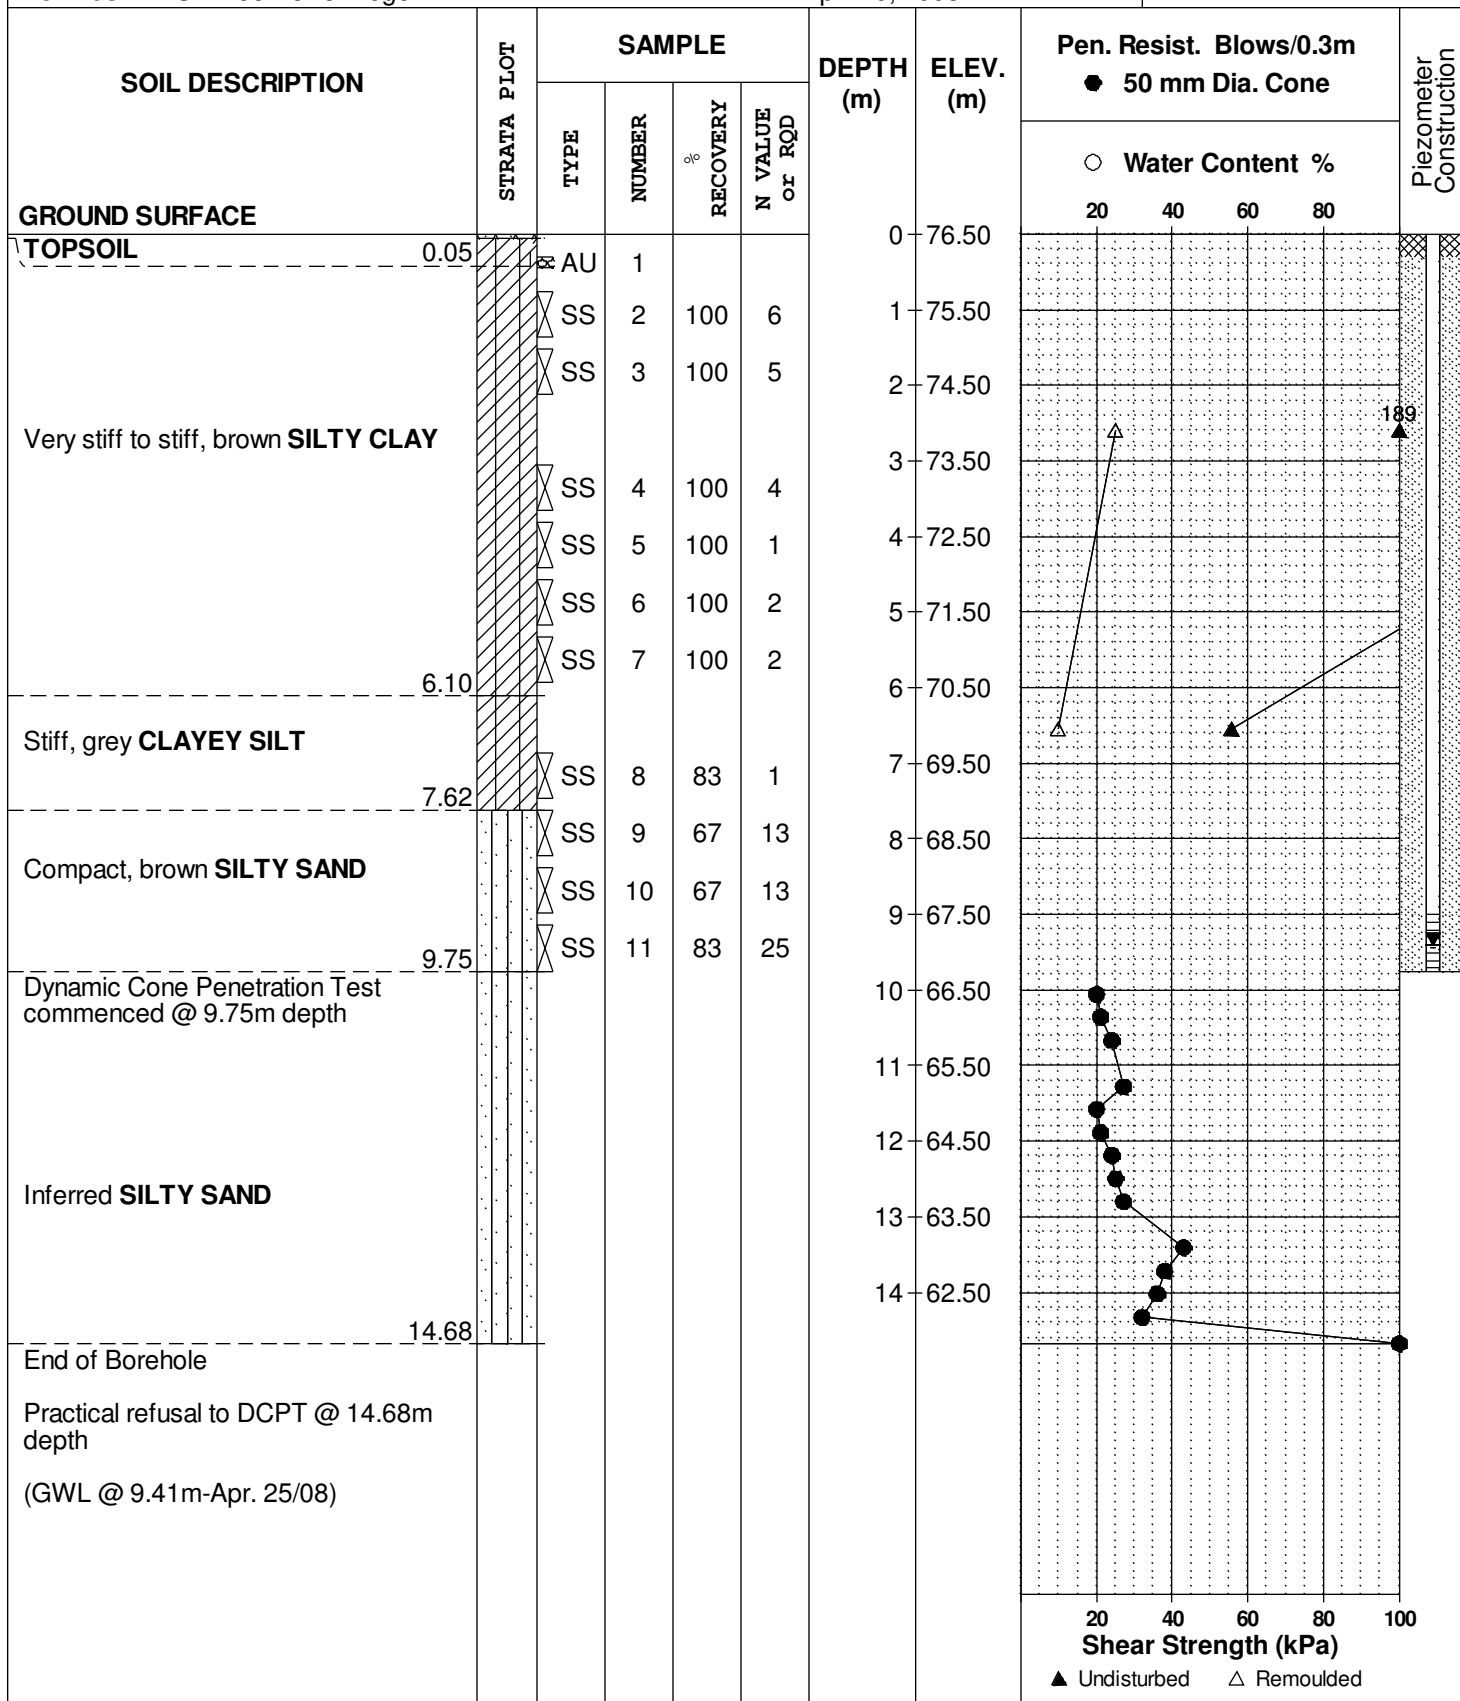
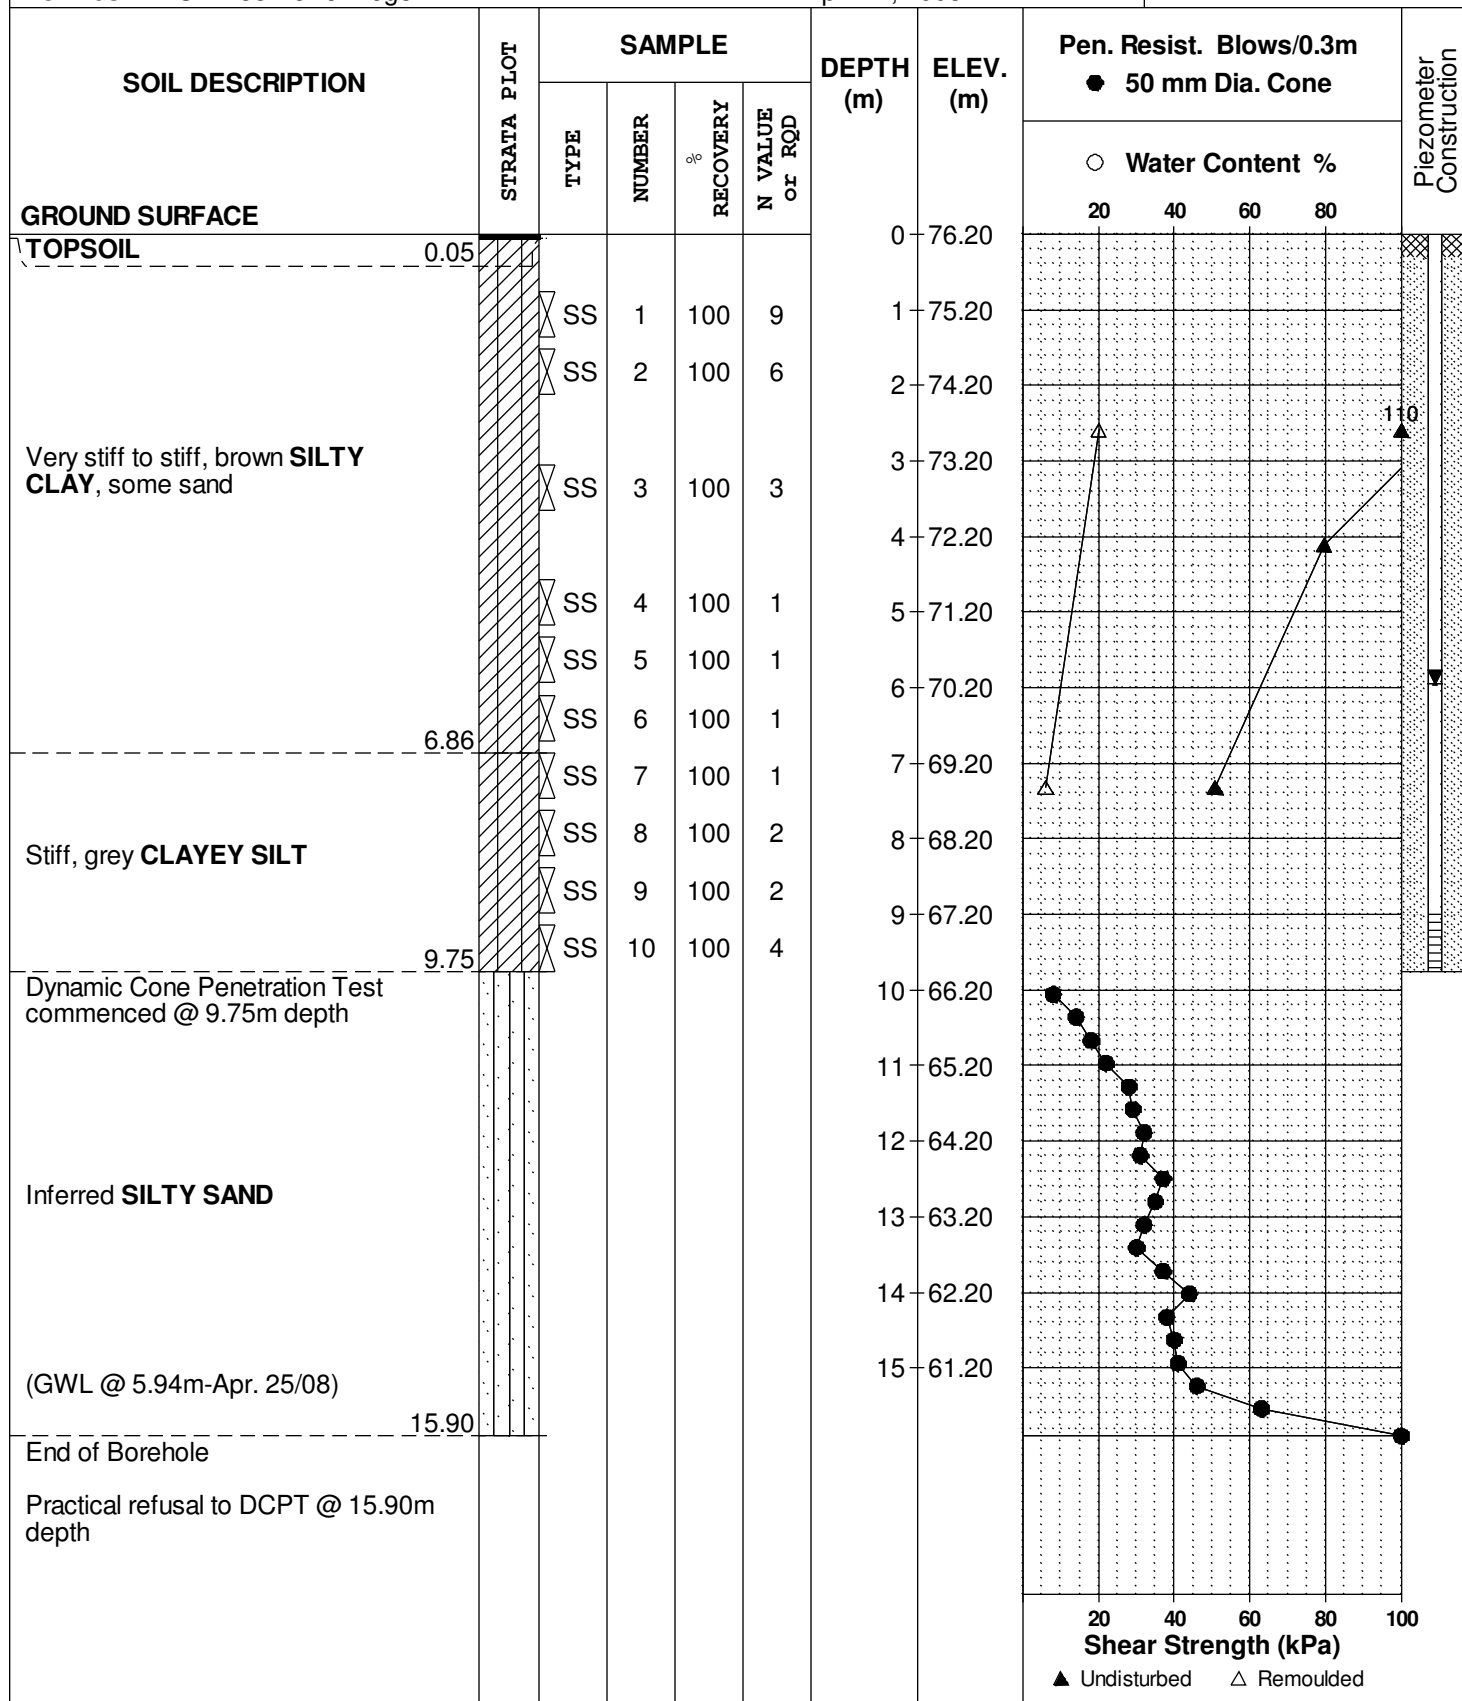
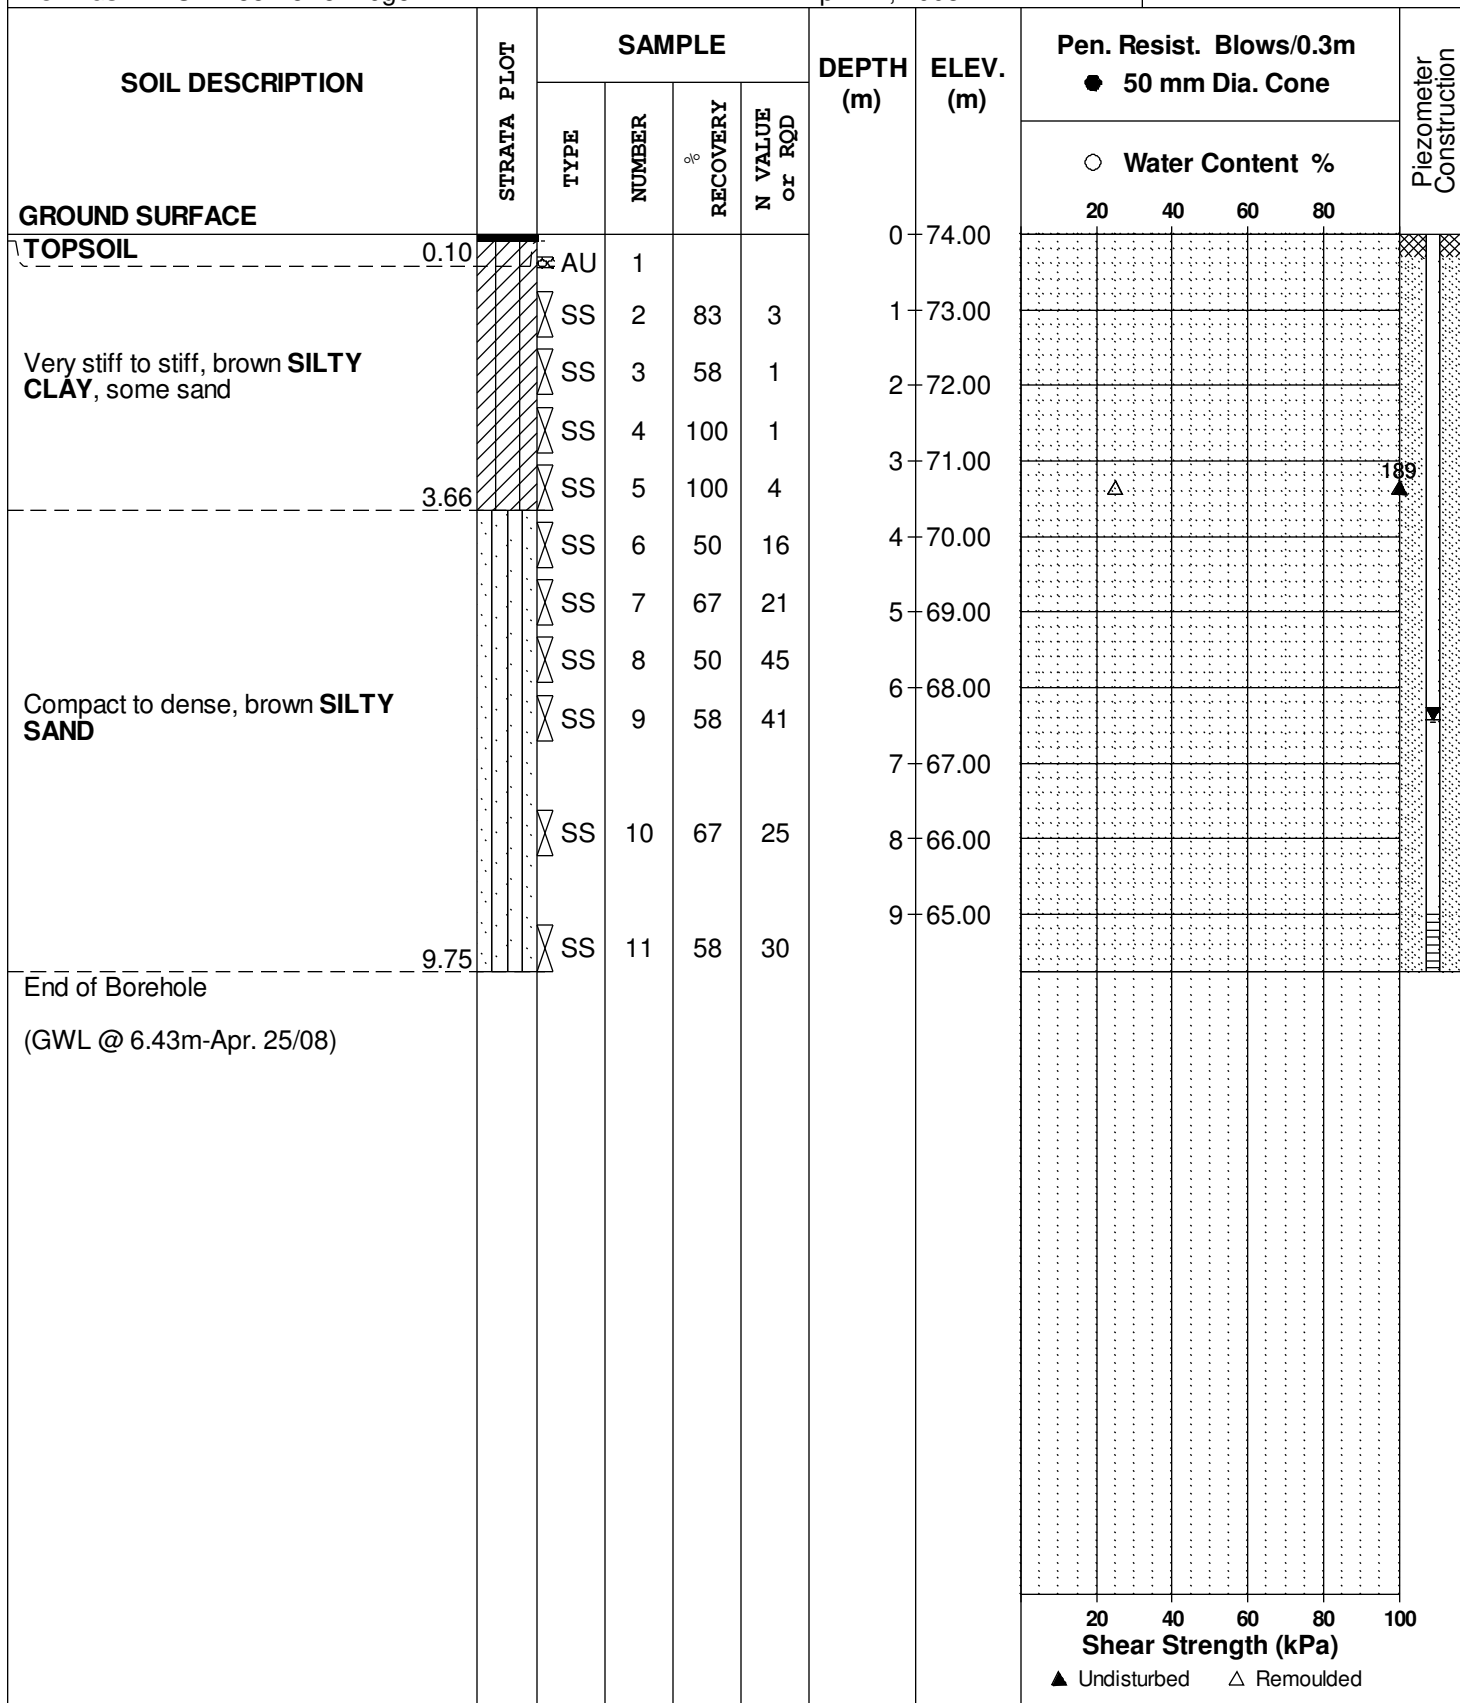
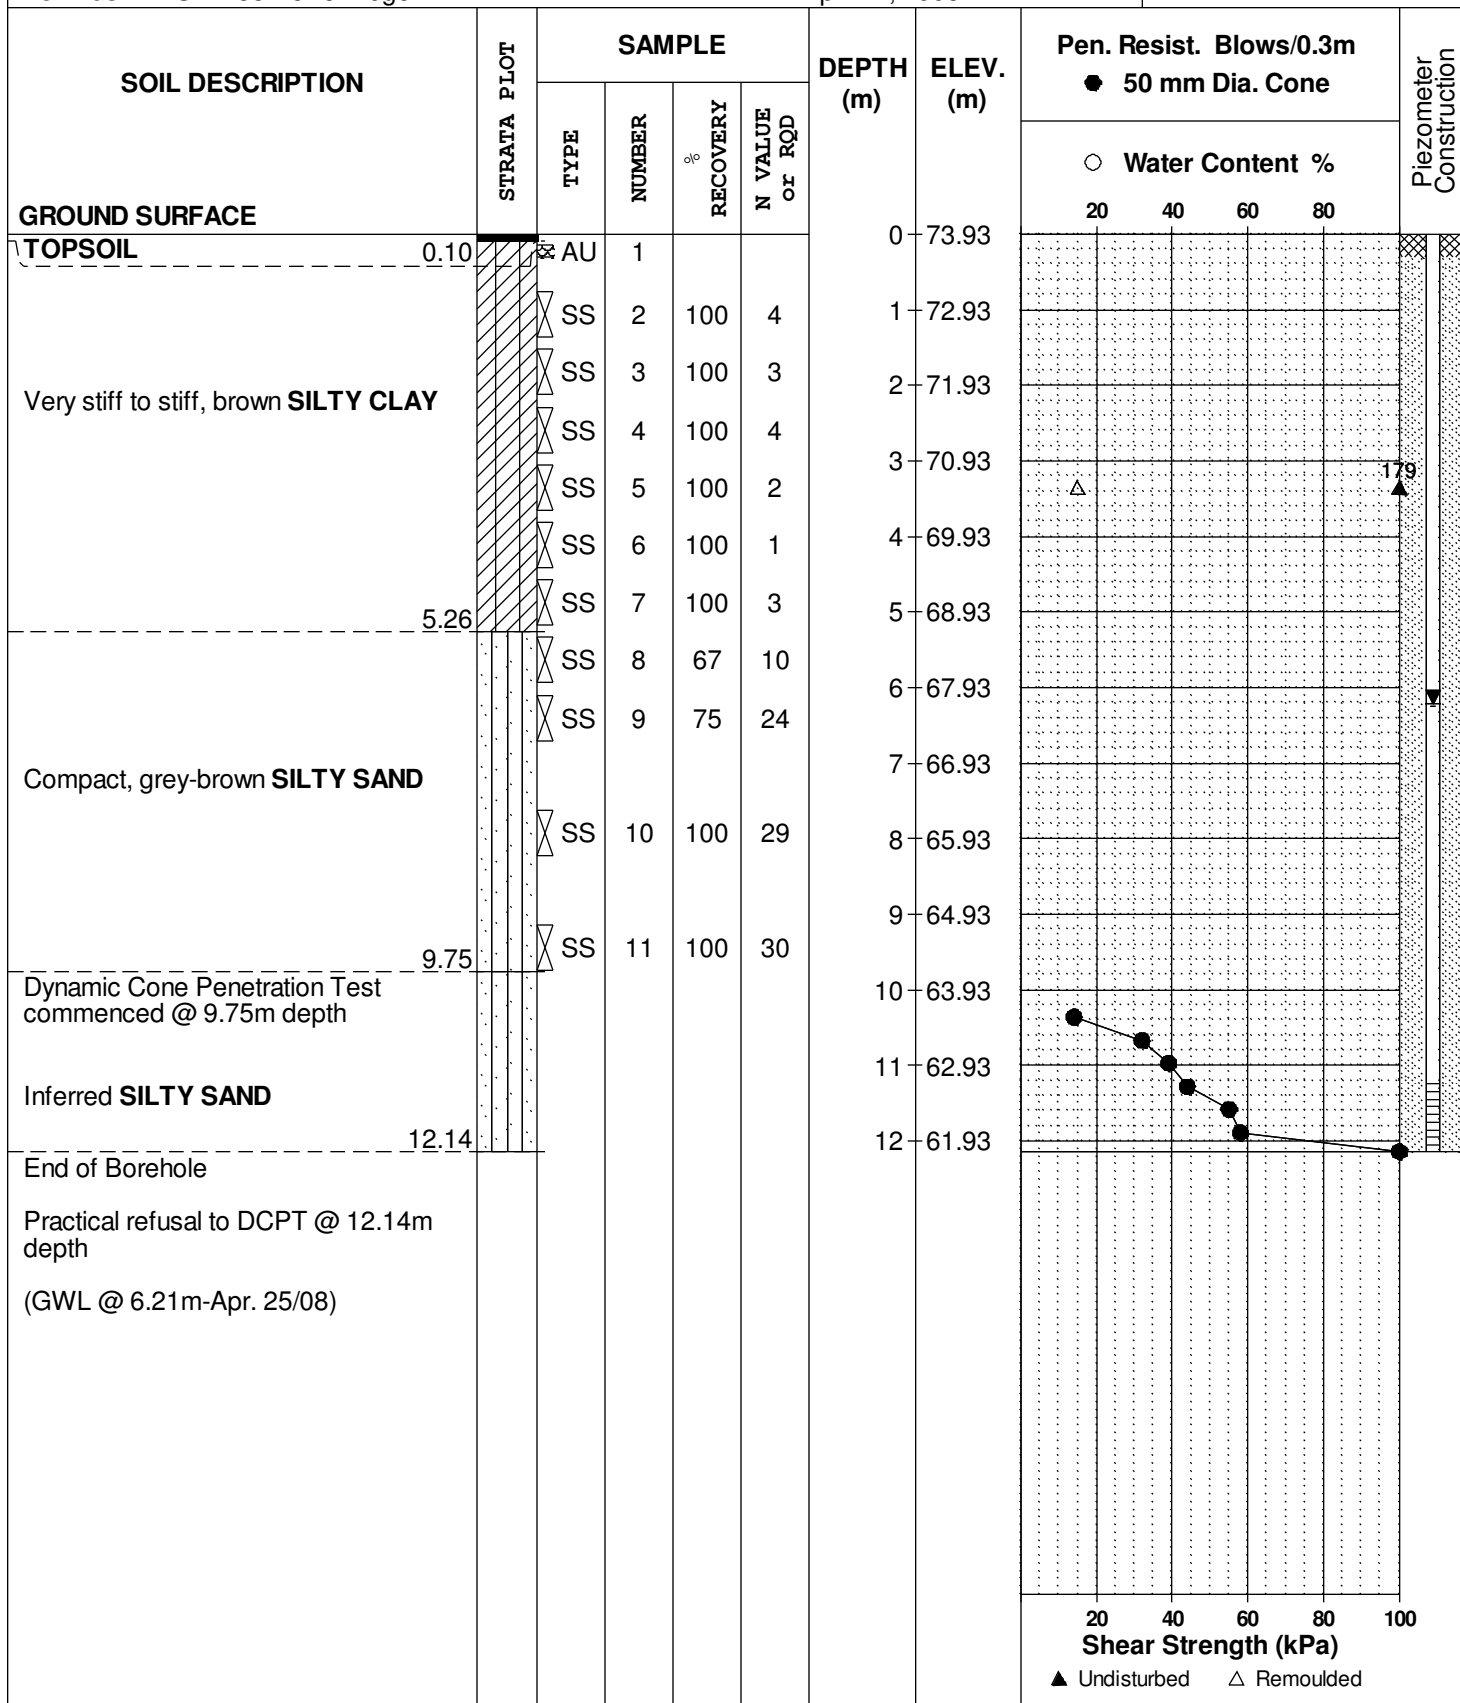
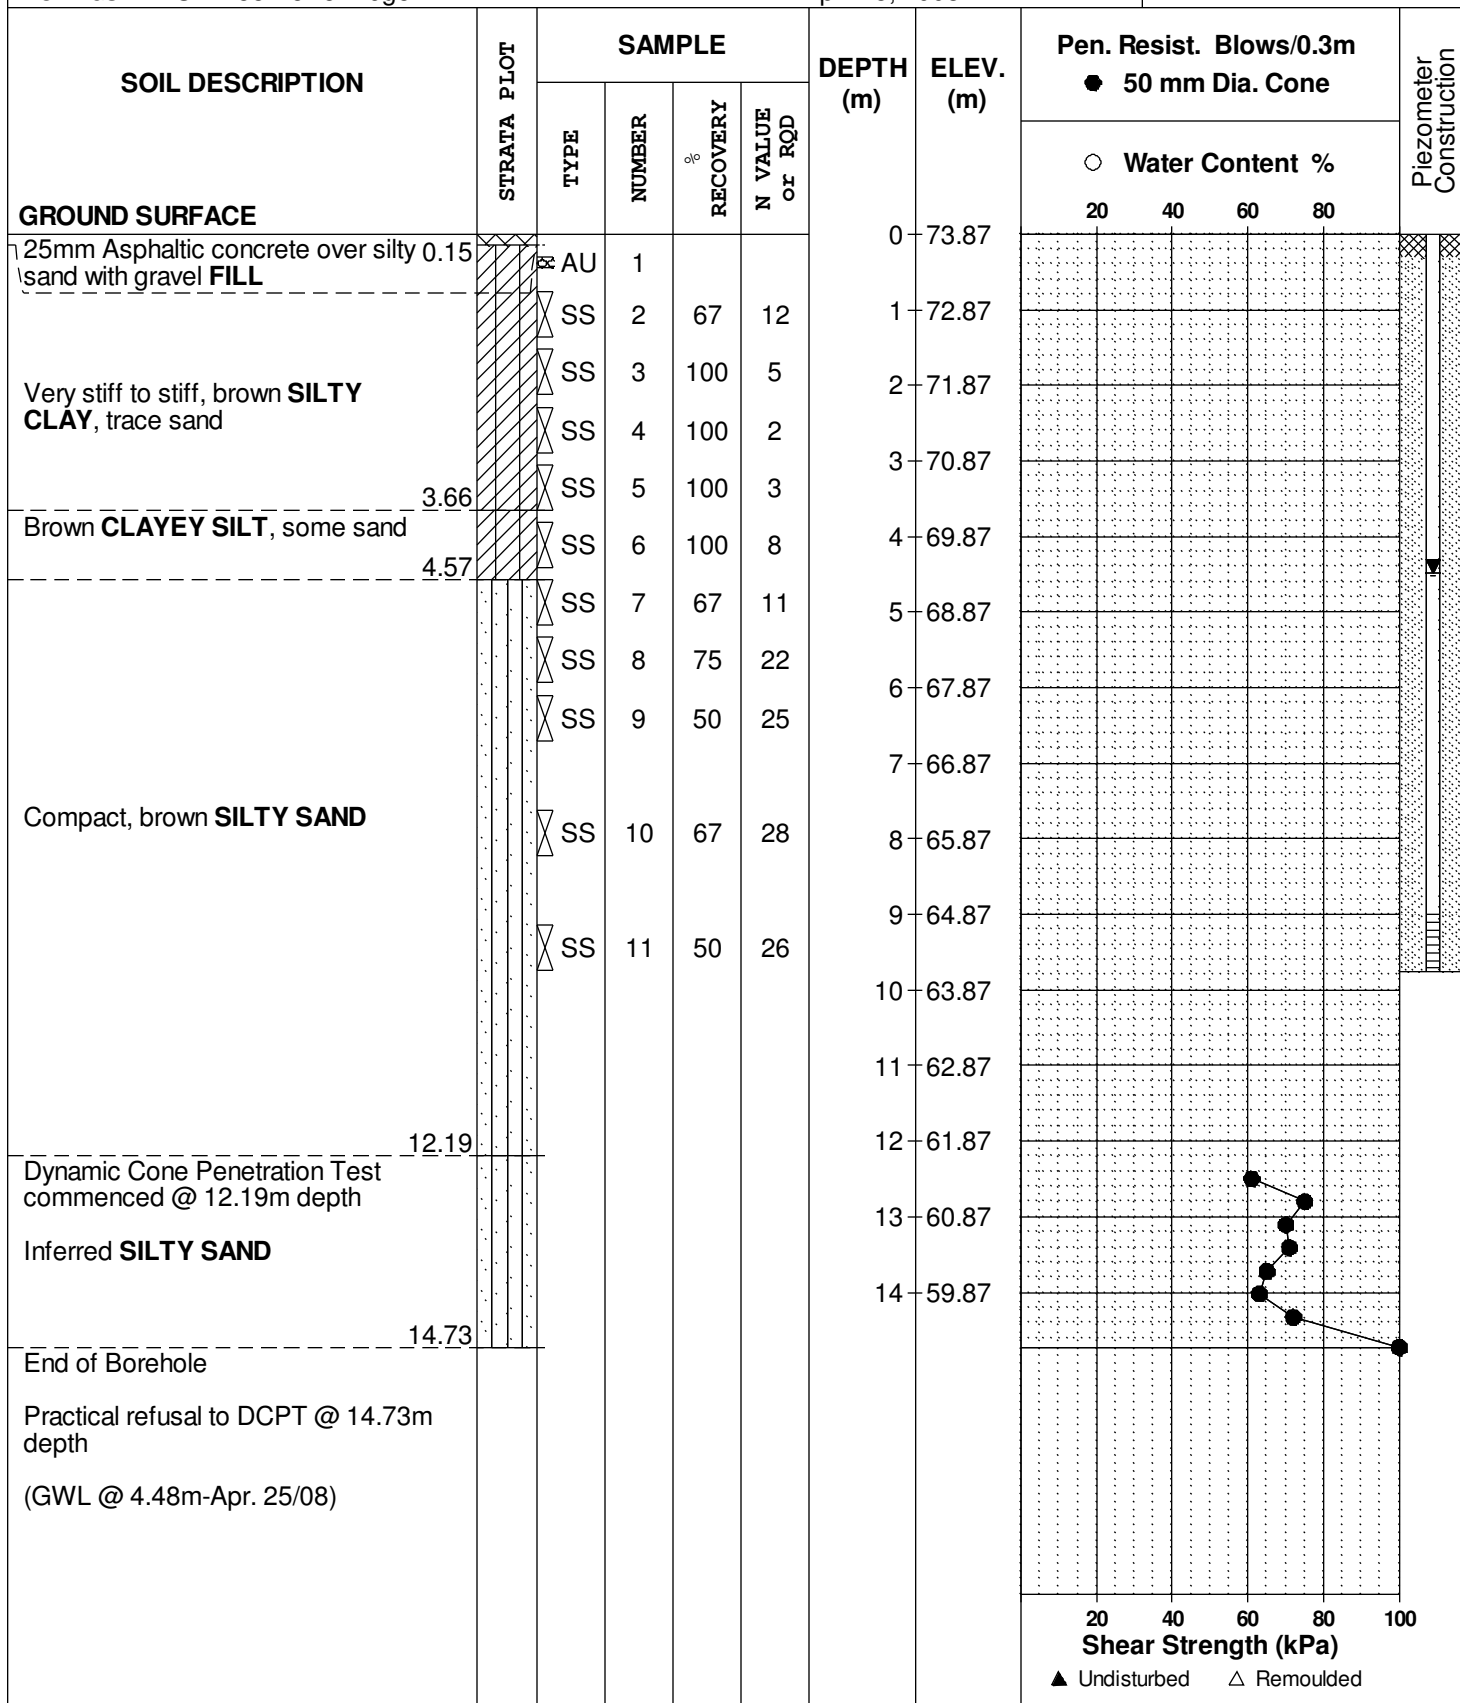
Undrained shear strength testing, using a vane apparatus, was carried out in cohesive soils. The subsurface conditions observed in the boreholes were recorded in detail in the field. The soil profiles are logged on the Soil Profile and Test Data sheets presented in Appendix 1 of this report.

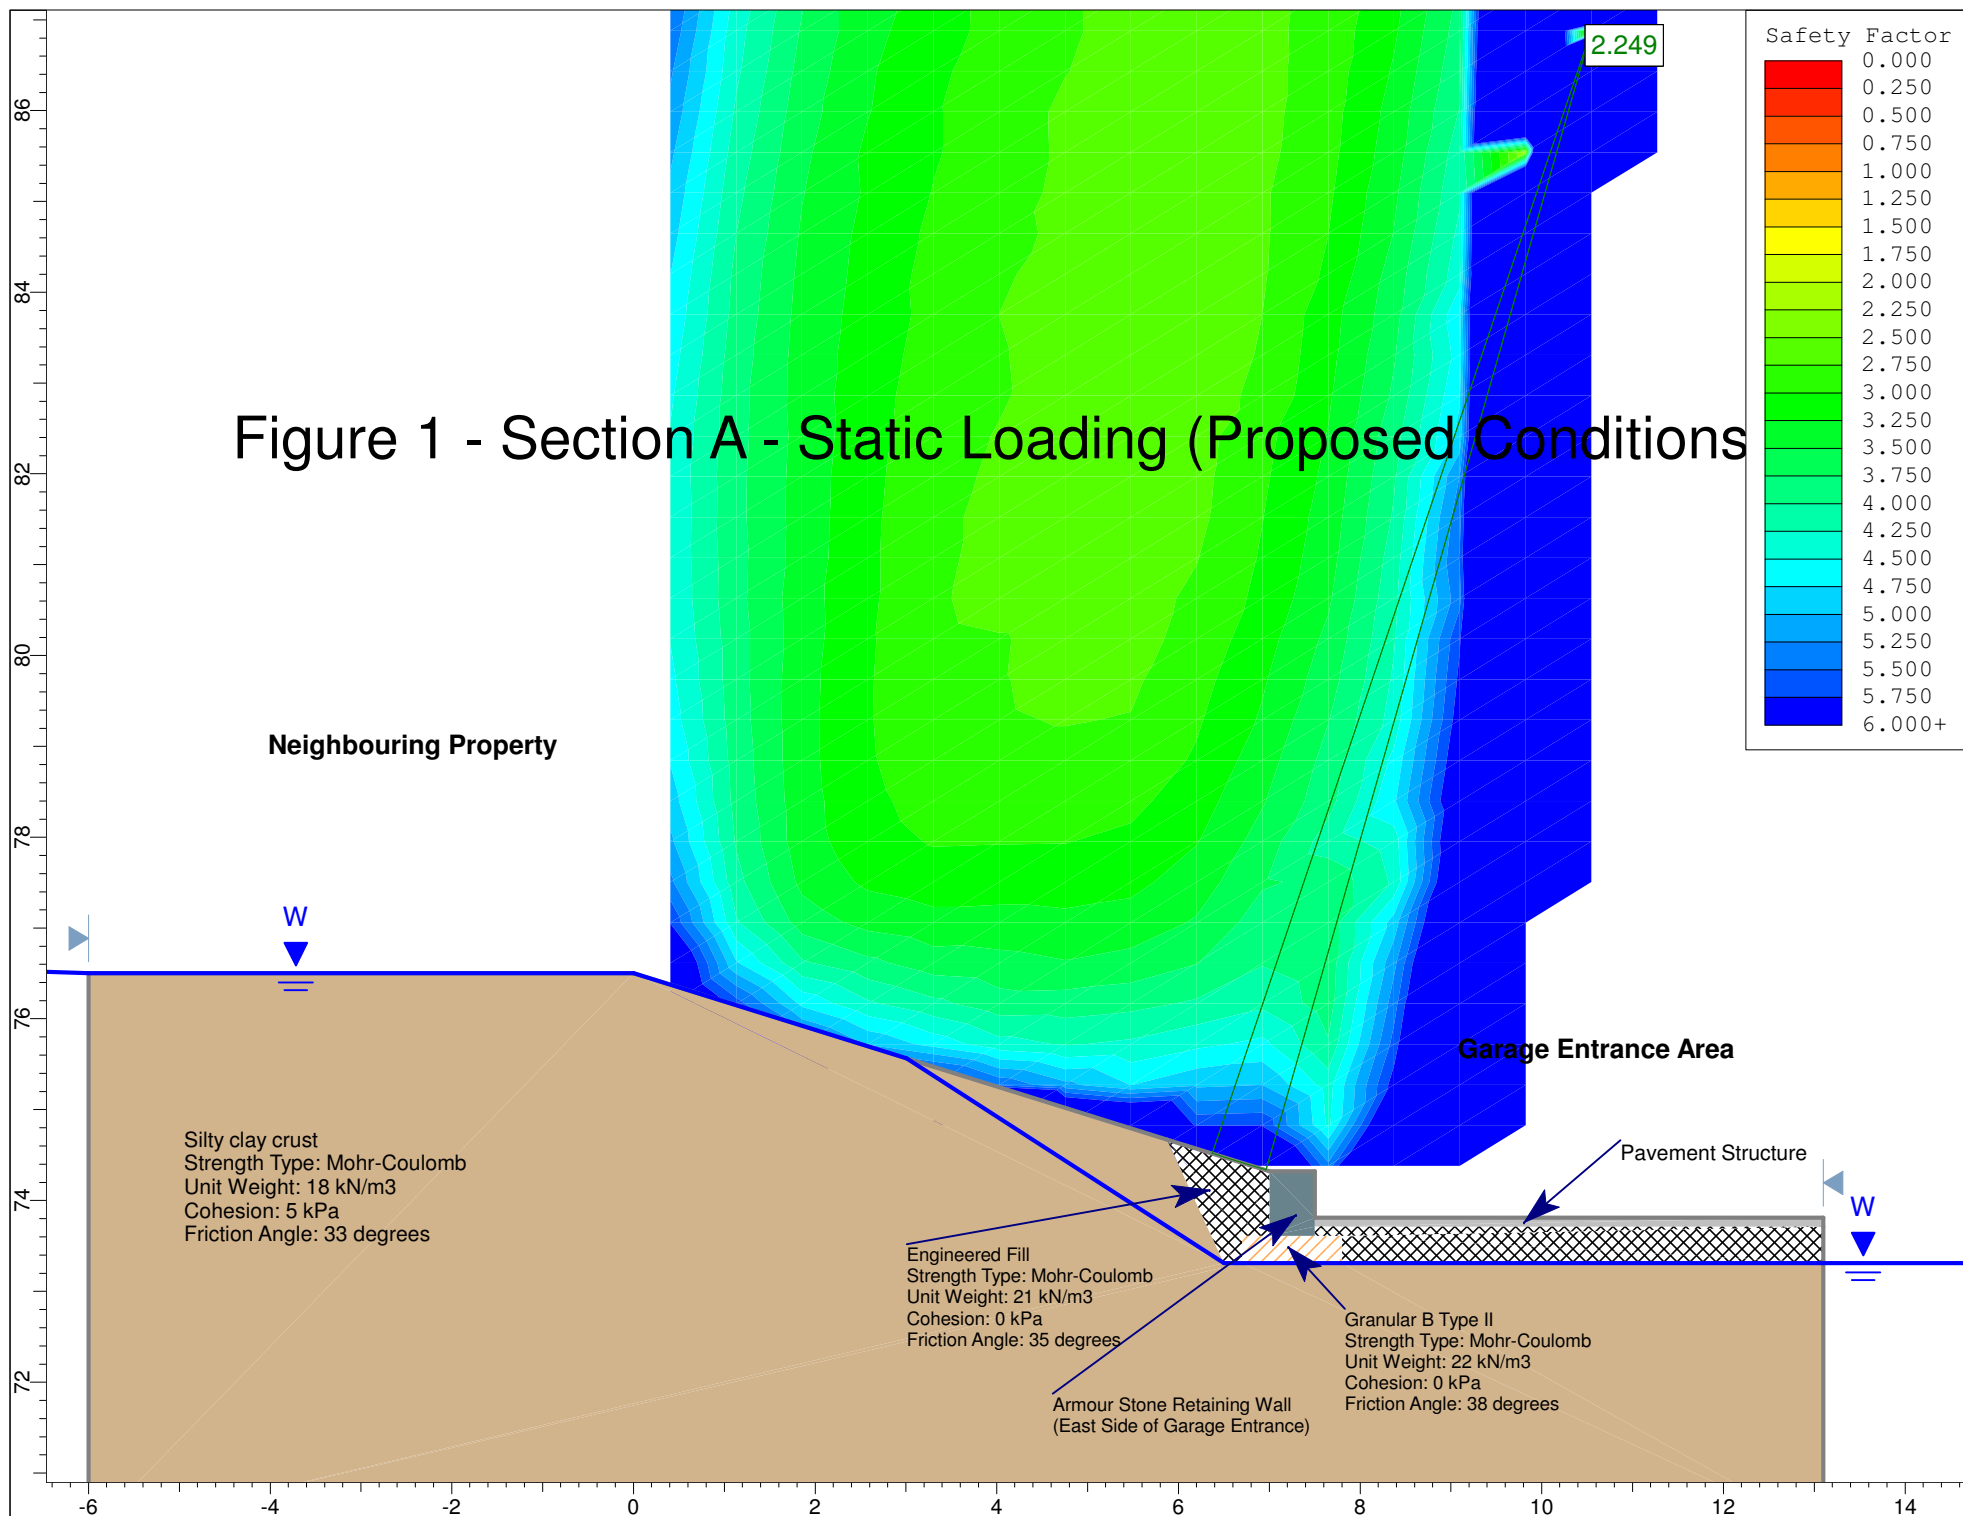
The results for the proposed conditions at section A are shown in Figure 1 attached to Appendix 2. The minimum slope stability factor of safety was calculated to be 2.3 which is greater than the minimum recommended factor of safety of 1.5 for static conditions. Based on the results, the proposed conditions are considered stable under static loading.

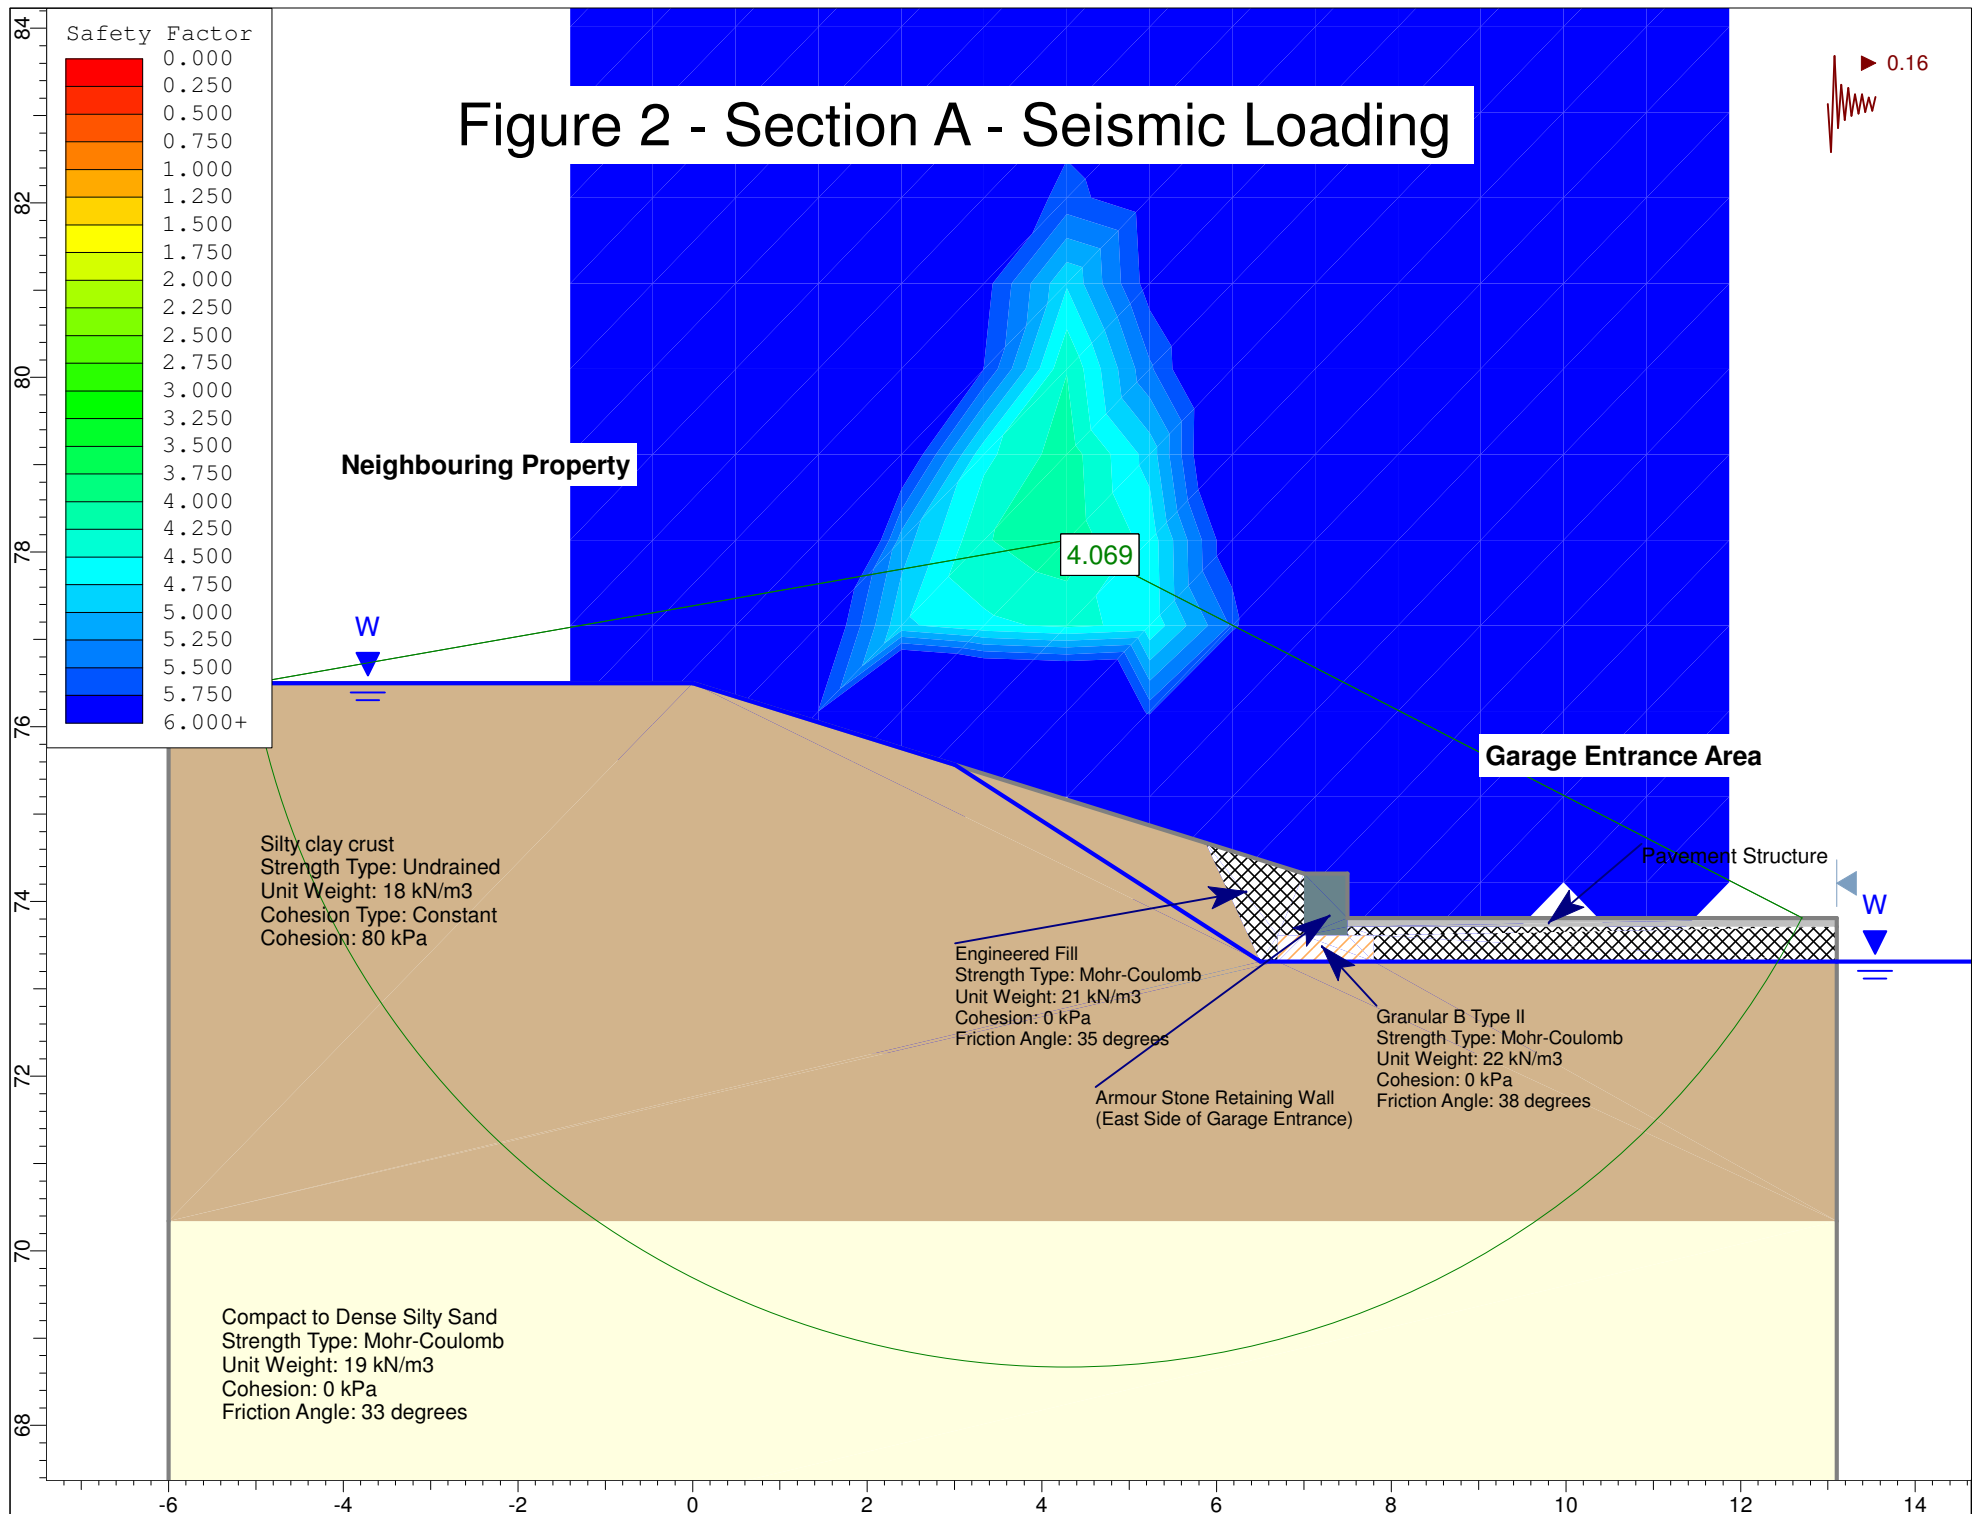
# Figure 2 - Section A - Seismic Loading

The results of the analysis including seismic loading is shown in Figure 2 in Appendix 2. The overall slope stability factor of safety for the subject sections when considering seismic loading was found to be greater than 1.1. Based on the results, the slope is considered stable under seismic loading.
