# **Geotechnical Investigation**

Proposed Car Dealership Carp Road and Westbrook Road Ottawa, Ontario

Report: PG4405-1

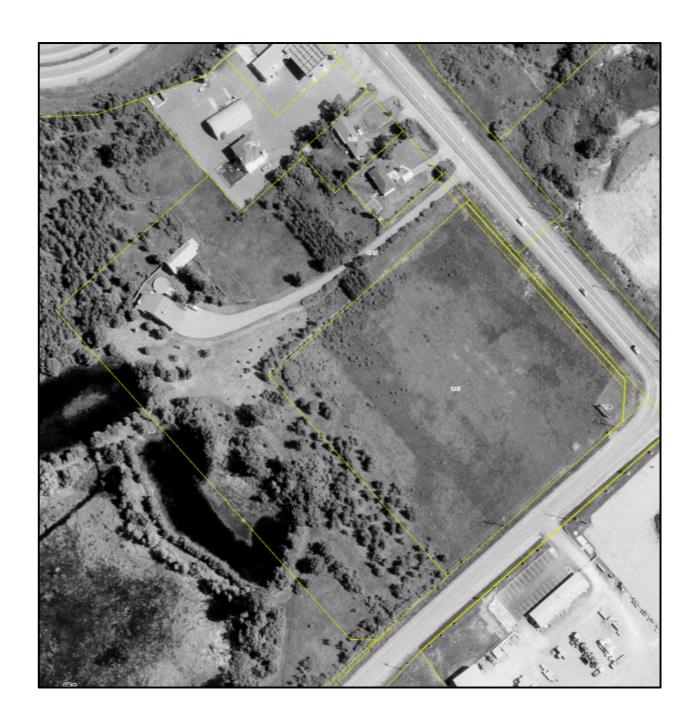
# FIGURE 2

Aerial Photograph - 1991

Based on the available historical photographs of the subject site, a former pond occupied the west limits of the site prior to 2008 and was noted to be backfilled in 2009.

The subsoil profile encountered at the test hole locations during the field portion of the geotechnical investigation generally consisted of a thin layer of topsoil and/or fill overlying a compact to dense silty sand. BH 4 and BH 5 completed within the west portion of the site within the former pond encountered fill material consisting of a brown silty clay to silty sand with gravel, cobbles and trace organics extending to a depth of 1.8 and 3.2 m, respectively. Reference should be made to the aerial photographs in Figure 2 - Aerial Photograph - 1991 and Figure 3 - Aerial Photograph - 2017 which illustrates the approximate limits of the in-filled area.

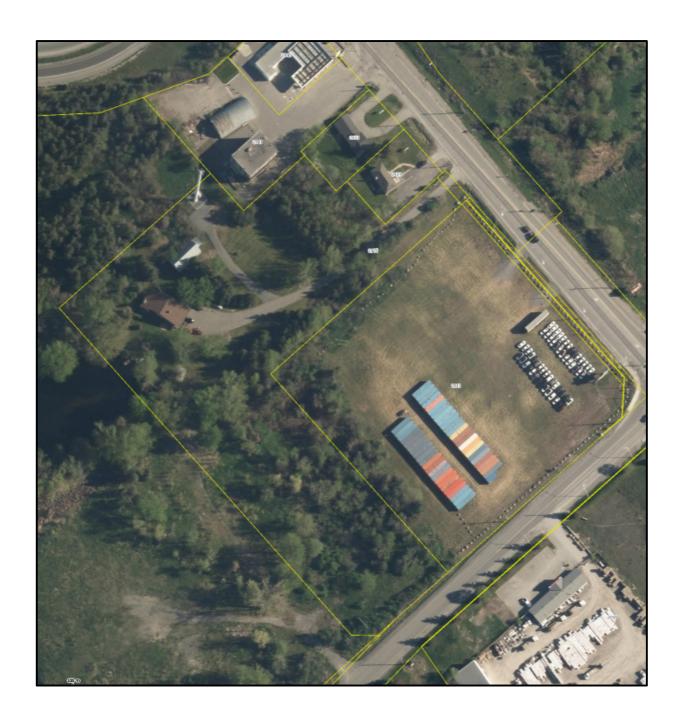
# FIGURE 3

Aerial Photograph - 2017
