GEMTEC

**Phase Two
Environmental Site Assessment
5986-5993 Hazeldean Road
Ottawa, Ontario**

August 29, 2019
Project: 61730.62

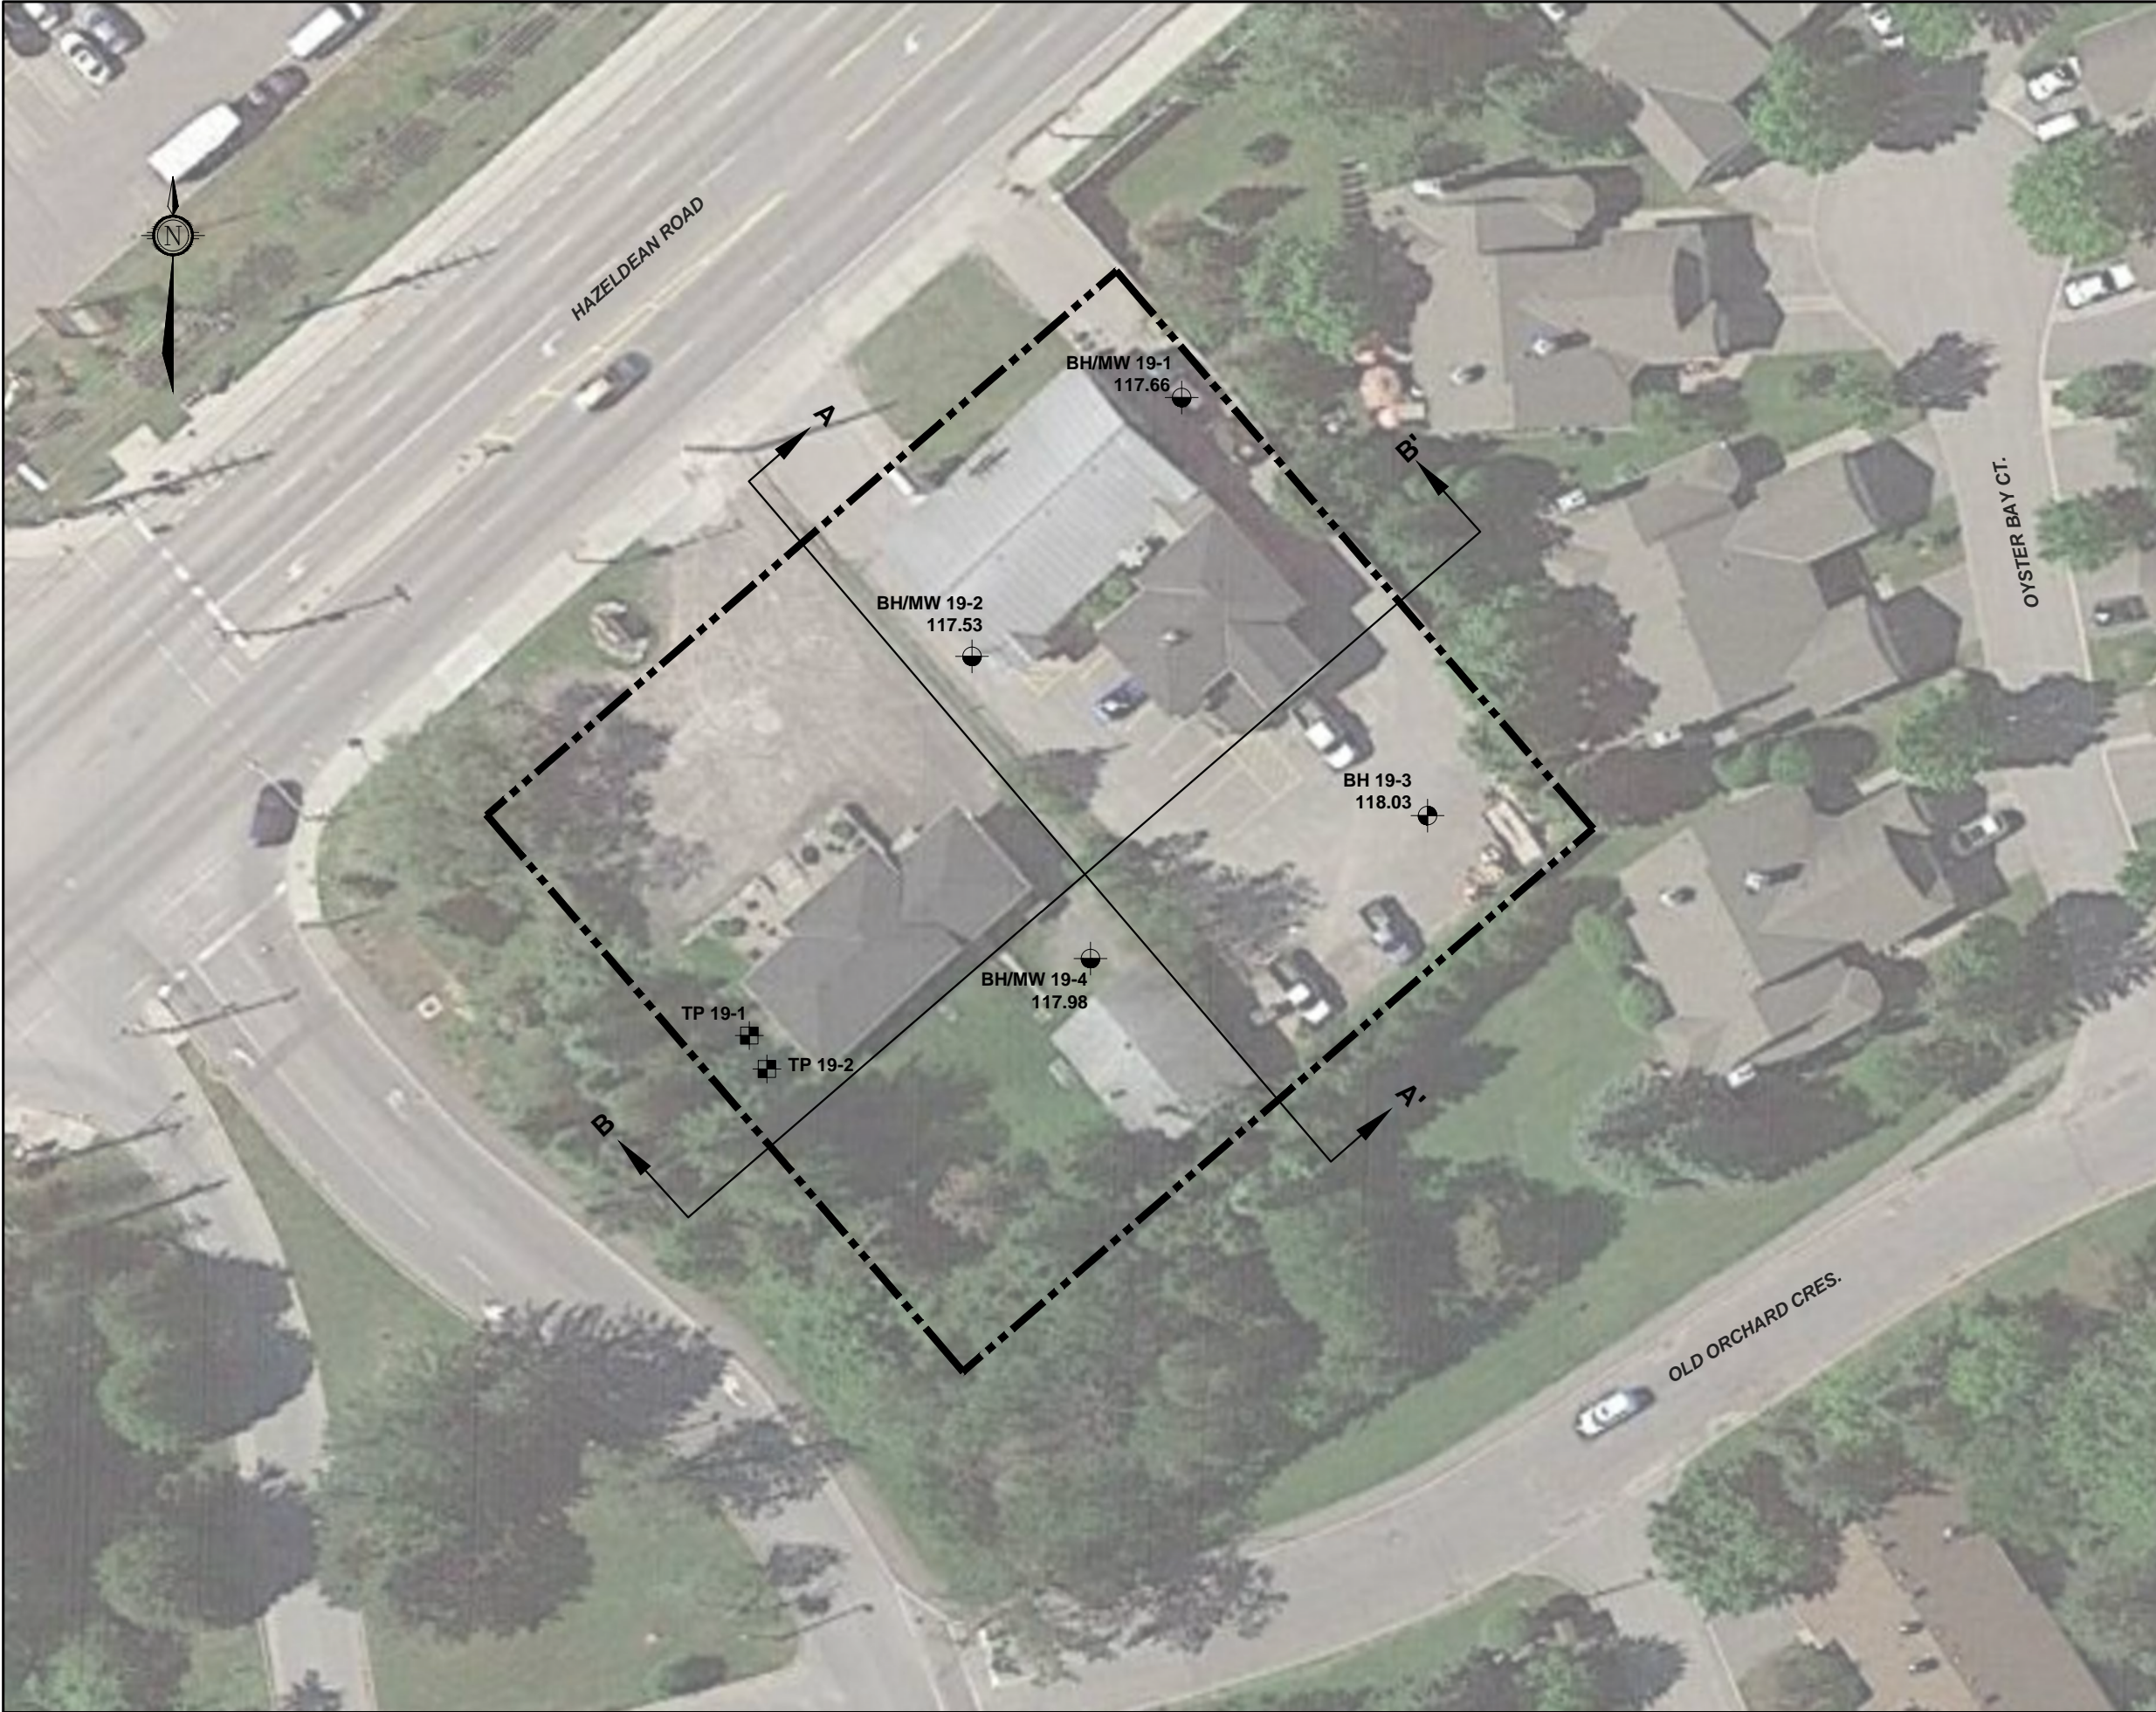
Date AUGUST 2019	Rev. 0	FIGURE 9.2
---------------------	-----------	-------------------

The subject property consists of two separate municipal addresses (5986 and 5992 Hazeldean Road) bounded to the north by Hazledean Road, to the east by residential developments along Oyster Bay Crescent, to the south by Old Orchard Crescent, and to the west by Springbrook Drive, and has an area of approximately 0.35 hectares (0.87 acres). The site layout is depicted on Figure 9.2.

Four boreholes, including three monitoring wells were advanced at the site to assess the soil and groundwater conditions in accordance with the sampling plan described in the Drilling Program from the Phase Two ESA Sampling and Analysis Plan. All boreholes were completed by George Downing Estate Drilling Ltd. All drilling was completed using hollow-stem auger, split-spoon techniques and coring methods. Monitoring wells were installed at three of the boreholes. The installed boreholes/monitoring wells are illustrated on Figure 9.2.

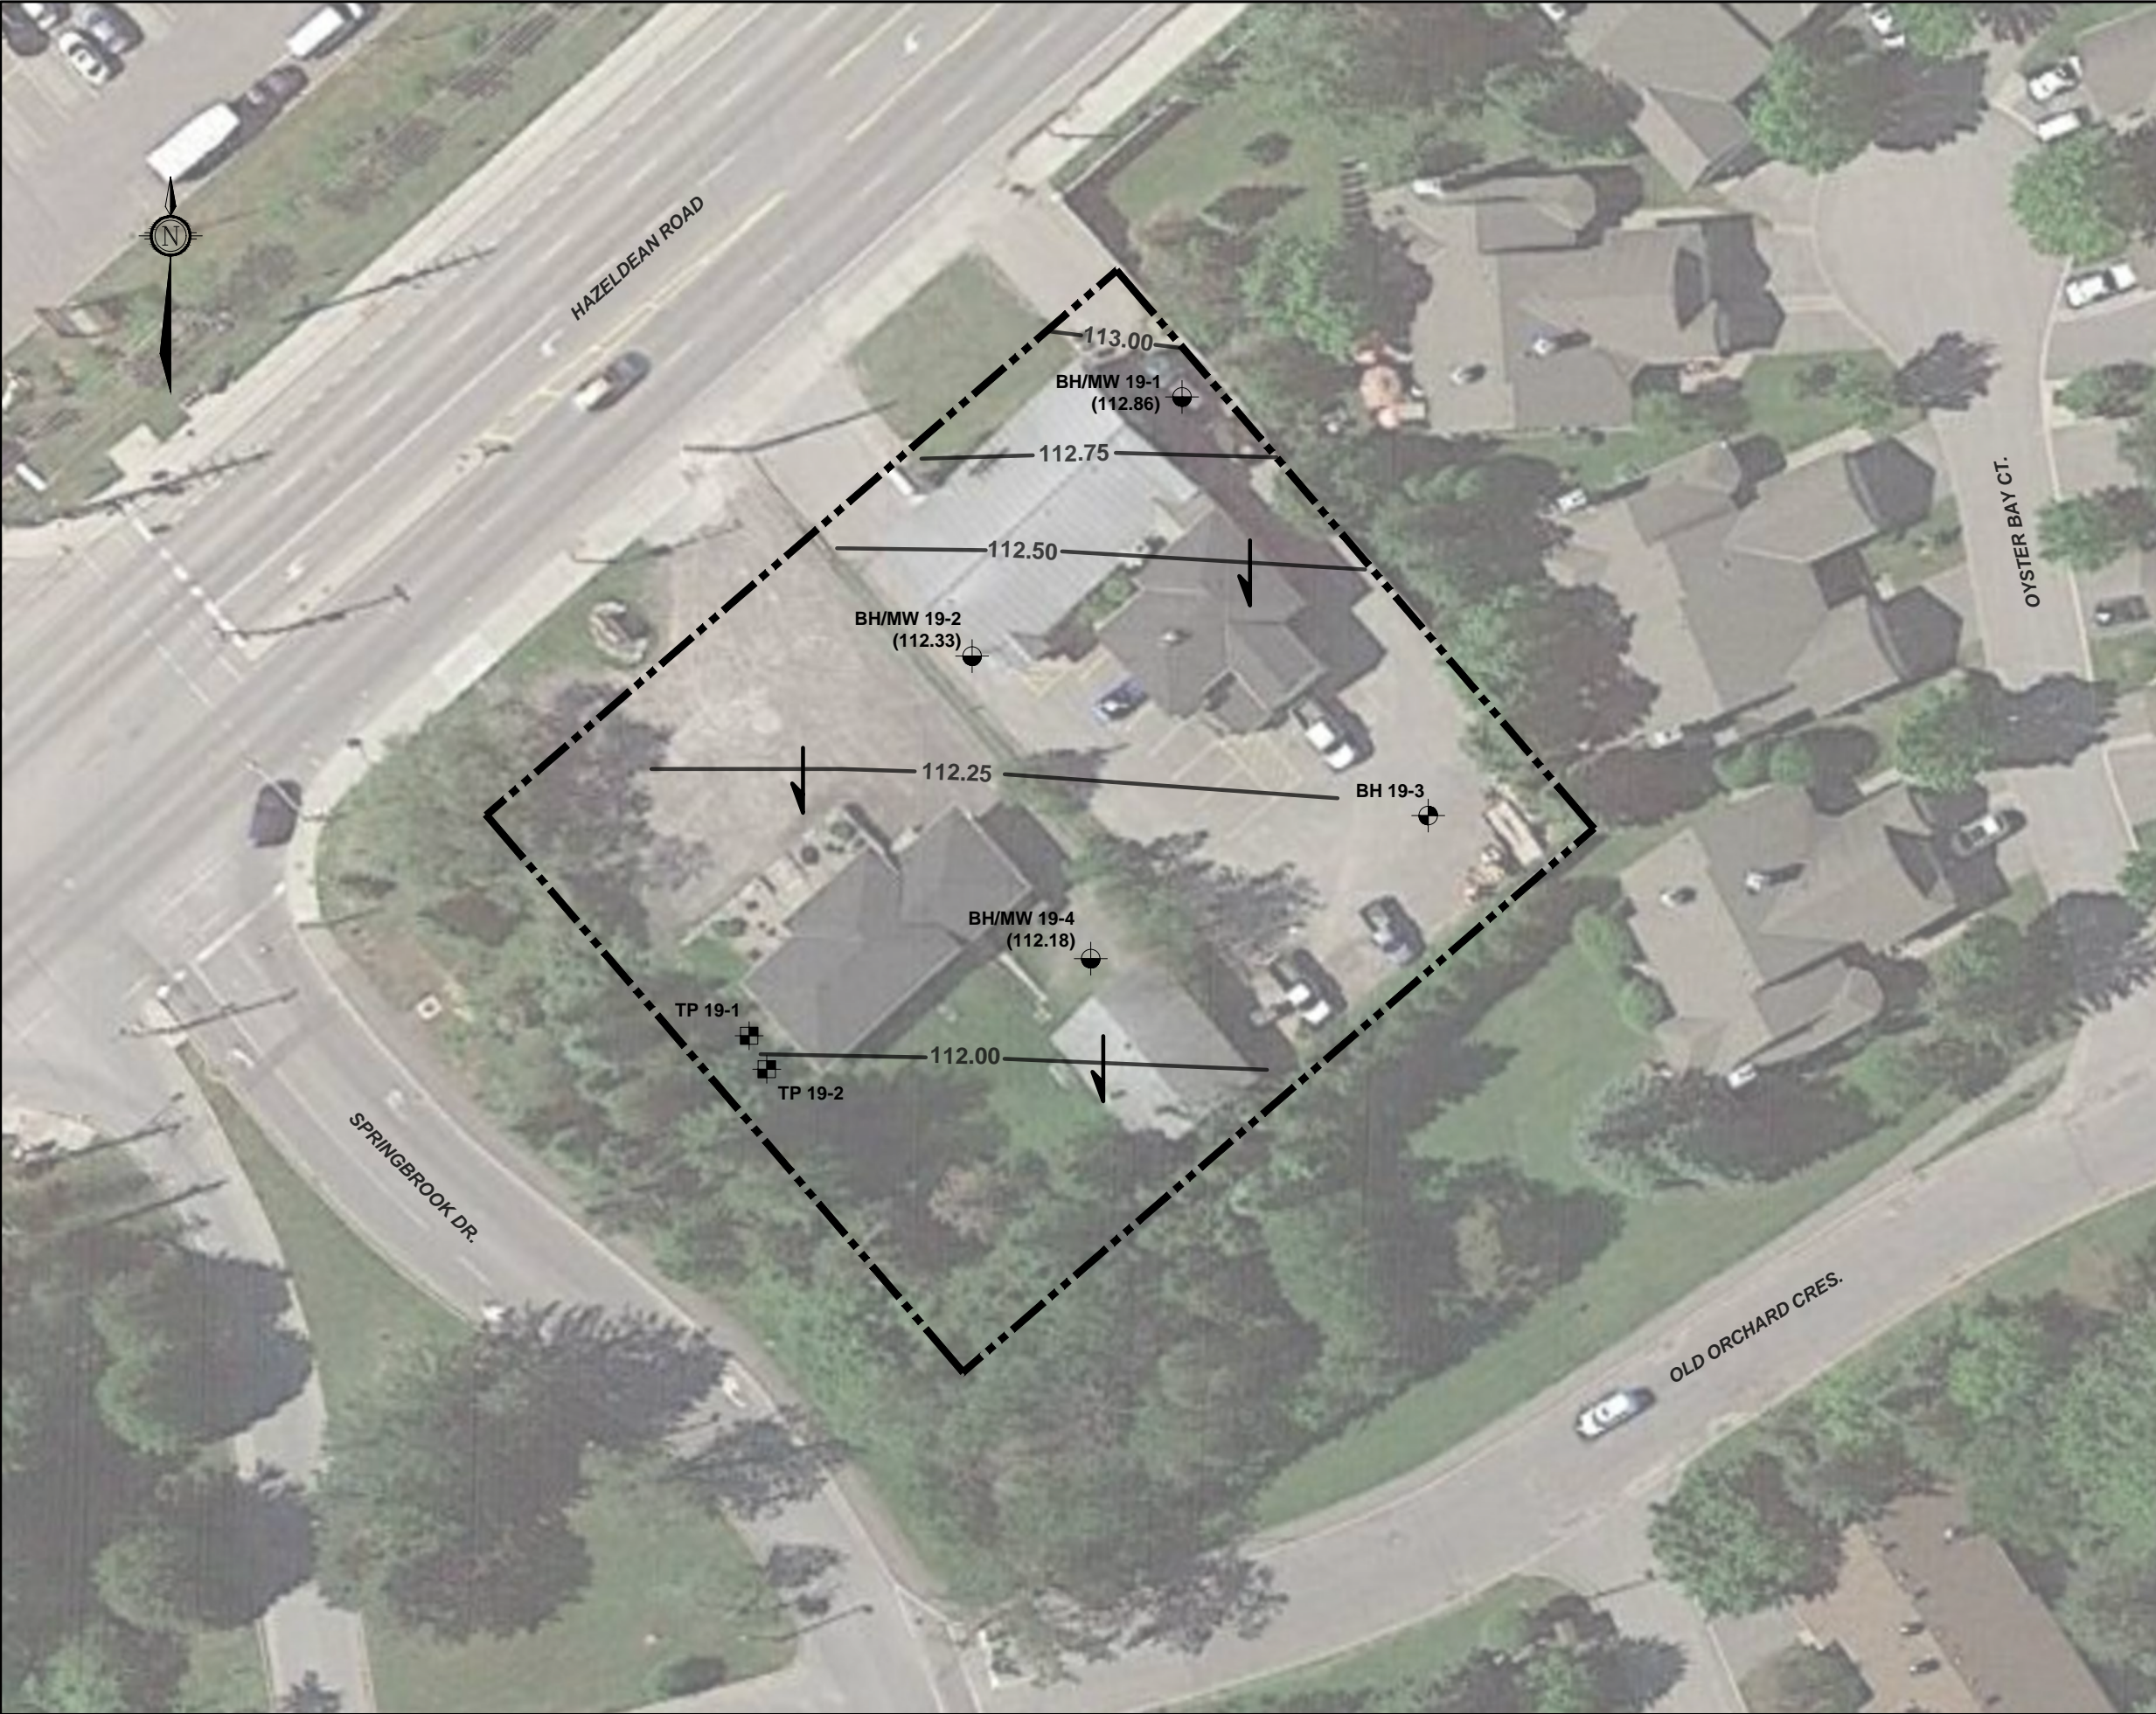
The average horizontal hydraulic gradient is approximately 0.015 m/m. It should be noted that vertical hydraulic gradients were not evaluated for the site as only one water bearing unit was encountered at the depths investigated at the site.

Based on the findings of the Phase One and Phase Two ESA reports, the applicable Site Condition Standards for the future use of the site is *Table 6 Generic Site Condition Standards for Shallow Soils in a Potable Ground Water Condition, Course Textured Soils* (MOE, 2011a). Environmental conditions at the subject site, as part of the Phase Two CSM are illustrated in plan view on Figure 9.4 and in cross sections A-A' and B-B', Figures 9.6 and 9.7, respectively.
