Geotechnical Investigation
Proposed Automobile Body Shop
2113 Carp Road
Ottawa, Ontario

Prepared For
BBS Construction

April 26, 2019

Report: PG4405-1
Revision 2

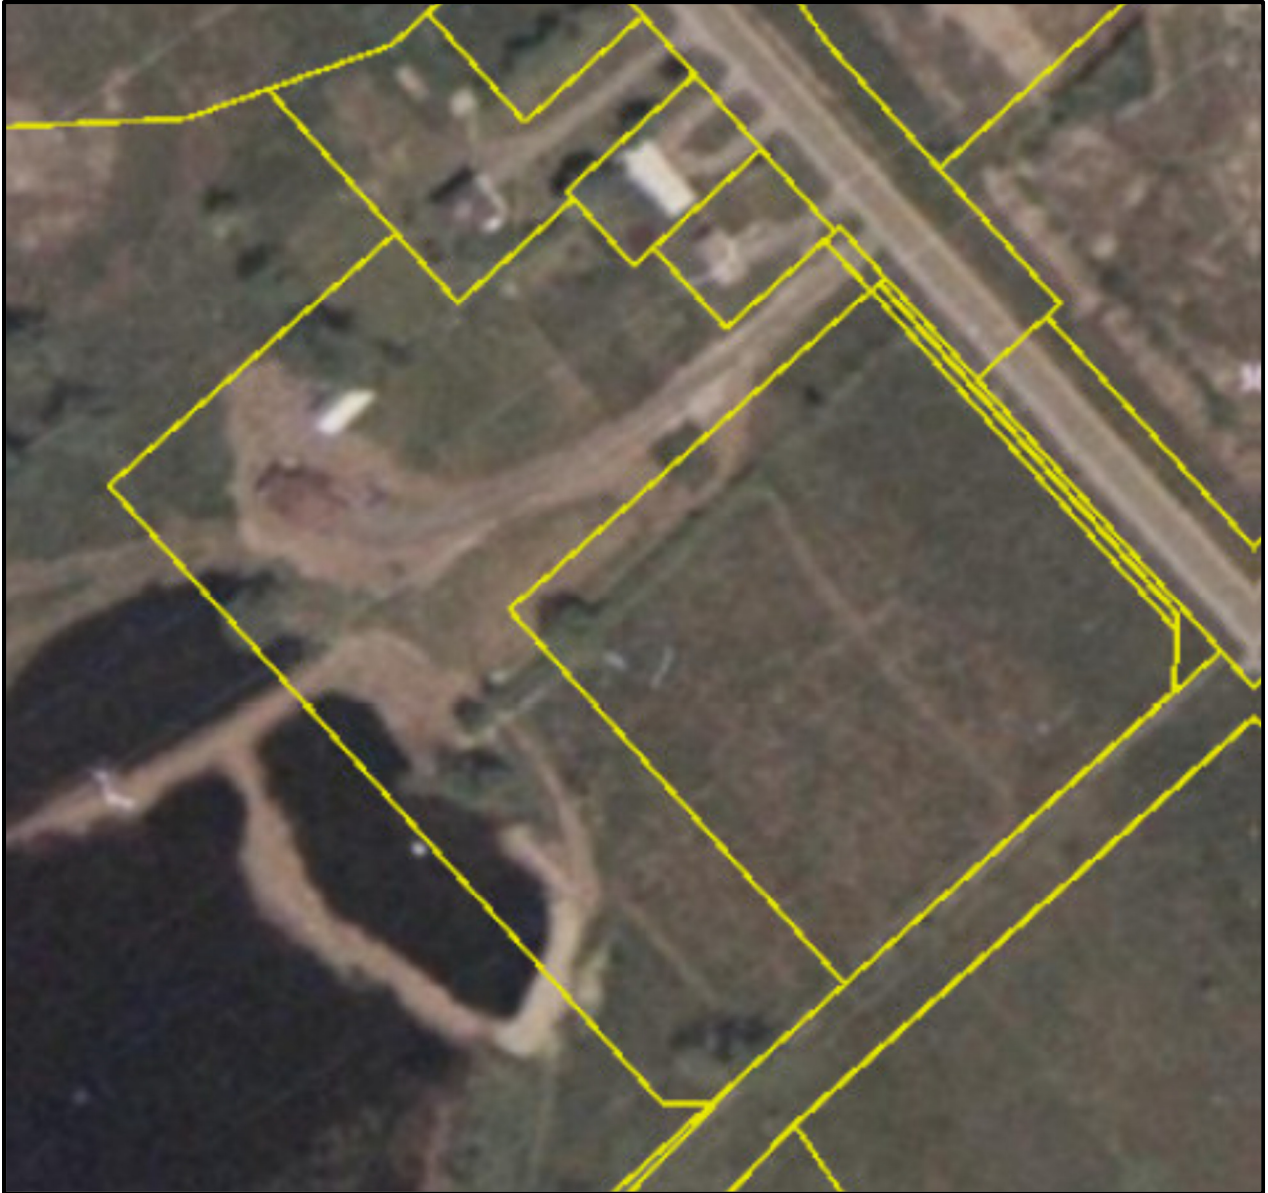
FIGURE 2

Aerial Photograph - 1976

Based on the available historical photographs of the subject site, a former pond occupied the west limits of the site prior to 2008 and was noted to be backfilled in 2009. Reference should be made to the aerial photographs in Figure 2 - Aerial Photograph - 1976, Figure 3 - Aerial Photograph - 1991, and Figure 4 - Aerial Photograph - 2017 which illustrate the approximate limits of the in-filled area.

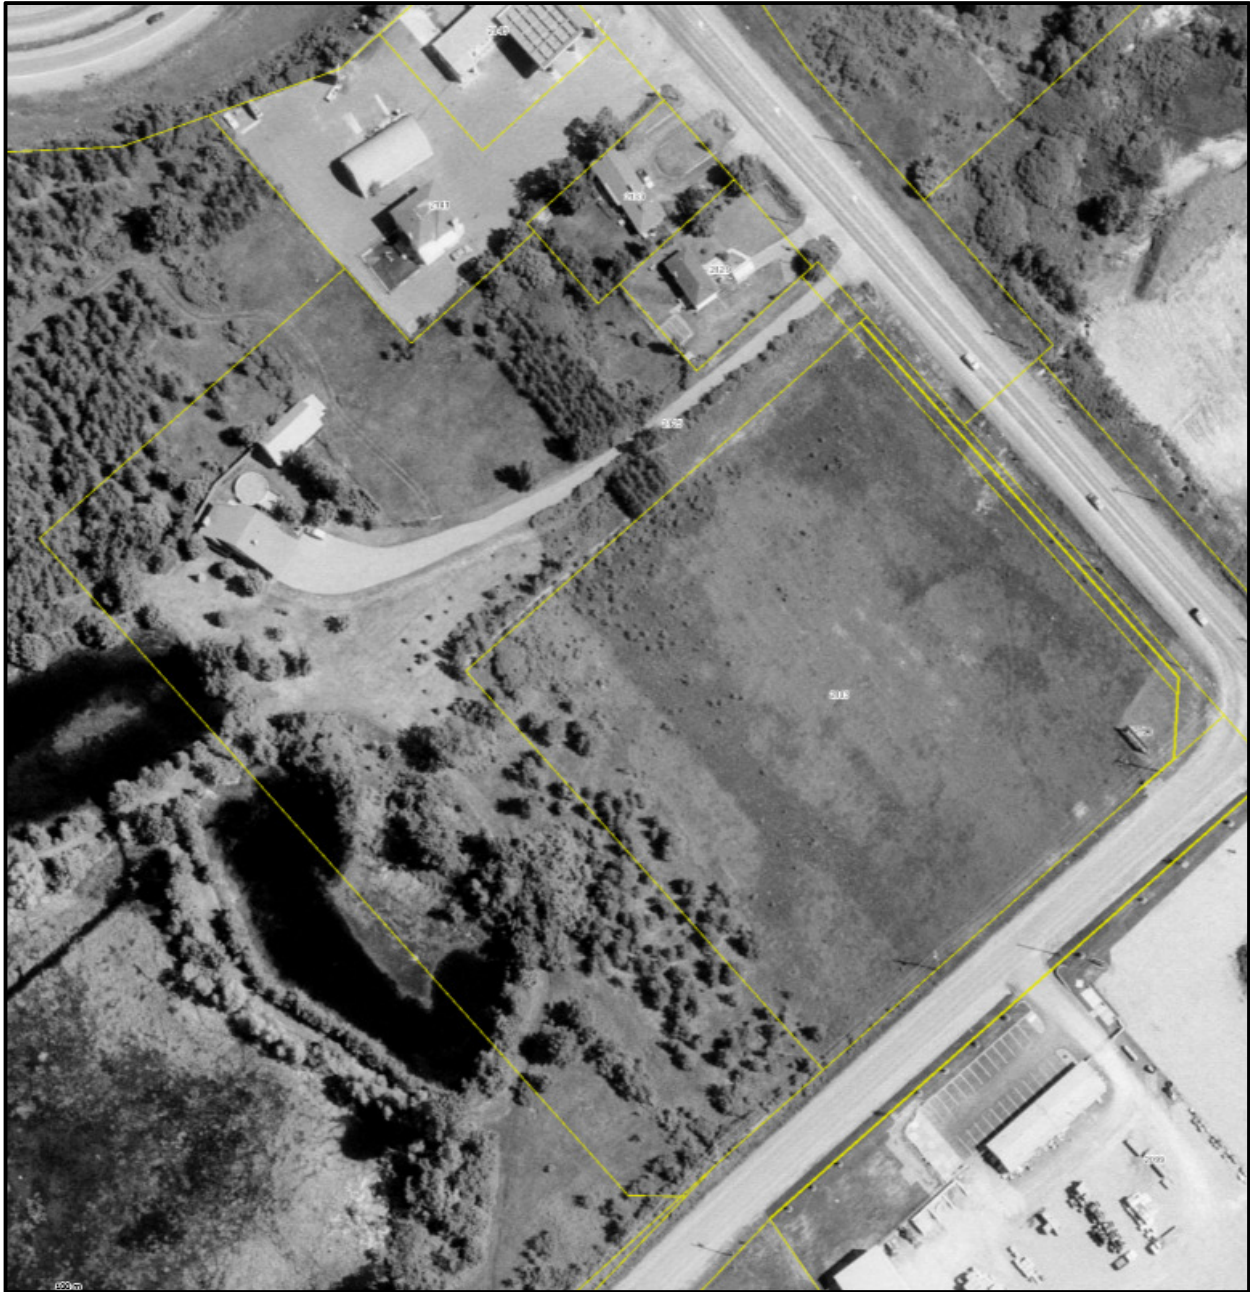
FIGURE 3

Aerial Photograph - 1991

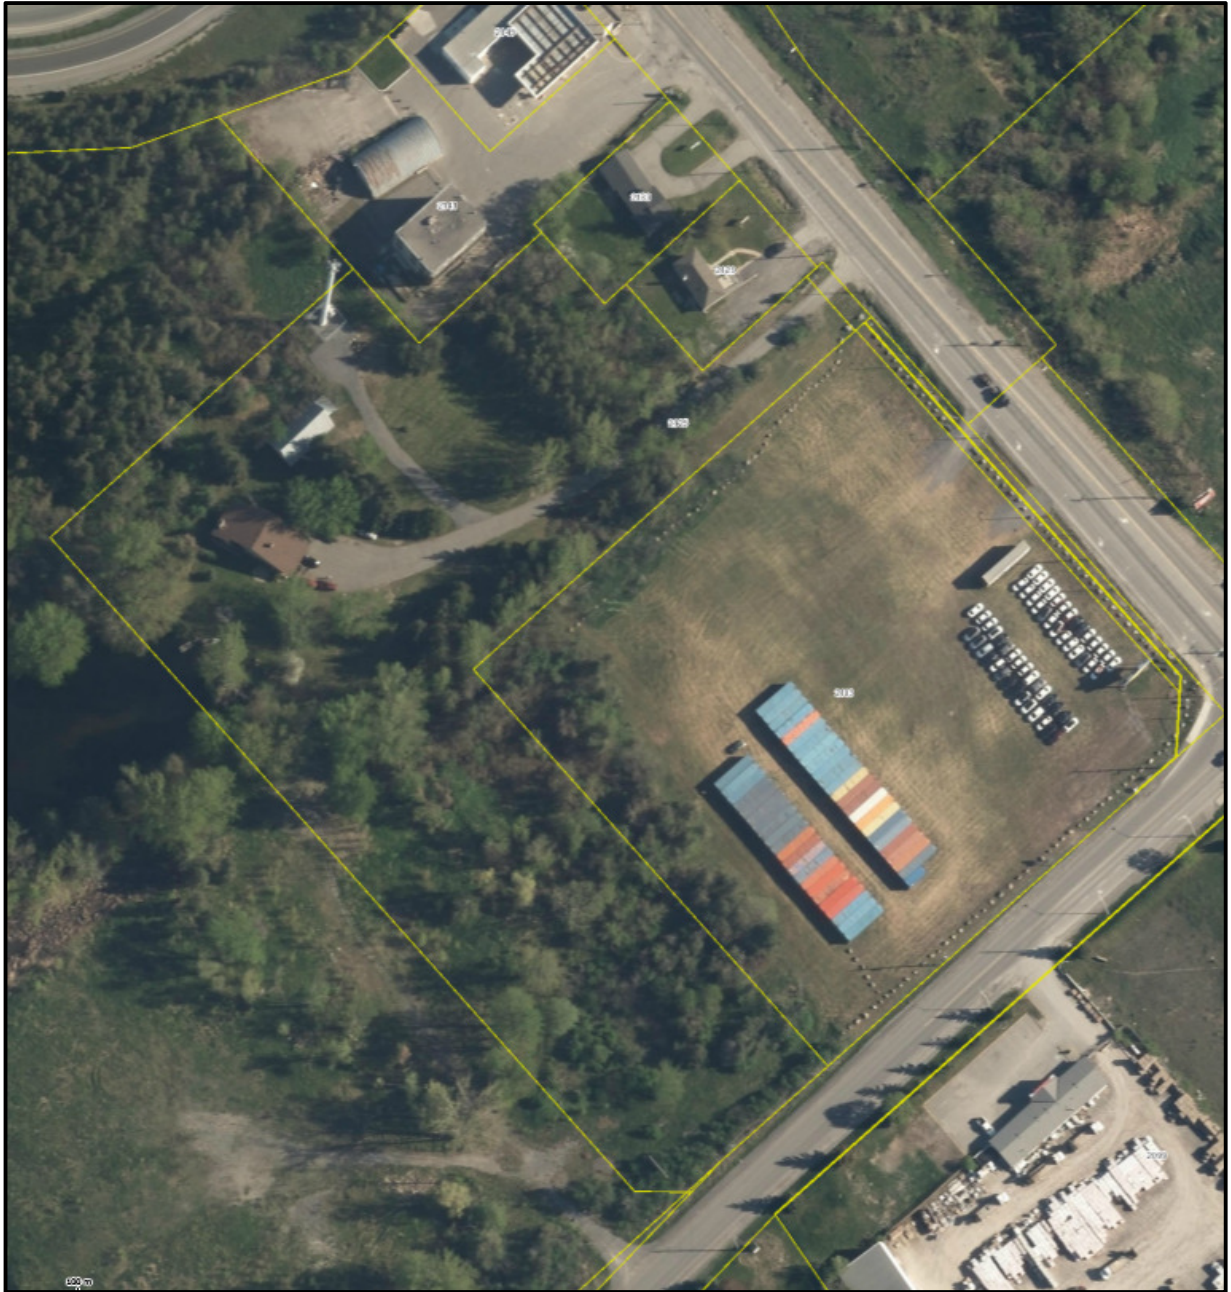
FIGURE 4

Aerial Photograph - 2017
