Cultural Heritage Impact Statement
593 Laurier Avenue, Ottawa

Report Prepared for: Project1 Studio

RMA Project No.: 19094

Date: December 10, 2019

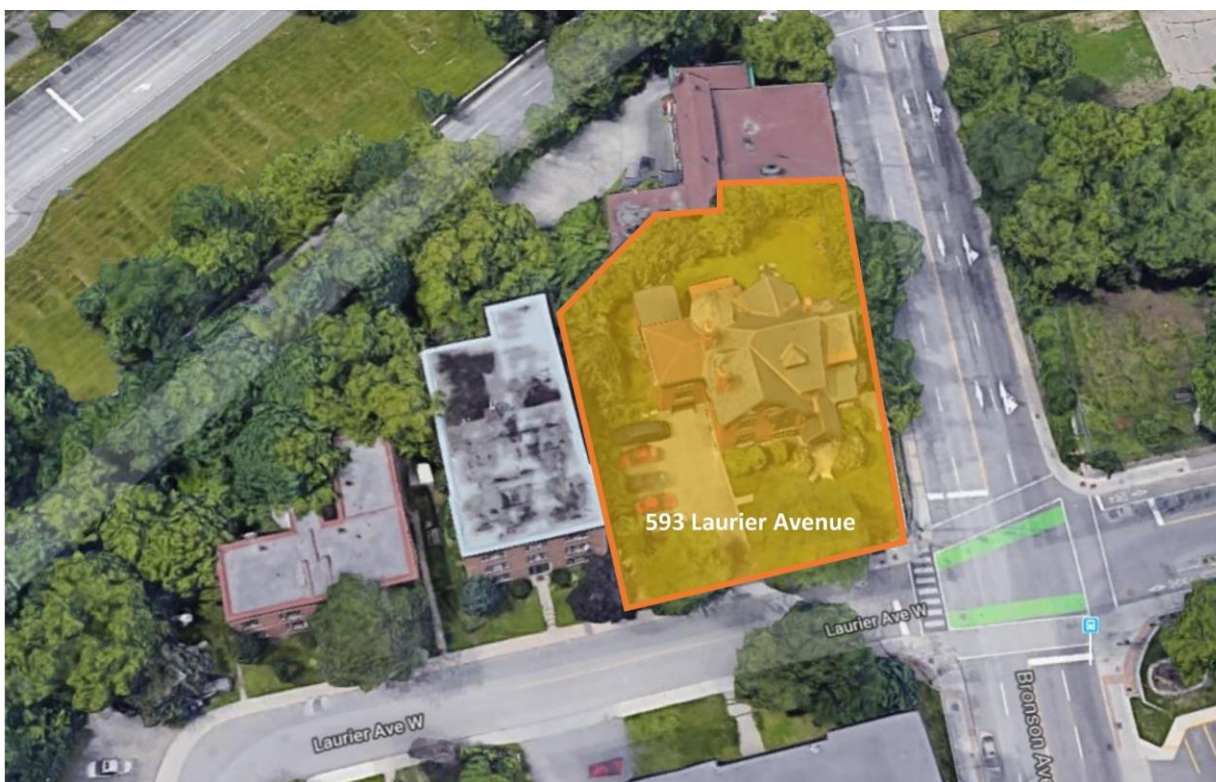
Figure 1: Detail of the property proposed for incorporation within the new development. (Google)

The proposed development is located at the corner of Laurier and Bronson Avenues (northwest corner of intersection), involving one existing lot at 593 Laurier Avenue (see *Figure 1*). The building was designated under *Part V* of the *Ontario Heritage Act (OHA)* (See *Figure 2*)

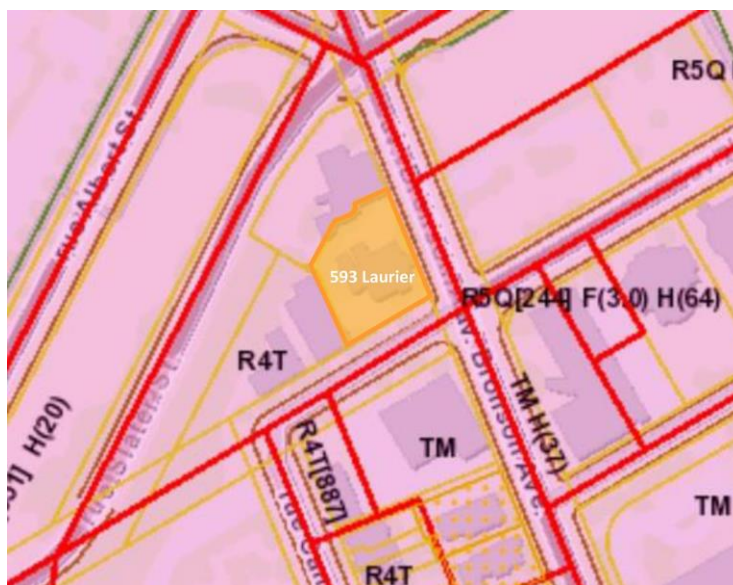
Figure 3: Zoning map of the properties. (maps.ottawa.ca/geoottawa/)

The *R4* zoning is mainly found in inner-urban neighborhoods that were developed in the late 1800's through the mid-twentieth century in recognition of their historically diverse housing stock which has long included low-rise multi-unit dwellings. Within the *R4* zoning category, there is a range of subzones distinguished by a letter at the end of the zone code (e.g. *R4F*, *R4H*, *R4T* etc.). The *R4T* falls under a subzones category that do not state a limit on the number of permitted units (see Figure 3).

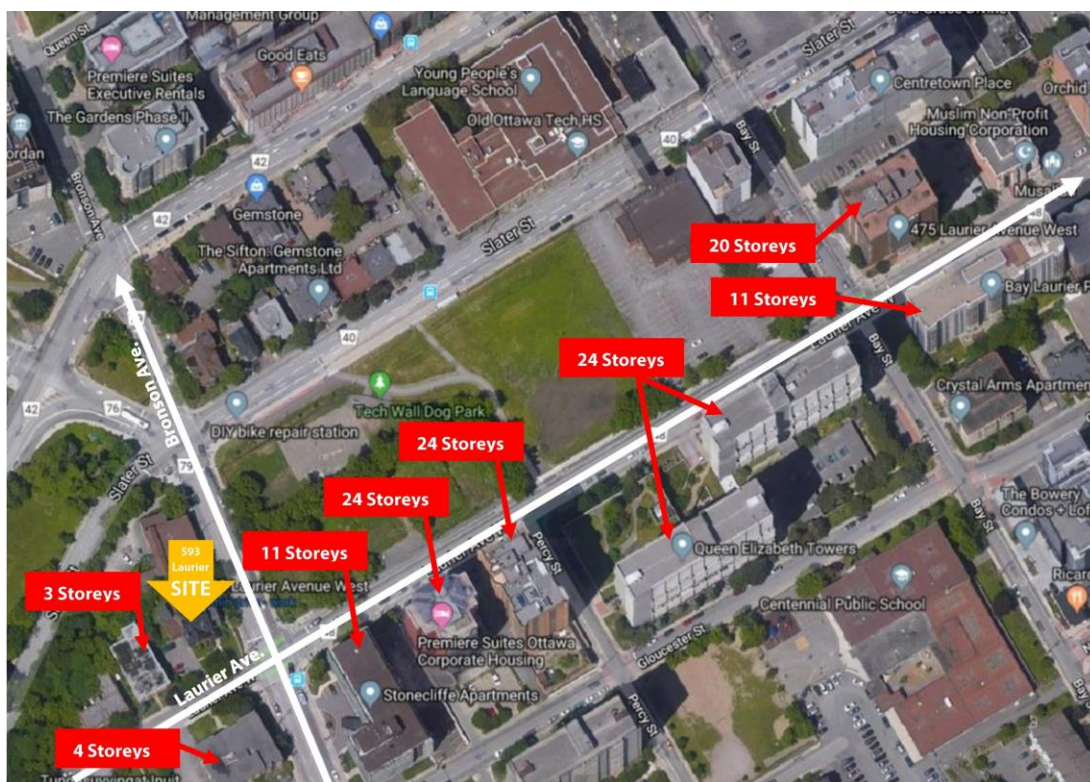
Figure 4: Height of surrounding buildings. (Google)

The site of the proposed development is situated on the corner of Laurier and Bronson Avenues. This neighbourhood underwent considerable densification through time. It consists of a mixture of low, medium and high-rise apartment buildings along Laurier Avenue with heights ranging between 11-24 storeys (See Figure 3). These new developments are mainly located to the south of Laurier Avenue, as the *Nanny Goat Hill Community Garden* occupies the area to the north of Laurier Avenue. However, the adjacent buildings to the development site do not exceed 4 storeys. Single residential units cannot be found at the immediate boundary of the development site; however, a few more modest single residential properties are located on Cambridge Street close to Laurier Street. Further north, similar heritage buildings are still preserved at the corner of Bronson Avenue and Slater Street (see Figures 4, 5 and 6).

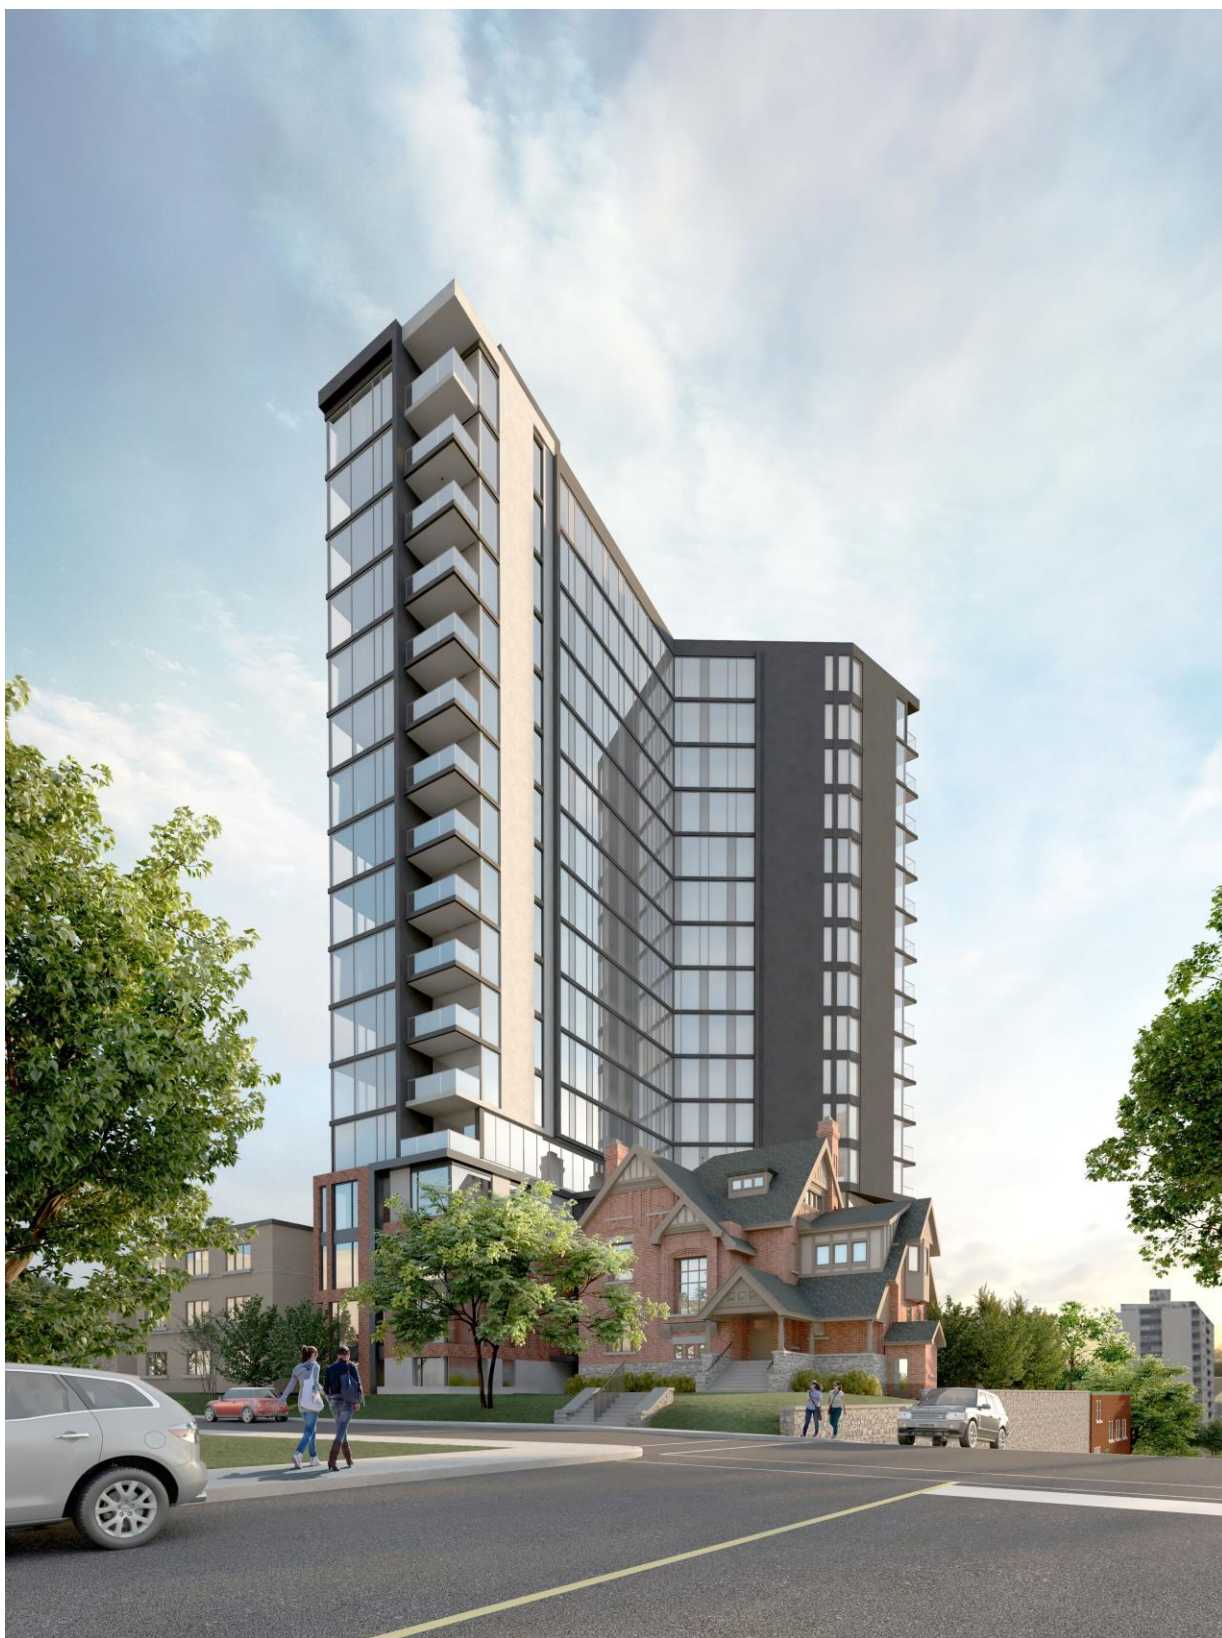
Figure 12: Model of the proposed development from the southeast. (Project1 Studio Incorporated)

The new building consists of an obtuse L-shape 16/17 storey block that surround the existing building at the west. The façade of the new tower that looks toward the future public library's Main Branch location has nice architectural vertical elements and design. The obtuse shape does not obscure the visibility of the heritage building viewed from the north, south and east. Nevertheless, the design of the projecting façade on the existing building is very simple highlighting the horizontal division between the different storeys. The main entrance of the building is the entrance of the Fleck house.

The new development appears to mimic the materiality and linear forms of the heritage building and the remaining buildings in the area throughout the new construction with the use of similar red brick and stone masonry for the podium.

Recommendation 1: Consider further refinement of the south façade's design.

The current design of the south façades could be in greater harmony with the heritage building on the site. Consideration for ensuring the continuity of the datum line and materiality (grey stone base and brick façade) on the western half of the south façade of the podium is encouraged. A simple elegant podium has the best chance of allowing the heritage building to remain as the focal point.

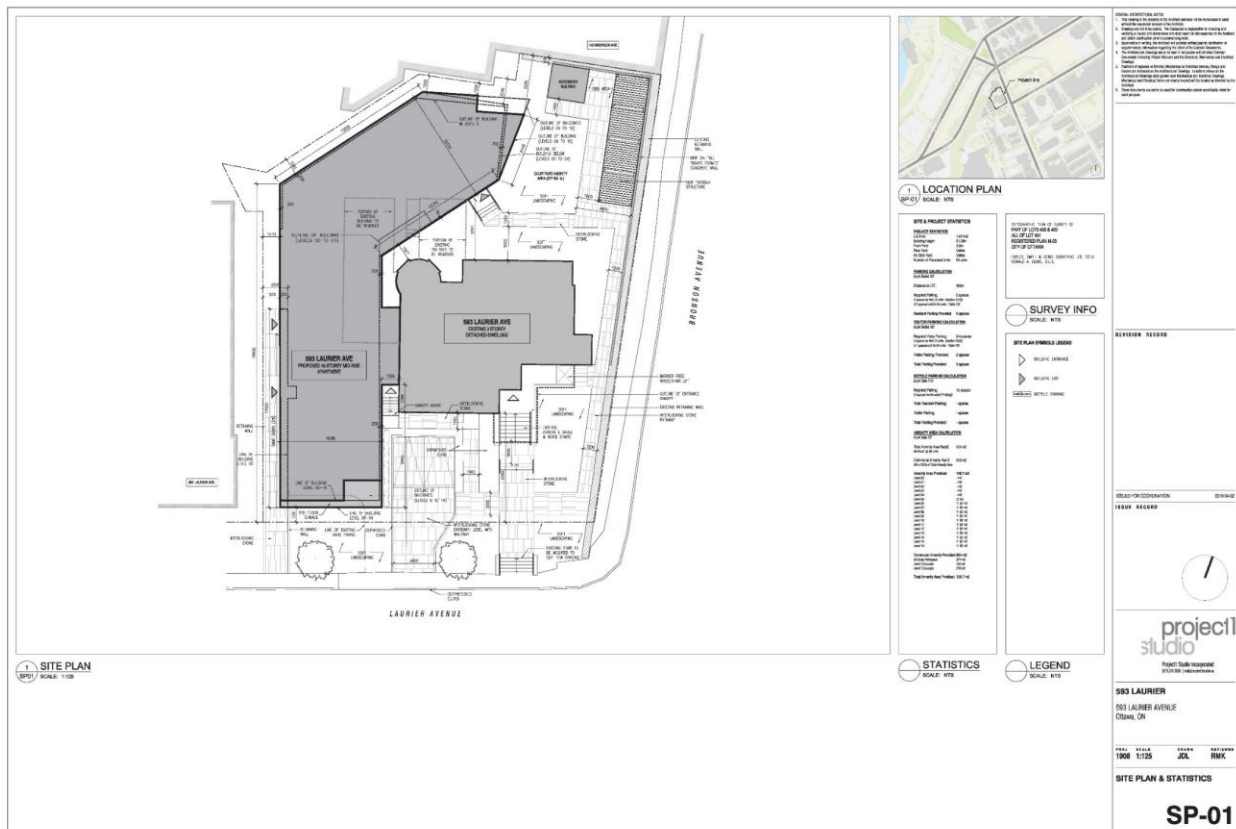
Figure 13: Site plan of the proposed development. (Project1 Studio Incorporated)

- The tower is close to the building at the west. The distance between the facades at the connection of the new and the existing building is narrow and becomes narrower at the Turret;
- The design of the podium's south façade is not fully in harmony with the heritage building in terms of datum lines, simple massing and materiality that will serve as a "foil" to the heritage building.

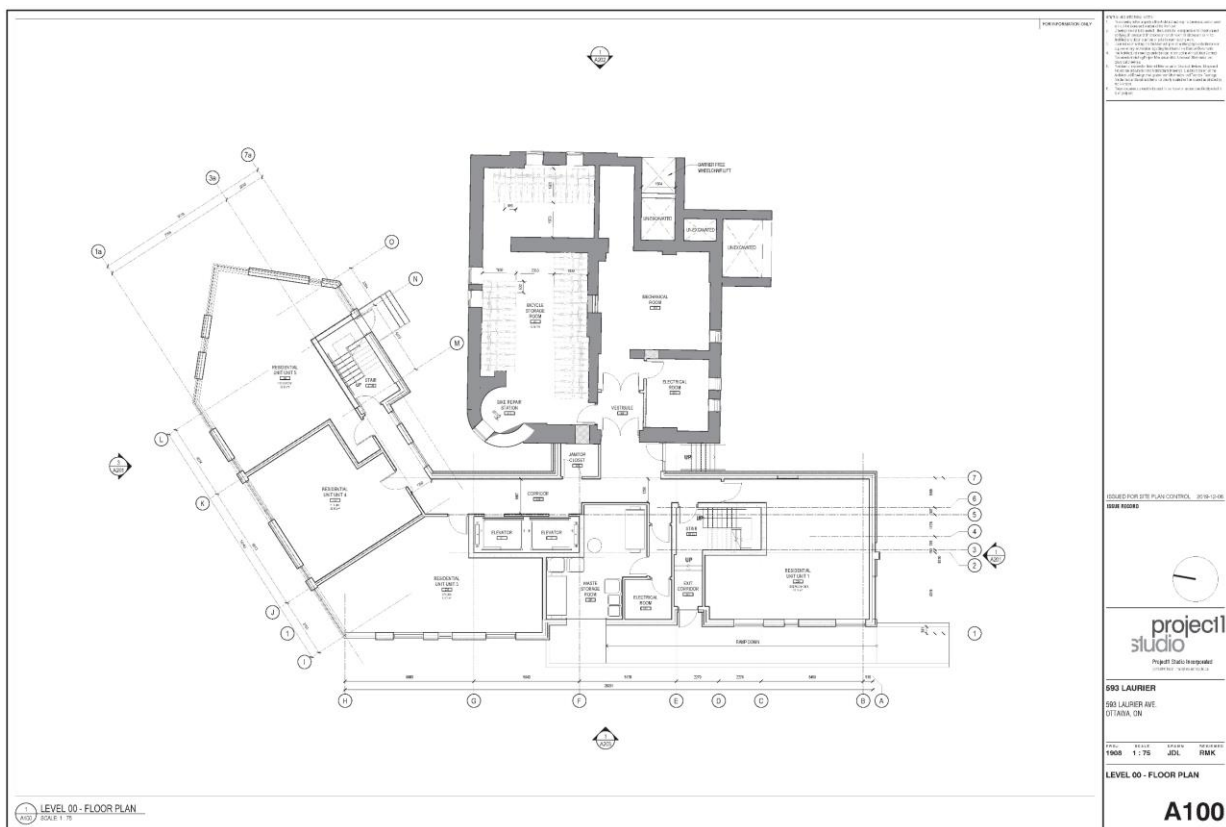
Figure 14: Plan of entrance level. Note the distance between the turret and the new tower. (Project1 Studio Incorporated)

The existing building is close to the new tower in the current design; this distance becomes even tighter at the turret. Alternative solutions need to be explored to ensure sufficient distance between the heritage building and the new development and some detailed study of the careful connection between old and new is advised.

Recommendation 2: *Explore alternate/improved design of the gasket connection.*

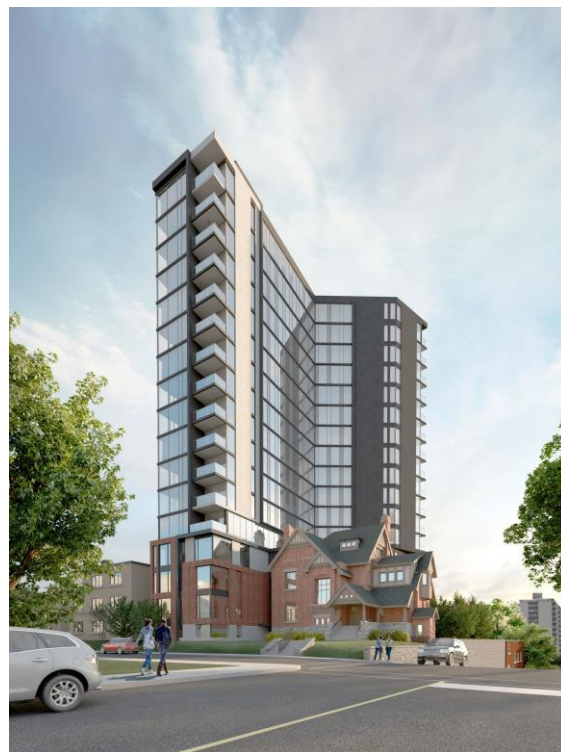
Figure 19: Model of the proposed development from the south. (Project1 Studio Incorporated)

In addition, the tightness of the 'gasket' connection between the new development and heritage building could be improved. The design of the podium's south façade is somewhat incoherent; it splits the façade visually into two vertical parts giving the impression that the 'datum line' and materiality (stone base and brick façade) in reference to the existing building facades on Laurier Avenue is respected only by the part adjacent to the heritage building. The continuity of the 'datum line' and materiality interrupts at the center line of the podium's south façade where the brick masonry becomes higher and covers the entire podium façade.
