**Geotechnical Investigation  
Proposed Addition  
Canadian Bank Note  
975 Gladstone Avenue  
Ottawa, Ontario**

January 28, 2020  
Project: 62463.84

**Re: Geotechnical Investigation  
Proposed Addition  
Canadian Bank Note,  
975 Gladstone Avenue  
Ottawa, Ontario**

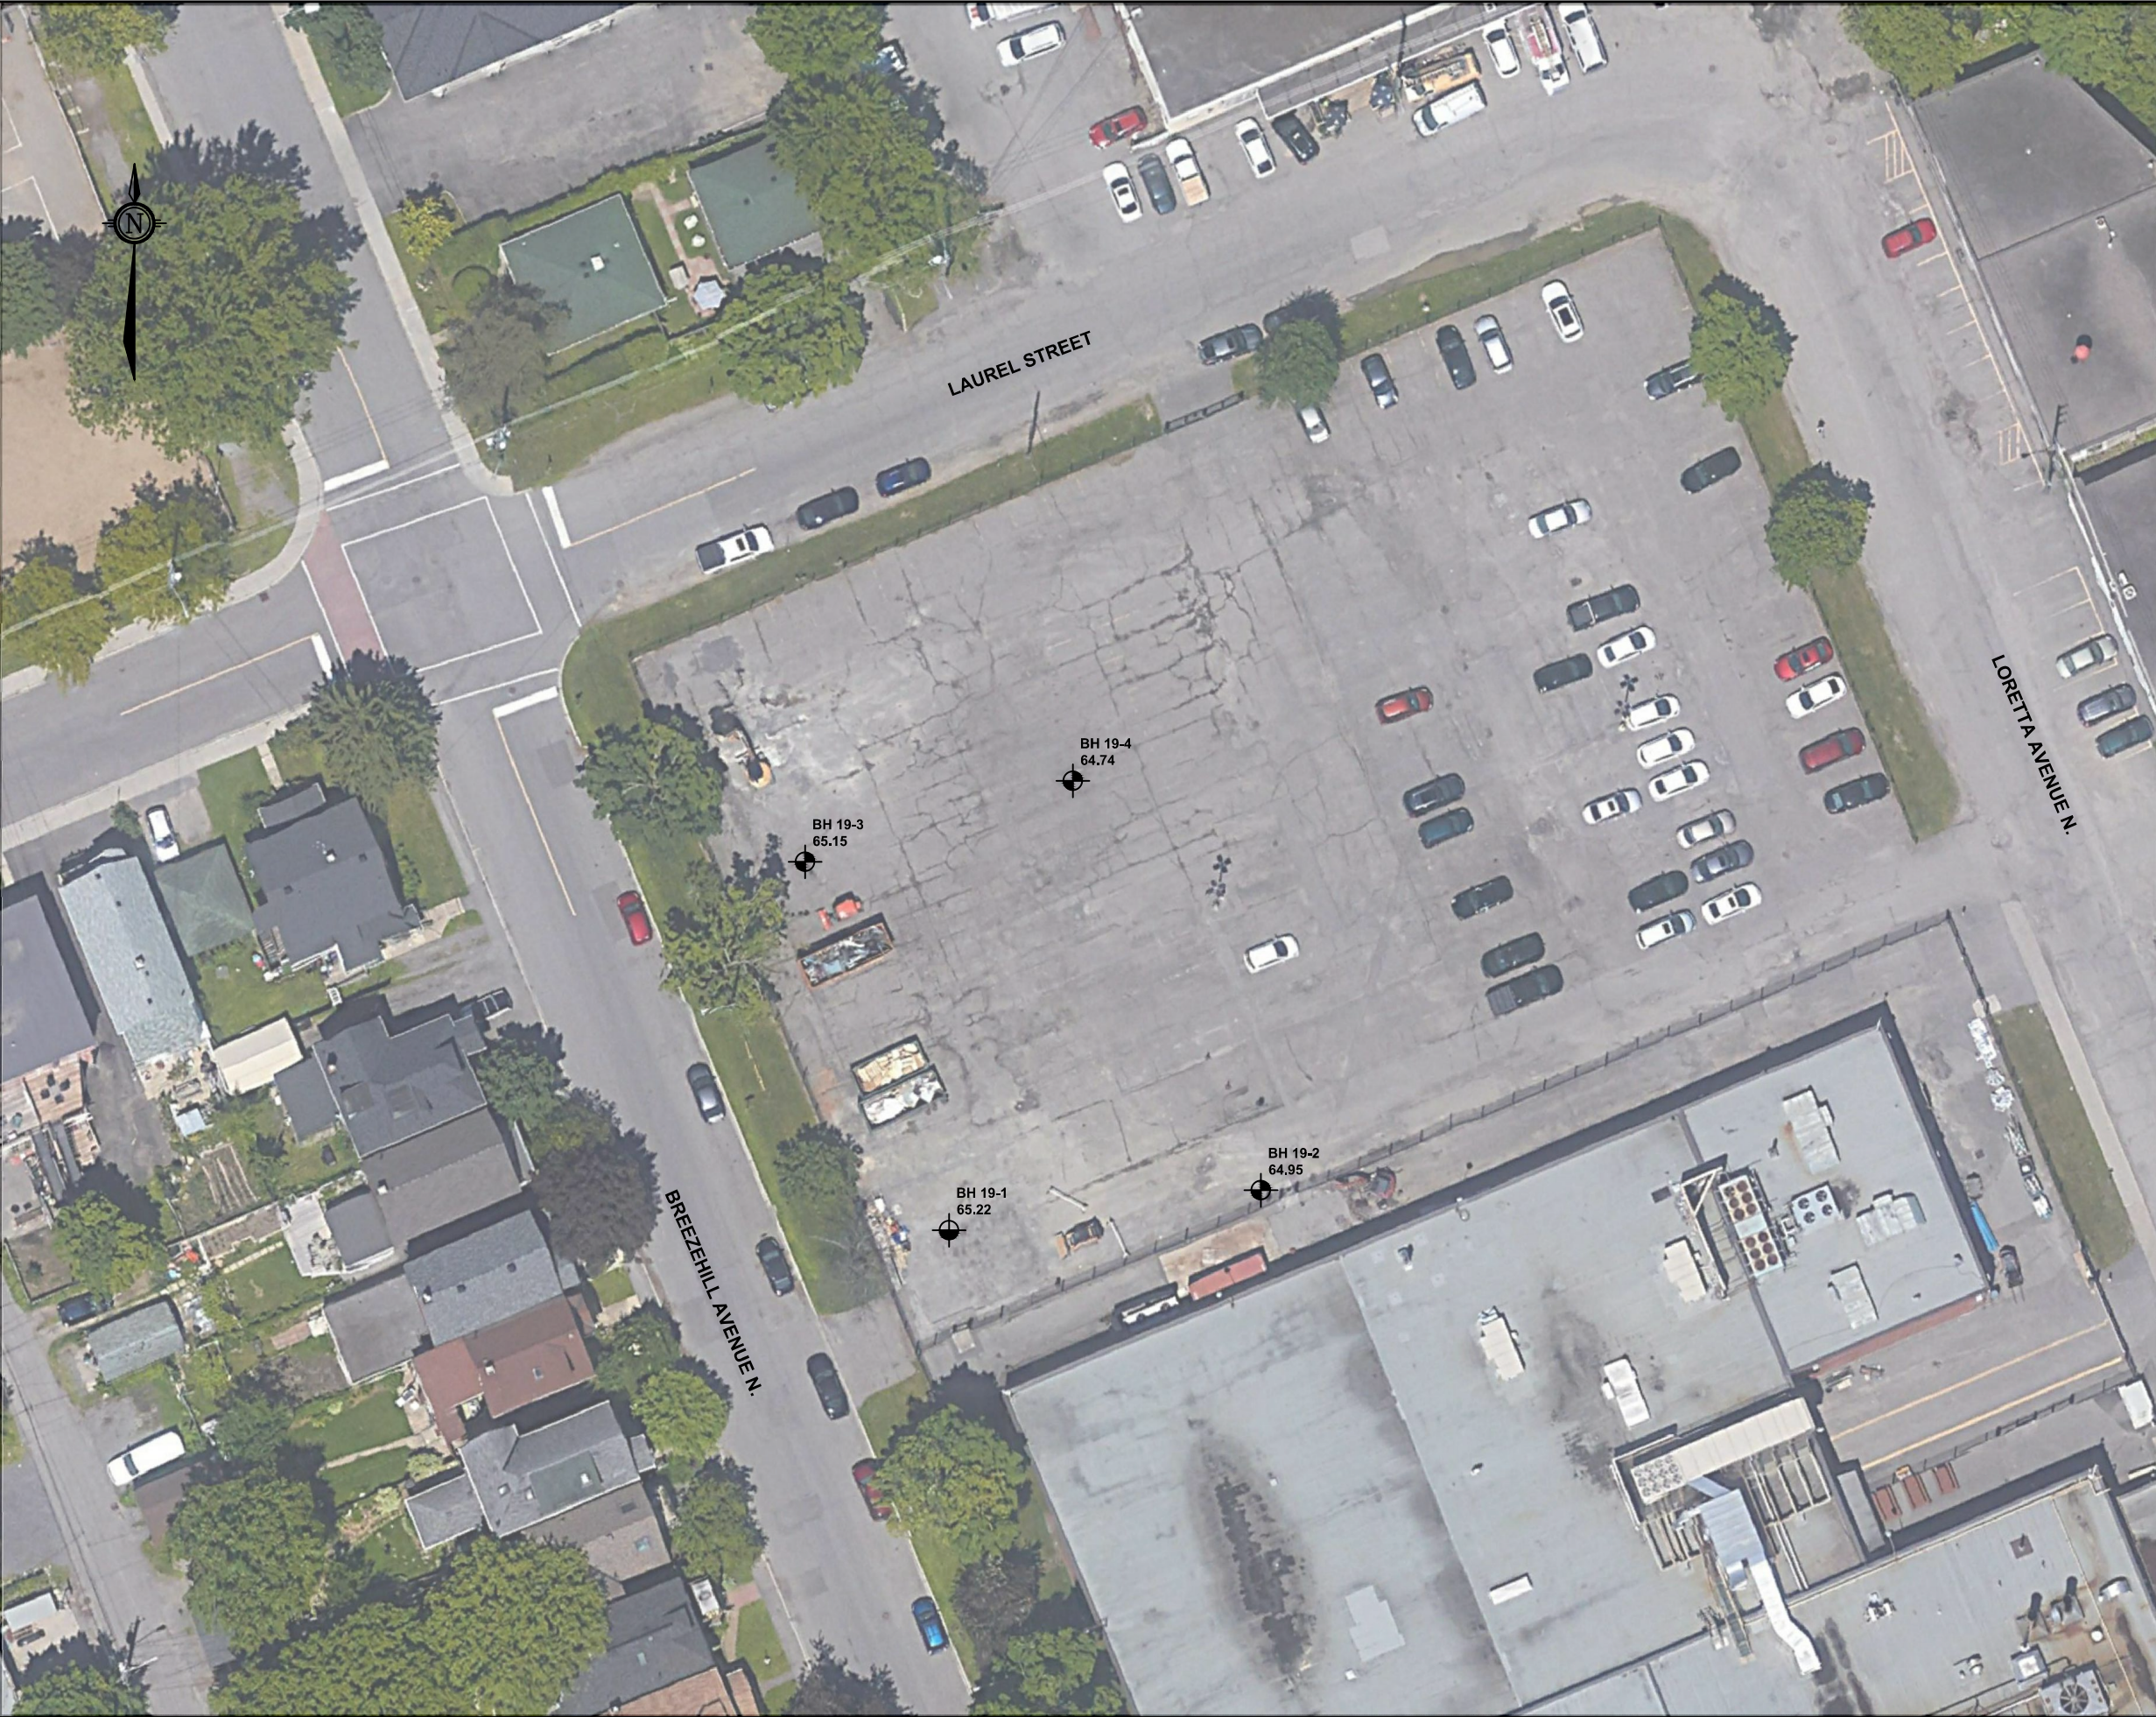
Figure 1: Borehole Location Plan

The results of the boreholes are provided on the Record of Borehole sheets in Appendix A. The locations of the boreholes are shown on the Borehole Location Plan, Figure 1. The results of the laboratory classification testing are provided on the Record of Borehole sheets and in Appendix B. The results of the chemical analysis related to corrosion of buried steel and concrete on the soil sample collected is provided in Appendix C.

The field work for the borehole investigation was carried out on May 27, 2019. During that time, four (4) boreholes, numbered 19-1 to 19-4, inclusive, were advanced within the footprint of the proposed building using a truck mounted drill rig supplied and operated by George Downing Estate Drilling Ltd. of Grenville-Sur-La-Rouge, Quebec. The boreholes were advanced to depths between approximately 6.7 and 7.4 metres below the existing ground surface level.
