Transportation Impact Assessment

Waterford Ottawa Senior Apartments
2431 Bank Street
Transportation Impact Assessment

May 1, 2020

Novatech File: 119247
Ref: R-2020-037

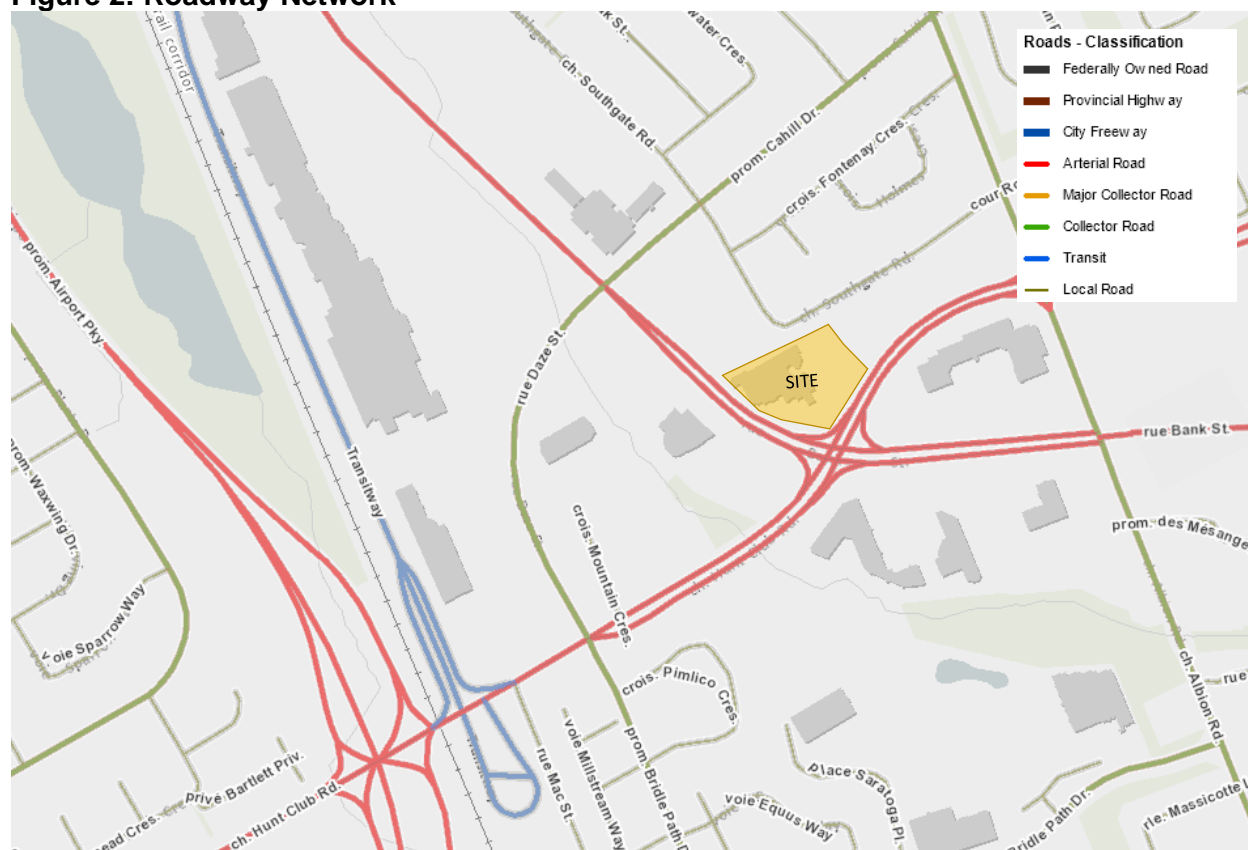
Figure 2: Roadway Network

The roadway network of the greater area surrounding the subject site is illustrated in **Figure 2**.

Bank Street is a two-way arterial roadway that runs on a north-south alignment and has a four-lane divided urban cross section adjacent to the subject site. Bank Street is classified as a truck route. The posted speed limit is 60km/h and concrete sidewalks are provided along both sides of Bank Street. The City of Ottawa's Official Plan identifies a right of way (ROW) protection of 37.5m along Bank Street between Riverside Drive and Hunt Club Road. The road widening, as identified in the City's Official Plan, is shown on the site plan.

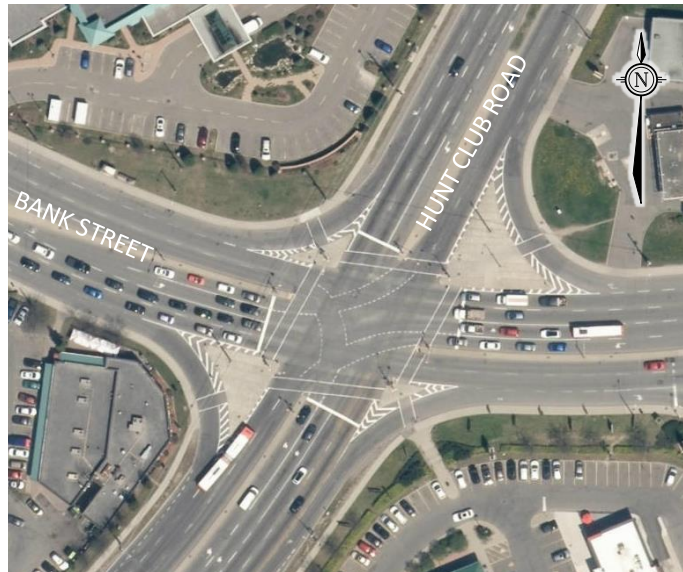
Bank Street/Hunt Club Road

- Signalized intersection
- Eastbound/Westbound: two left turn lanes, two through lanes, one channelized right turn lane
- Southbound: one left turn lane, two through lanes, one channelized right turn lane
- Northbound: two left turn lanes, two through lanes, one channelized right turn lane
- Standard crosswalks provided on all approaches
