Our File Ref.: 170132.04

The Hindu Temple of Ottawa Carleton Inc.
4835 Bank Street
Ottawa, Ontario K1X 1G6

Subject: Terrain Analysis and Private Sewage Disposal System Impact Assessment
- Proposed Assembly Hall
The Hindu Heritage Centre of Ottawa Carleton, 4835 Bank Street, Ottawa,
Ontario

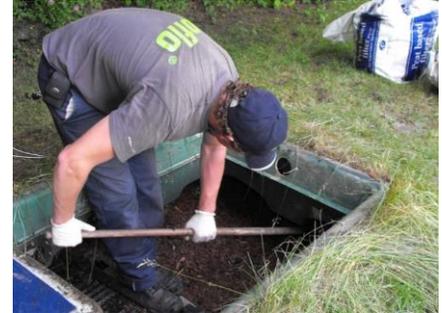
Ecoflo® Coco Filter-ECDn with Pump

Ecoflo® Coco Filters-ECDn unit are equipped with a pump that directs the treated effluent to an appropriate disposal mean according to local regulations and the primary tank via the recirculation line. The electro-mechanical components are included in this system. To learn more about electro-mechanical components, consult the Timed Dosing Units TPA-350DN Installation Guide and Owner's Manual.
